2017 UNDERWATER BRIDGE INSPECTION REPORT

BRIDGE # 70532 QUAKER AVE over Minnesota River

Date of Inspection: 05/25/2017

Contractor: Collins Engineers, Inc.

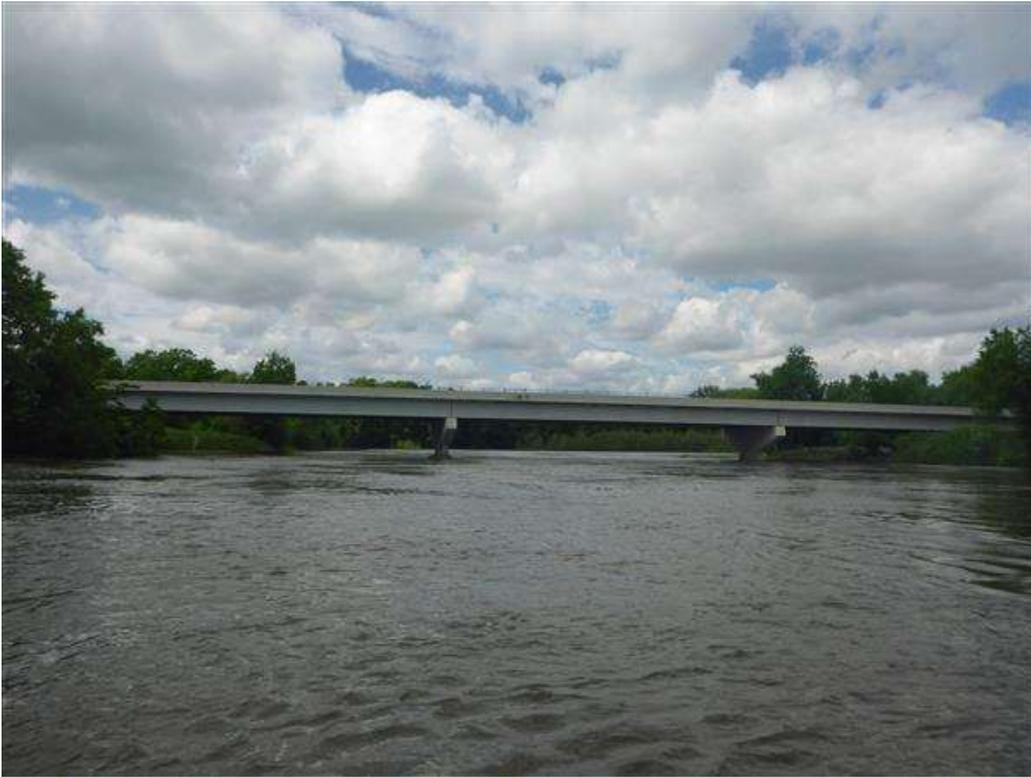
Photo 1 - East Elevation Looking West

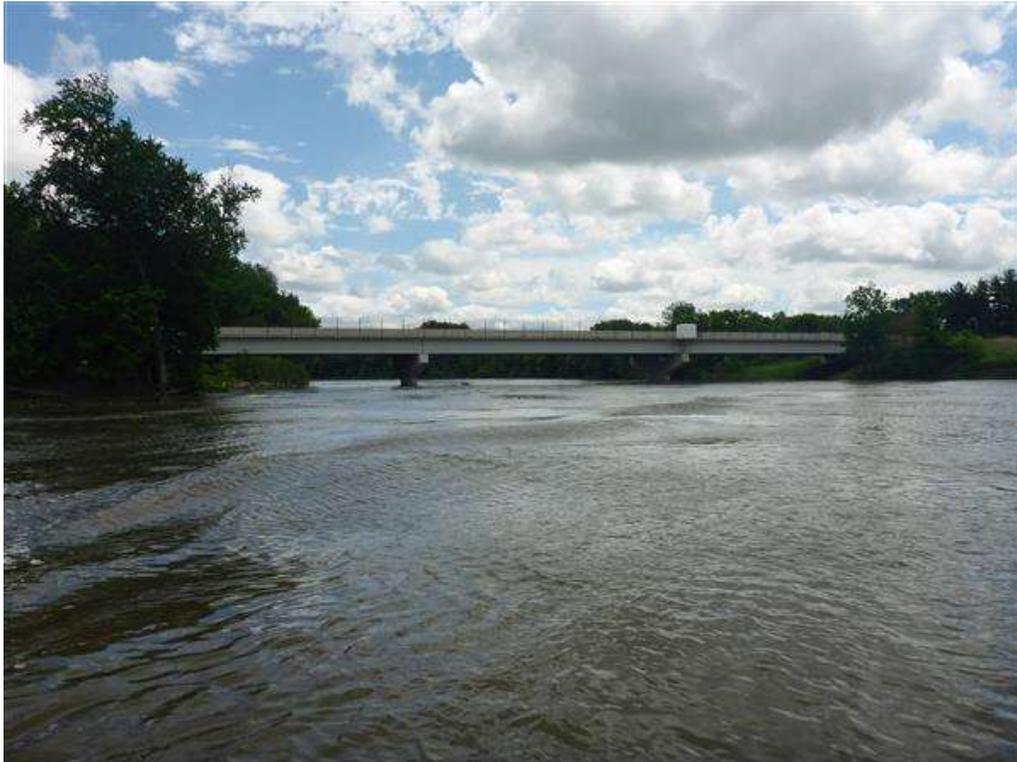
Photo 2 - West Elevation Looking East

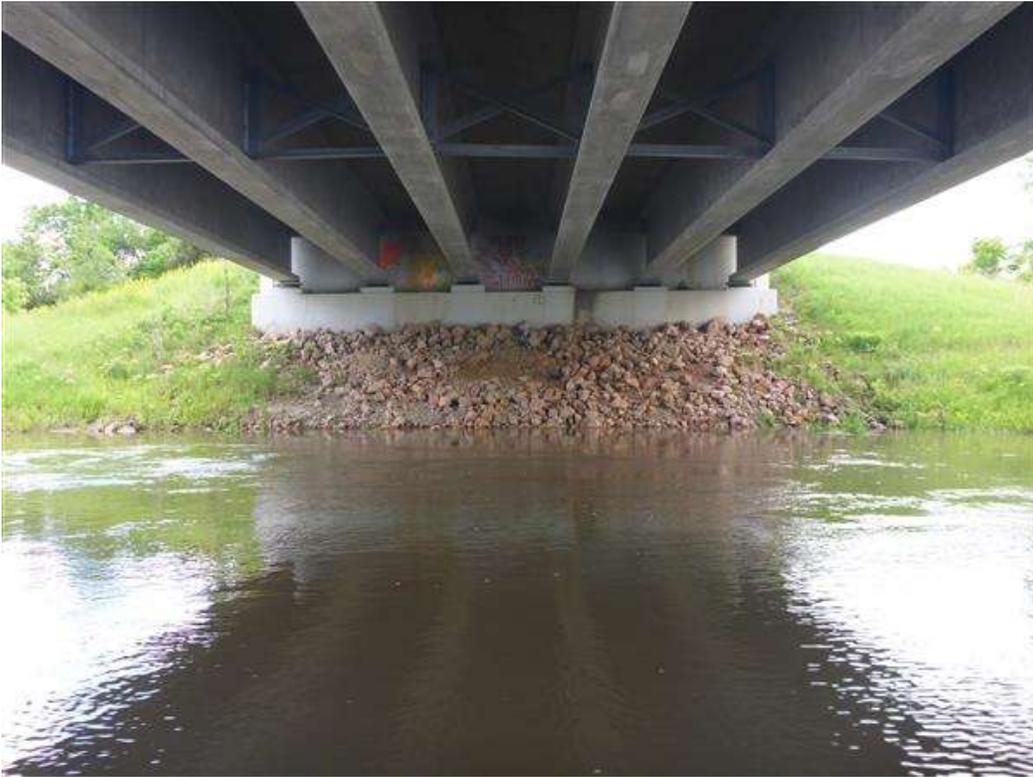
Photo 3 - South Abutment and Shoreline Looking South

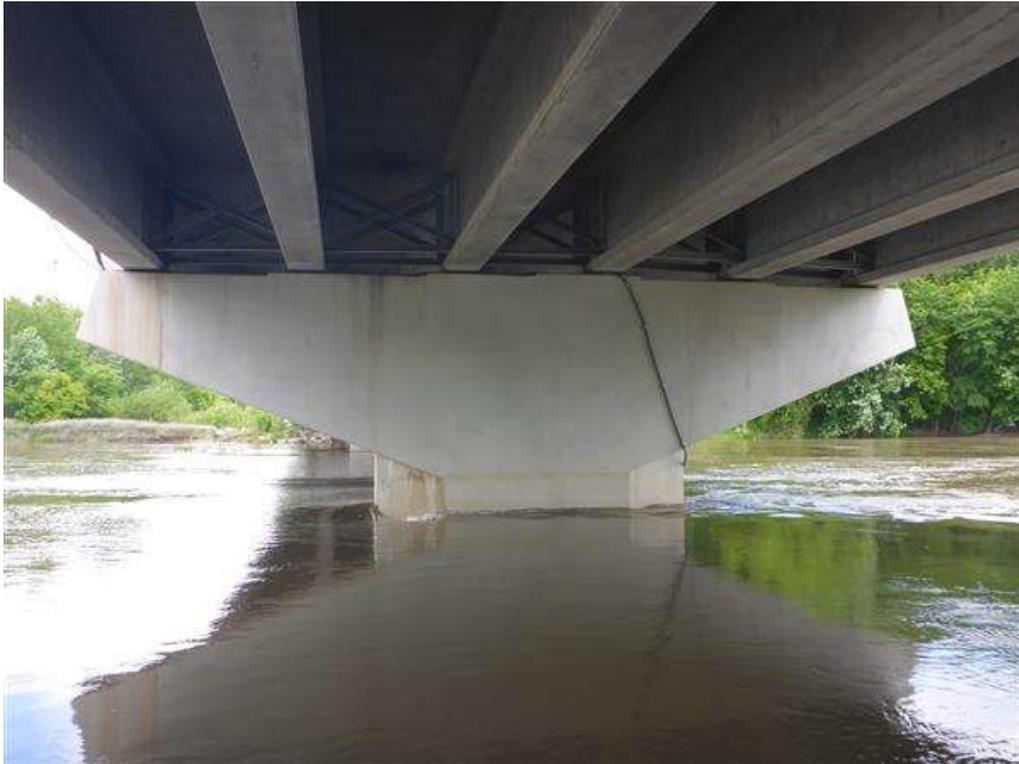
- (C) A moderate accumulation of timber debris, consisting of up to 12 inch diameter drift pieces, was observed at the upstream nose of Pier 1, extending up to 5 feet off the pier nose and from the channel bottom to 10 feet above the mudline.

- (F) The footing was exposed at the upstream nose and along the entire north face of Pier 1 with a maximum vertical exposure of up to 5.1 feet.

Photo 4 - Pier 1 Looking North

- (A) Remove the timber debris during future maintenance operations.
- (B) Consider scour countermeasures at Pier 1 to inhibit any further exposure of the pier foundations.
- (C) Reinspect the submerged substructure units at the normal maximum recommended (NBIS) interval of sixty (60) months.

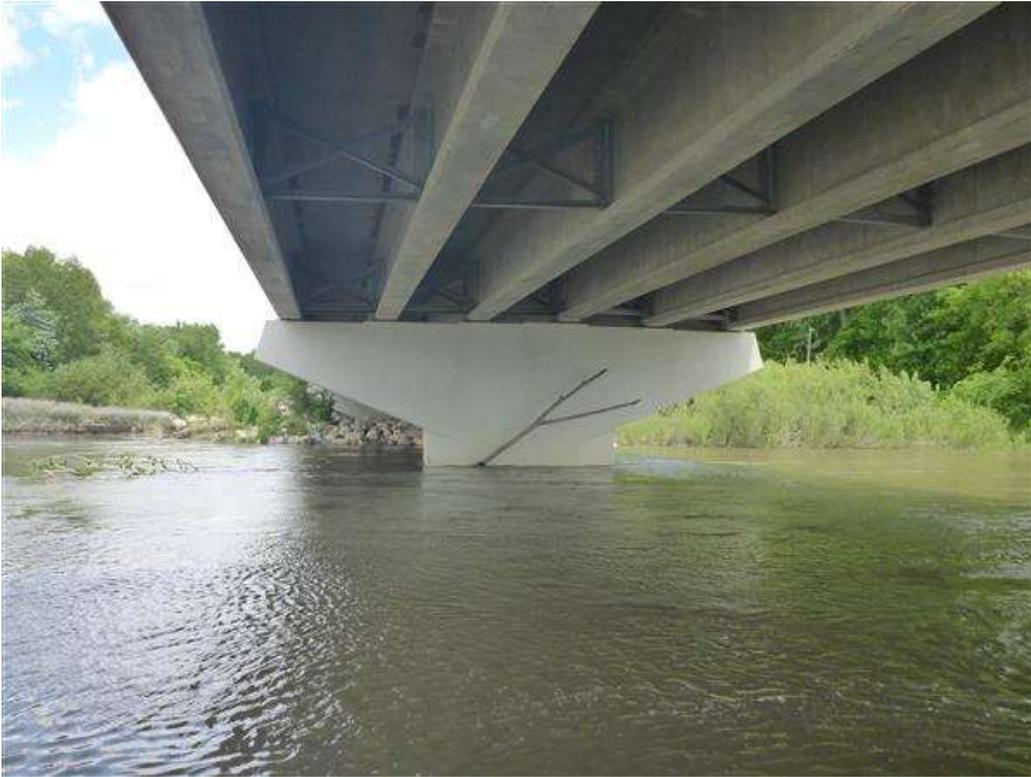
- (A) The channel bottom consisted of firm silty clay with a maximum probe rod penetration of 3 inches.
- (B) A heavy accumulation of timber debris consisting of logs and branches 18 inches in diameter and smaller was observed around the entire perimeter of Pier 2 extending 20 feet off the upstream nose and faces and from the channel bottom to 7 feet above the waterline.

- (D) The concrete was smooth and sound with no notable defects or deterioration.
- (E) Remnants of a old abandoned sheet pile cofferdam were encountered extending 1 to 2 feet up out of the channel bottom along the south face of Pier 2.

Photo 5 - Pier 2 Looking Northeast

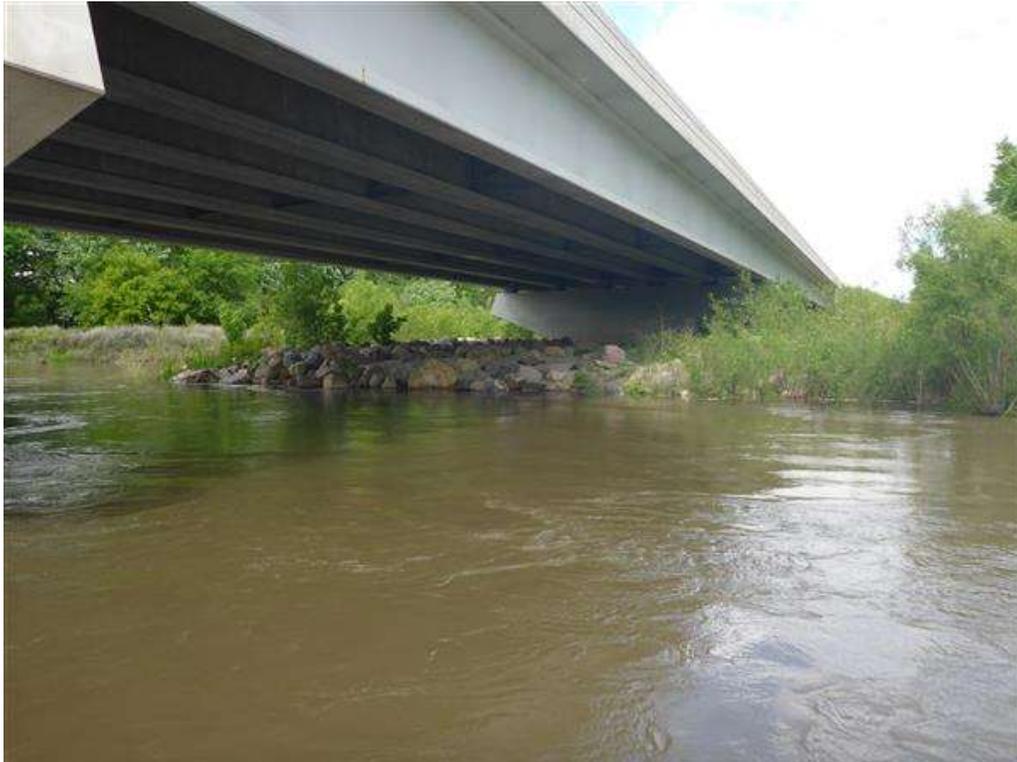
Photo 6 - North Shoreline and Pier 3 Looking North

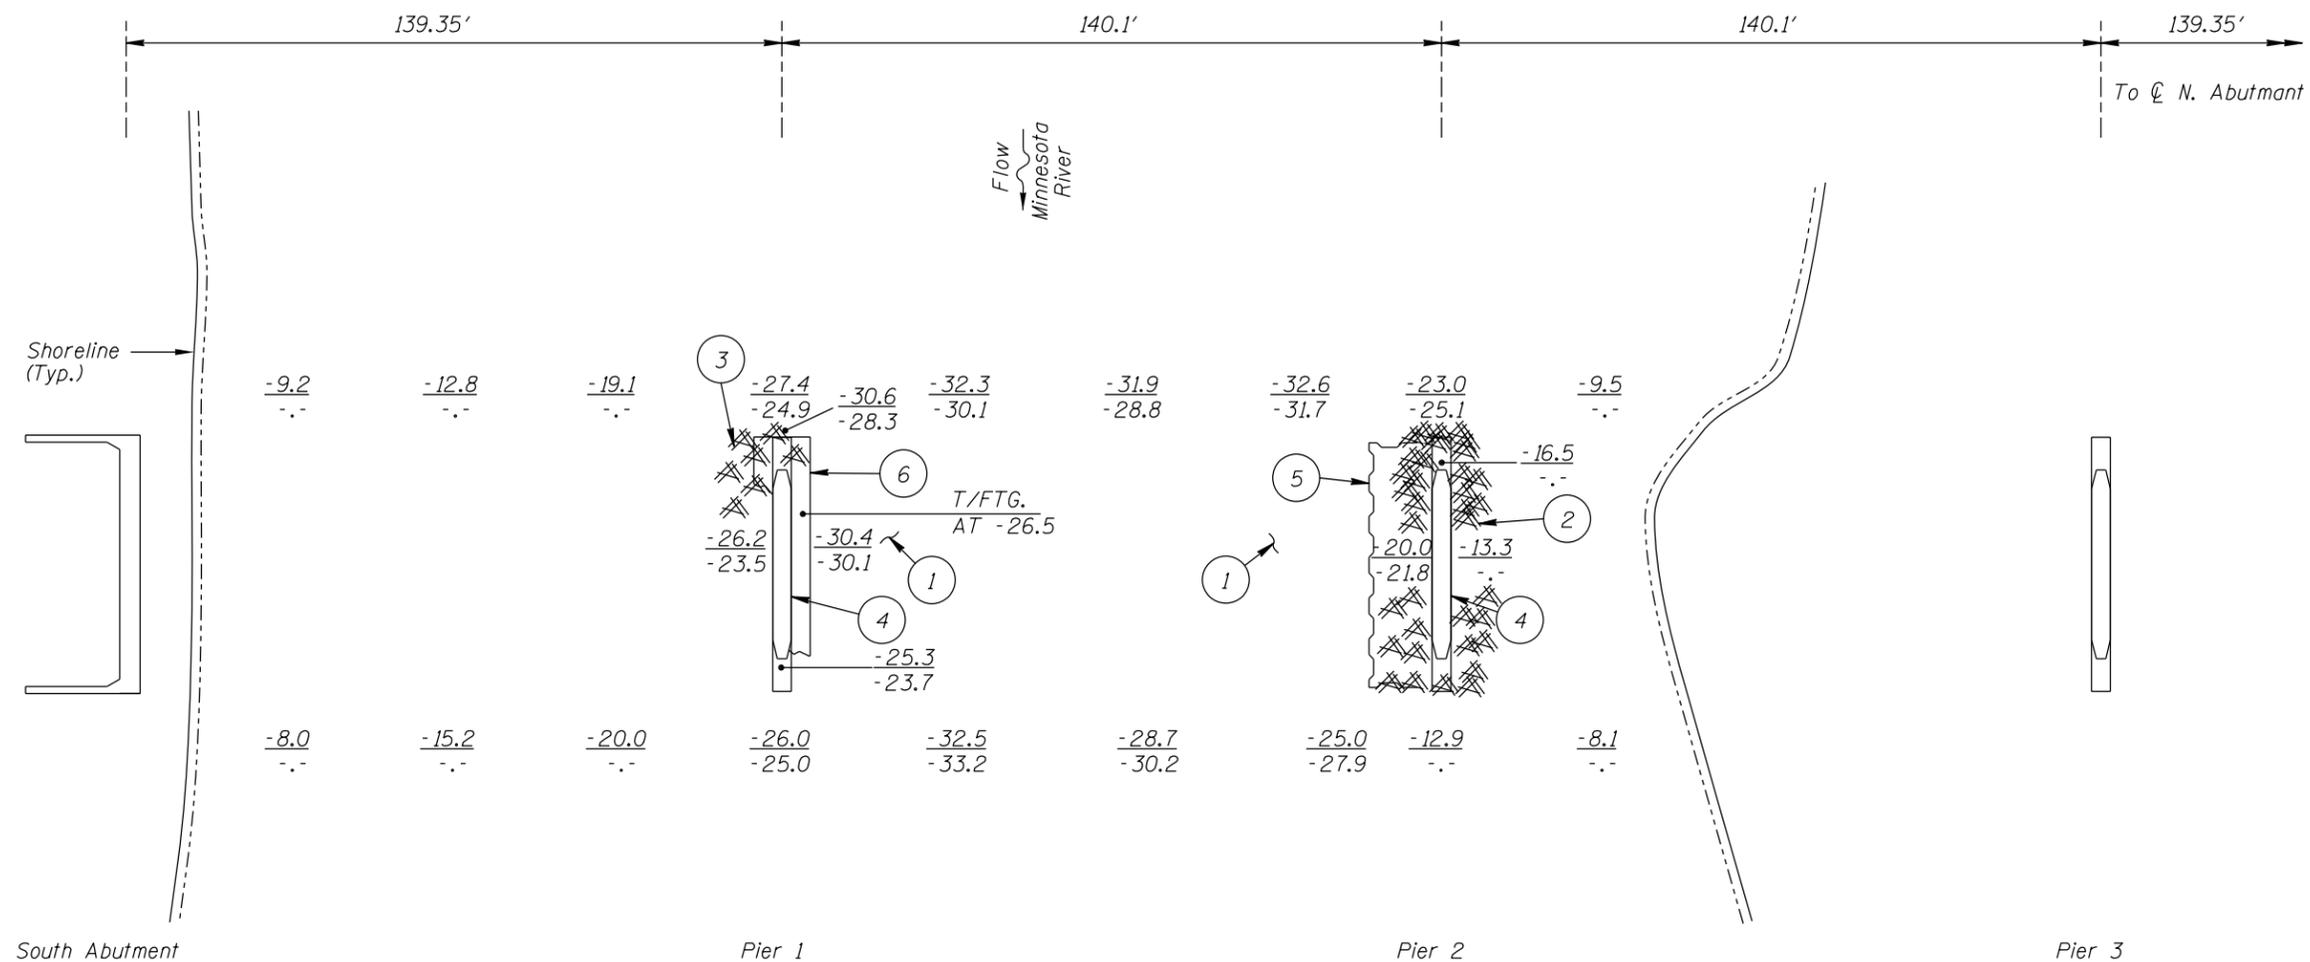
- 1 The channel bottom consisted of firm silty clay with a maximum probe rod penetration of 3 inches.
- 2 A heavy accumulation of timber debris consisting of logs and branches 18 inches in diameter and smaller was observed around the entire perimeter of Pier 2 extending 20 feet off the upstream nose and faces and from the channel bottom to 7 feet above the waterline.

- 3 A moderate accumulation of timber debris, consisting of up to 12 inch diameter drift pieces, was observed at the upstream nose of Pier 1, extending up to 5 feet off the pier nose and from the channel bottom to 10 feet above the mudline.

- 4 The concrete was smooth and sound with no notable defects or deterioration.
- 5 Remnants of a old abandoned sheet pile cofferdam were encountered extending 1 to 2 feet up out of the channel bottom along the south face of Pier 2.

- 6 The footing was exposed at the upstream nose and along the entire north face of Pier 1 with a maximum vertical exposure of up to 5.1 feet.
