# 2016 UNDERWATER BRIDGE INSPECTION REPORT

## BRIDGE # 90475 CSAH 17(FRANCE AV) over NINE MILE CREEK

Date of Inspection: 06/20/2016  
Equipment Used: Boat

Contractor: Collins Engineers, Inc.

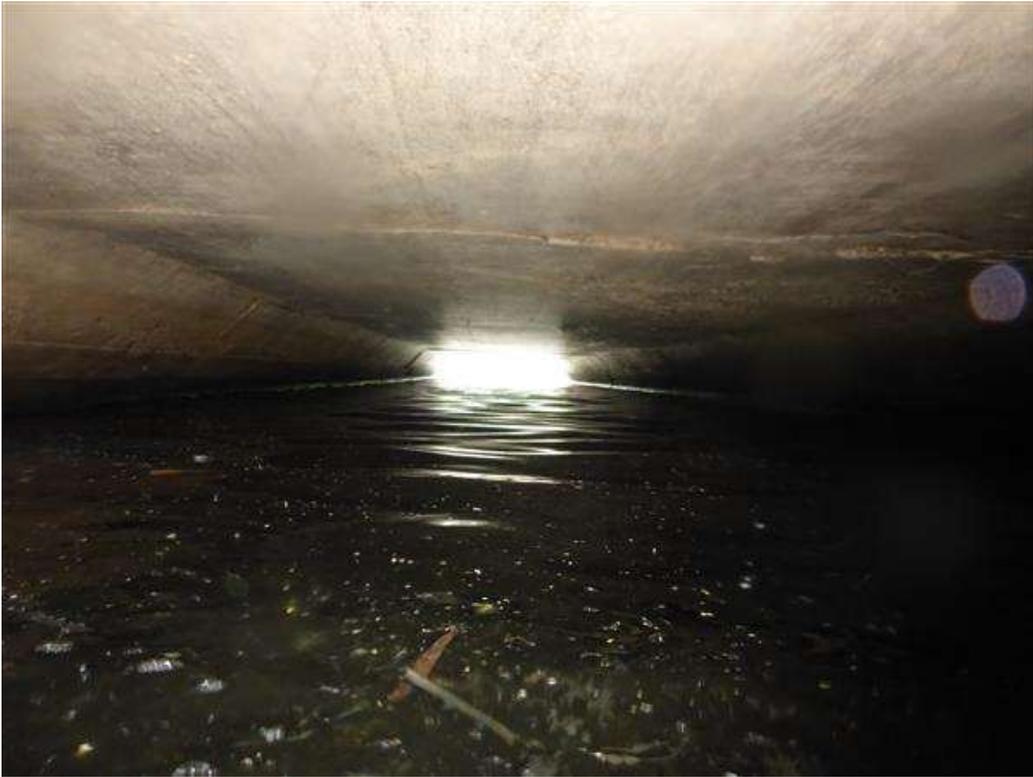
Photo 3 - Typical Interior Barrel, North Barrel Looking West

The substructure units of Bridge No. 90475, Barrels 1 and 2, were found to be in satisfactory condition with no defects of structural significance. The channel bottom was also in satisfactory condition with moderate sediment on the culvert floor.

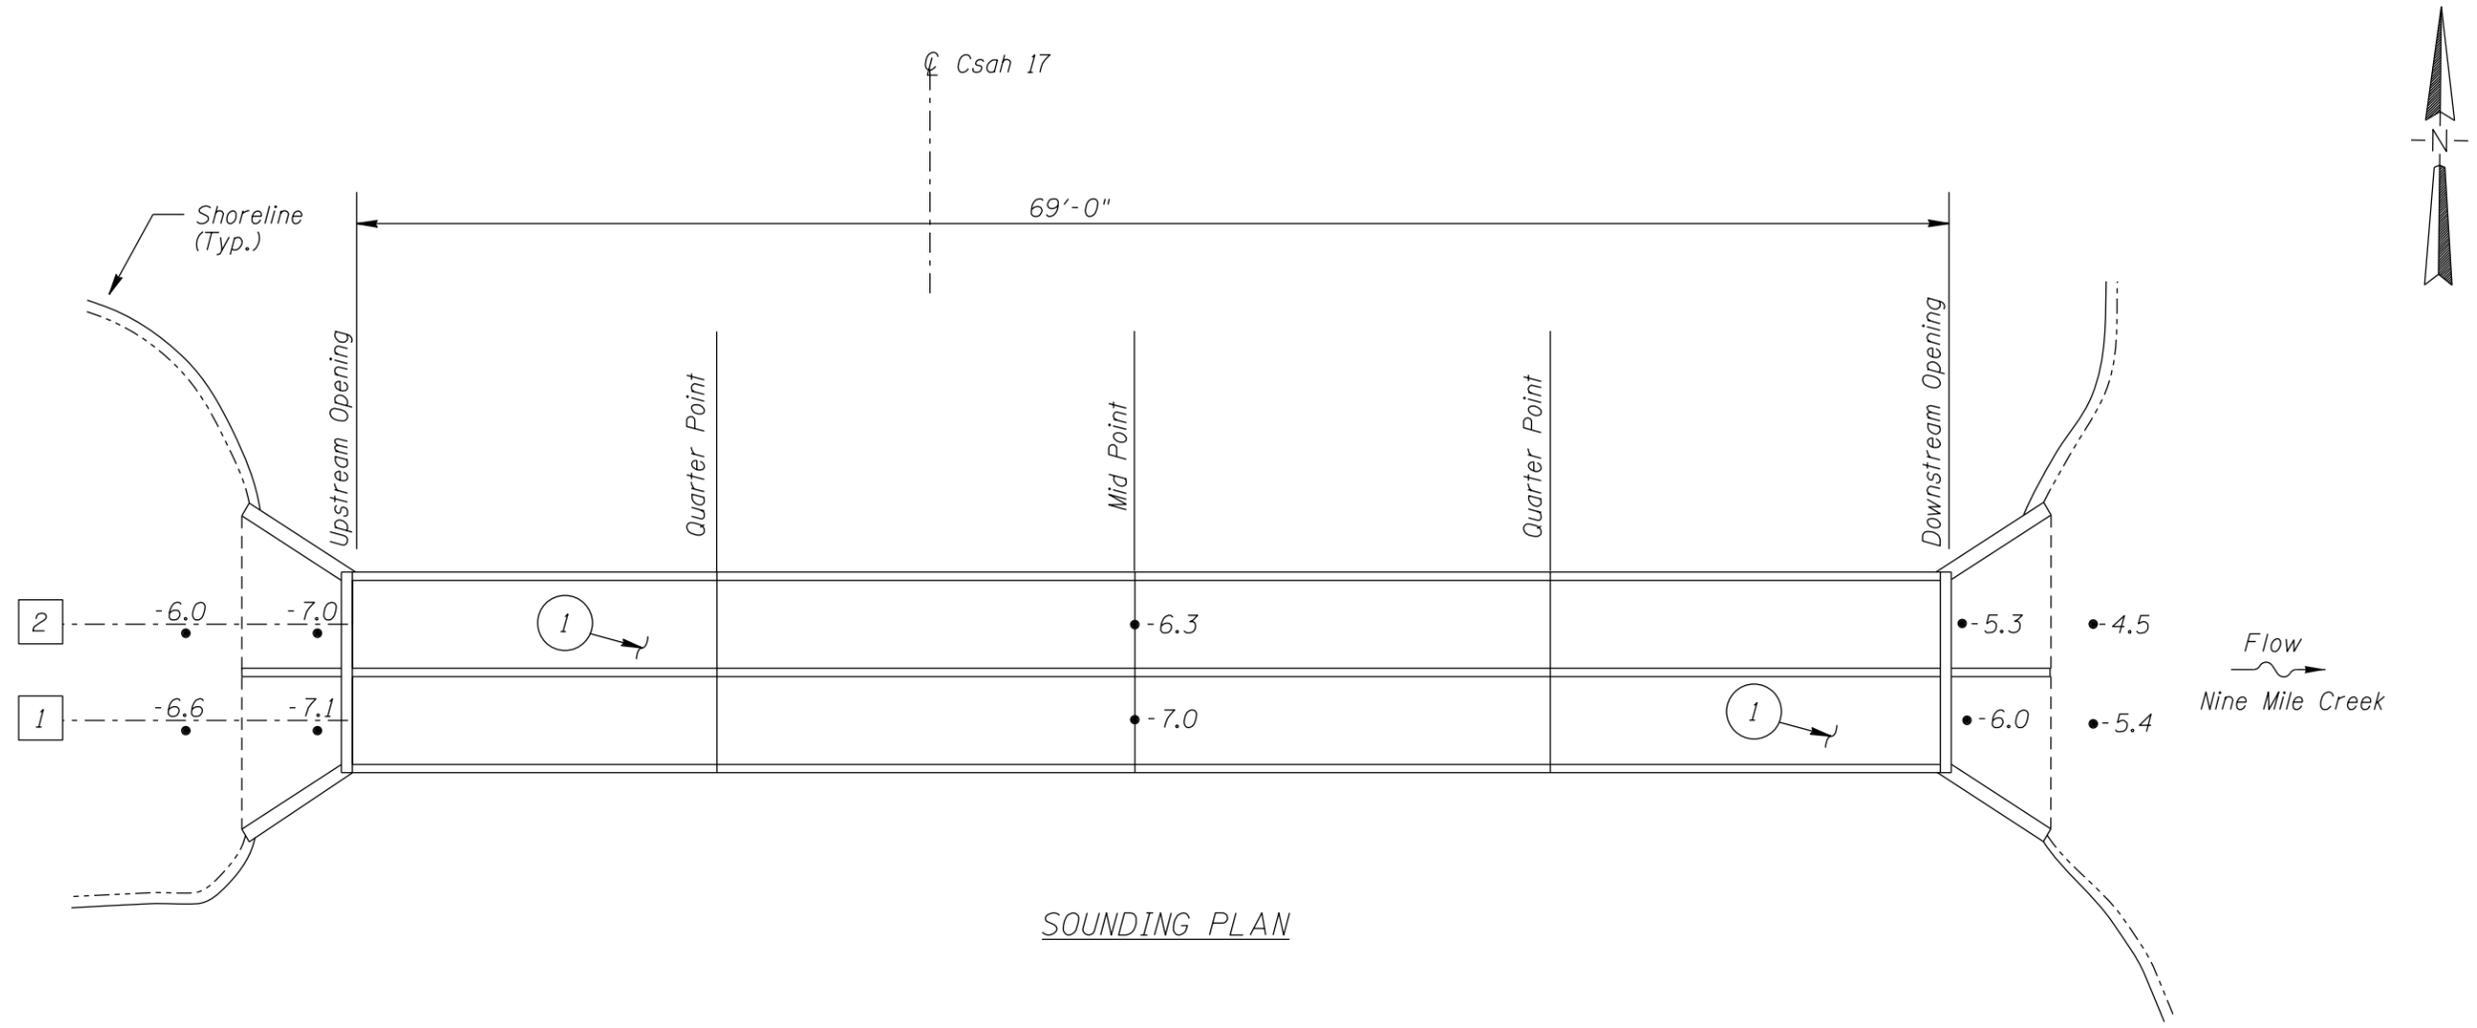
- ① The bottom consisted of organic material with random rip-rap and gravel penetration up to 6 inches.
