# TH 10 Road Safety Audit Review

## Randall, MN

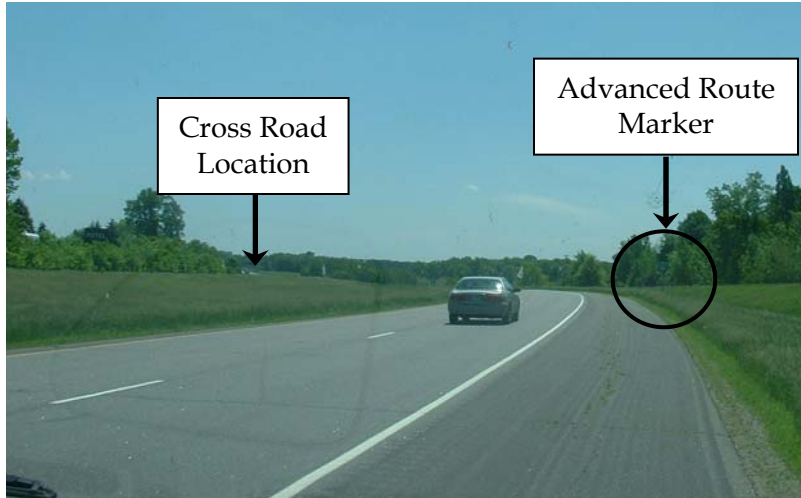
**FIGURE 3-1**  
A Rolling TH 10 Alignment and Advance Route Markers that are Difficult to See can “Hide” Intersections (SB approach to CSAH 104)

- When driving on TH 10, the advanced route markers for the cross streets appeared to be undersized, making them difficult to see at the posted speed limit (see **Figure 3-1**). The placement of the route markers also do not appear to be consistent with current practices.
- The new traffic control practice on a four-lane divided highway is to provide signs or pavement markings for right and left turn lanes. The right and left turn lanes on TH 10 are inconsistent with current traffic control practices since they are neither signed as turn lanes nor have pavement markings identifying them as turn lanes (see **Figure 3-2**).
- STOP signs, ONE WAY signs, and DIVIDED HIGHWAY signs are one size smaller than

- At the TH 115 intersection, revising the STOP sign assembly so that the junction signing is on a separate structure.
- Upgrade the advance junction/junction signing from the present county route markers to large green signs. This is intended to provide drivers on TH 10 with more information about the presence of major intersections (with a higher probability of conflicts) that are not readily apparent to drivers because of the rolling topography and curvilinear alignment.
- In line with increasing the conspicuity of the intersections, street lighting could also be installed. TH 115 is the only intersection where night time crashes are over represented. Street lighting is a low cost proven safety device which would help identify the presence of the intersections during both day light and night time hours.

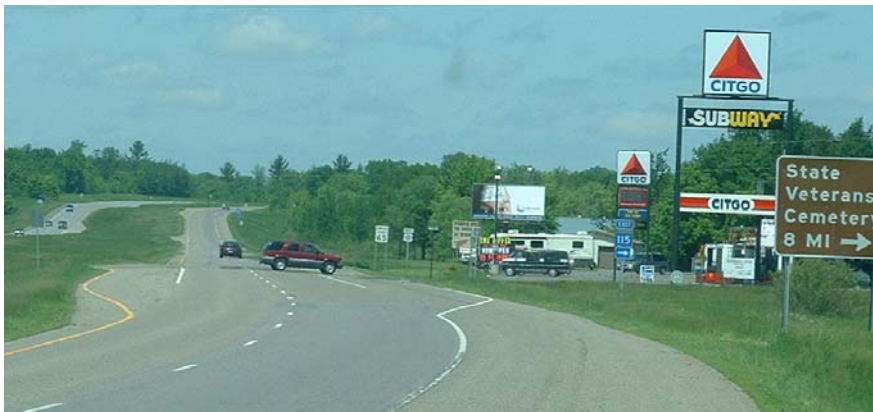
**FIGURE 3-2**  
TH 10 Left and Right Turn Lanes are Unmarked (NB approach to TH 115)

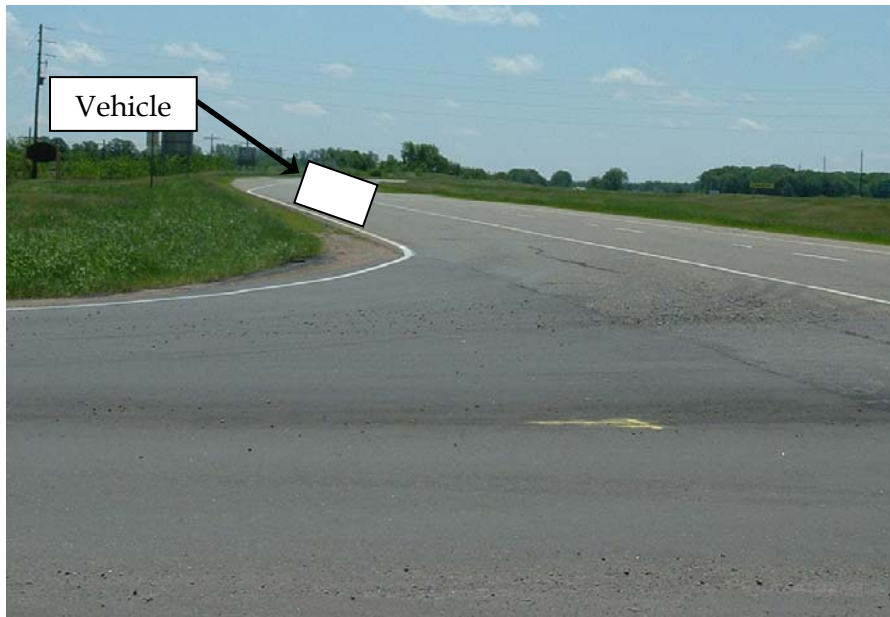
**FIGURE 3-3**

- Because of the horizontal curve located south of TH 115, a vehicle in the right turn lane (northbound TH 10) can obscure a driver's line of sight for a large portion of TH 10 (driver stopped on east approach of TH 10 & TH 115 intersection). This scenario has been simulated in **Figure 3-3**.
- Sign assembly combines regulatory and guide signs on same supports, which is inconsistent with current guidelines (see **Figure 3-4**).
- The only development in the vicinity of the intersection is a gas/convenience store located in the northeast quadrant.
- There is no intersection lighting at the intersection, but the signing and lights at the gas station do provide limited destination lighting.

A Vehicle in Right Turn Lane can Obstruct a Driver Stopped on TH 115 (looking south from east approach)

- The minor geometric improvements consist of detaching the right turn lanes (the NB right turn lanes at TH 115 and at CSAH 14 would be the highest priority based on usage). This geometric change would improve intersection sight distance for drivers on the minor street approaches by moving right turning vehicles out of their line of sight.

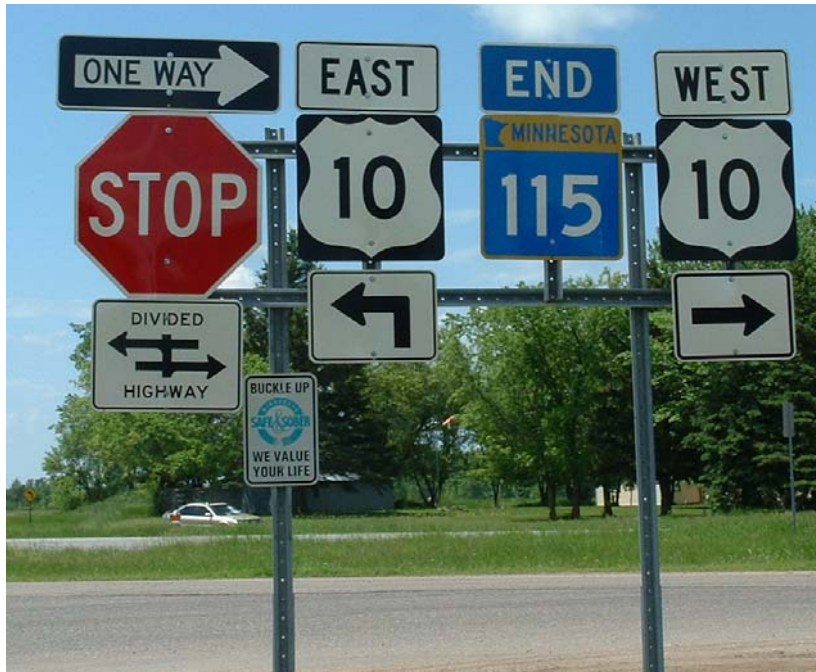
**FIGURE 3-4**  
STOP Sign and Route Marker Assembly

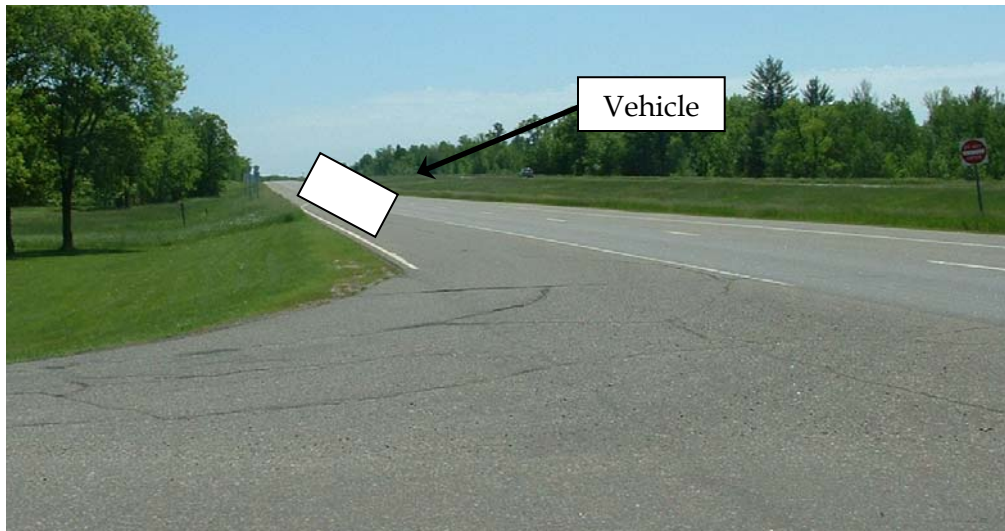
- Due to the skew angle of the intersection, for a driver stopped on either CSAH 14 approach, it appears that a vehicle in the TH 10 right turn lane can “hide” another vehicle in a large portion of the TH 10 alignment. This scenario has been simulated in **Figure 3-5**.
- There is one non-standard street light in the northeast quadrant of the intersection that would illuminate only the east approach(see **Figure 3-6**).
- The only development in the vicinity of the intersection is residential.

**FIGURE 3-5**  
A Vehicle in Right Turn Lane can Obstruct a Driver Stopped on CSAH 14 (looking south from east approach)

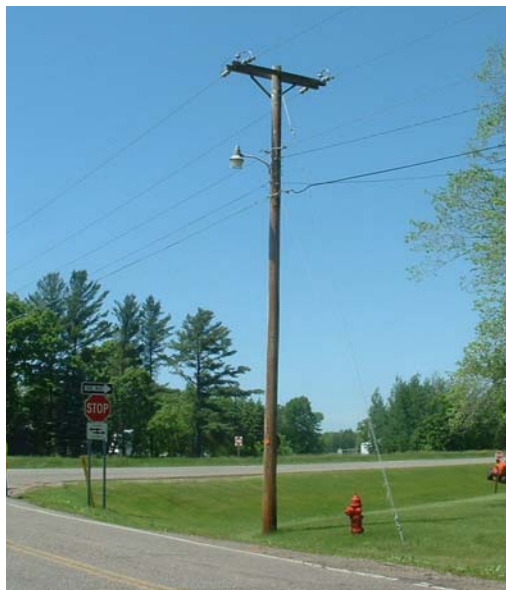
**FIGURE 3-6**  
Intersection Lighting at TH 10 & CSAH 14
