Pavement Condition Report

Bigfork Municipal Airport (FOZ)

December 2016

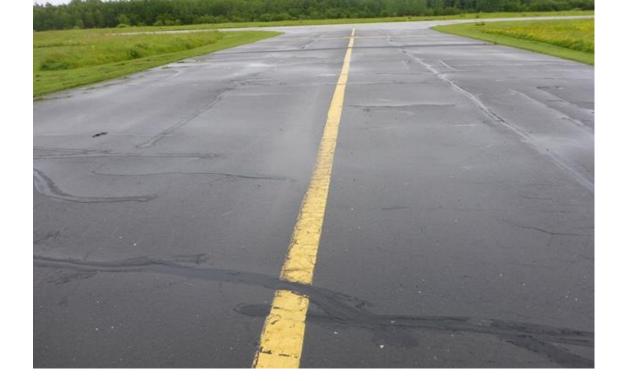
FOZ APA 001 (PCI = 58)

Section / Work	Sum of Work Qty (Ft, SqFt)	Sum of Work Cost (\$)		
APA::001	Preventative: PCI Before: 58 After: 60	2,008		
Crack Sealing - AC	1,646	2,008		
RY1533::001	Preventive: PCI Before: 87 After: 89	83		
Crack Sealing - AC	68	83		
TLA::001	Preventive: PCI Before: 72 After: 76	79		
Crack Sealing - AC	65	79		
Grand Total		2,170

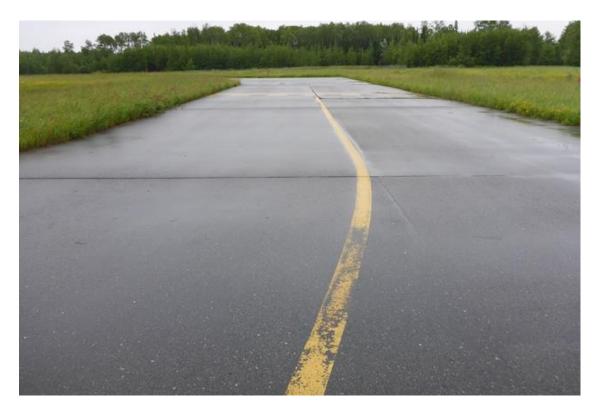
FOZ RTA33 001 (PCI = 93)

Network:	FOZ			Na	me: BIG	GFORK			
Branch:	RTA33		Name:	Runway 33	Furnaround	Use:	TAXIWAY	Area:	10,200 SqFt
Section:	001	0	f 1 F	rom: 100			To: 103		Last Const.: 7/16/2009
Surface:	AC	Family:	MN2013 Aspha Taxiways	lt Zo	ne: N		Category: 3		Rank: S
Area:	10,2	200 SqFt	Length:	220	Ft	Width:	35 Ft		
Slabs:		Slab Ler	igth:	Ft	Slab Width:		Ft	Joint Length:	Ft
Shoulder:		Street T	ype:		Grade: 0	1		Lanes: 0	
Section Co	mments:								
Last Insp. l	Date: 7/14/20	16	TotalSa	mples: 3		Surveye	ed: 1		
Conditions	s: PCI: 93								
Inspection	Comments:								
Sample Nu	mber: 101	Туј	pe: R	Area:	350	0.00 SqFt	PCI: 93		
Sample Co	omments:								
48 L &	T CR		L	70.00 Ft

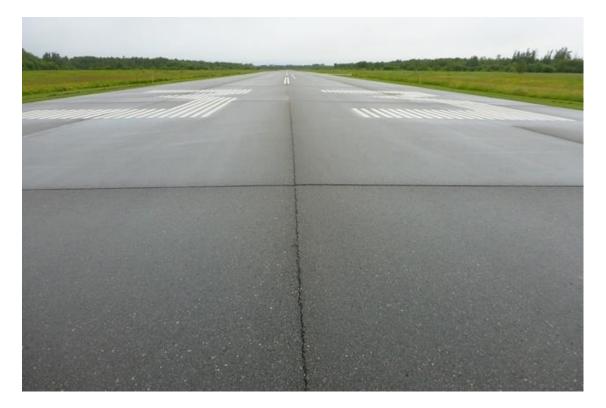
FOZ RY1533 001 (PCI = 87)

Network: FOZ		Name:	BIGFORK				
Branch: RY1533	Name:	RUNWAY 15-33	Use:	RUNWAY	Area: 30	03,700 SqFt	
Section: 001	of 1 F	rom: 100		To: 179		Last Const.: 7/16/2009	
Surface: AC Fa	mily: MN2013 Aspha	lt Runways Zone:	Ν	Category: 3		Rank: P	
Area: 303,700 So	qFt Length:	4,000 Ft	Width:	75 Ft			
Slabs: Sl	lab Length:	Ft Slab	Width:	Ft	Joint Length:	Ft	
Shoulder: St	treet Type:	Grad	e: 0		Lanes: 0		
Section Comments:							
Last Insp. Date: 7/14/2016	TotalSa	mples: 80	Surveye	d: 9			
Conditions: PCI: 87							
Inspection Comments:							
Sample Number: 103	Type: R	Area:	3750.00 SqFt	PCI: 93			
Sample Comments:							
48 L & T CR	L	70.00 Ft					
Sample Number: 112	Type: R	Area:	3750.00 SqFt	PCI: 79			
Sample Comments:			-				
48 L & T CR	L	145.00 Ft					
41 ALLIGATOR CR	L	5.00 SqFt					
48 L & T CR	М	3.00 Ft					
Sample Number: 121	Type: R	Area:	3750.00 SqFt	PCI: 87			
Sample Comments:							
48 L & T CR	L	150.00 Ft

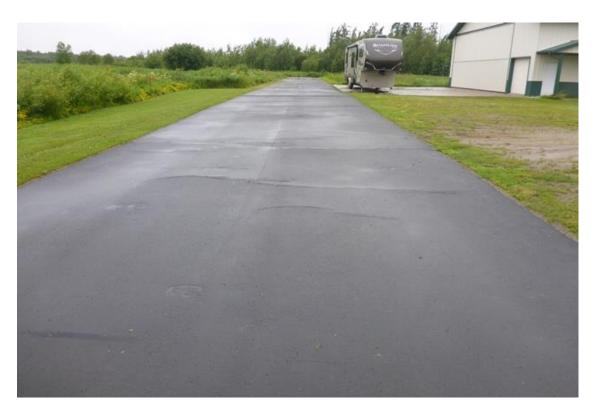
FOZ TLA 001 (PCI = 72)

Network:	FOZ			Na	me: BIG	GFORK			
Branch:	TLA		Name:	Taxilane A		Use:	TAXILANE	Area:	10,400 SqFt
Section:	001	0	f 1	From: 100			To: 102		Last Const.: 7/16/2007
Surface:	AC	Family:	MN2013 Ası Taxilanes	ohalt Zor	ne: N		Category: 3		Rank: T
Area:		10,400 SqFt	Length	: 520	Ft	Width:	20 Ft		
Slabs:		Slab Ler	ıgth:	Ft	Slab Width:		Ft	Joint Length:	Ft
Shoulder:		Street T	ype:		Grade: 0	1		Lanes: 0	
Section Co	omments:	Estimated LCD	1						
Last Insp.	Date: 7/1	14/2016	Total	Samples: 3		Surveye	e d: 1		
Condition	s: PCI:	72							
Inspection	n Comment	s:							
Sample Nu	umber: 1	01 Ty	pe: R	Area:	400	0.00 SqFt	PCI: 72	2	
Sample Co	omments:								
48 L&	& T CR		L	318.00 Ft					
48 L &	& T CR		М	25.00 Ft					
50 PA	TCHING		L	30.00 SqFt
