Pavement Condition Report

Moorhead Municipal Airport (JKJ)

December 2018

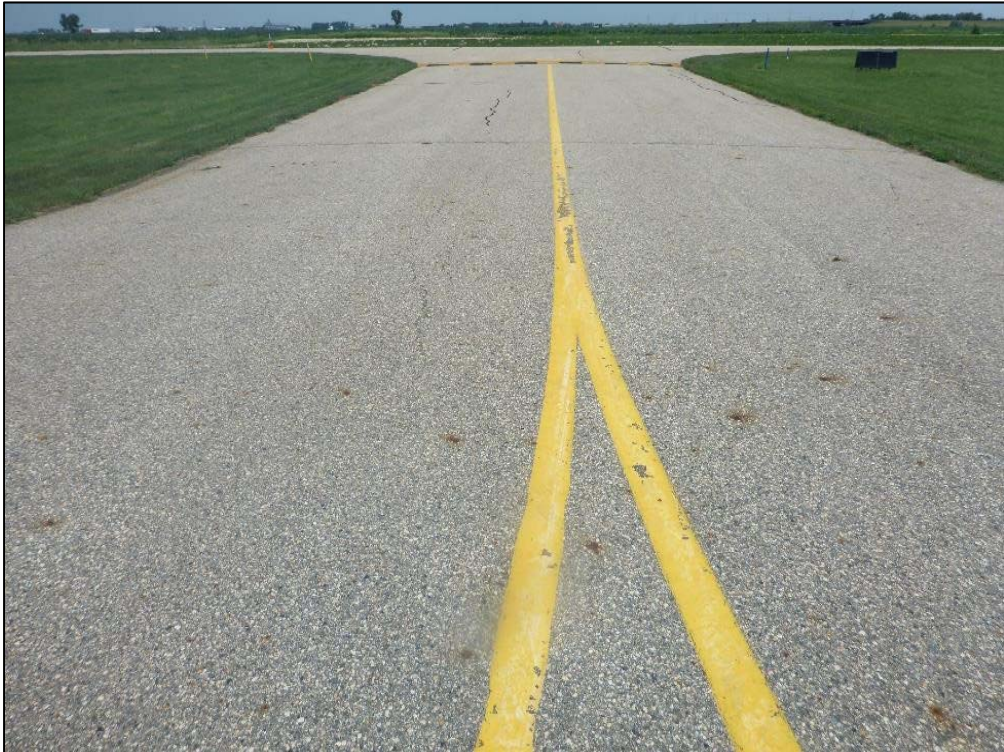
JKJ CTA3 001 (PCI = 70)

Network:	JKJ	Name:	MOORHEAD						
Branch:	CTA3	Name:	CONNECTING TXWY A3	Use:	TAXIWAY	Area:	9,000 SqFt		
Section:	001	of 1	From:	300	To:	301	Last Const.:	9/30/2002	
Surface:	AC	Family:	MN2018 Asphalt Runway- Taxiways	Zone:	W	Category:	2	Rank:	S
Area:	9,000 SqFt	Length:	190 Ft	Width:	35 Ft				
Slabs:	Slab Length:	Ft	Slab Width:	Ft	Joint Length:	Ft			
Shoulder:	Street Type:	Grade:	0	Lanes:	0				
Section Comments:									
Last Insp. Date:	7/4/2018	TotalSamples:	2	Surveyed:	1				
Conditions:	PCI: 70								
Inspection Comments:									
Sample Number:	300	Type:	R	Area:	4170.00 SqFt	PCI:	70		
Sample Comments:									
48	L & T CR	M	24.00	Ft					
48	L & T CR	L	281.00	Ft					
57	WEATHERING	M	4000.00	SqFt

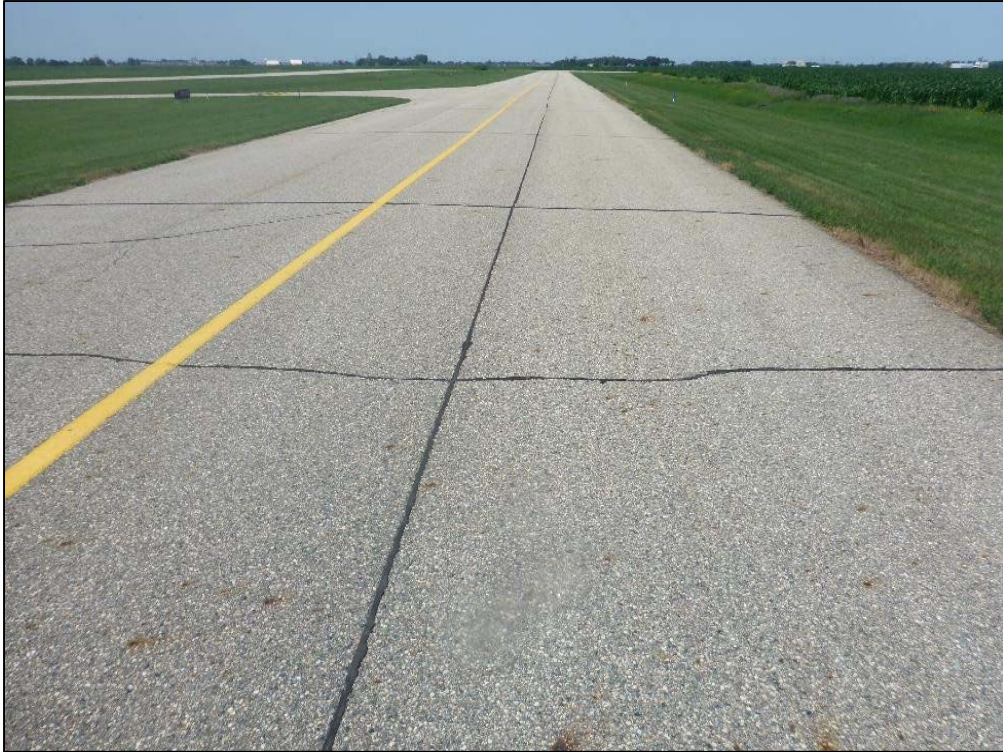
JKJ PTA 001 (PCI = 71)

Network:	JKJ	Name:	MOORHEAD						
Branch:	PTA	Name:	Parallel Taxiway A	Use:	TAXIWAY	Area:	171,630 SqFt		
Section:	001	of 2	From:	100	To:	141+7.5	Last Const.:	9/30/2002	
Surface:	AC	Family:	MN2018 Asphalt Runway-Taxiways	Zone:	W	Category:	2	Rank:	P
Area:	161,330 SqFt	Length:	4,193 Ft	Width:	35 Ft				
Slabs:		Slab Length:	Ft	Slab Width:	Ft	Joint Length:	Ft		
Shoulder:		Street Type:		Grade:	0	Lanes:	0		
Section Comments:									
Last Insp. Date:	7/4/2018	TotalSamples:	42	Surveyed:	5				
Conditions:	PCI: 71								
Inspection Comments: maintenance done									
Sample Number:	100	Type:	A	Area:	3925.00 SqFt	PCI:	47		
Sample Comments:									
48	L & T CR	M	34.00 Ft						
57	WEATHERING	M	2000.00 SqFt						
48	L & T CR	H	7.00 Ft						
48	L & T CR	L	113.00 Ft						
57	WEATHERING	L	1925.00 SqFt						
56	SWELLING	L	450.00 SqFt						
52	RAVELING	M	15.00 SqFt						
50	PATCHING	L	63.00 SqFt						
Sample Number:	103	Type:	R	Area:	3500.00 SqFt	PCI:	72

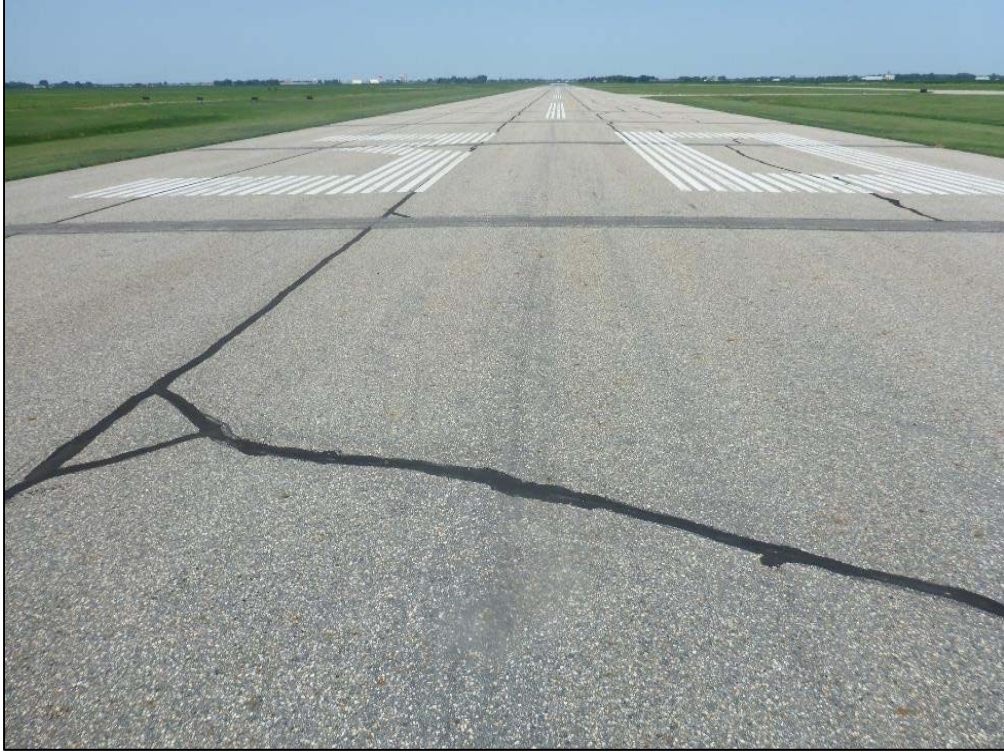
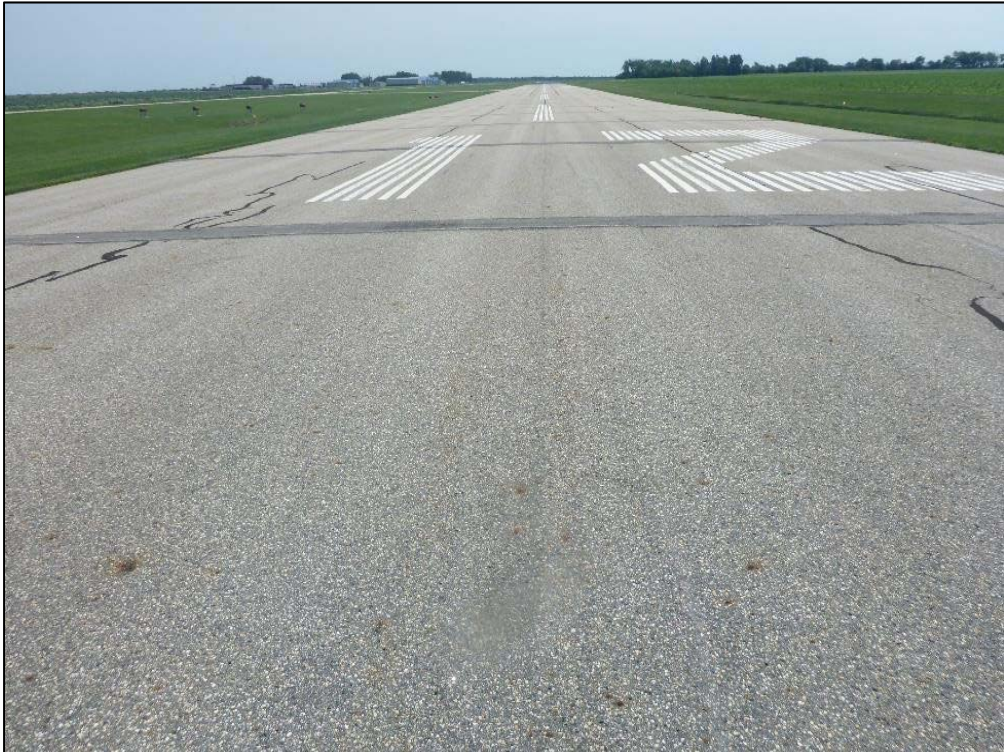
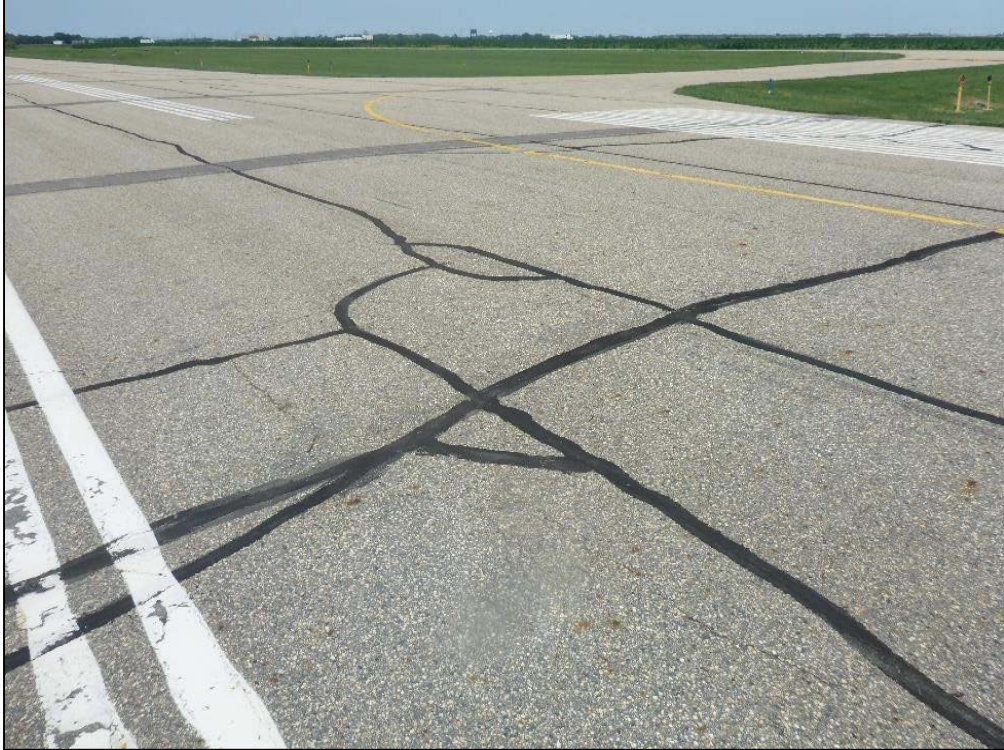
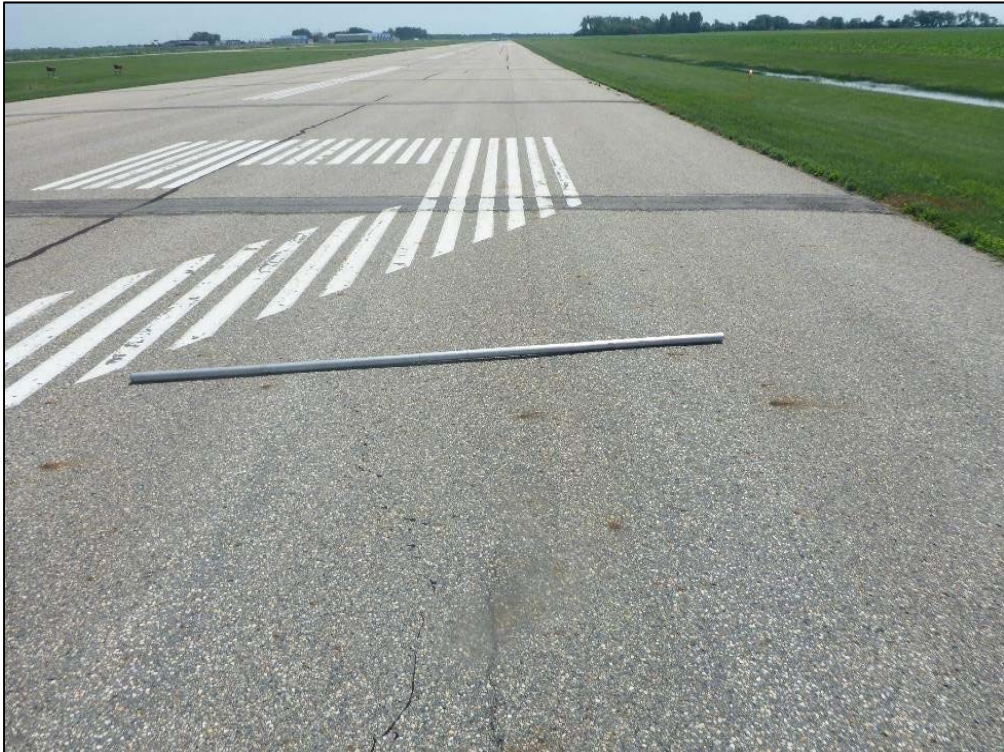
JKJ RY1230 001 (PCI = 67)

Network:	JKJ	Name:	MOORHEAD						
Branch:	RY1230	Name:	RUNWAY 12-30	Use:	RUNWAY	Area:	322,500 SqFt		
Section:	001	of 2	From:	100	To:	179	Last Const.:	9/30/1996	
Surface:	AC	Family:	MN2018 Asphalt Runway-Taxiways	Zone:	W	Category:	2	Rank:	P
Area:	300,000 SqFt	Length:	4,000 Ft	Width:	75 Ft				
Slabs:		Slab Length:	Ft	Slab Width:	Ft	Joint Length:	Ft		
Shoulder:		Street Type:		Grade:	0	Lanes:	0		
Section Comments:									
Last Insp. Date:	7/4/2018	TotalSamples:	80	Surveyed:	8				
Conditions:	PCI: 67								
Inspection Comments: maint done									
Sample Number:	104	Type:	R	Area:	3750.00 SqFt	PCI:	72		
Sample Comments:									
52	RAVELING	L	500.00	SqFt					
50	PATCHING	L	150.00	SqFt					
57	WEATHERING	L	2500.00	SqFt					
48	L & T CR	L	157.00	Ft					
Sample Number:	114	Type:	R	Area:	3750.00 SqFt	PCI:	63		
Sample Comments:									
50	PATCHING	L	150.00	SqFt					
57	WEATHERING	M	1800.00	SqFt					
48	L & T CR	L	242.00	Ft

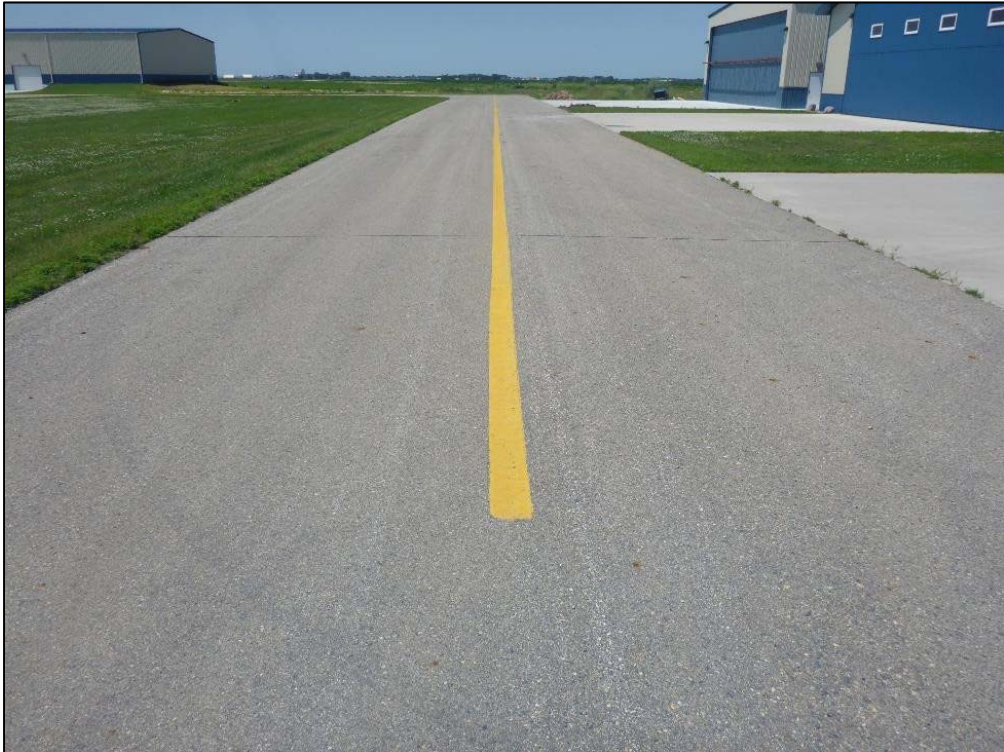
JKJ TLC 001 (PCI = 98)

Network:	JKJ	Name:	MOORHEAD				
Branch:	TLC	Name:	Taxilane C	Use:	TAXILANE	Area:	13,325 SqFt
Section:	001	of 1	From:	100	To:	105	Last Const.: 4/28/2015
Surface:	AC	Family:	MN2018 Asphalt Taxilanes	Zone:		Category:	Rank: P
Area:	13,325 SqFt	Length:	560 Ft	Width:	25 Ft		
Slabs:		Slab Length:	Ft	Slab Width:	Ft	Joint Length:	Ft
Shoulder:		Street Type:		Grade:	0	Lanes:	0
Section Comments:							
Last Insp. Date:	7/4/2018	TotalSamples:	5	Surveyed:	2		
Conditions:	PCI: 98						
Inspection Comments:							
Sample Number:	102	Type:	R	Area:	2500.00 SqFt	PCI:	99
Sample Comments: sawcuts not counted							
57	WEATHERING		L		100.00 SqFt		
Sample Number:	104	Type:	R	Area:	2500.00 SqFt	PCI:	98
Sample Comments:							
49	OIL SPILLAGE		N		5.00 SqFt
