Pavement Condition Report

Moose Lake-Carlton County Airport (MZH)

December 2018

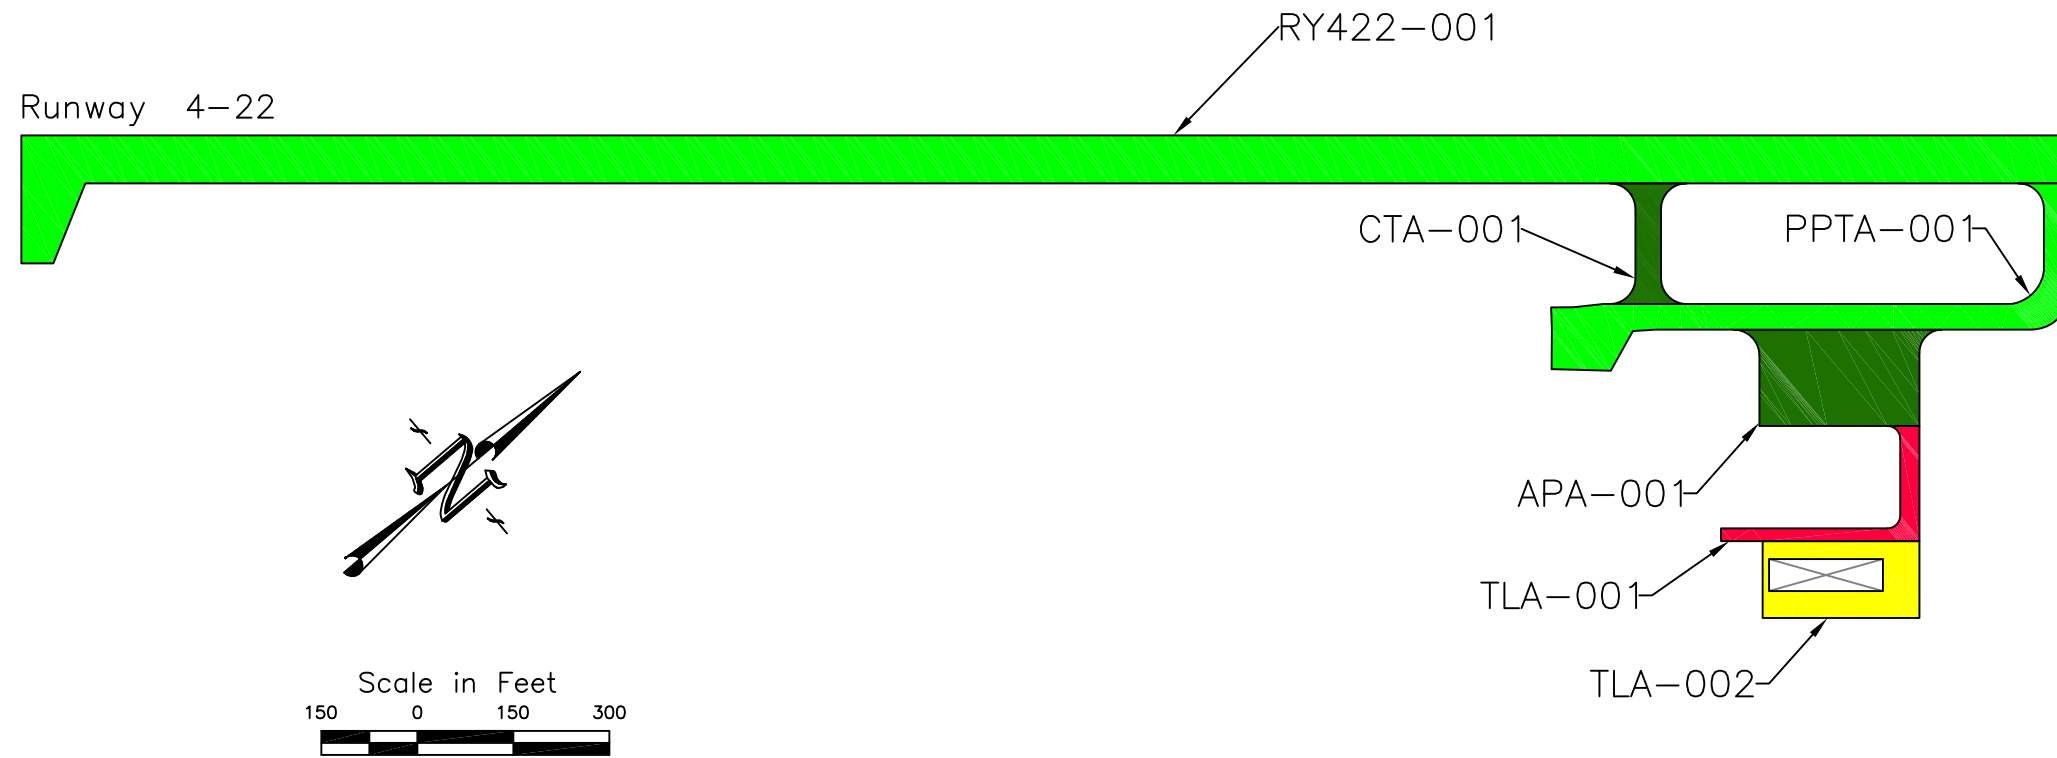
Figure 4. 2018 Pavement Condition Index Rating at Moose Lake-Carlton County Airport (MZH).

Figures 5 and 6 present the overall PCI for MZH by area distribution and pavement use, respectively. Table 3 presents the PCI summary for each section at MZH, including the drop in PCI per year. Generally, pavement sections will deteriorate between 1 and 3 PCI points per year. Sections deteriorating at higher rates may need maintenance above the normal application rates and should be closely monitored in case major repairs become necessary earlier than expected.

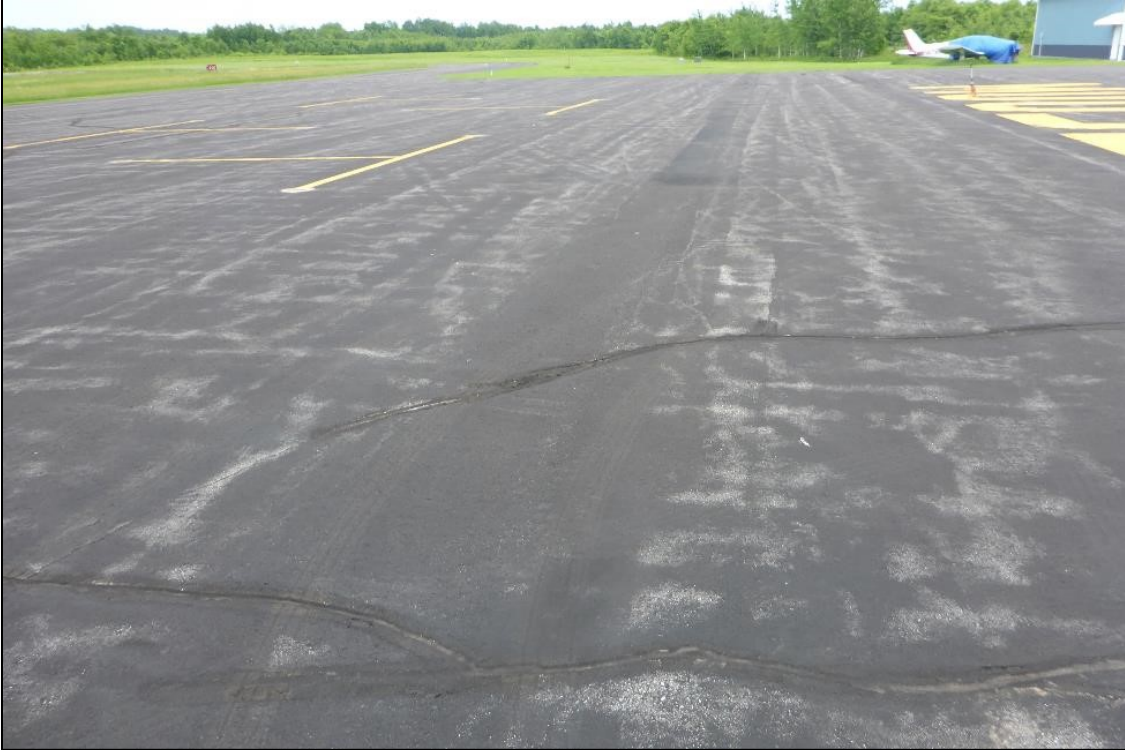
MZH APA 001 (PCI = 86)

Network:	MZH	Name:	MOOSE LAKE						
Branch:	APA	Name:	APRON A	Use:	APRON	Area:	38,250 SqFt		
Section:	001	of	1	From:	100	To:	302	Last Const.:	5/1/2013
Surface:	AC	Family:	MN2018 Asphalt Aprons	Zone:	N	Category:	2	Rank:	S
Area:	38,250 SqFt	Length:	250 Ft	Width:	150 Ft				
Slabs:	Slab Length:	Ft	Slab Width:	Ft	Joint Length:	Ft			
Shoulder:	Street Type:	Grade:	0	Lanes:	0				
Last Insp. Date:	6/10/2018	TotalSamples:	9	Surveyed:	2				
Conditions:	PCI: 86								
Sample Number:	100	Type:	R	Area:	5000.00 SqFt	PCI:	82		
48	L & T CR	L	343.00	Ft					
Sample Number:	201	Type:	R	Area:	5000.00 SqFt	PCI:	90		
48	L & T CR	L	148.00	Ft

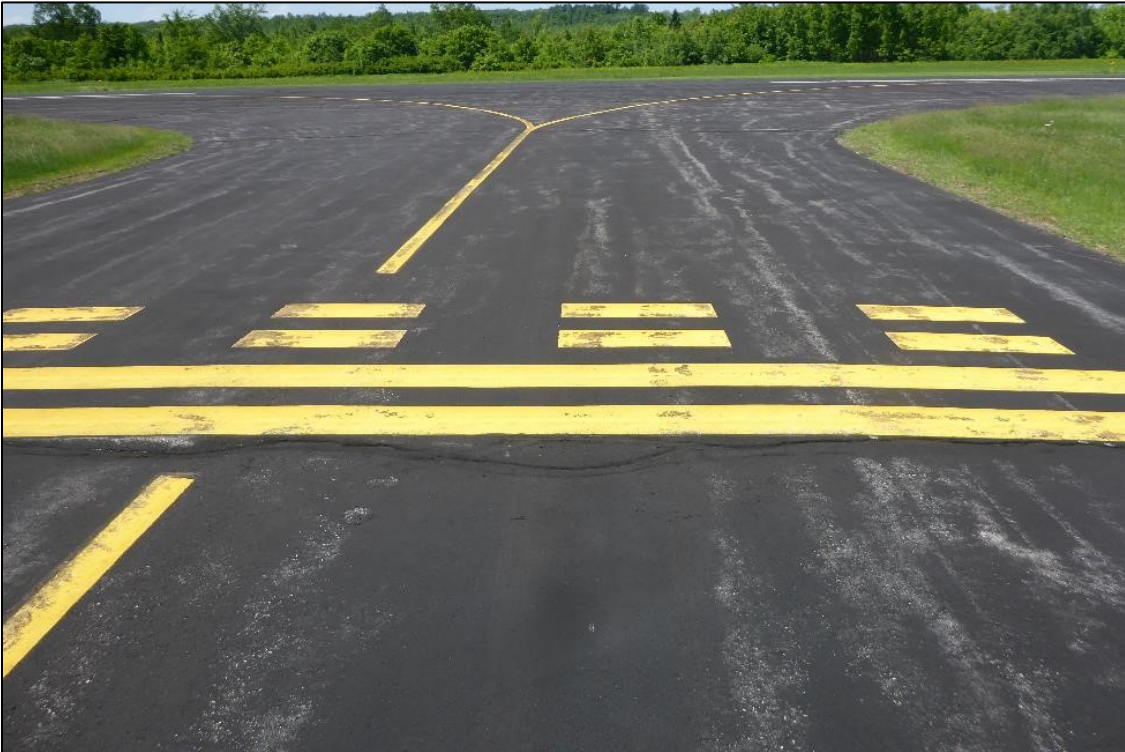
MZH CTA 001 (PCI = 91)

Network:	MZH	Name:	MOOSE LAKE						
Branch:	CTA	Name:	CONNECTING TAXIWAY A	Use:	TAXIWAY	Area:	8,900 SqFt		
Section:	001	of	1	From:	200	To:	201	Last Const.:	5/1/2013
Surface:	AC	Family:	MN2018 Asphalt Runway- Taxiways	Zone:	N	Category:	2	Rank:	P
Area:	8,900 SqFt	Length:	200 Ft	Width:	40 Ft				
Slabs:		Slab Length:	Ft	Slab Width:	Ft	Joint Length:	Ft		
Shoulder:		Street Type:		Grade:	0	Lanes:	0		
Last Insp. Date:	6/10/2018	TotalSamples:	2	Surveyed:	1				
Conditions:	PCI: 91								
Sample Number:	200	Type:	R	Area:	4670.00 SqFt	PCI:	91		
48	L & T CR	Type:	L	Area:	124.00 Ft

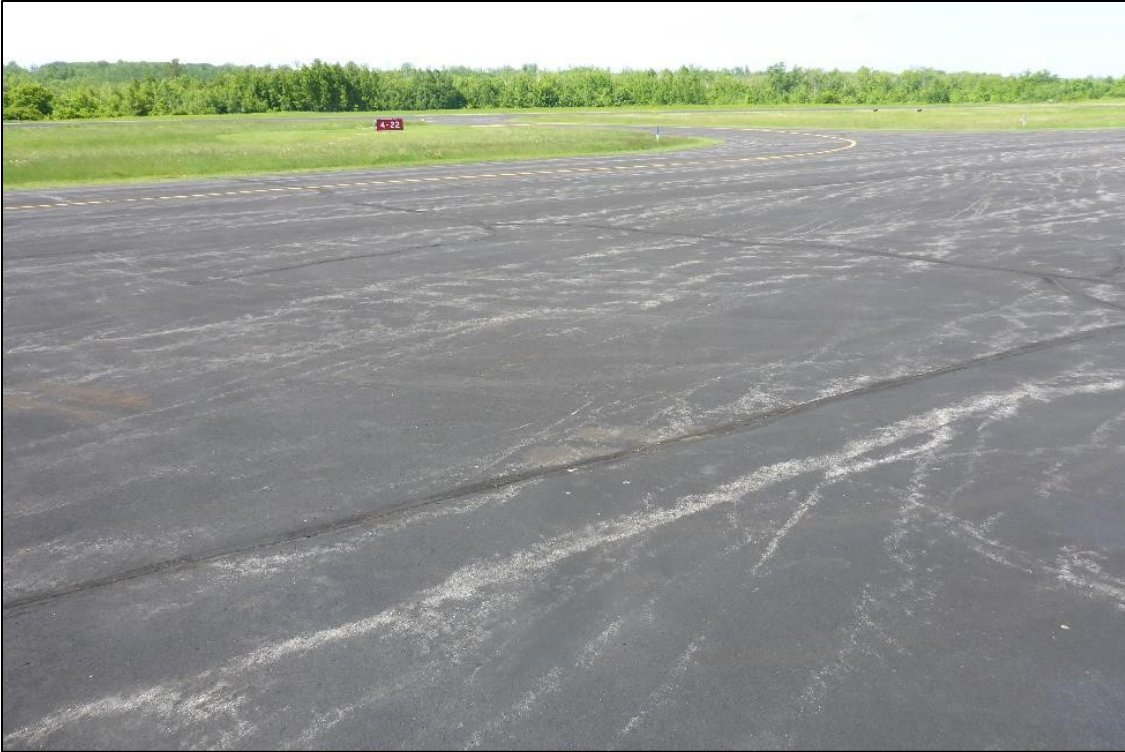
MZH PPTA 001 (PCI = 84)

Network:	MZH	Name:	MOOSE LAKE						
Branch:	PPTA	Name:	Partial Parallel Taxiway A	Use:	TAXIWAY	Area:	46,950 SqFt		
Section:	001	of	1	From:	300	To:	303	Last Const.:	5/1/2013
Surface:	AC	Family:	MN2018 Asphalt Runway- Taxiways	Zone:	N	Category:	2	Rank:	P
Area:	46,950 SqFt	Length:	435 Ft	Width:	40 Ft				
Slabs:		Slab Length:	Ft	Slab Width:	Ft	Joint Length:	Ft		
Shoulder:		Street Type:		Grade:	0	Lanes:	0		
Last Insp. Date:	6/10/2018	TotalSamples:	11	Surveyed:	4				
Conditions:	PCI: 84								
Sample Number:	300	Type:	R	Area:	4425.00 SqFt	PCI:	83		
48	L & T CR		L	268.00	Ft				
Sample Number:	302	Type:	R	Area:	4000.00 SqFt	PCI:	84		
48	L & T CR		L	214.00	Ft				
Sample Number:	305	Type:	R	Area:	4000.00 SqFt	PCI:	86		
48	L & T CR		L	193.00	Ft				
Sample Number:	308	Type:	R	Area:	4000.00 SqFt	PCI:	81		
48	L & T CR		L	286.00	Ft

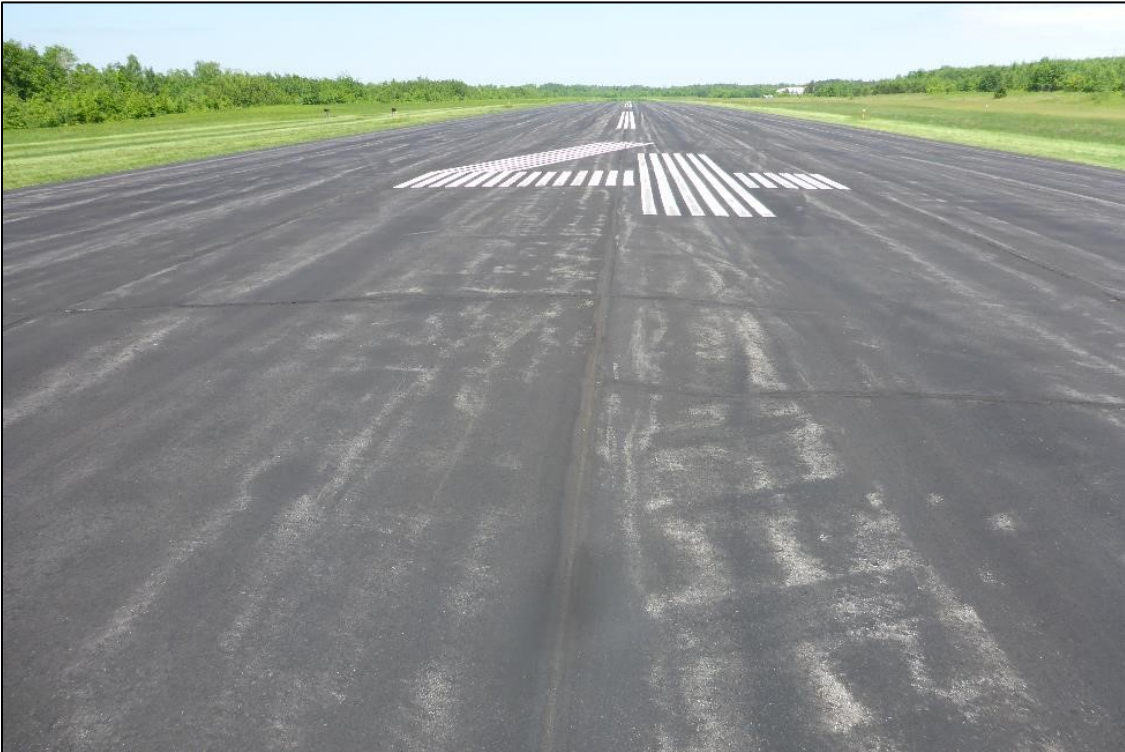
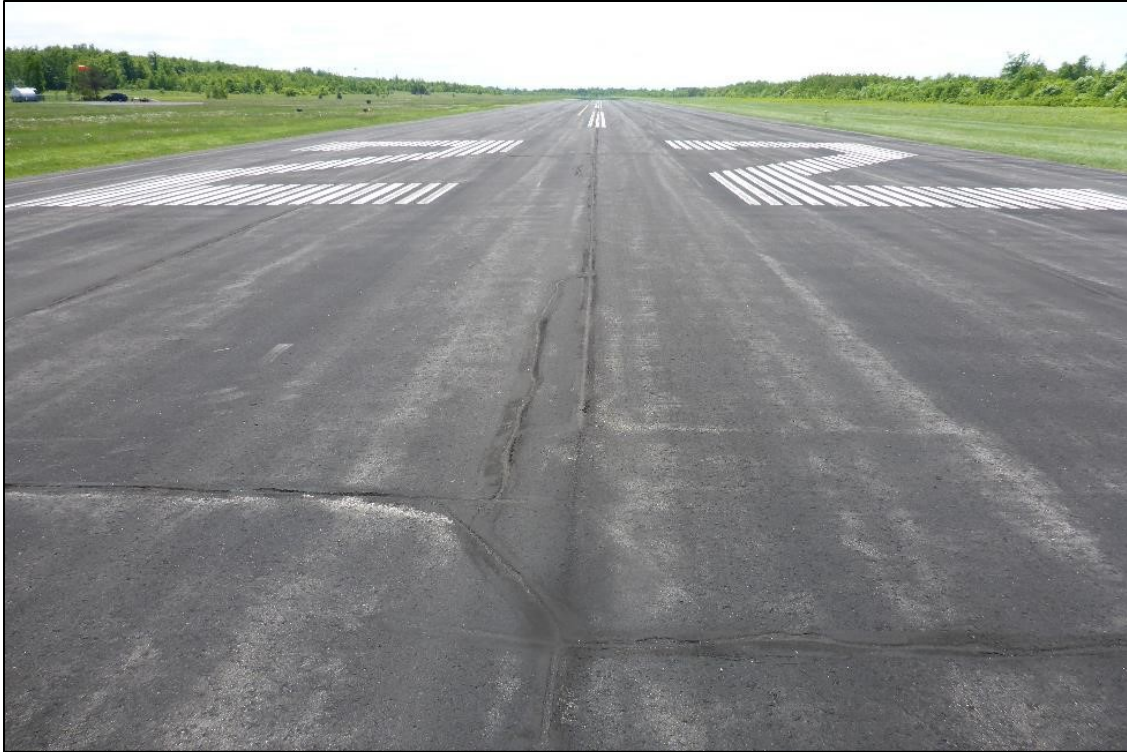
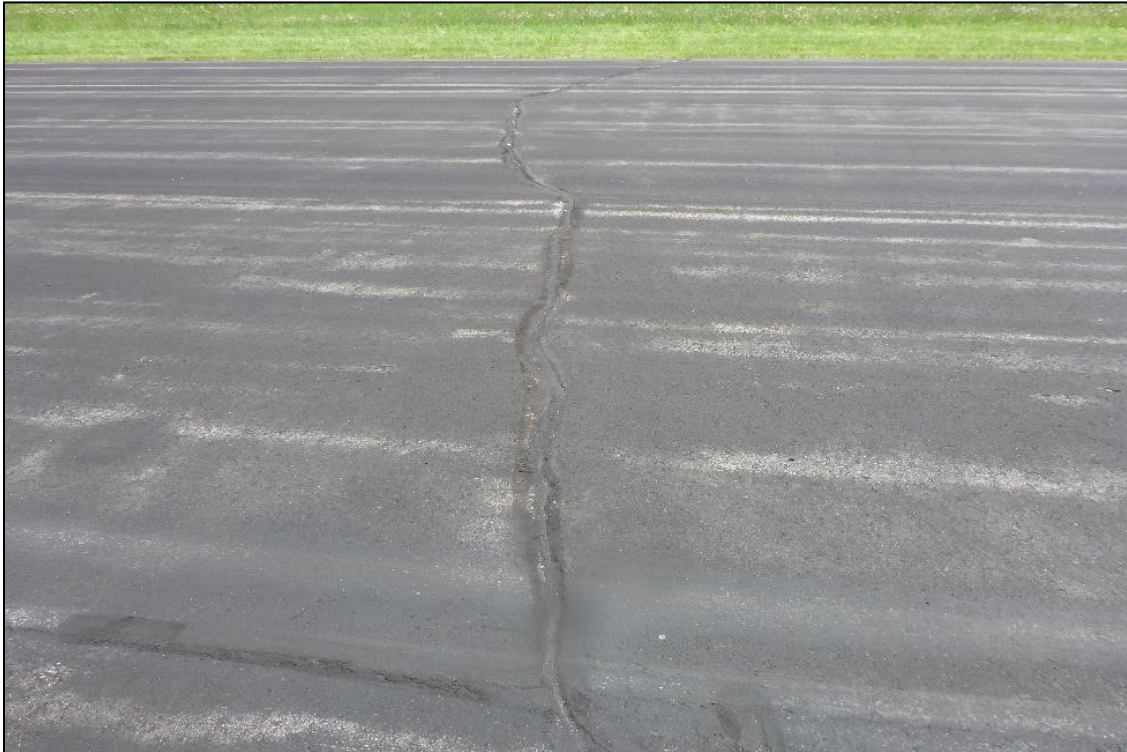
MZH RY422 001 (PCI = 85)

Network:	MZH	Name:	MOOSE LAKE						
Branch:	RY422	Name:	RUNWAY 4-22	Use:	RUNWAY	Area:	249,375 SqFt		
Section:	001	of	1	From:	100	To:	165	Last Const.:	5/1/2013
Surface:	AC	Family:	MN2018 Asphalt Runway- Taxiways	Zone:	N	Category:	2	Rank:	P
Area:	249,375 SqFt	Length:	3,325 Ft	Width:	75 Ft				
Slabs:		Slab Length:	Ft	Slab Width:	Ft	Joint Length:	Ft		
Shoulder:		Street Type:		Grade:	0	Lanes:	0		
Last Insp. Date:	6/10/2018	TotalSamples:	66	Surveyed:	8				
Conditions:	PCI: 85								
Sample Number:	106	Type:	R	Area:	3750.00 SqFt	PCI:	82		
48	L & T CR		L	254.00	Ft				
Sample Number:	115	Type:	R	Area:	3750.00 SqFt	PCI:	82		
48	L & T CR		L	252.00	Ft				
Sample Number:	124	Type:	R	Area:	3750.00 SqFt	PCI:	81		
48	L & T CR		L	269.00	Ft				
Sample Number:	133	Type:	R	Area:	3750.00 SqFt	PCI:	85		
48	L & T CR		L	195.00	Ft				
Sample Number:	142	Type:	R	Area:	3750.00 SqFt	PCI:	86		
48	L & T CR		L	175.00	Ft				
Sample Number:	151	Type:	R	Area:	3750.00 SqFt	PCI:	80

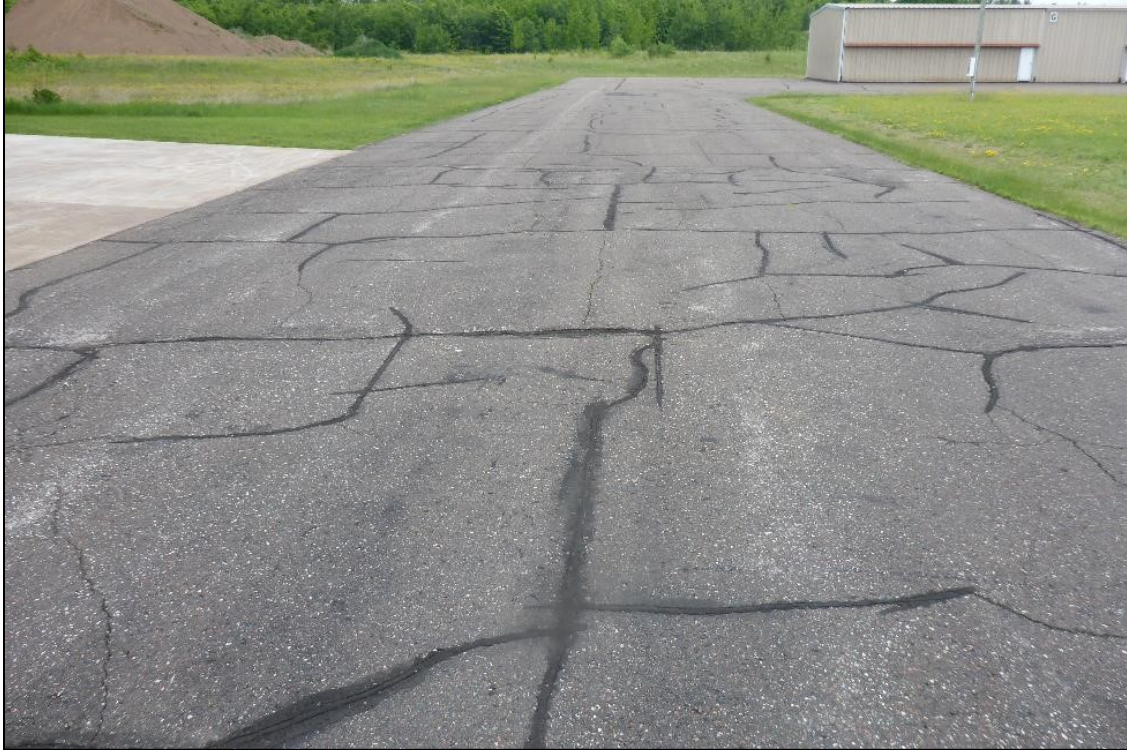
MZH TLA 001 (PCI = 29)

Network:	MZH	Name:	MOOSE LAKE				
Section:	001	of 2	From: 100	To: 102	Last Const.: 9/30/1992		
Surface:	AC	Family:	MN2018 Asphalt Taxilanes	Zone:	N	Category: 2	Rank: T
Area:	11,200 SqFt	Length:	540 Ft	Width:	20 Ft	Joint Length:	Ft
Slabs:	Slab Length:	Ft	Slab Width:	Ft	Joint Length:	Ft	
Shoulder:	Street Type:		Grade:	0	Lanes:	0	
Last Insp. Date:	6/10/2018	TotalSamples:	3	Surveyed:	1		
Conditions:	PCI:	29					
Sample Number:	100	Type:	R	Area:	4962.00 SqFt	PCI:	29
57	WEATHERING	L		4900.00 SqFt			
41	ALLIGATOR CR	M		200.00 SqFt			
43	BLOCK CR	M		1410.00 SqFt			
43	BLOCK CR	L		3500.00 SqFt			
45	DEPRESSION	L		5.00 SqFt

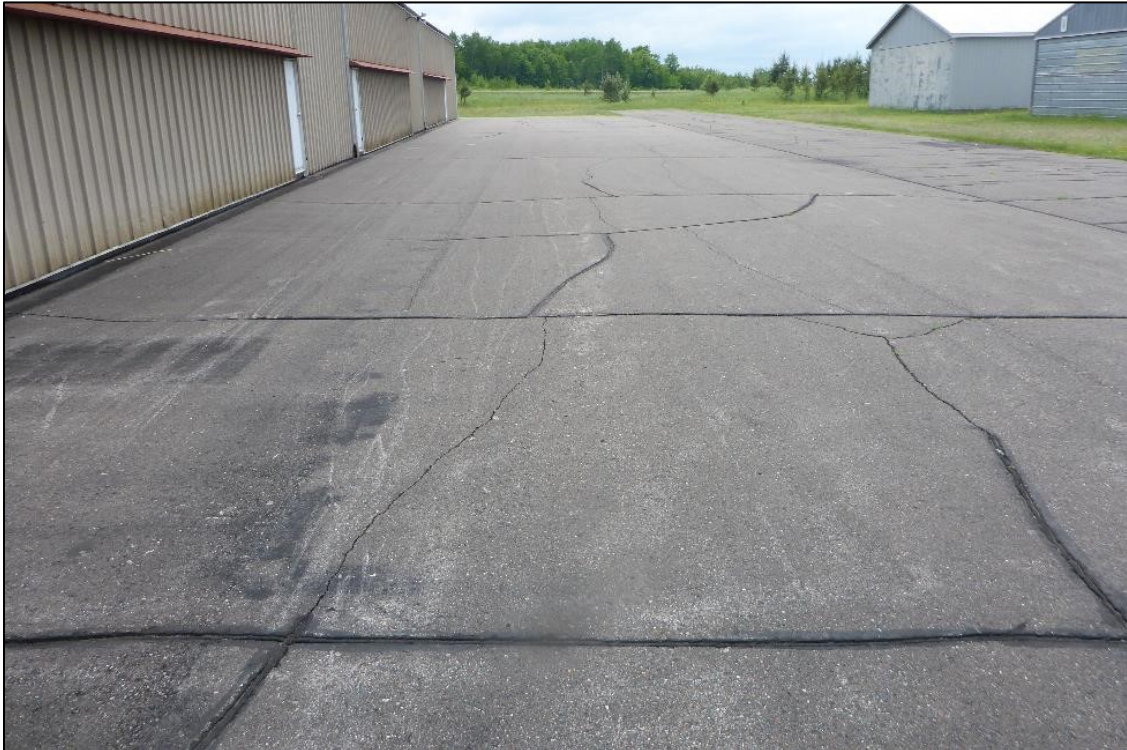
MZH TLA 002 (PCI = 67)

Network:	MZH	Name:	MOOSE LAKE						
Branch:	TLA	Name:	Taxilane A	Use:	TAXILANE	Area:	31,700 SqFt		
Section:	002	of 2	From:	200	To:	205	Last Const.: 6/1/1995		
Surface:	AC	Family:	MN2018 Asphalt Taxilanes	Zone:	N	Category:	2	Rank:	T
Area:	20,500 SqFt	Length:	420 Ft	Width:	50 Ft				
Slabs:		Slab Length:	Ft	Slab Width:	Ft	Joint Length:	Ft		
Shoulder:		Street Type:		Grade:	0	Lanes:	0		
Last Insp. Date:	6/10/2018	TotalSamples:	6	Surveyed:	2				
Conditions:	PCI: 67								
Sample Number:	200	Type:	R	Area:	4648.00 SqFt	PCI:	68		
48	L & T CR		L	543.00 Ft					
48	L & T CR		M	198.00 Ft					
Sample Number:	202	Type:	R	Area:	3872.00 SqFt	PCI:	67		
48	L & T CR		L	255.00 Ft					
48	L & T CR		M	157.00 Ft					
48	L & T CR		H	8.00 Ft
