Pavement Condition Report

Tower Municipal Airport (12D)

December 2019

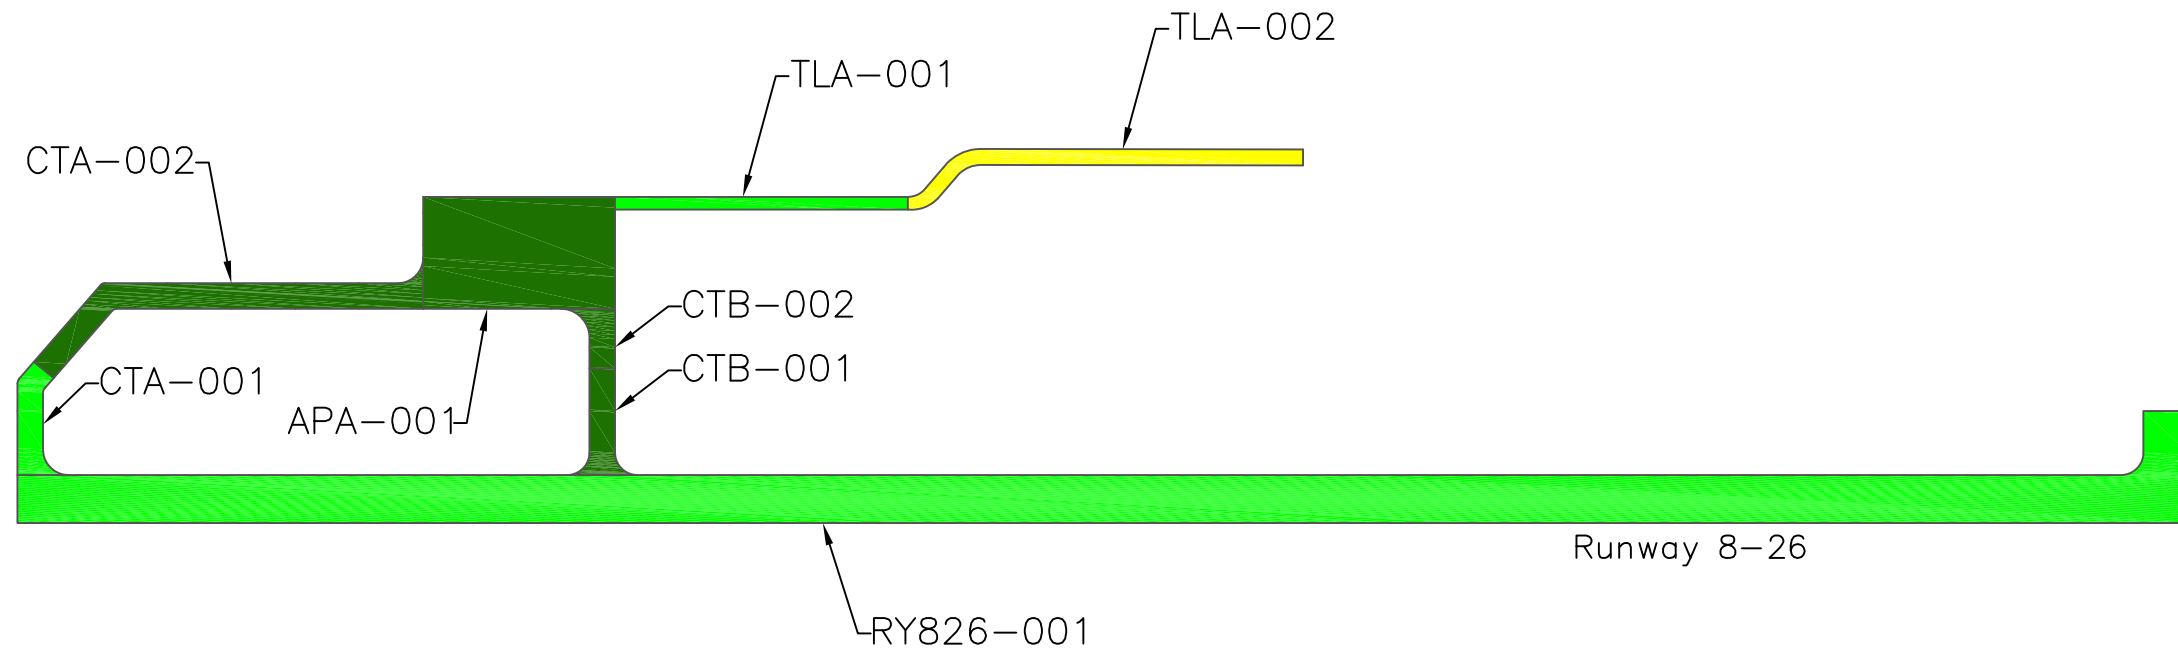
Figure 4. 2019 Pavement Condition Index Rating at Tower Municipal Airport (12D).

Figures 5 and 6 present the overall PCI for 12D by area distribution and pavement use, respectively. Table 3 presents the PCI summary for each section at 12D, including the drop in PCI per year. Generally, pavement sections will deteriorate between 1 and 3 PCI points per year. Sections deteriorating at higher rates may need maintenance above the normal application rates and should be closely monitored in case major repairs become necessary earlier than expected.

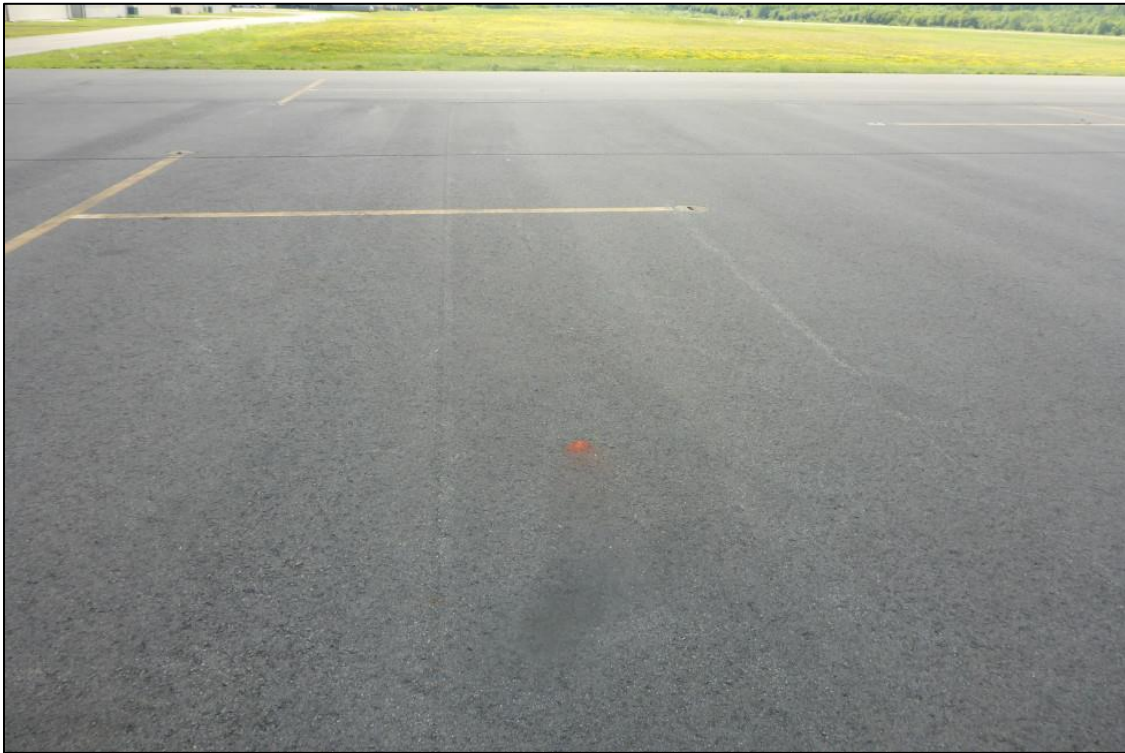
12D APA 001 (PCI = 90)

Conditions: PCI: 90

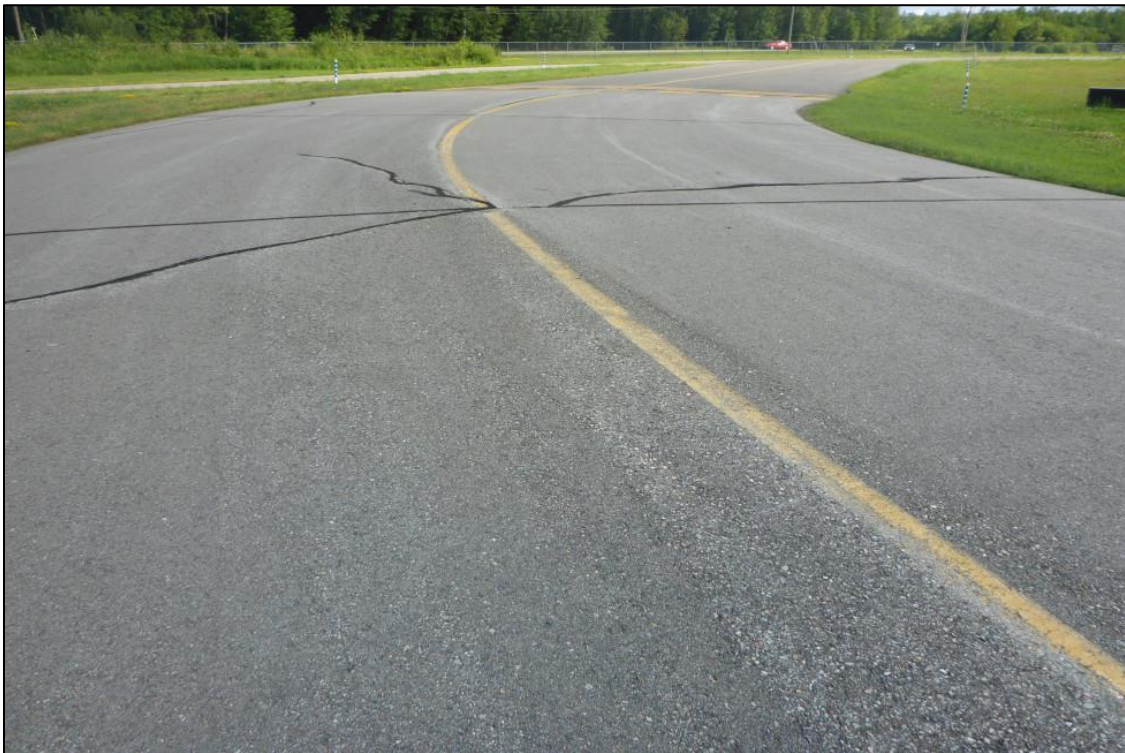
12D CTA 001 (PCI = 73)

Conditions: PCI: 73

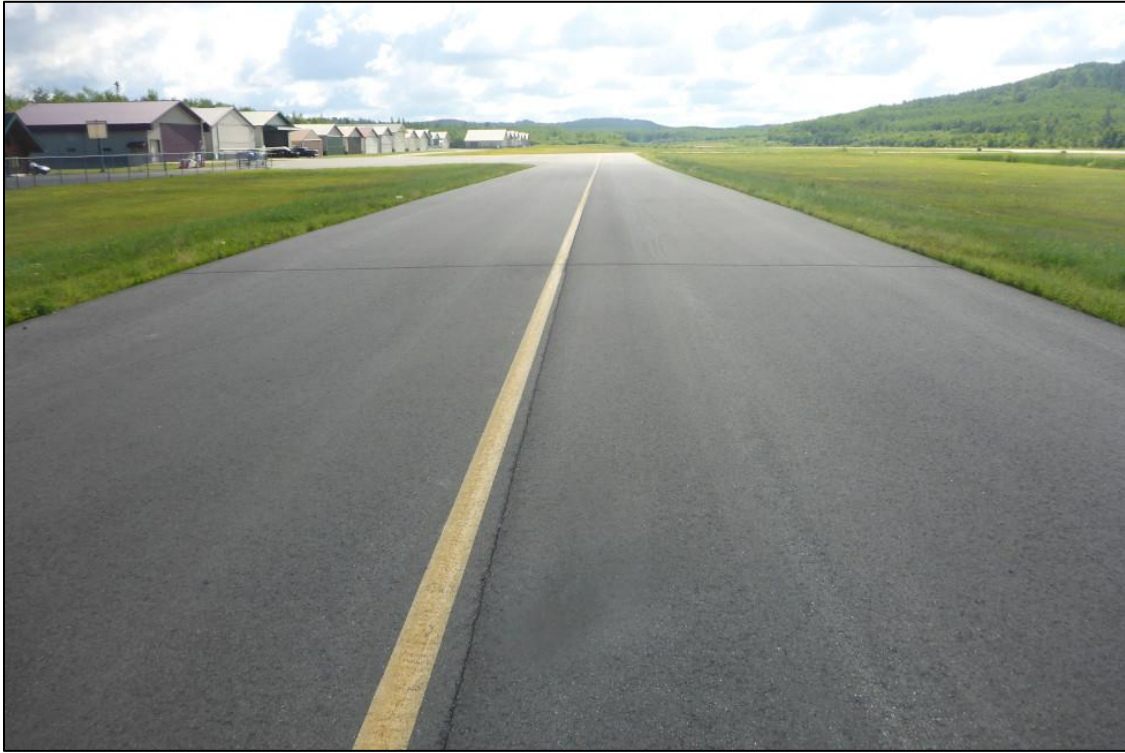
12D CTA 002 (PCI = 91)

Network:	12D	Name:	TOWER						
Branch:	CTA	Name:	CONNECTING TAXIWAY A	Use:	TAXIWAY	Area:	32,585 SqFt		
Section:	002	of 2	From:	1+85	To:	107	Last Const.:	11/15/2016	
Surface:	AC	Family:	MN2018 Asphalt Runway- Taxiways	Zone:	N	Category:	3	Rank:	P
Area:	24,935 SqFt	Length:	615 Ft	Width:	40 Ft				
Slabs:		Slab Length:	Ft	Slab Width:	Ft	Joint Length:	Ft		
Shoulder:		Street Type:		Grade:	0	Lanes:	0		
Section Comments:	maint. (R&E) CS								
Last Insp. Date:	7/16/2019	TotalSamples:	6	Surveyed:	2				
Conditions:	PCI: 91								
Inspection Comments:									
Sample Number:	103	Type:	R	Area:	4000.00 SqFt	PCI:	91		
Sample Comments:	new AC p149								
48	L & T CR	L	100.00	Ft					
Sample Number:	105	Type:	R	Area:	4000.00 SqFt	PCI:	91		
Sample Comments:	p148								
48	L & T CR	L	100.00	Ft

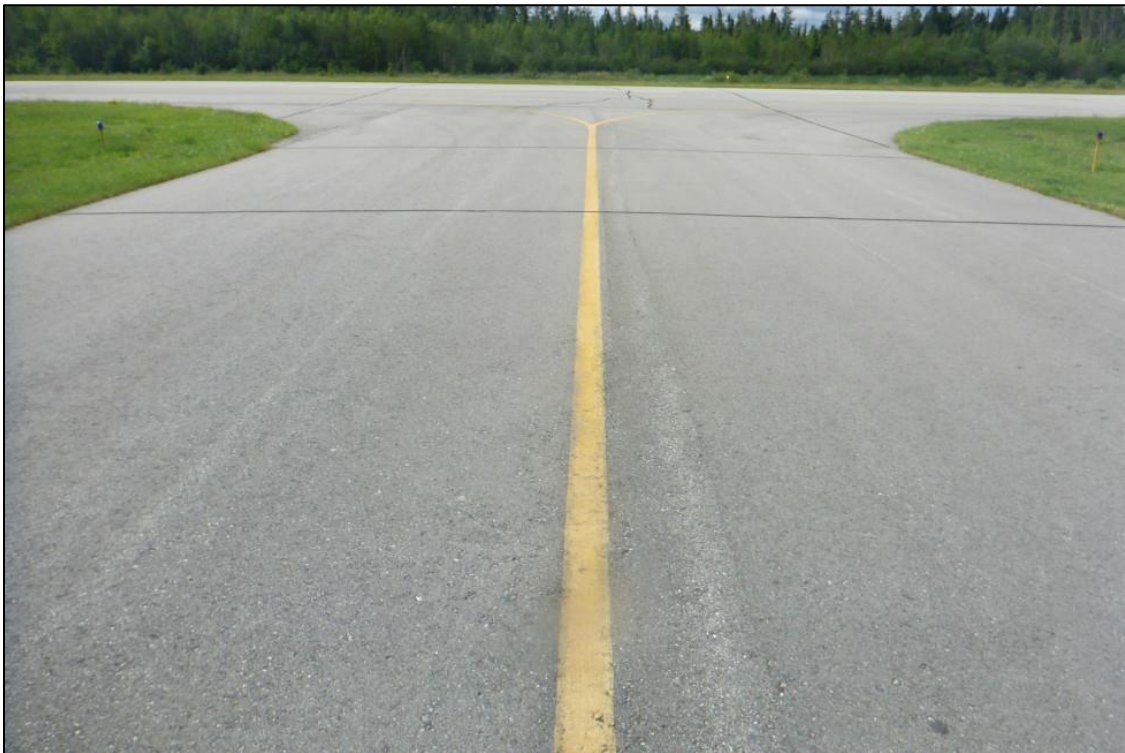
12D CTB 001 (PCI = 92)

Network:	12D	Name:	TOWER						
Branch:	CTB	Name:	CONNECTING TAXIWAY B	Use:	TAXIWAY	Area:	10,840 SqFt		
Section:	001	of 2	From:	100	To:	101	Last Const.: 9/1/2012		
Surface:	AC	Family:	MN2018 Asphalt Runway- Taxiways	Zone:	N	Category:	3	Rank:	P
Area:	6,920 SqFt	Length:	163 Ft	Width:	40 Ft				
Slabs:		Slab Length:	Ft	Slab Width:	Ft	Joint Length:	Ft		
Shoulder:		Street Type:		Grade:	0	Lanes:	0		
Section Comments:									
Last Insp. Date:	7/16/2019	TotalSamples:	2	Surveyed:	1				
Conditions:	PCI: 92								
Inspection Comments:									
Sample Number:	100	Type:	R	Area:	4400.00 SqFt	PCI:	92		
Sample Comments:	p150								
48	L & T CR	L	92.00	Ft

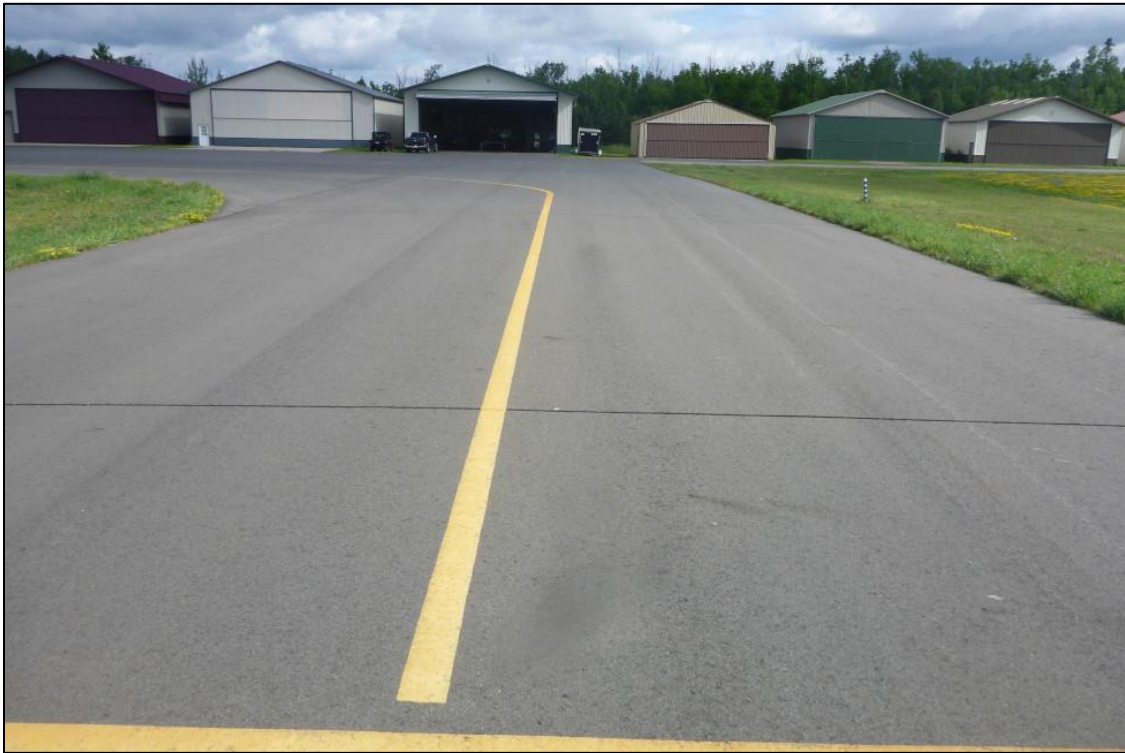
12D CTB 002 (PCI = 100)

Conditions: PCI: 100

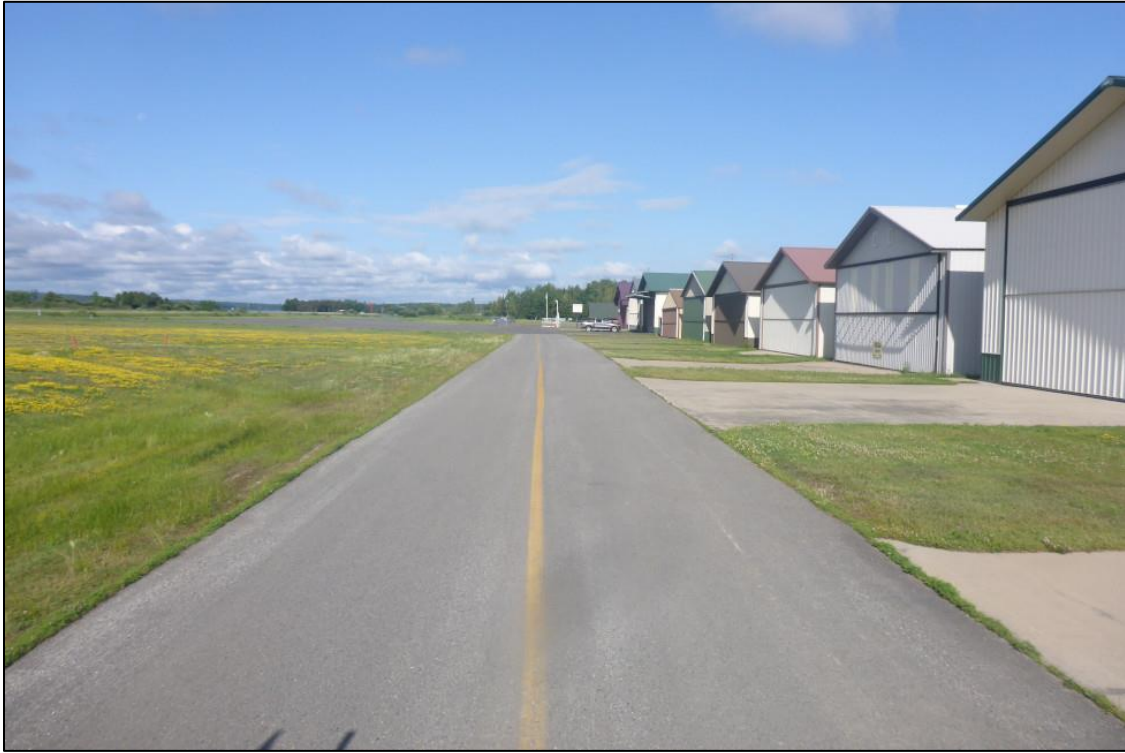
12D TLA 001 (PCI = 75)

Network:	12D	Name:	TOWER						
Branch:	TLA	Name:	Taxilane A	Use:	TAXILANE	Area:	24,450 SqFt		
Section:	001	of 2	From:	100	To:	101	Last Const.: 7/1/2013		
Surface:	AC	Family:	MN2018 Asphalt Taxilanes	Zone:	N	Category:	3	Rank:	T
Area:	9,200 SqFt	Length:	460 Ft	Width:	20 Ft				
Slabs:	Slab Length:	Ft	Slab Width:	Ft	Joint Length:	Ft			
Shoulder:	Street Type:	Grade:		0	Lanes:	0			
Section Comments:	had removed old AC, will repave in 2013								
Last Insp. Date:	7/16/2019	TotalSamples:	2	Surveyed:	1				
Conditions:	PCI: 75								
Inspection Comments:									
Sample Number:	101	Type:	R	Area:	4000.00 SqFt	PCI:	75		
Sample Comments:	p145								
48	L & T CR	L	13.00	Ft					
53	RUTTING	L	10.00	SqFt					
53	RUTTING	M	15.00	SqFt

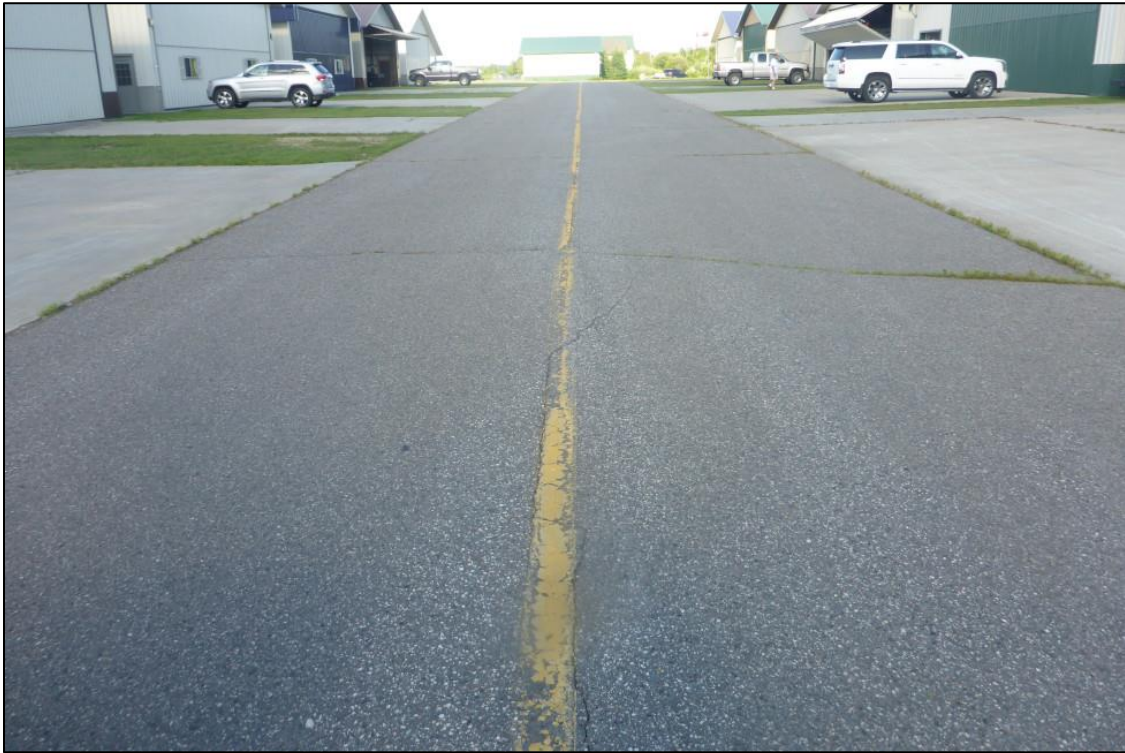
12D TLA 002 (PCI = 66)

Network:	12D	Name:	TOWER						
Branch:	TLA	Name:	Taxilane A	Use:	TAXILANE	Area:	24,450 SqFt		
Section:	002	of 2	From:	102	To:	105	Last Const.: 7/16/2006		
Surface:	AC	Family:	MN2018 Asphalt Taxilanes	Zone:	N	Category:	3	Rank:	T
Area:	15,250 SqFt	Length:	610 Ft	Width:	25 Ft				
Slabs:	Slab Length:	Ft	Slab Width:	Ft	Joint Length:	Ft			
Shoulder:	Street Type:	Grade:	0	Lanes:	0				
Section Comments:	estimated LCD								
Last Insp. Date:	7/16/2019	TotalSamples:	3	Surveyed:	1				
Conditions:	PCI: 66								
Inspection Comments:									
Sample Number:	104	Type:	R	Area:	4000.00 SqFt	PCI:	66		
Sample Comments:	p144								
41	ALLIGATOR CR	L	25.00	SqFt					
48	L & T CR	L	289.00	Ft					
48	L & T CR	M	127.00	Ft					
57	WEATHERING	L	400.00	SqFt
