Pavement Condition Report

Waseca Municipal Airport (ACQ)

December 2019

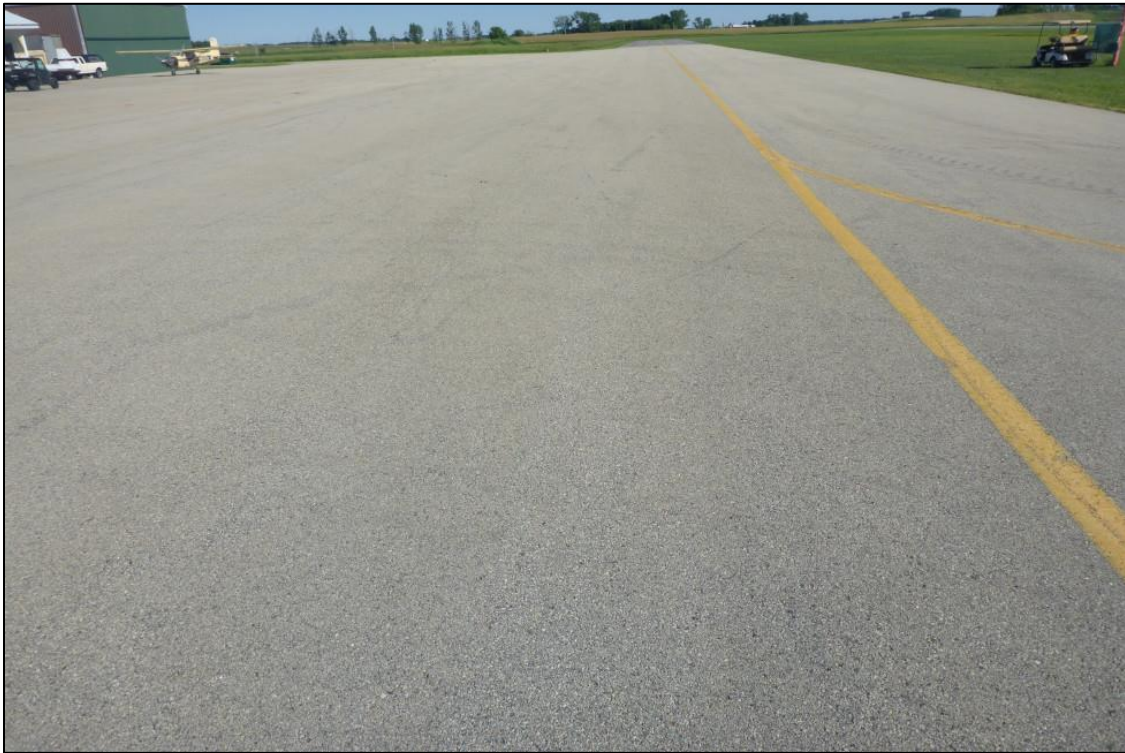
ACQ APA 001 (PCI = 93)

Conditions: PCI: 93

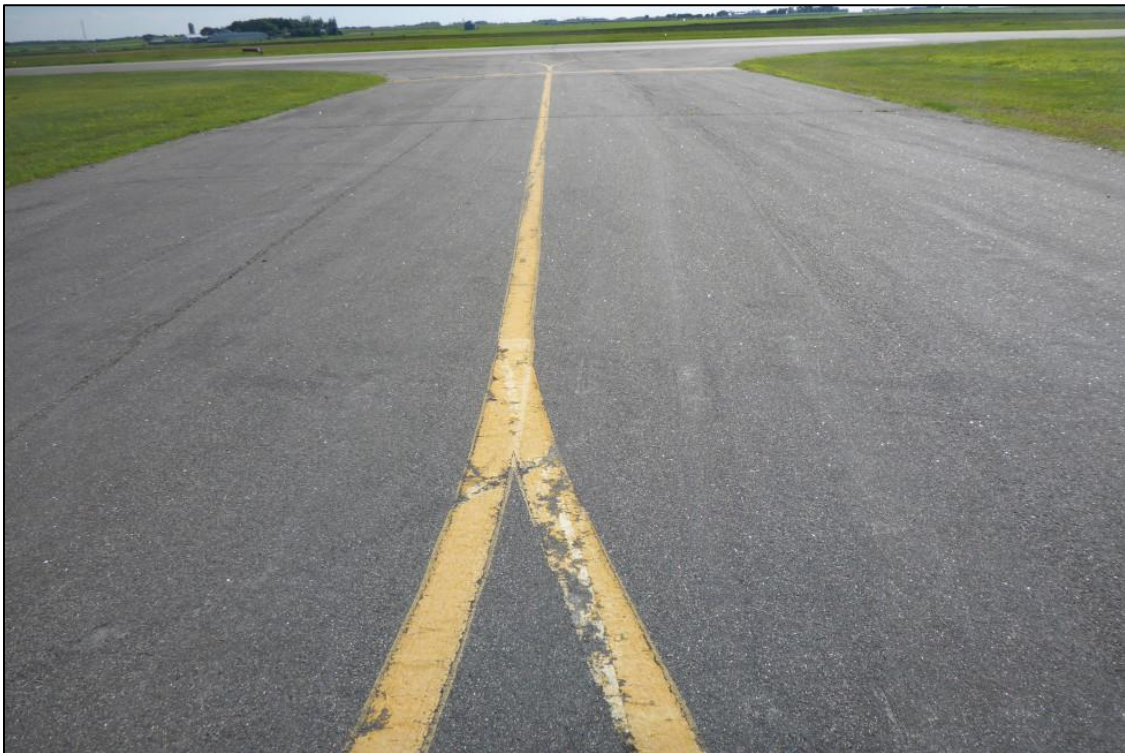
ACQ CTA 001 (PCI = 82)

Network:	ACQ	Name:	WASECA						
Branch:	CTA	Name:	CONNECTING TAXIWAY A	Use:	TAXIWAY	Area:	14,000 SqFt		
Section:	001	of 1	From:	100	To:	101	Last Const.:	11/16/1999	
Surface:	AC	Family:	MN2018 Asphalt Runway- Taxiways	Zone:	S	Category:	3	Rank:	P
Area:	14,000 SqFt	Length:	225 Ft	Width:	40 Ft				
Slabs:		Slab Length:	Ft	Slab Width:	Ft	Joint Length:	Ft		
Shoulder:		Street Type:		Grade:	0	Lanes:	0		
Section Comments:									
Last Insp. Date:	6/11/2019	TotalSamples:	3	Surveyed:	1				
Conditions:	PCI: 82								
Inspection Comments:									
Sample Number:	101	Type:	R	Area:	4000.00 SqFt	PCI:	82		
Sample Comments: p312									
48	L & T CR	L	172.00 Ft						
50	PATCHING	L	60.00 SqFt

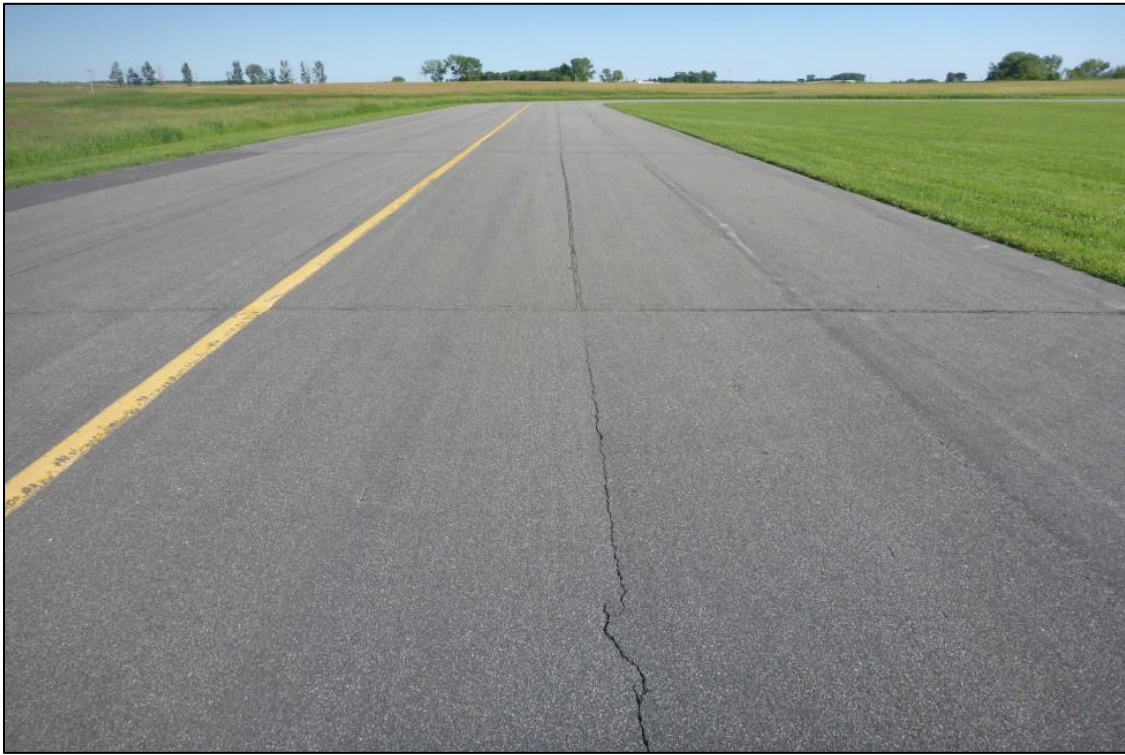
ACQ PPTA 001 (PCI = 77)

Conditions: PCI: 77

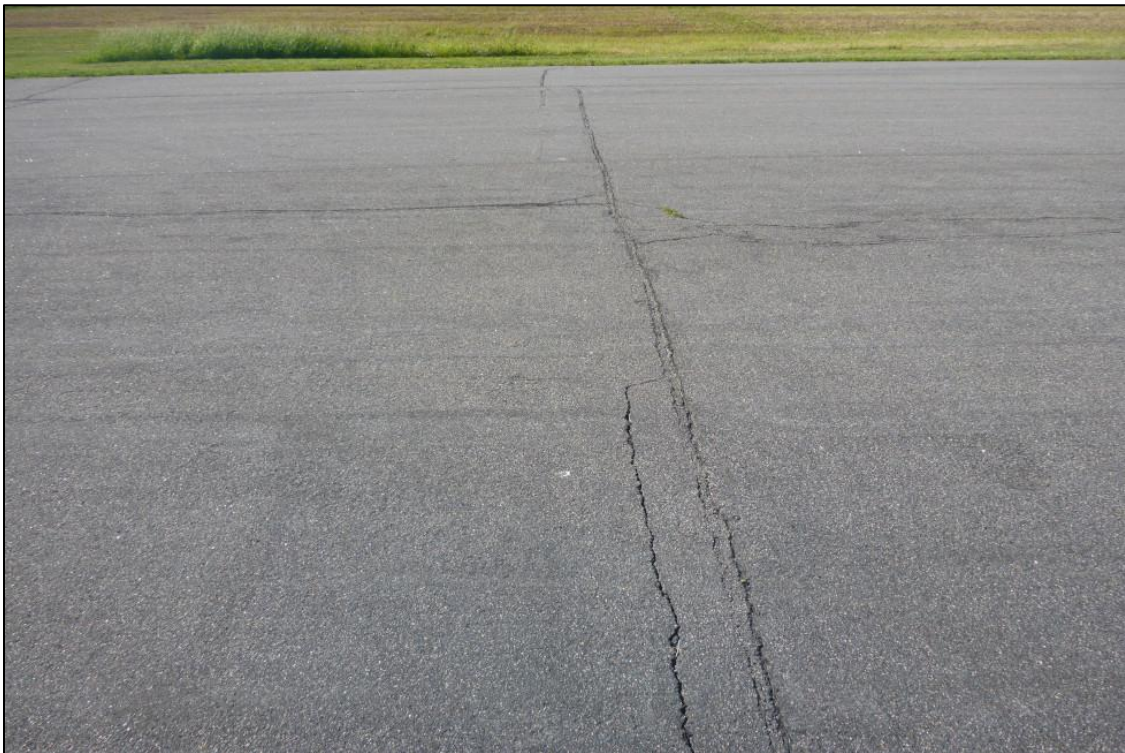
ACQ RTA 001 (PCI = 79)

Network:	ACQ	Name:	WASECA						
Branch:	RTA	Name:	RUNWAY TURNAROUND	Use:	TAXIWAY	Area:	12,225 SqFt		
Section:	001	of 1	From:	168	To:	169	Last Const.:	11/16/1999	
Surface:	AC	Family:	MN2018 Asphalt Runway- Taxiways	Zone:	S	Category:	3	Rank:	S
Area:	12,225 SqFt	Length:	130 Ft	Width:	90 Ft				
Slabs:		Slab Length:	Ft	Slab Width:	Ft	Joint Length:	Ft		
Shoulder:		Street Type:		Grade:	0	Lanes:	0		
Section Comments:									
Last Insp. Date:	6/11/2019	TotalSamples:	2	Surveyed:	1				
Conditions:	PCI: 79								
Inspection Comments:									
Sample Number:	267	Type:	R	Area:	7150.00 SqFt	PCI:	79		
Sample Comments:	Slurry Seal Good p309 found where patch may have been and now covered by slurry seal								
48	L & T CR	L	598.00	Ft

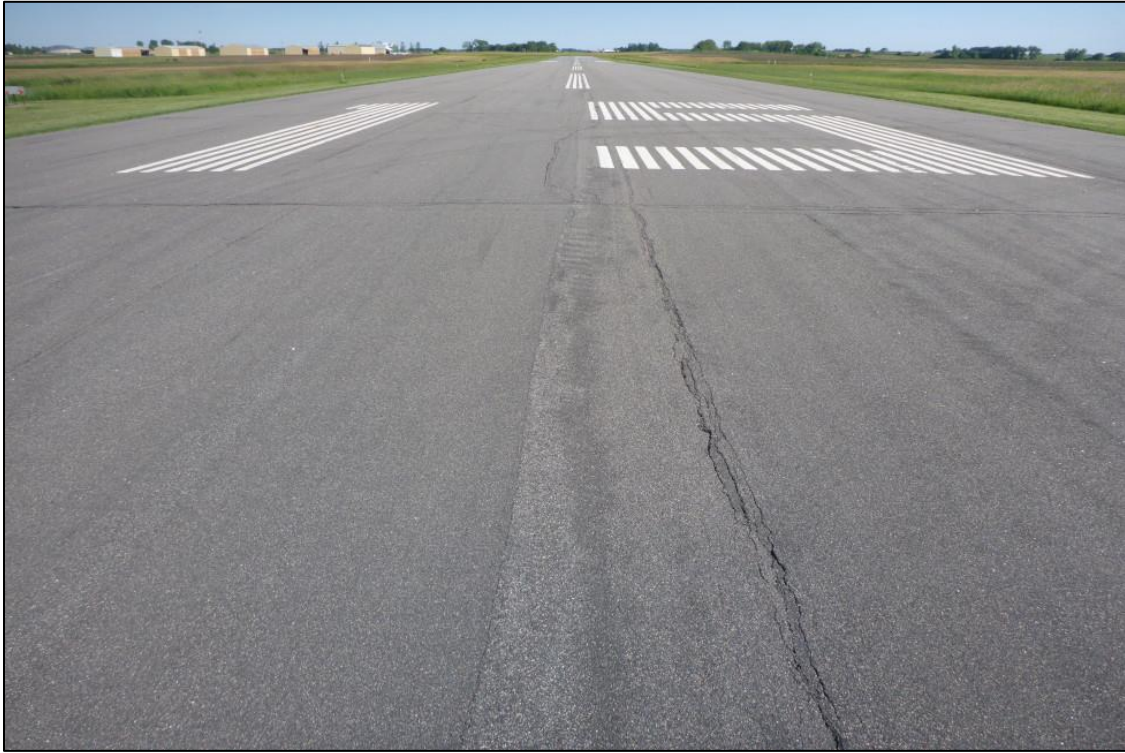
ACQ RY1533 001 (PCI = 76)

Network:	ACQ	Name:	WASECA						
Branch:	RY1533	Name:	RUNWAY 15-33	Use:	RUNWAY	Area:	262,350 SqFt		
Section:	001	of 2	From:	100	To:	167	Last Const.:	11/16/1999	
Surface:	AC	Family:	MN2018 Asphalt Runway- Taxiways	Zone:	S	Category:	3	Rank:	P
Area:	254,850 SqFt	Length:	3,398 Ft	Width:	75 Ft				
Slabs:		Slab Length:	Ft	Slab Width:	Ft	Joint Length:	Ft		
Shoulder:		Street Type:		Grade:	0	Lanes:	0		
Section Comments:									
Last Insp. Date:	6/11/2019	TotalSamples:	68	Surveyed:	7				
Conditions:	PCI: 76								
Inspection Comments:									
Sample Number:	104	Type:	R	Area:	3750.00 SqFt	PCI:	75		
Sample Comments:	p306 numbers old slurry seal								
48	L & T CR	L	298.00	Ft					
48	L & T CR	M	30.00	Ft					
Sample Number:	114	Type:	R	Area:	3750.00 SqFt	PCI:	78		
Sample Comments:									
48	L & T CR	L	340.00	Ft					
Sample Number:	124	Type:	R	Area:	3750.00 SqFt	PCI:	77		
Sample Comments:									
48	L & T CR	L	358.00	Ft

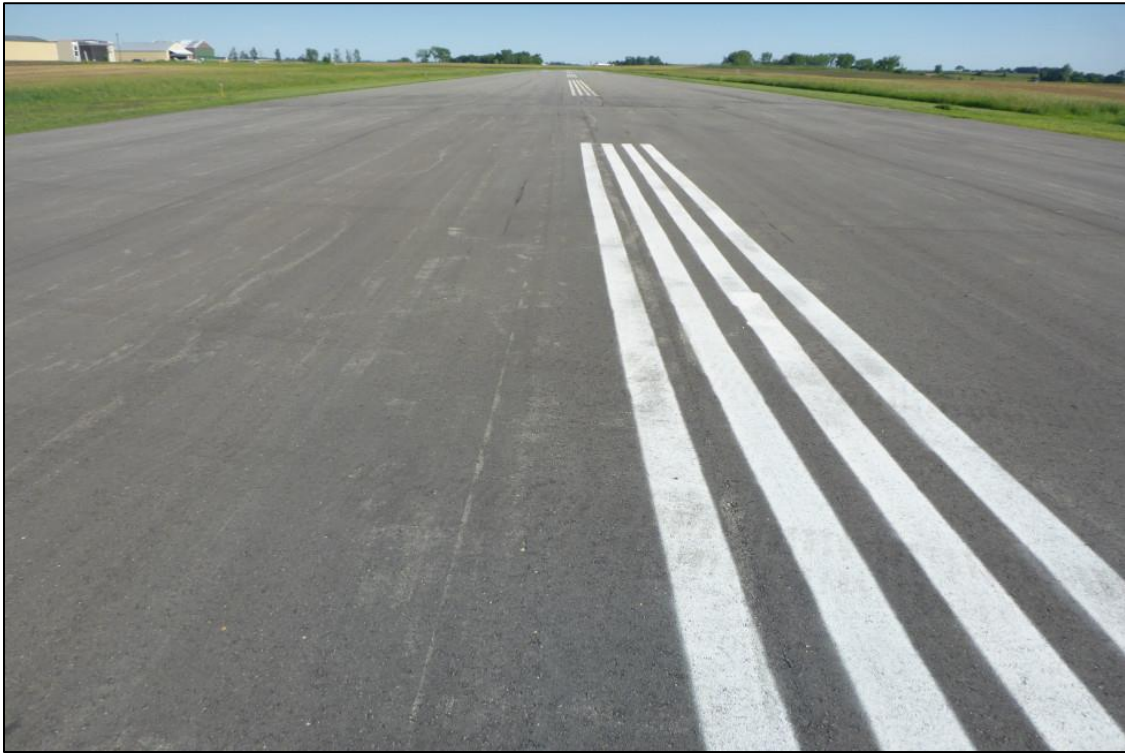
ACQ RY1533 002 (PCI = 100)

Network:	ACQ	Name:	WASECA						
Branch:	RY1533	Name:	RUNWAY 15-33	Use:	RUNWAY	Area:	262,350 SqFt		
Section:	002	of 2	From:	138	To:	139	Last Const.:	9/30/2018	
Surface:	AC	Family:	DEFAULT	Zone:		Category:		Rank:	P
Area:	7,500 SqFt	Length:	100 Ft	Width:	75 Ft				
Slabs:		Slab Length:	Ft	Slab Width:	Ft	Joint Length:		Ft	
Shoulder:		Street Type:		Grade:	0	Lanes:	0		
Section Comments:									
Last Insp. Date:	7/16/2019	TotalSamples:	2	Surveyed:	2				
Conditions:	PCI: 100								
Inspection Comments:									
Sample Number:	138	Type:	R	Area:	3750.00 SqFt	PCI:	100		
Sample Comments:	nd								
<No Distress>									
Sample Number:	139	Type:	R	Area:	3750.00 SqFt	PCI:	100		
Sample Comments:	nd								
<No Distress>

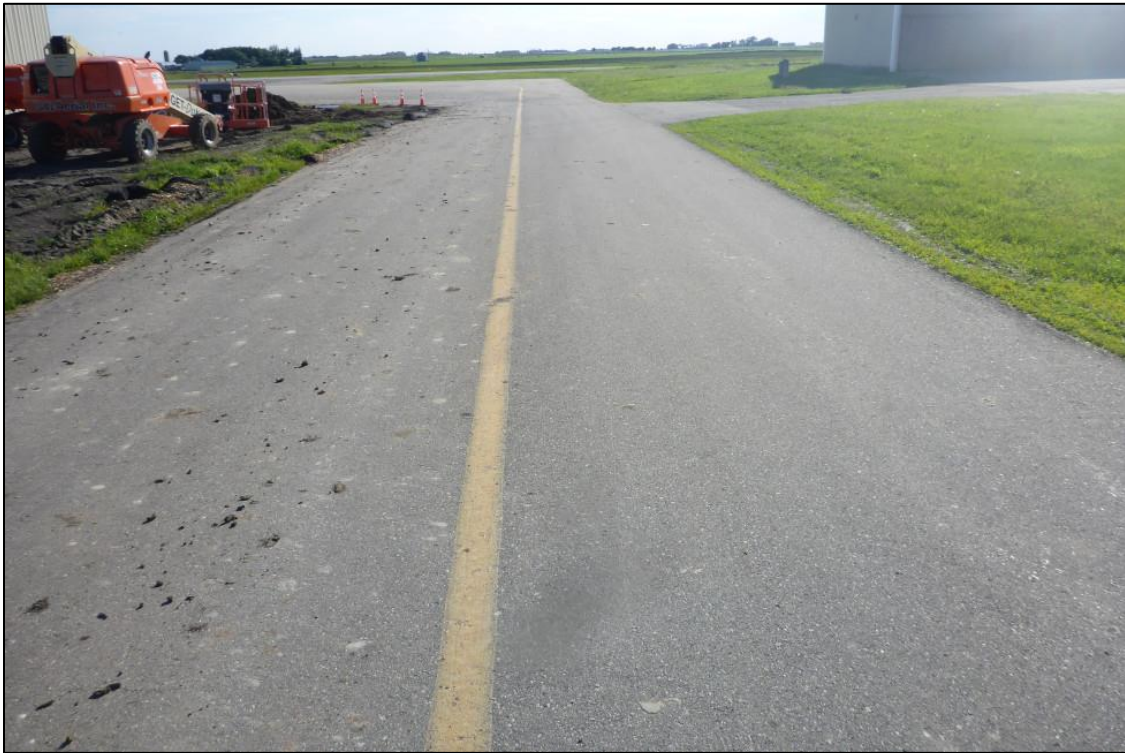
ACQ TLA 001 (PCI = 85)

Network:	ACQ	Name:	WASECA						
Branch:	TLA	Name:	TAXILANE A	Use:	TAXILANE	Area:	30,200 SqFt		
Section:	001	of 2	From:	407	To:	408	Last Const.:	10/11/2013	
Surface:	AAC	Family:	MN2018 Asphalt Taxilanes	Zone:	S	Category:	3	Rank:	T
Area:	9,300 SqFt	Length:	300 Ft	Width:	20 Ft				
Slabs:	Slab Length:	Ft	Slab Width:	Ft	Joint Length:	Ft			
Shoulder:	Street Type:	Grade:	0	Lanes:	0				
Section Comments:	Estimated LCD								
Last Insp. Date:	6/11/2019	TotalSamples:	3	Surveyed:	1				
Conditions:	PCI: 85								
Inspection Comments:									
Sample Number:	404	Type:	R	Area:	3000.00 SqFt	PCI:	85		
Sample Comments:	p893								
48	L & T CR	L	67.00	Ft					
48	L & T CR	M	17.00	Ft					
57	WEATHERING	L	250.00	SqFt

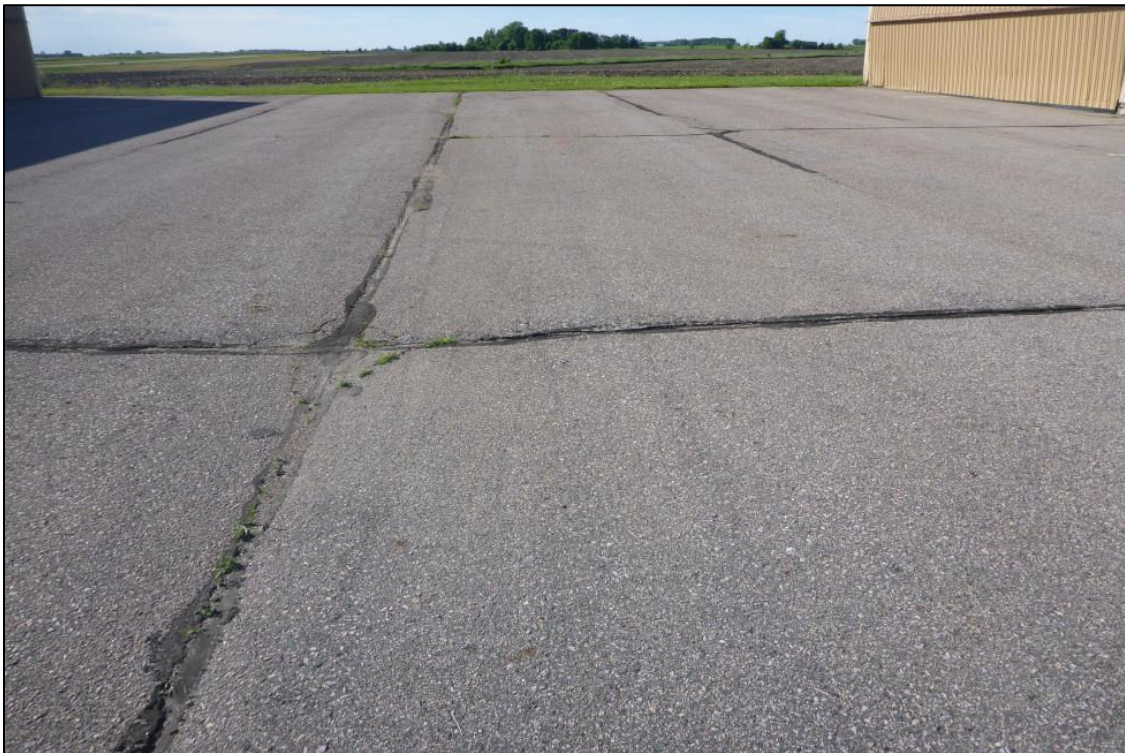
ACQ TLA 002 (PCI = 63)

Network:	ACQ	Name:	WASECA						
Branch:	TLA	Name:	TAXILANE A	Use:	TAXILANE	Area:	30,200 SqFt		
Section:	002	of 2	From:	403	To:	406	Last Const.: 6/30/2002		
Surface:	AAC	Family:	MN2018 Asphalt Taxilanes	Zone:	S	Category:	3	Rank:	T
Area:	20,900 SqFt	Length:	400 Ft	Width:	50 Ft				
Slabs:	Slab Length:	Ft	Slab Width:	Ft	Joint Length:	Ft			
Shoulder:	Street Type:	Grade:	0	Lanes:	0				
Section Comments:	Estimated LCD								
Last Insp. Date:	6/11/2019	TotalSamples:	4	Surveyed:	3				
Conditions:	PCI: 63								
Inspection Comments:									
Sample Number:	407	Type:	R	Area:	3800.00 SqFt	PCI:	70		
Sample Comments:	p316								
48	L & T CR	L	138.00	Ft					
48	L & T CR	M	36.00	Ft					
57	WEATHERING	M	3500.00	SqFt					
Sample Number:	408	Type:	R	Area:	3800.00 SqFt	PCI:	70		
Sample Comments:									
48	L & T CR	L	153.00	Ft					
48	L & T CR	M	41.00	Ft					
57	WEATHERING	L	800.00	SqFt					
57	WEATHERING	M	3000.00	SqFt

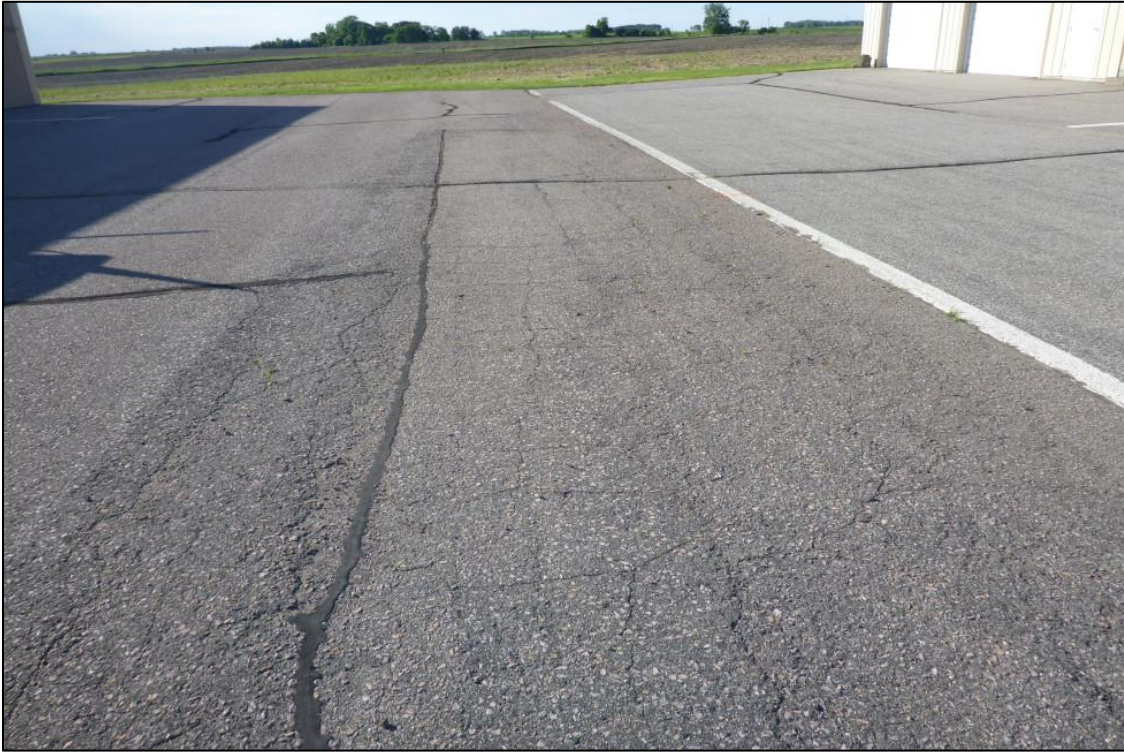
ACQ TLB 001 (PCI = 34)

⁶Higher than expected 3-year drop in PCI between inspections for TLB-001 is due to the development of Alligator and Block cracking in significant quantities

Conditions: PCI: 34

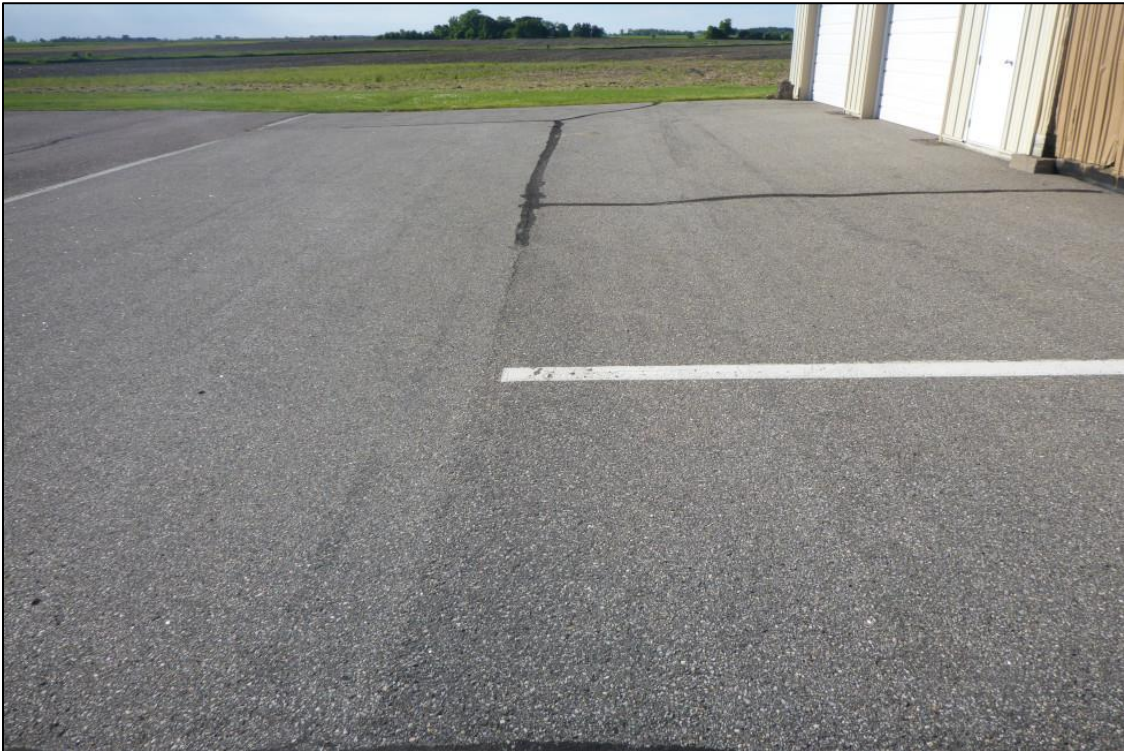
ACQ TLB 002 (PCI = 69)

⁷Higher than expected 3-year drop in PCI between inspections for TLB-002 is due to Raveling and the development of L&T cracking in significant quantities

Network:	ACQ	Name:	WASECA						
Branch:	TLB	Name:	TAXILANE B	Use:	TAXILANE	Area:	17,480 SqFt		
Section:	002	of 2	From:	510	To:	511	Last Const.:	6/30/2008	
Surface:	AAC	Family:	MN2018 Asphalt Taxilanes	Zone:	S	Category:	3	Rank:	T
Area:	5,550 SqFt	Length:	170 Ft	Width:	30 Ft				
Slabs:	Slab Length:	Ft	Slab Width:	Ft	Joint Length:	Ft			
Shoulder:	Street Type:	Grade:	0	Lanes:	0				
Section Comments:	Estimated LCD								
Last Insp. Date:	6/11/2019	TotalSamples:	2	Surveyed:	1				
Conditions:	PCI: 69								
Inspection Comments:									
Sample Number:	906	Type:	R	Area:	3000.00 SqFt	PCI:	69		
Sample Comments:	p320,321								
48	L & T CR	L	155.00	Ft					
48	L & T CR	M	25.00	Ft					
52	RAVELING	L	800.00	SqFt					
57	WEATHERING	L	2200.00	SqFt

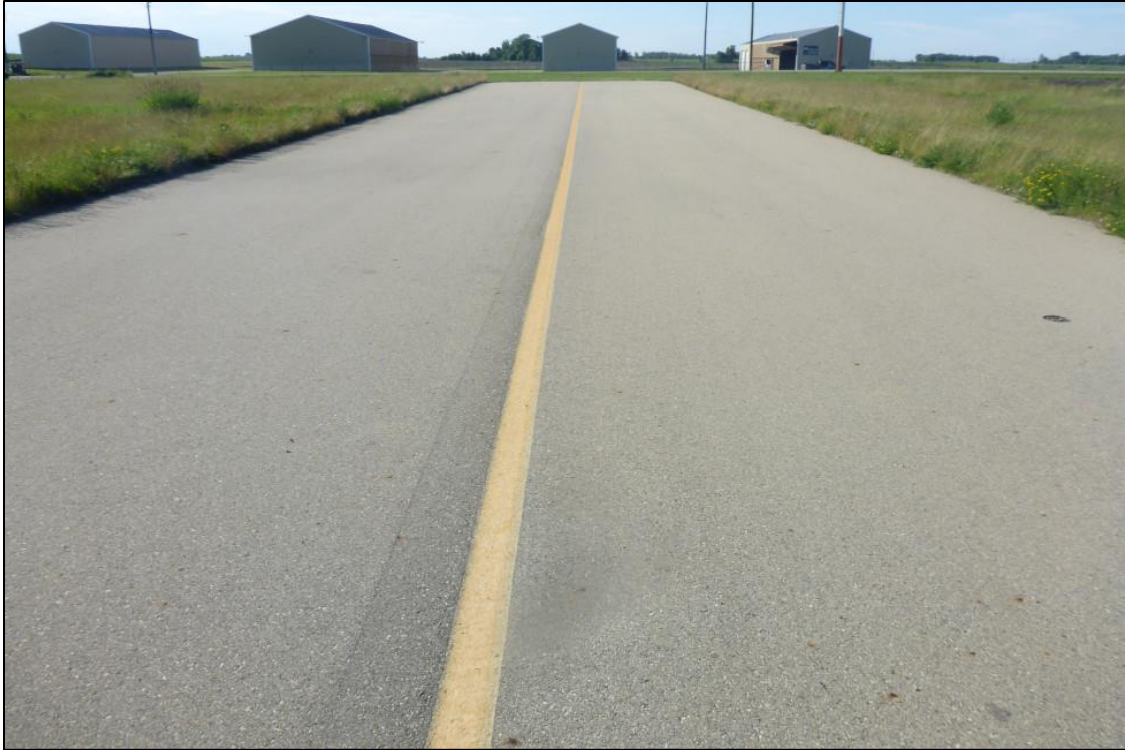
ACQ TLC 001 (PCI = 91)

Network:	ACQ	Name:	WASECA				
Branch:	TLC	Name:	TAXILANE C	Use:	TAXILANE	Area:	21,700 SqFt
Section:	001	of 1	From:	-	To:	-	Last Const.: 7/1/2012
Surface:	AC	Family:	MN2018 Asphalt Taxilanes	Zone:		Category:	Rank: T
Area:	21,700 SqFt	Length:	620 Ft	Width:	35 Ft		
Slabs:		Slab Length:	Ft	Slab Width:	Ft	Joint Length:	Ft
Shoulder:		Street Type:		Grade:	0	Lanes:	0
Section Comments:							
Last Insp. Date:	6/11/2019	TotalSamples:	6	Surveyed:	2		
Conditions:	PCI: 91						
Inspection Comments:							
Sample Number:	101	Type:	R	Area:	3500.00 SqFt	PCI:	89
Sample Comments:							
48	L & T CR	L	100.00 Ft				
57	WEATHERING	L	250.00 SqFt				
Sample Number:	104	Type:	R	Area:	3500.00 SqFt	PCI:	92
Sample Comments: p892							
48	L & T CR	L	54.00 Ft				
57	WEATHERING	L	250.00 SqFt
