Hydraulics Inspection Vehicle Explorer (HIVE)

Rob Coughlin & Kristoffer Langlie, PE
Minnesota Department of Transportation

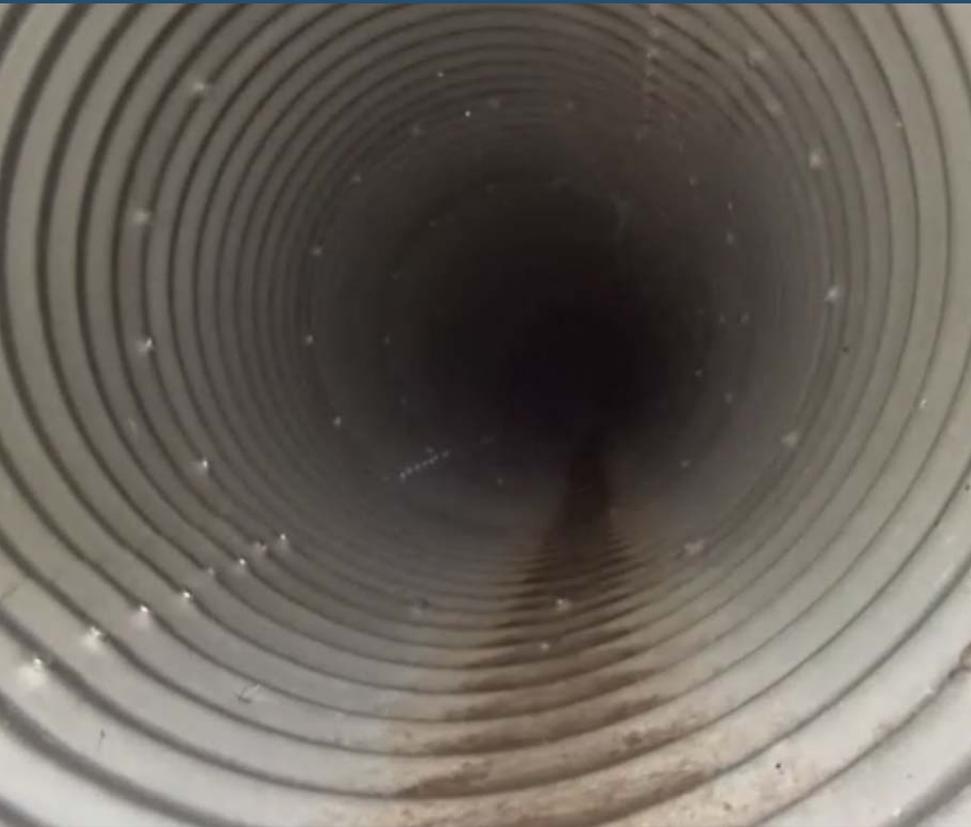
End of Pipe Inspection

I-90 Dakota HIVE Video – 24” CMP

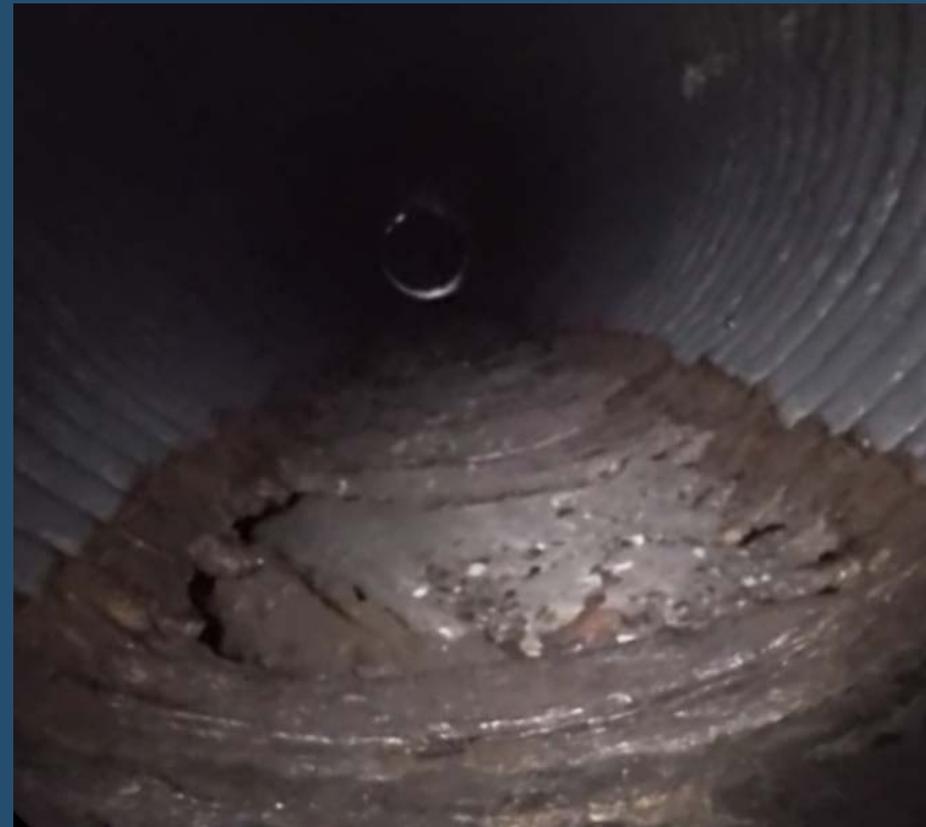
HIVE Video – 55ft from Pipe End

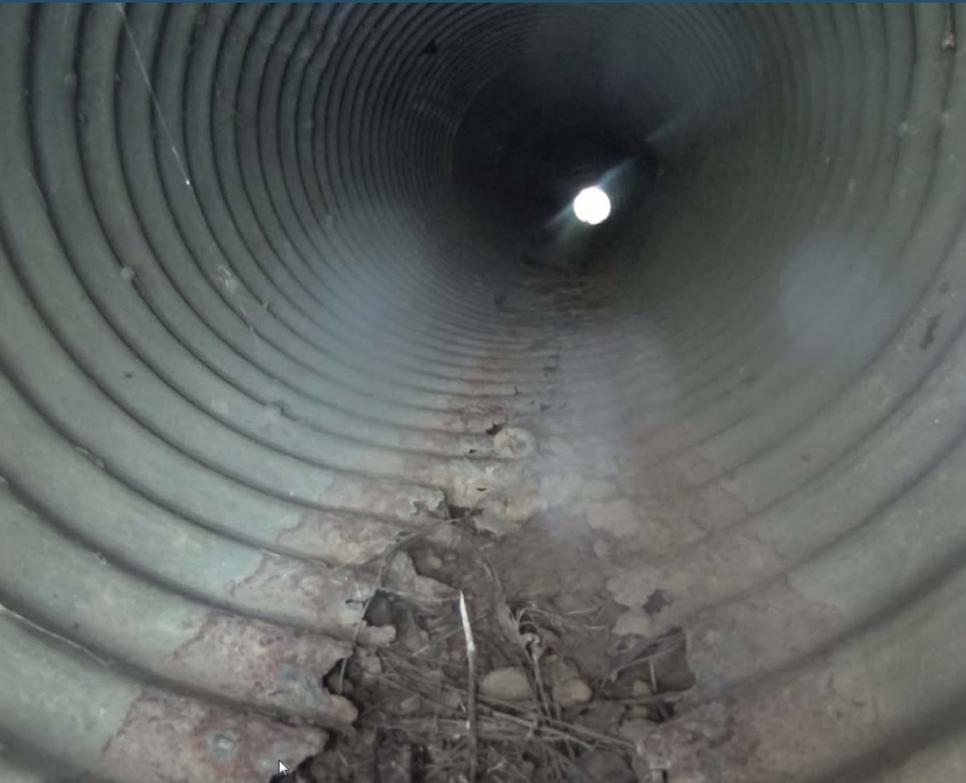
End of Pipe Inspection

MN26 Maintenance Repair Case Study – 24” CMP

Repair: Replacement (\$45k)

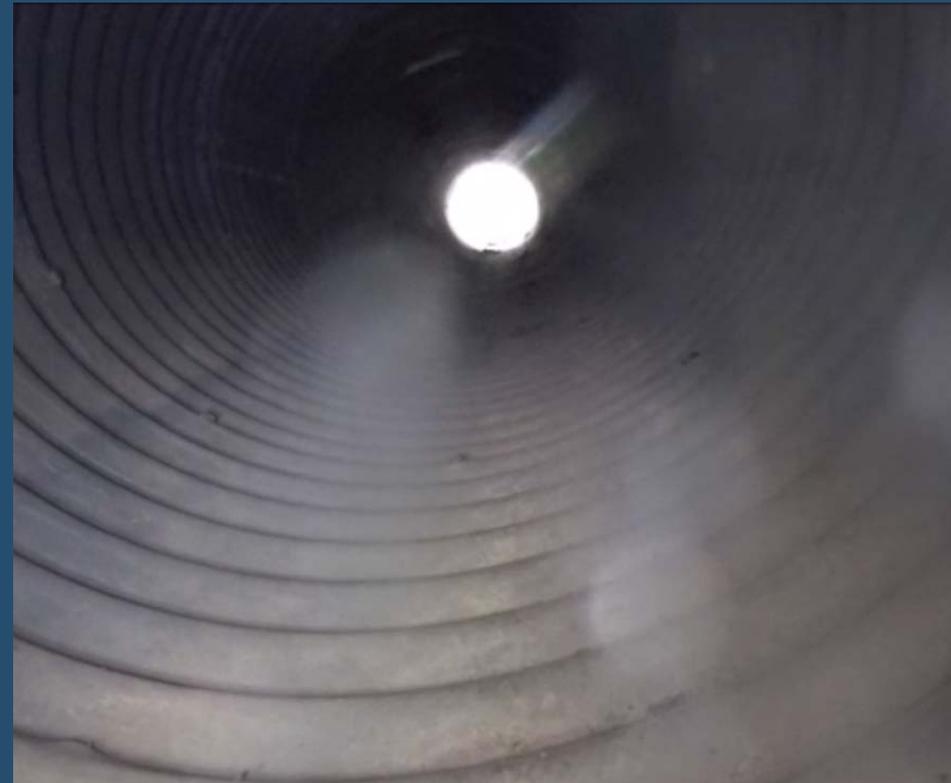
HIVE Video – Rest of Pipe “Good”

Repair: 12ft of Paved Invert (\$1k)

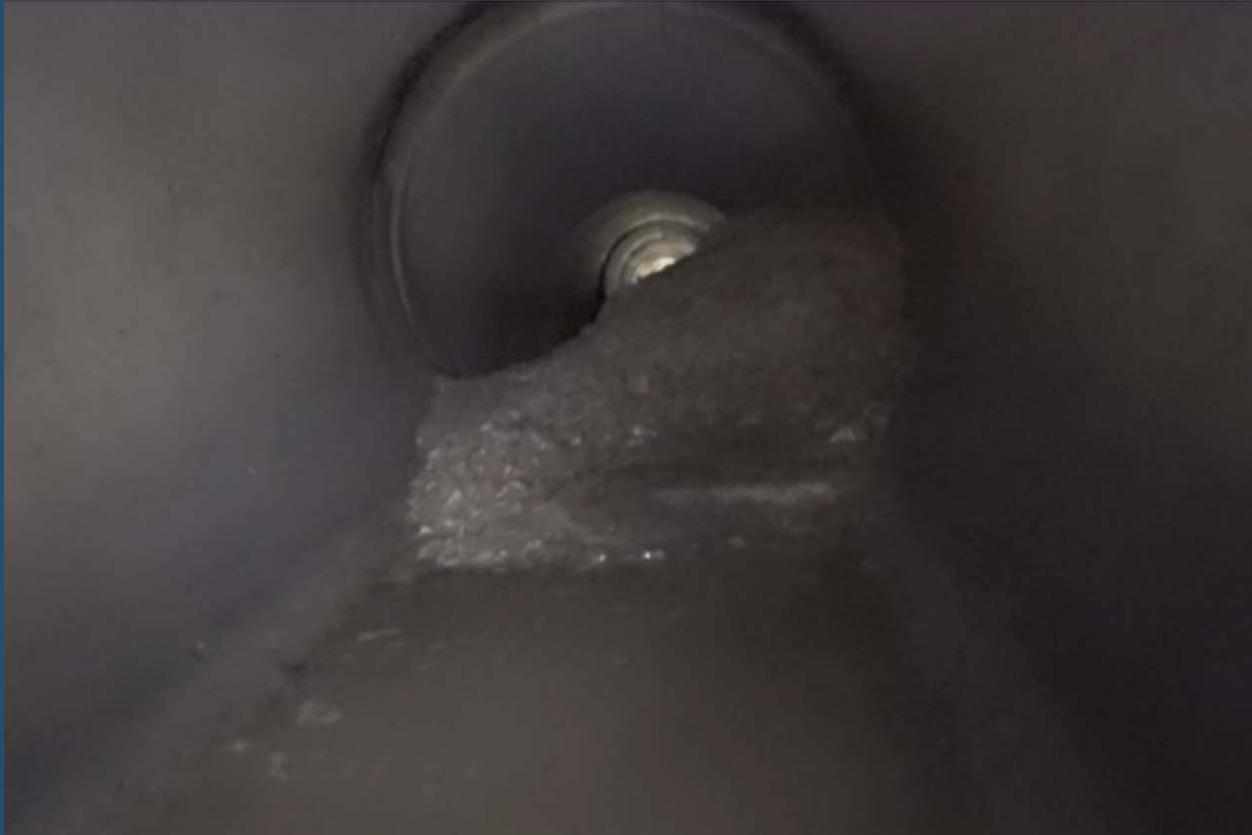
US52 Maneuverability/Waterproof HIVE Video – 24” RCP

- 8 Culverts Changed from No Work Needed to Repair Needed
 - Large joint separations or broken flanges with exposed soil visible

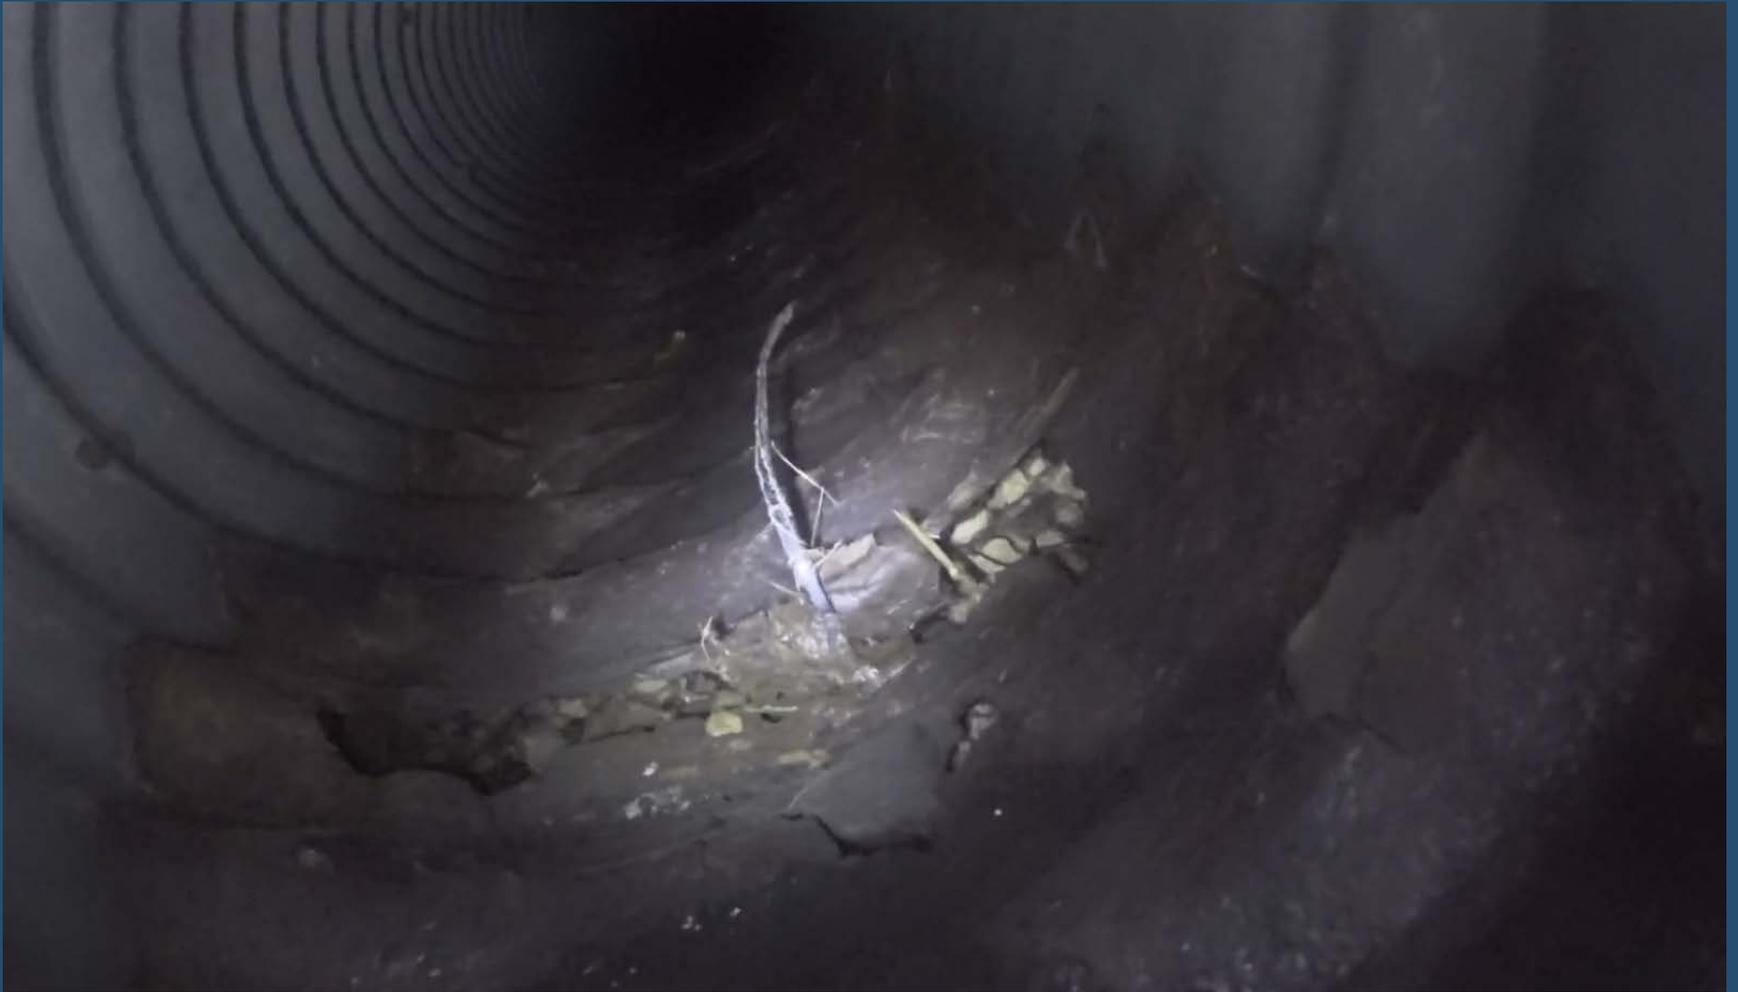
MN44 Hokah HIVE Video – 15” CMP Storm Sewer at 60ft
