Asset Management Memorandum

Re: *Asset Management*
TH 11 Corridor Assessment
WSB Project No. 03063-000

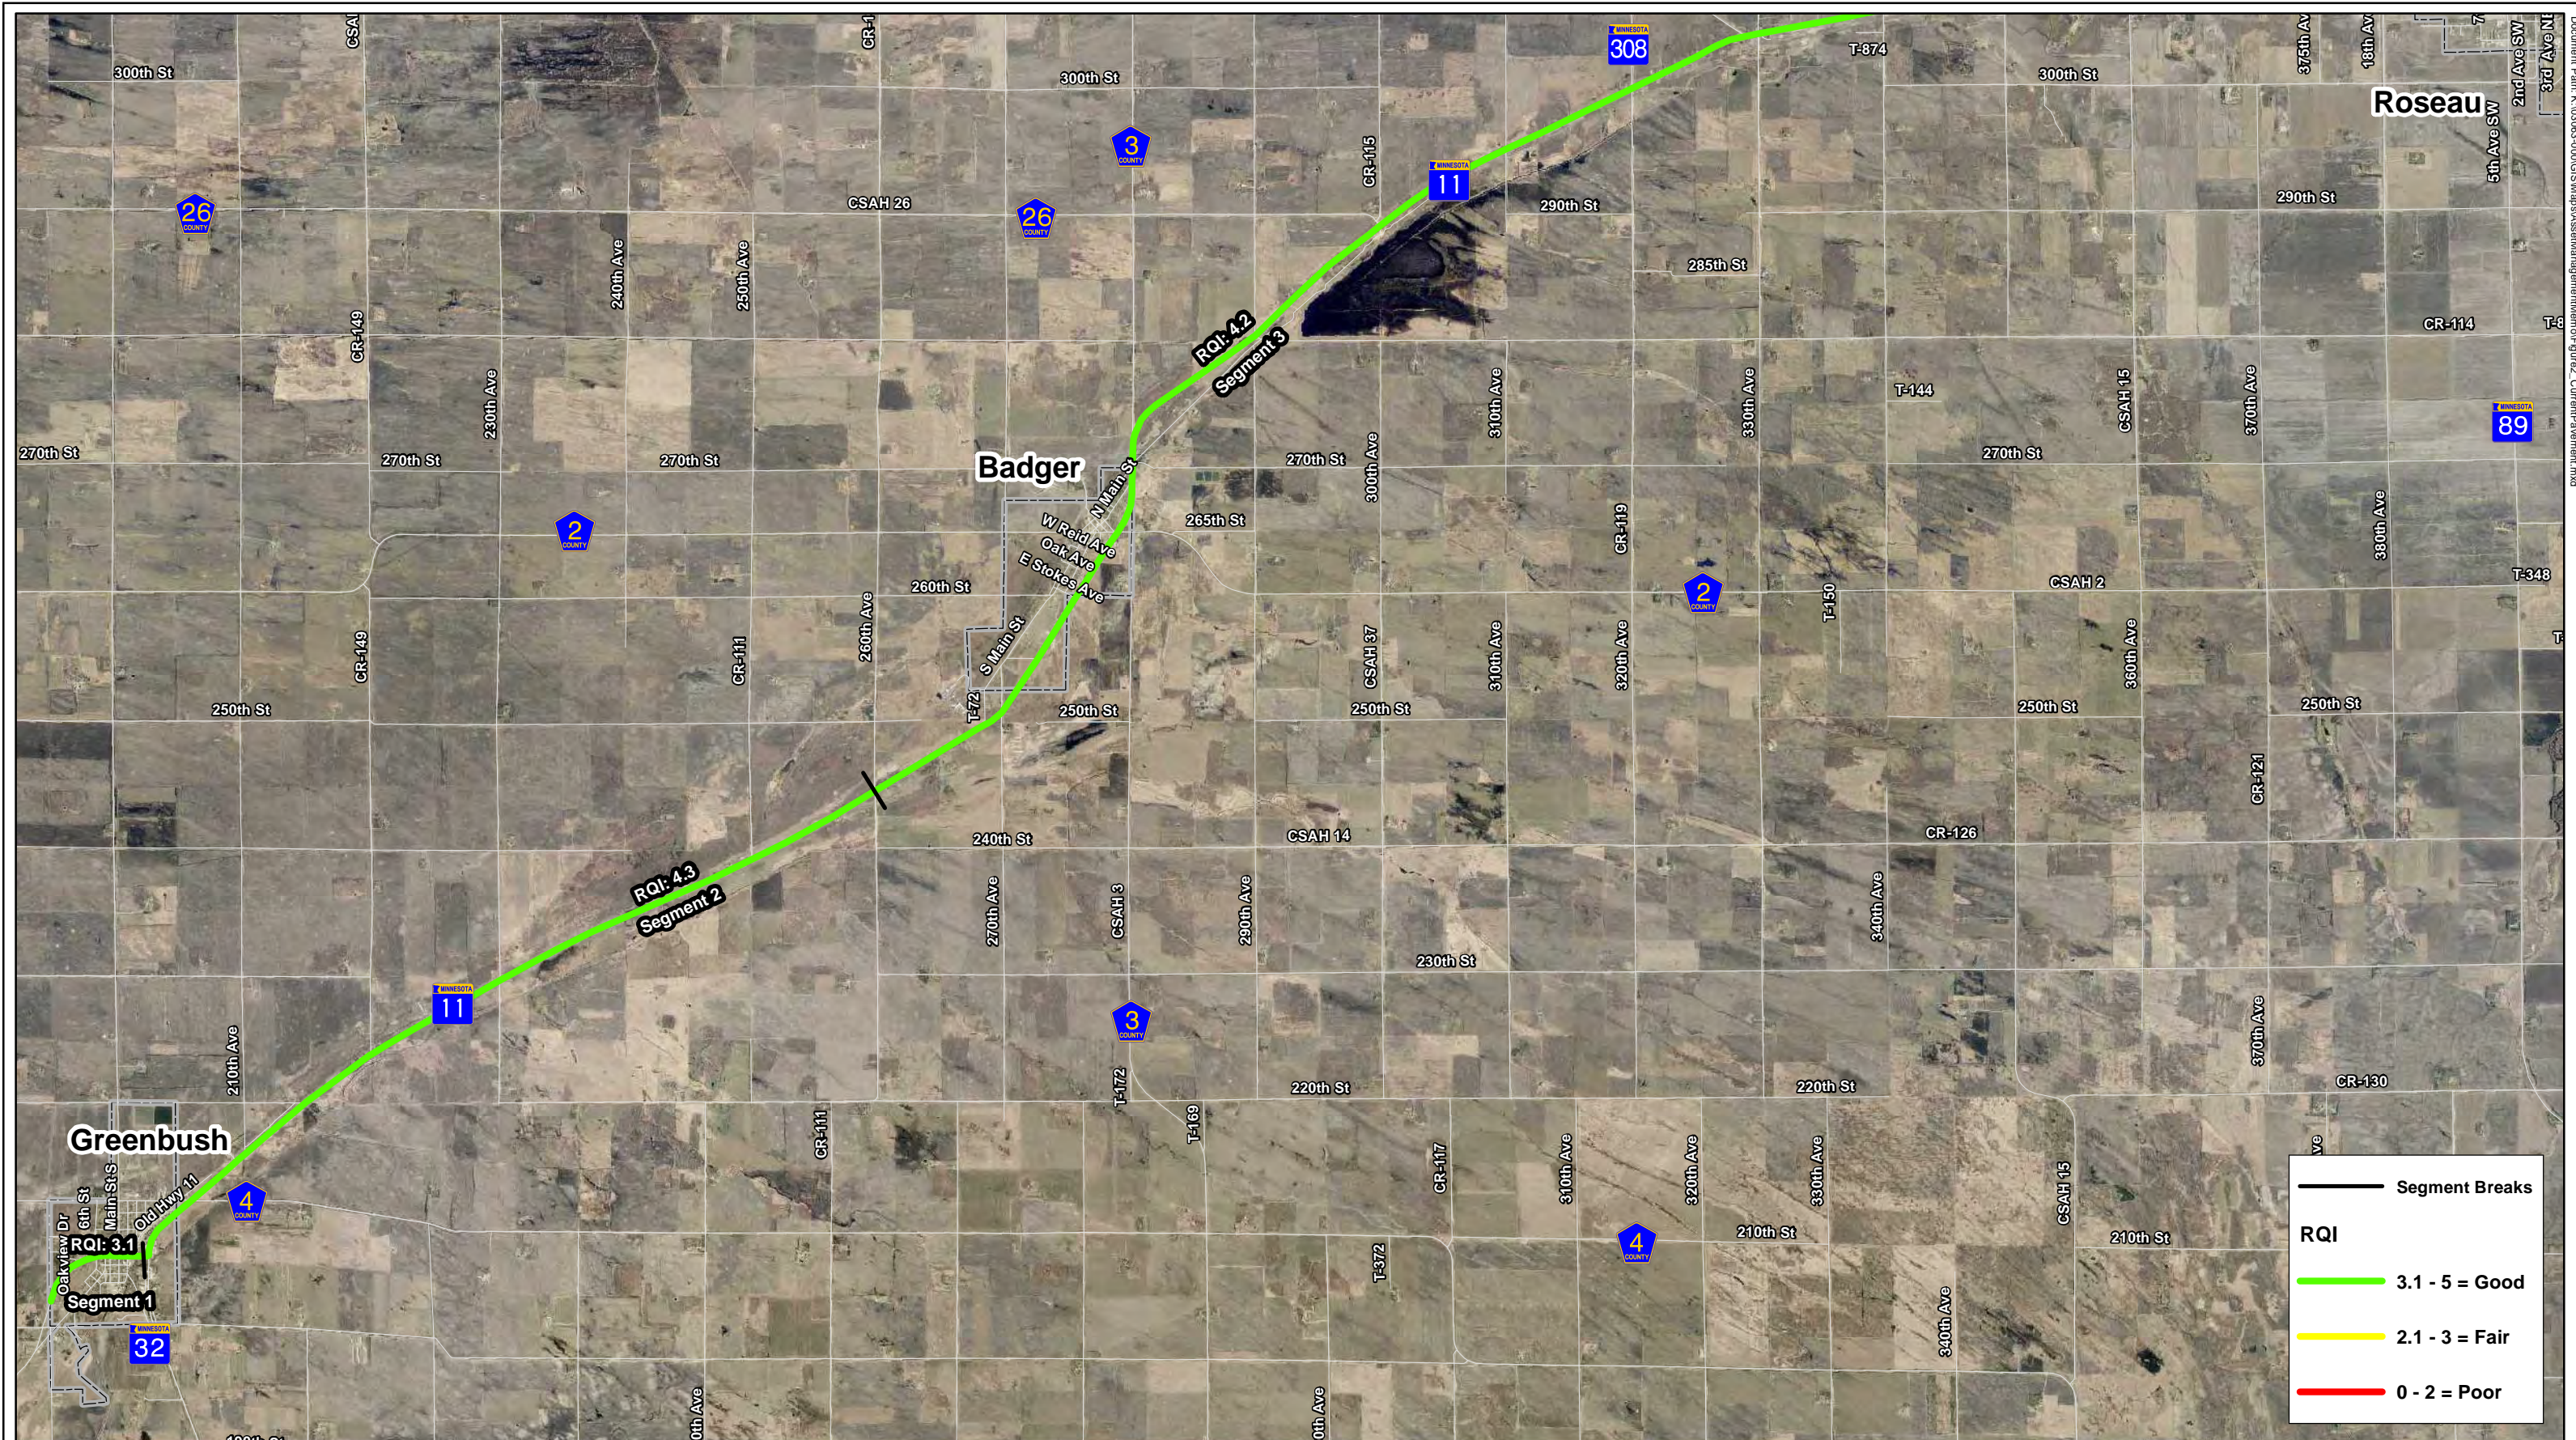
Figure 2
2014 Pavement Condition
Greenbush-Badger

As of 2014, nearly the entire TH 11 corridor was considered to have good pavement condition. Only two segments had an RQI below 3.1. Segment 5 has an RQI of 2.3. This segment is a 1.2 mile segment of TH 11 in the center of Roseau, from TH 89/TH 310 to 14th Avenue NE. The RQI for this segment indicates an immediate need for reconditioning. No pavement reconditioning activities have occurred since 2006.

Segment 10 has an RQI of 3, at the upper limit of fair pavement condition. This is an 800-foot segment of TH 11 at the southern city limits of Warroad (300 feet north of CSAH 5 to 500 feet southeast of CSAH 5). The most recent maintenance on this segment was a thin mill and overlay in 2008. MnDOT is completing a 2 inch mill and overlay on segments 8-10 in 2015. Following the mill and overlay RQI is expected to be at 4.0 or above, which should extend the life of these segments until 2030. Pavement maintenance history on TH 11 indicates that the life of a mill and overlay is approximately 15 years. While **Table 1** shows that a thin mill and overlay was performed on segments 8-10 in 2008, the pavement seams near the wheel path have rapidly raveled between 2013 and 2014. As a result, MnDOT plans to accelerate the normal maintenance schedule for this segment.

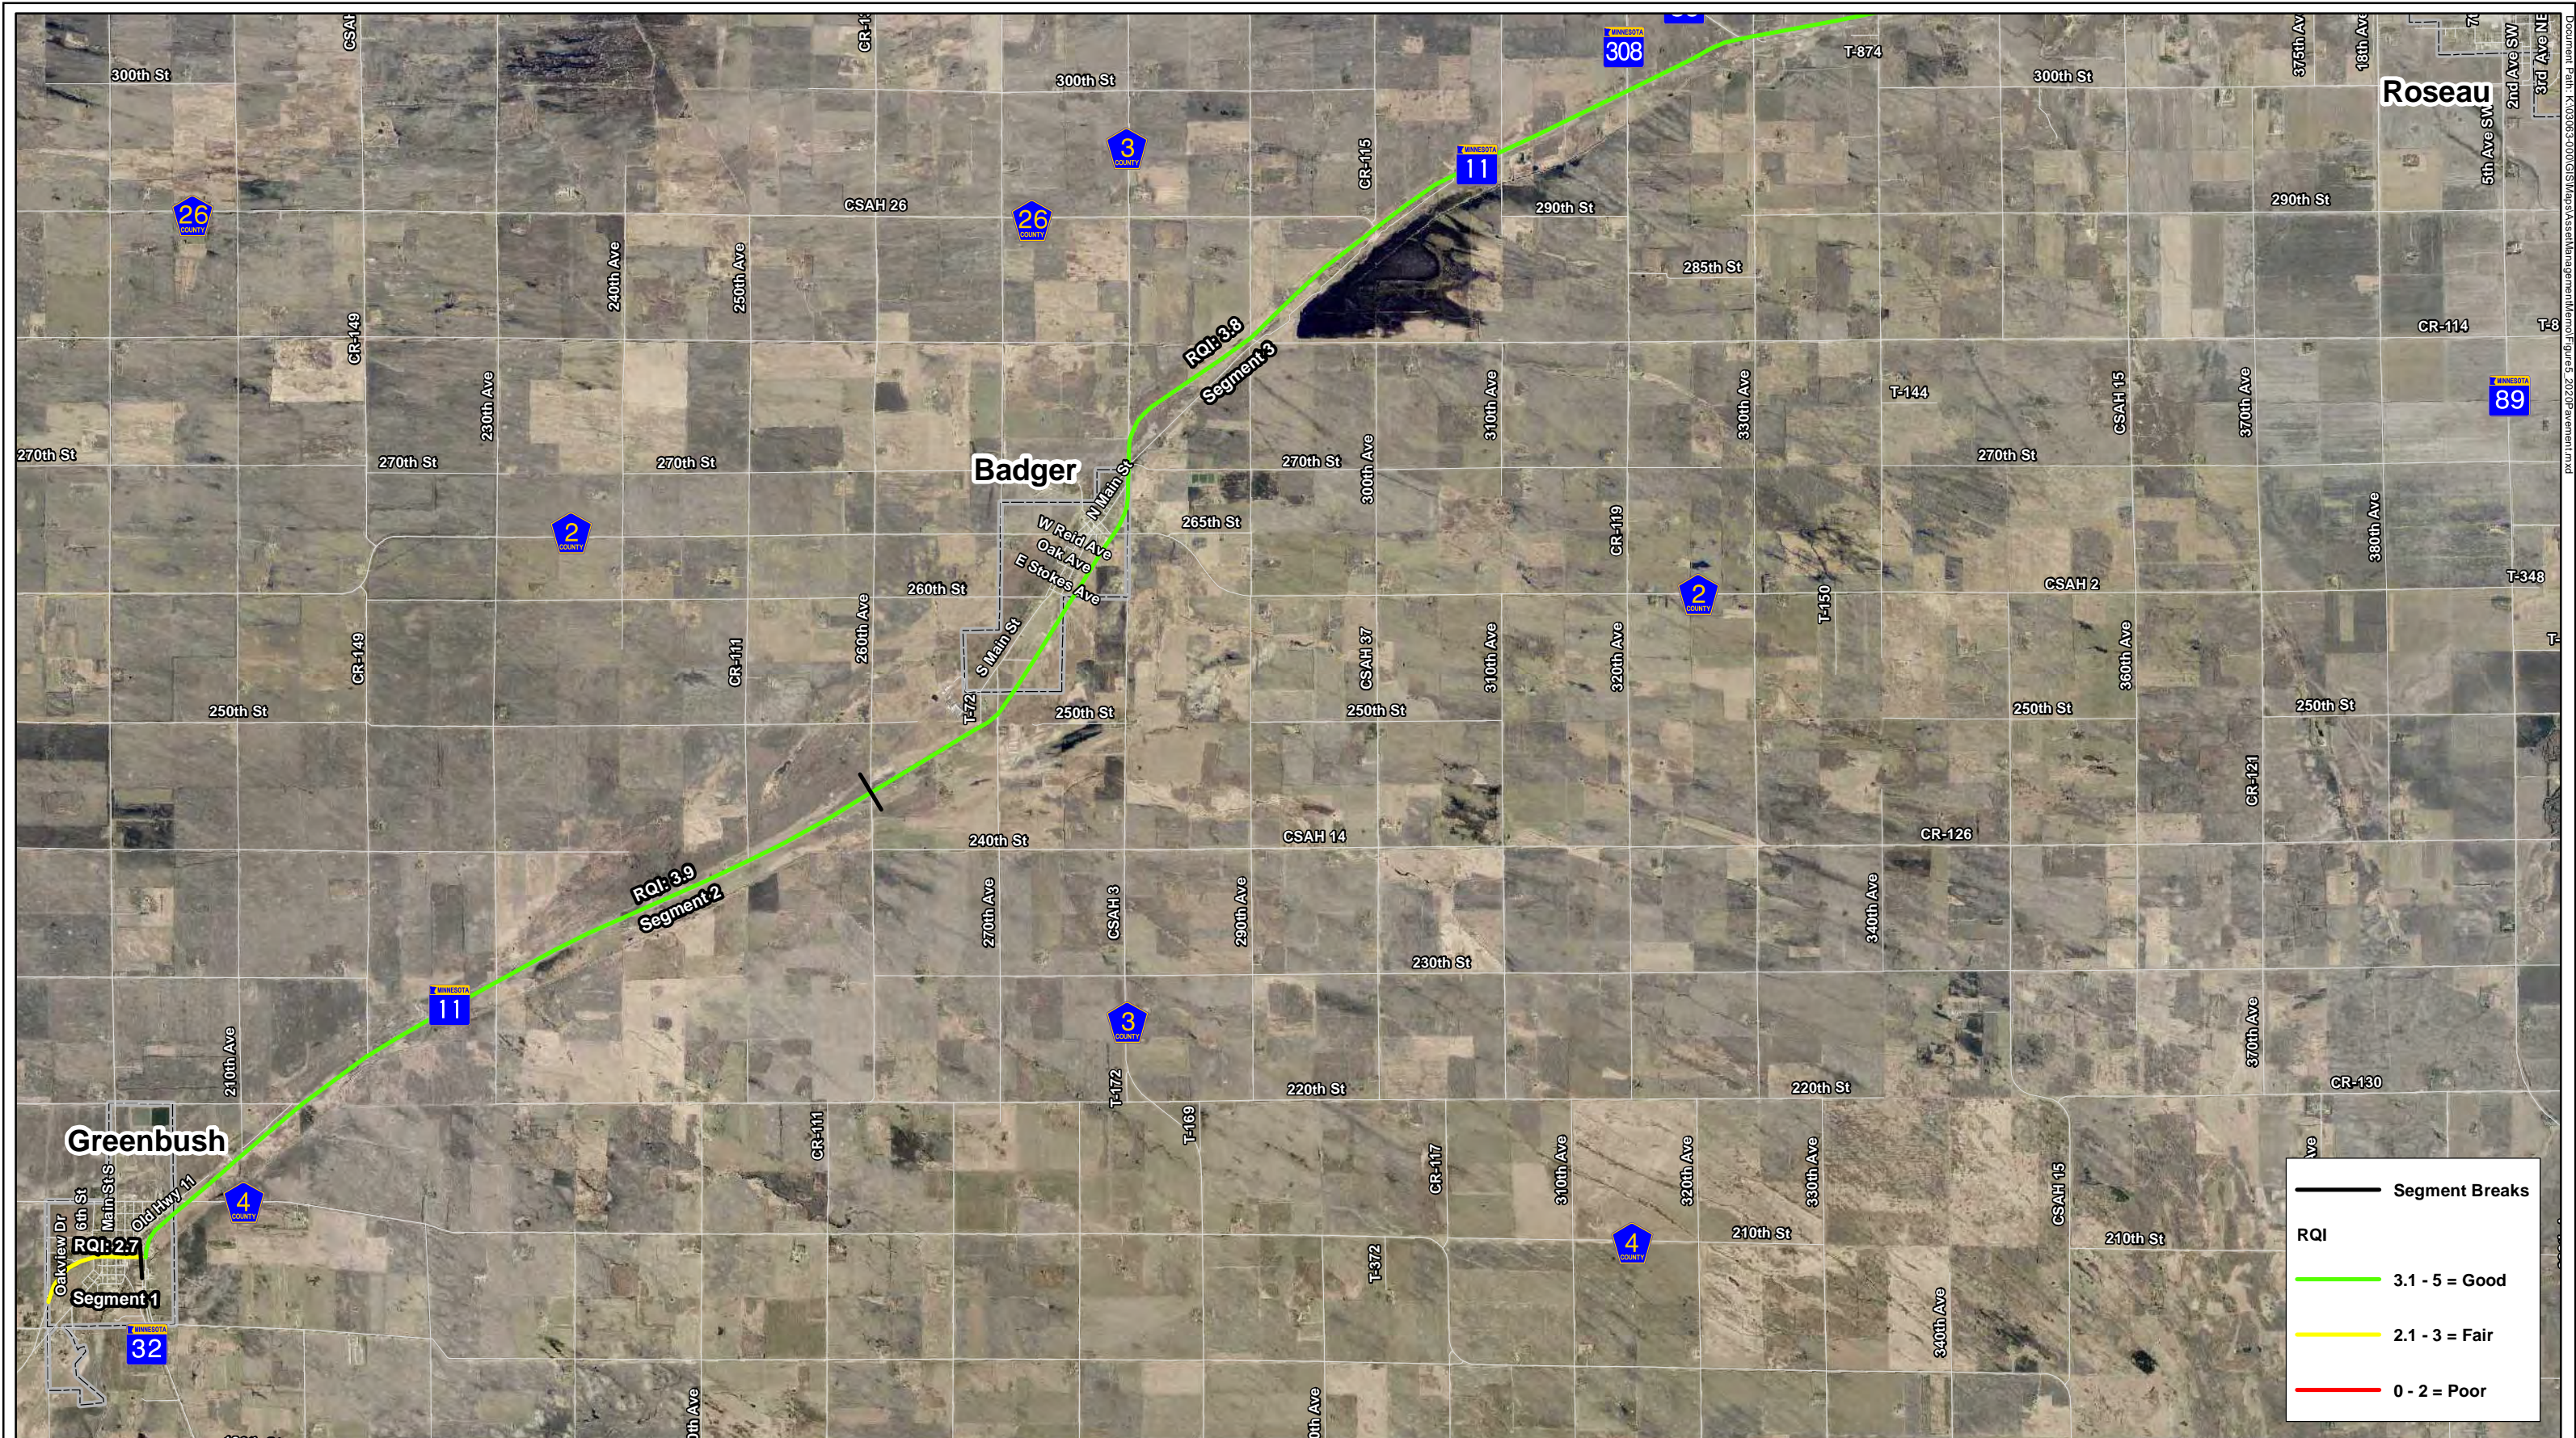
Figure 5
Predicted 2020 Pavement Condition
Greenbush-Badger

Based on the data presented in Table 3, MnDOT is predicting that three segments of TH 11 will have good pavement condition (RQI of 3.1 or greater). Those include Segments 2 and 3 at the western end of the corridor between TH 32 in Greenbush and 360th Avenue near Roseau and Segment 7. Segment 7 includes the area just west of the Warroad city limits to TH 313/Cedar Avenue.

As a result of planned maintenance activity before 2020, only one segment of TH 11 will remain below the 2.5 RQI threshold. Segment 5 in the center of Roseau (TH 89/TH 310 to 14th Avenue NE) is predicted to have an RQI of 1.9. No maintenance activities are planned for this segment prior to 2020; however, preventative maintenance is needed on this segment to extend the life of the roadway and reduce the need for roadway reconstruction. It should be noted that RQI measured in urban areas can be skewed because the measure is based on a 50 mph speed. In urban areas, there are also more manholes and utilities in the pavement that affect ride quality.

Following completion of the 2014 pavement condition evaluation and prior to the start of the TH 11 Corridor Study, MnDOT identified proposed pavement projects to address the deficiencies identified in Table 3. These improvements included the sections in Warroad between TH 313 and 500 feet southeast of CSAH 5 (Segments 8-10) in 2015 and a reclaim and overlay in Roseau from CSAH 15 to just east of TH 89 (Segment 4) in 2015. The 2015 improvements should increase RQI above 4.0, with an expected RQI of approximately 3.5-3.9 in 2020.

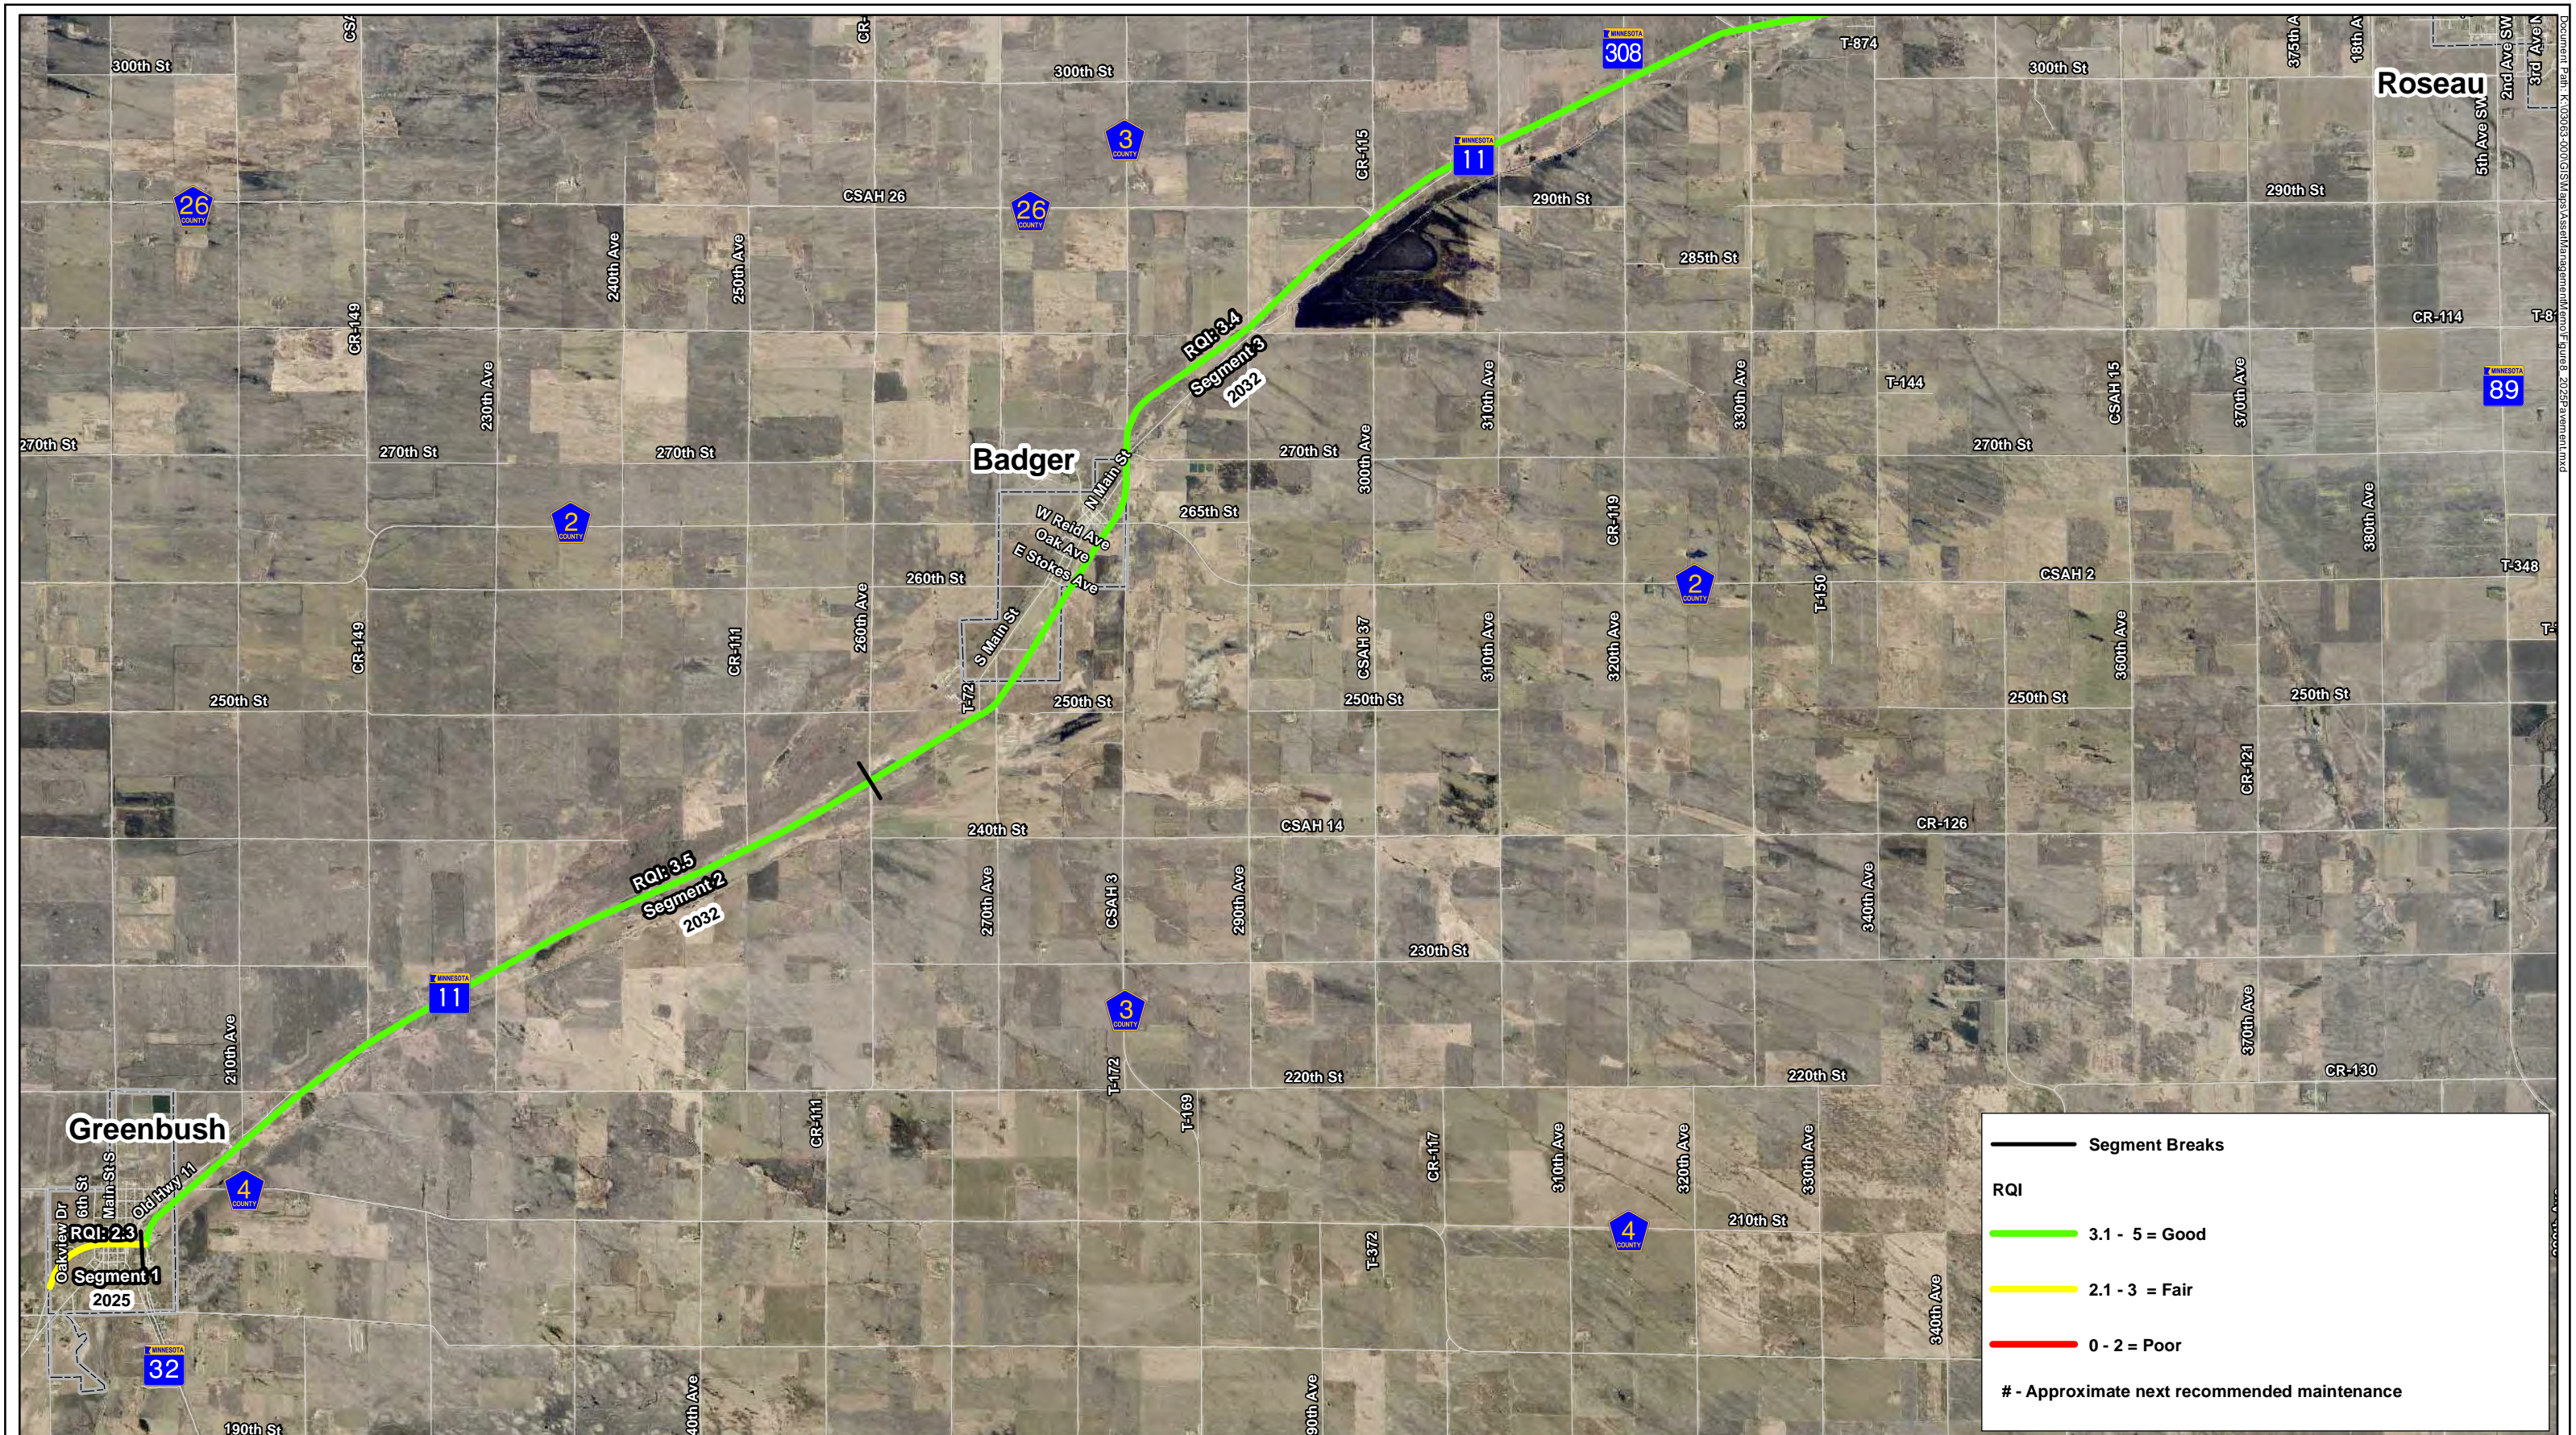
Figure 8
Predicted 2025 Pavement Condition
Greenbush & Badger

Following these maintenance projects, all but one segment of TH 11 is expected to have an RQI above 2.5 in 2030. Segment 1 in Greenbush is expected to have an RQI of 2.3 in 2025. A mill and overlay is recommended on this segment between 2020 and 2025 to address expected pavement condition issues.

Figures 8 – 10 show predicted 2025 pavement condition and date of recommended pavement maintenance between 2025 and 2040.

- Segment 1: Mill and overlay (if not completed during 2020-2025 timeframe)

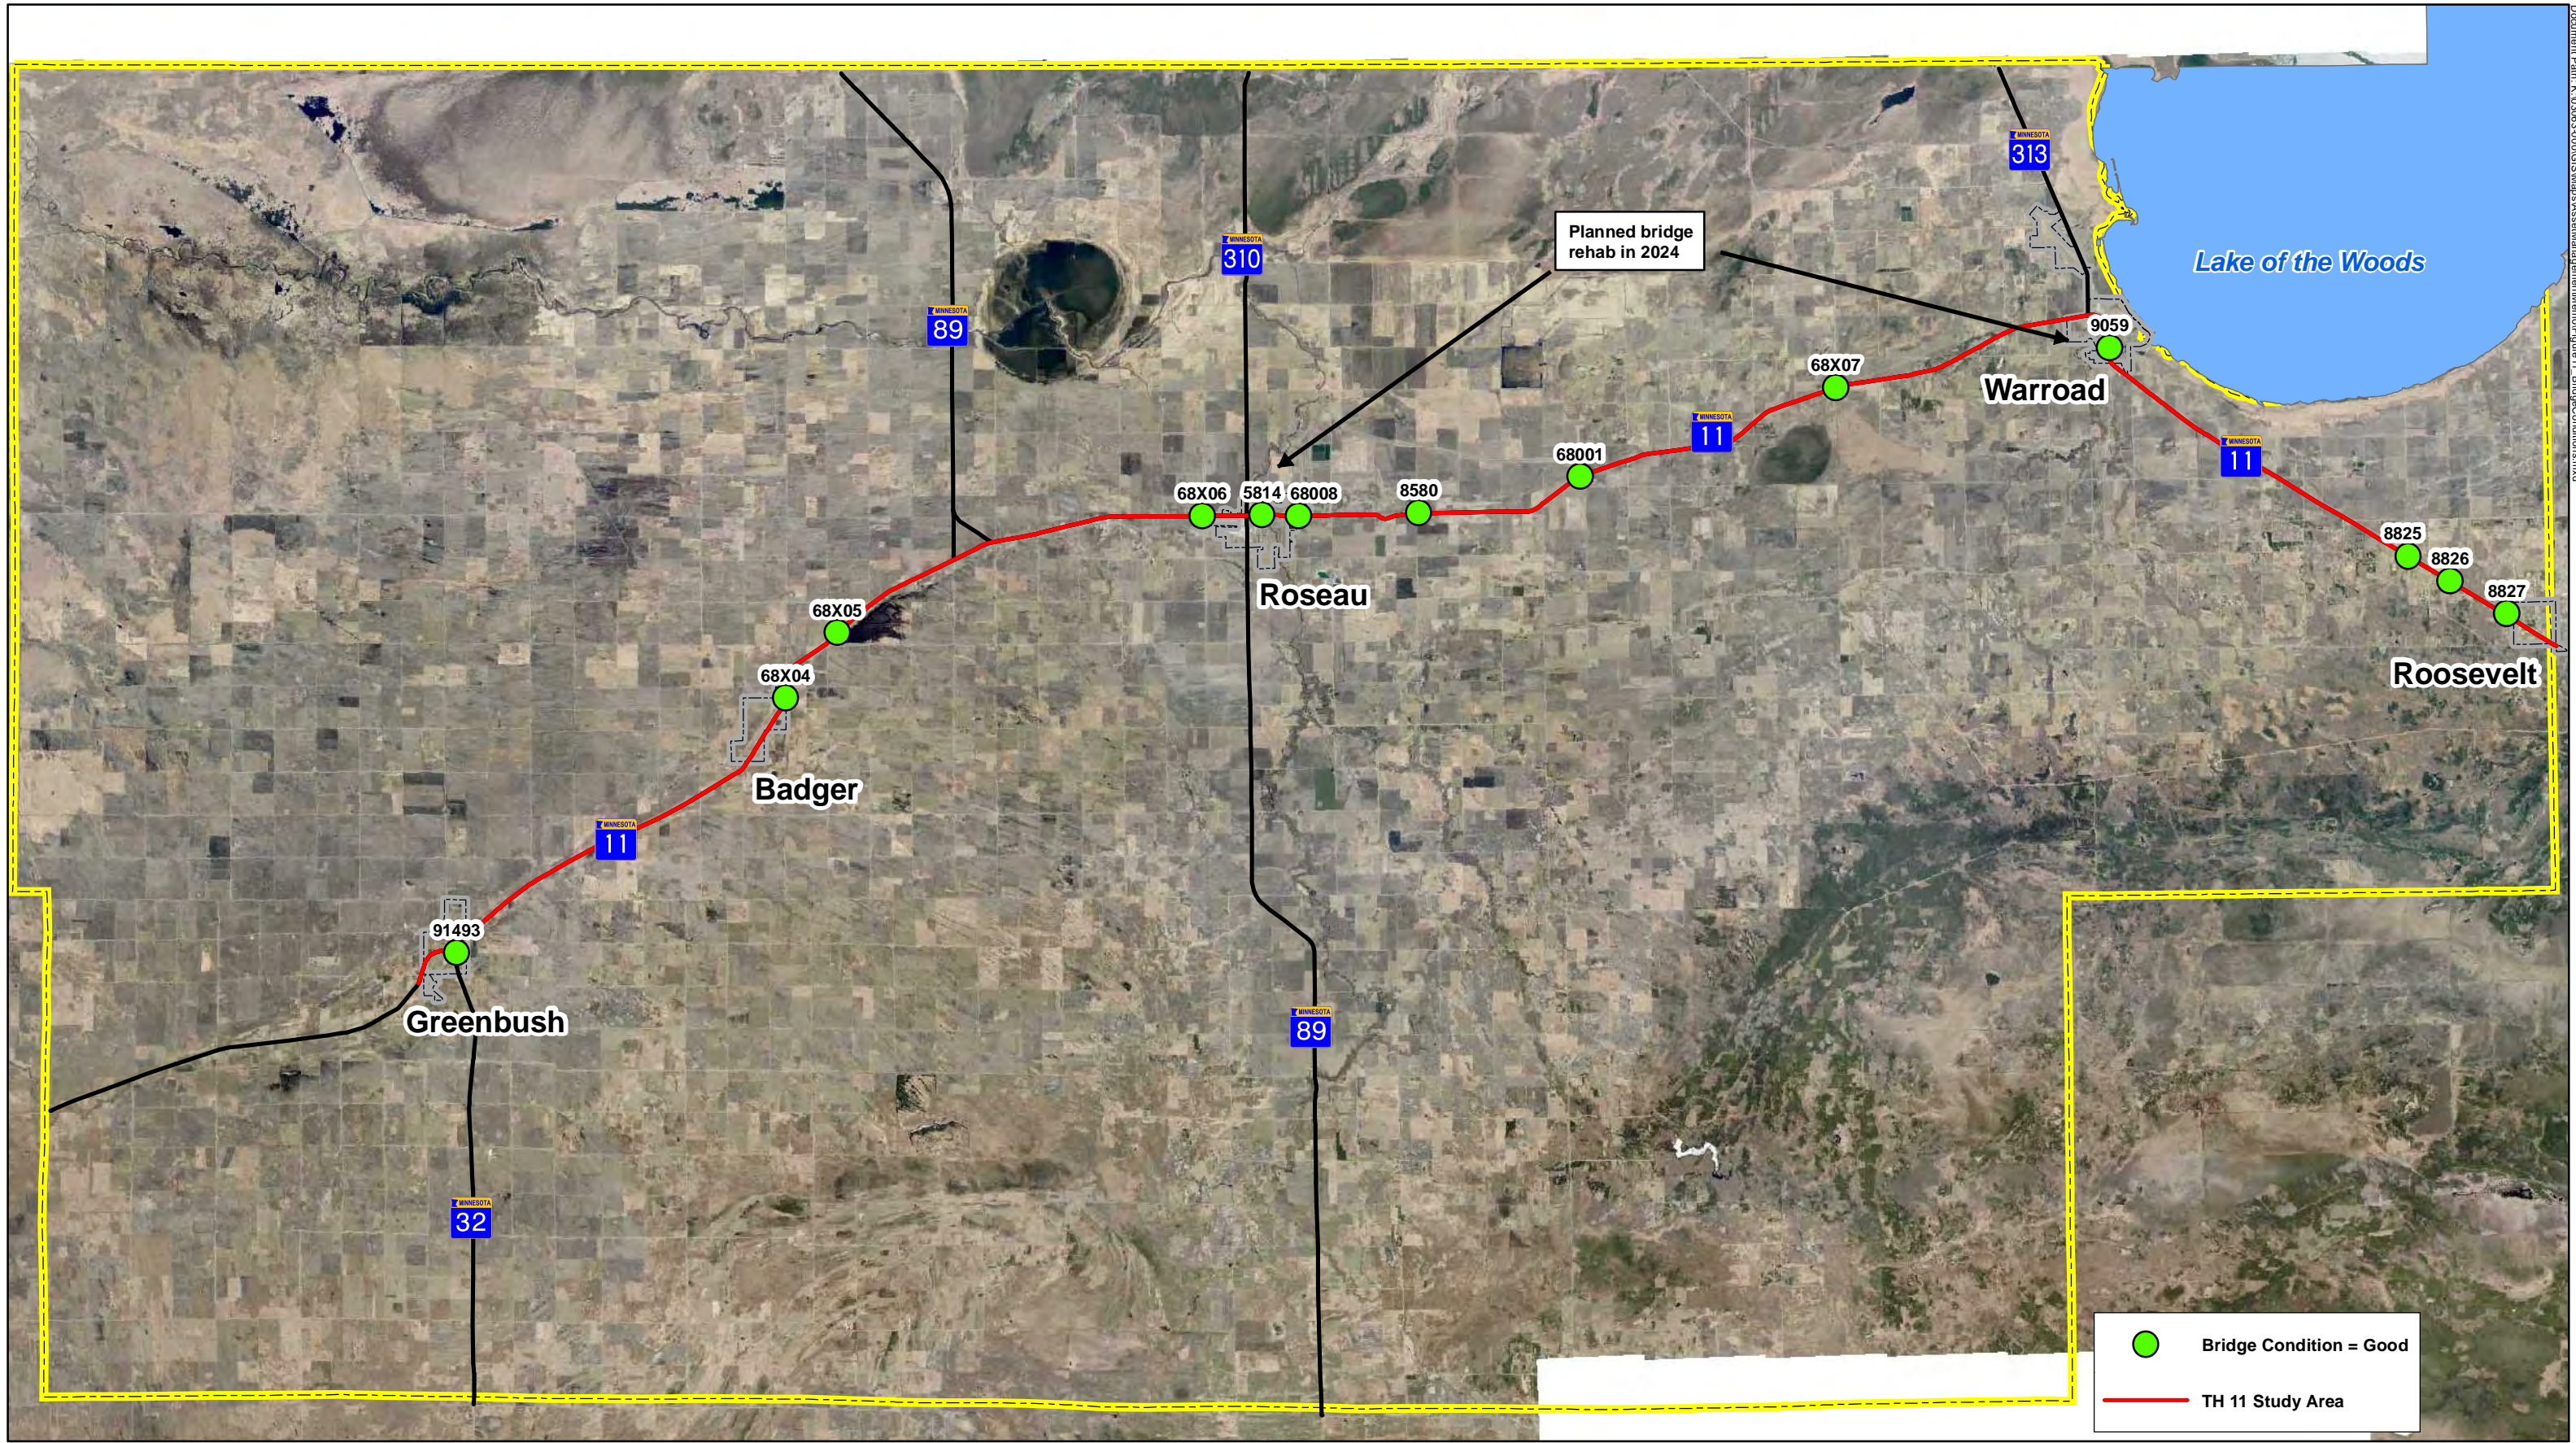
Figure 11
Current Bridge Conditions

All bridges within the study area are in good condition based on inspections in 2012-2014. No bridges within the study area are considered functionally obsolete or fracture critical. All bridges but one have sufficiency ratings above 97.4. Bridge 8580, located 4 miles east of Roseau, has a sufficiency rating of 87.3. MnDOT considers bridges with sufficiency ratings of 80 or less to be candidates for bridge rehabilitation. Ratings of 50 or less indicate a potential need for bridge replacement.

Based upon the information contained in the bridge inspection reports and planned improvements, it is anticipated that two additional bridges will need rehabilitation or replacement prior to 2040. Bridge 8580 is a precast box culvert constructed in 1927 located four miles east of Roseau. Recent inspections found cracks on the inside of the culvert that will need to be addressed prior to 2040. This bridge is a W-type box culvert that should not be rehabilitated by installing a concrete liner. It is anticipated that this box culvert would be replaced rather than rehabilitated.

Based on the review of bridge inspection reports, rehabilitation is also recommended on bridge 68001 over Hay Creek, located 1.3 miles west of Salol. This bridge is a concrete slab span that was constructed in 1969 and re-decked in 1998. Recent inspections indicate cracking on the bridge deck. An overlay of low-slump concrete is recommended to address cracks on the bridge deck.

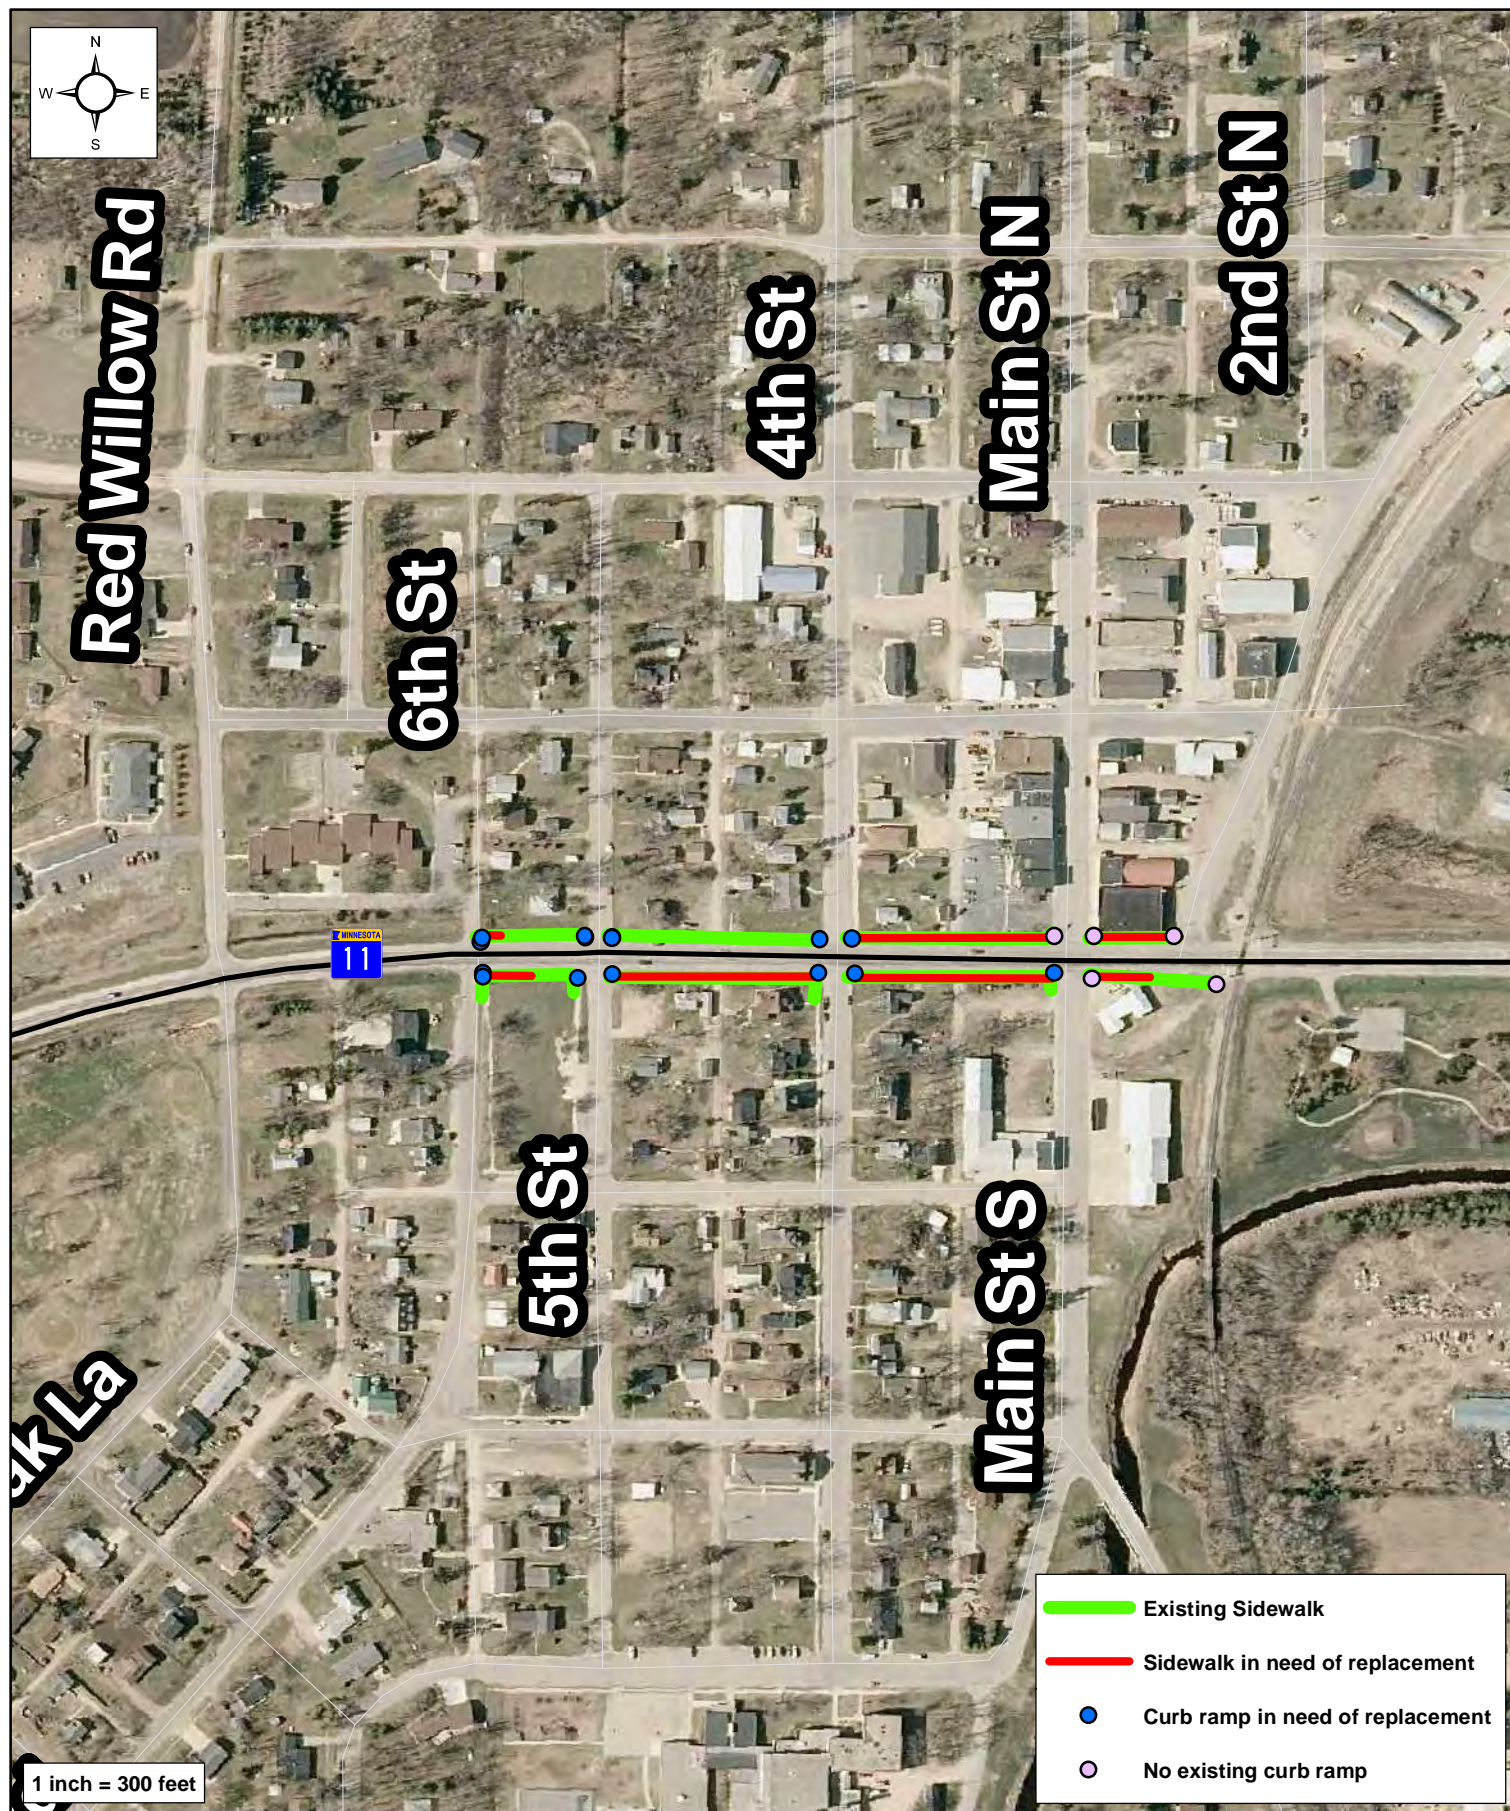
Figure 12
Existing Sidewalk and
Sidewalk Replacement Needs
Greenbush

Figure 12 shows sidewalk condition and recommendations for replacement within the City of Greenbush. Along both sides of TH 11, there is sidewalk from 6th Street to approximately 50 feet west of the Minnesota Northern Railroad. There is approximately 2,050 feet of existing sidewalk and 15 curb ramps in Greenbush. The majority of sidewalk within Greenbush has poor surface condition. Sidewalk cross-slope within Greenbush is generally below 3 percent, except for at the intersection with 6th Street and in some sections between 4th and Main Streets. None of the curb ramps meet current ADA standards. Additionally, there are five corners without curb ramps between Main Street and 1st Street N.

Based on existing sidewalk conditions and the criteria outlined above, 1,280 feet of sidewalk is recommended for replacement. 15 curb ramps are recommended for replacement and 5 new curb ramps will need to be constructed to be provided at corners where there are no existing curb ramps. Sidewalks and curb ramps recommended for replacement are shown on **Figure 12**. **Table 7** shows the length of sidewalk segments recommended for replacement.

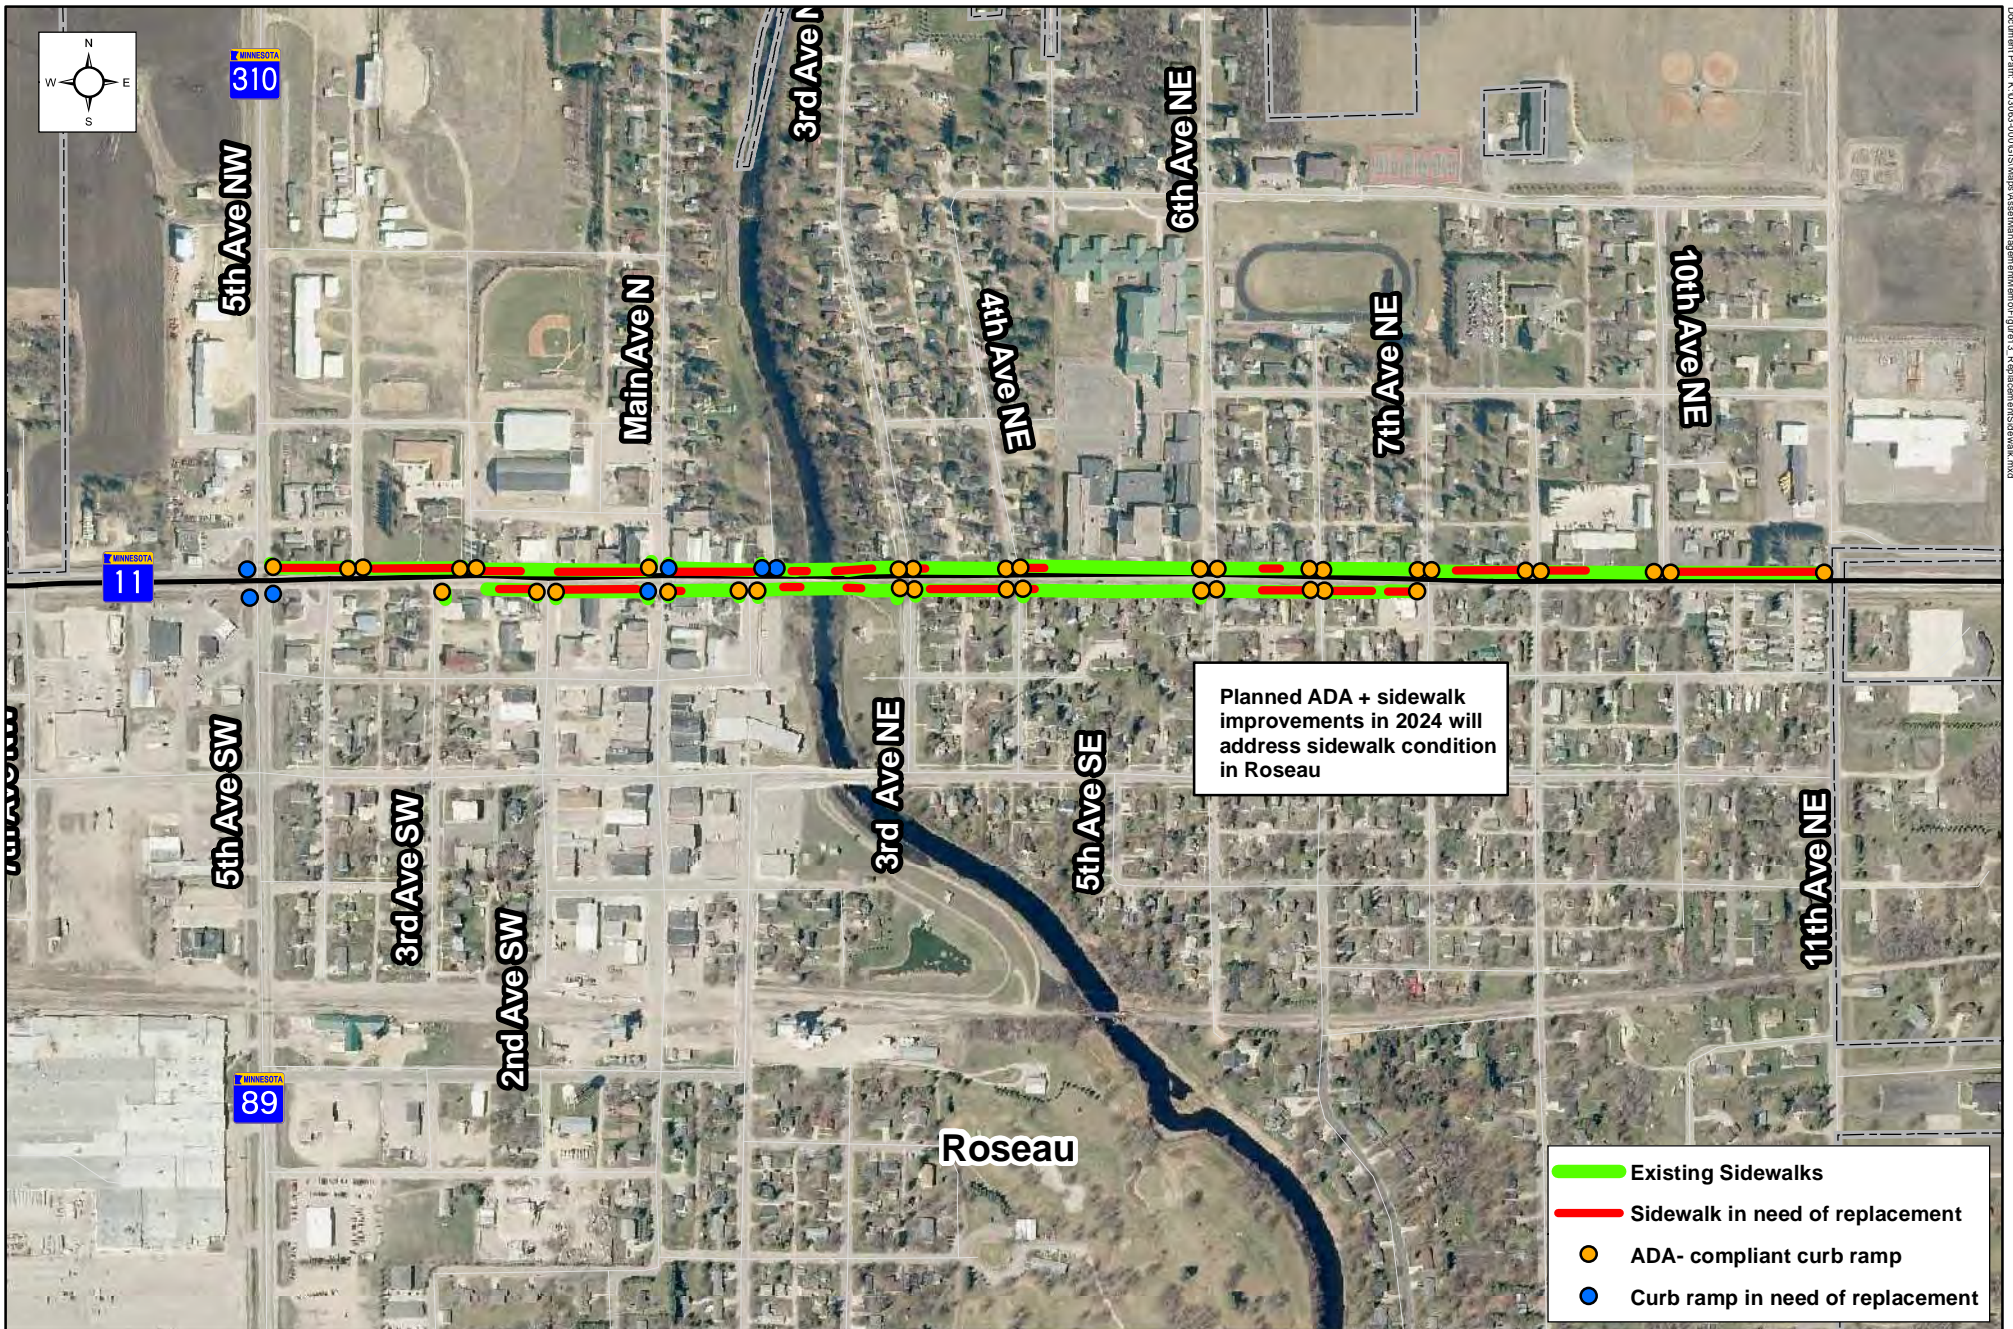
Figure 13
Existing Sidewalk and
Sidewalk Replacement Needs
Roseau

Figure 13 shows sidewalk condition and recommendations for replacement within the City of Roseau. There is sidewalk along both sides of TH 11 from 3rd Avenue NW to 8th Avenue NE. Additionally, there is sidewalk along the north side of TH 11 from TH 89/TH 310 to 3rd Avenue NW and between 8th and 11th Avenues NE.

Sidewalks along TH 11 within Roseau generally have fair to good surface condition. Most sidewalk segments west of 3rd Avenue NE have fair surface condition. Sidewalks east of 3rd Avenue NE vary between fair and good condition. While sidewalk surface condition is generally acceptable, the majority of sidewalk segments in Roseau have cross-slopes greater than 3 percent which is problematic for ADA requirements.

Based on existing sidewalk conditions, approximately 3,860 feet of sidewalk is recommended for replacement. Seven curb ramps are recommended for replacement. The length of sidewalk segments recommended for replacement is shown in **Table 7**.
