Asset Management Memorandum

Re: *Asset Management*
TH 11 Corridor Assessment
WSB Project No. 03063-000

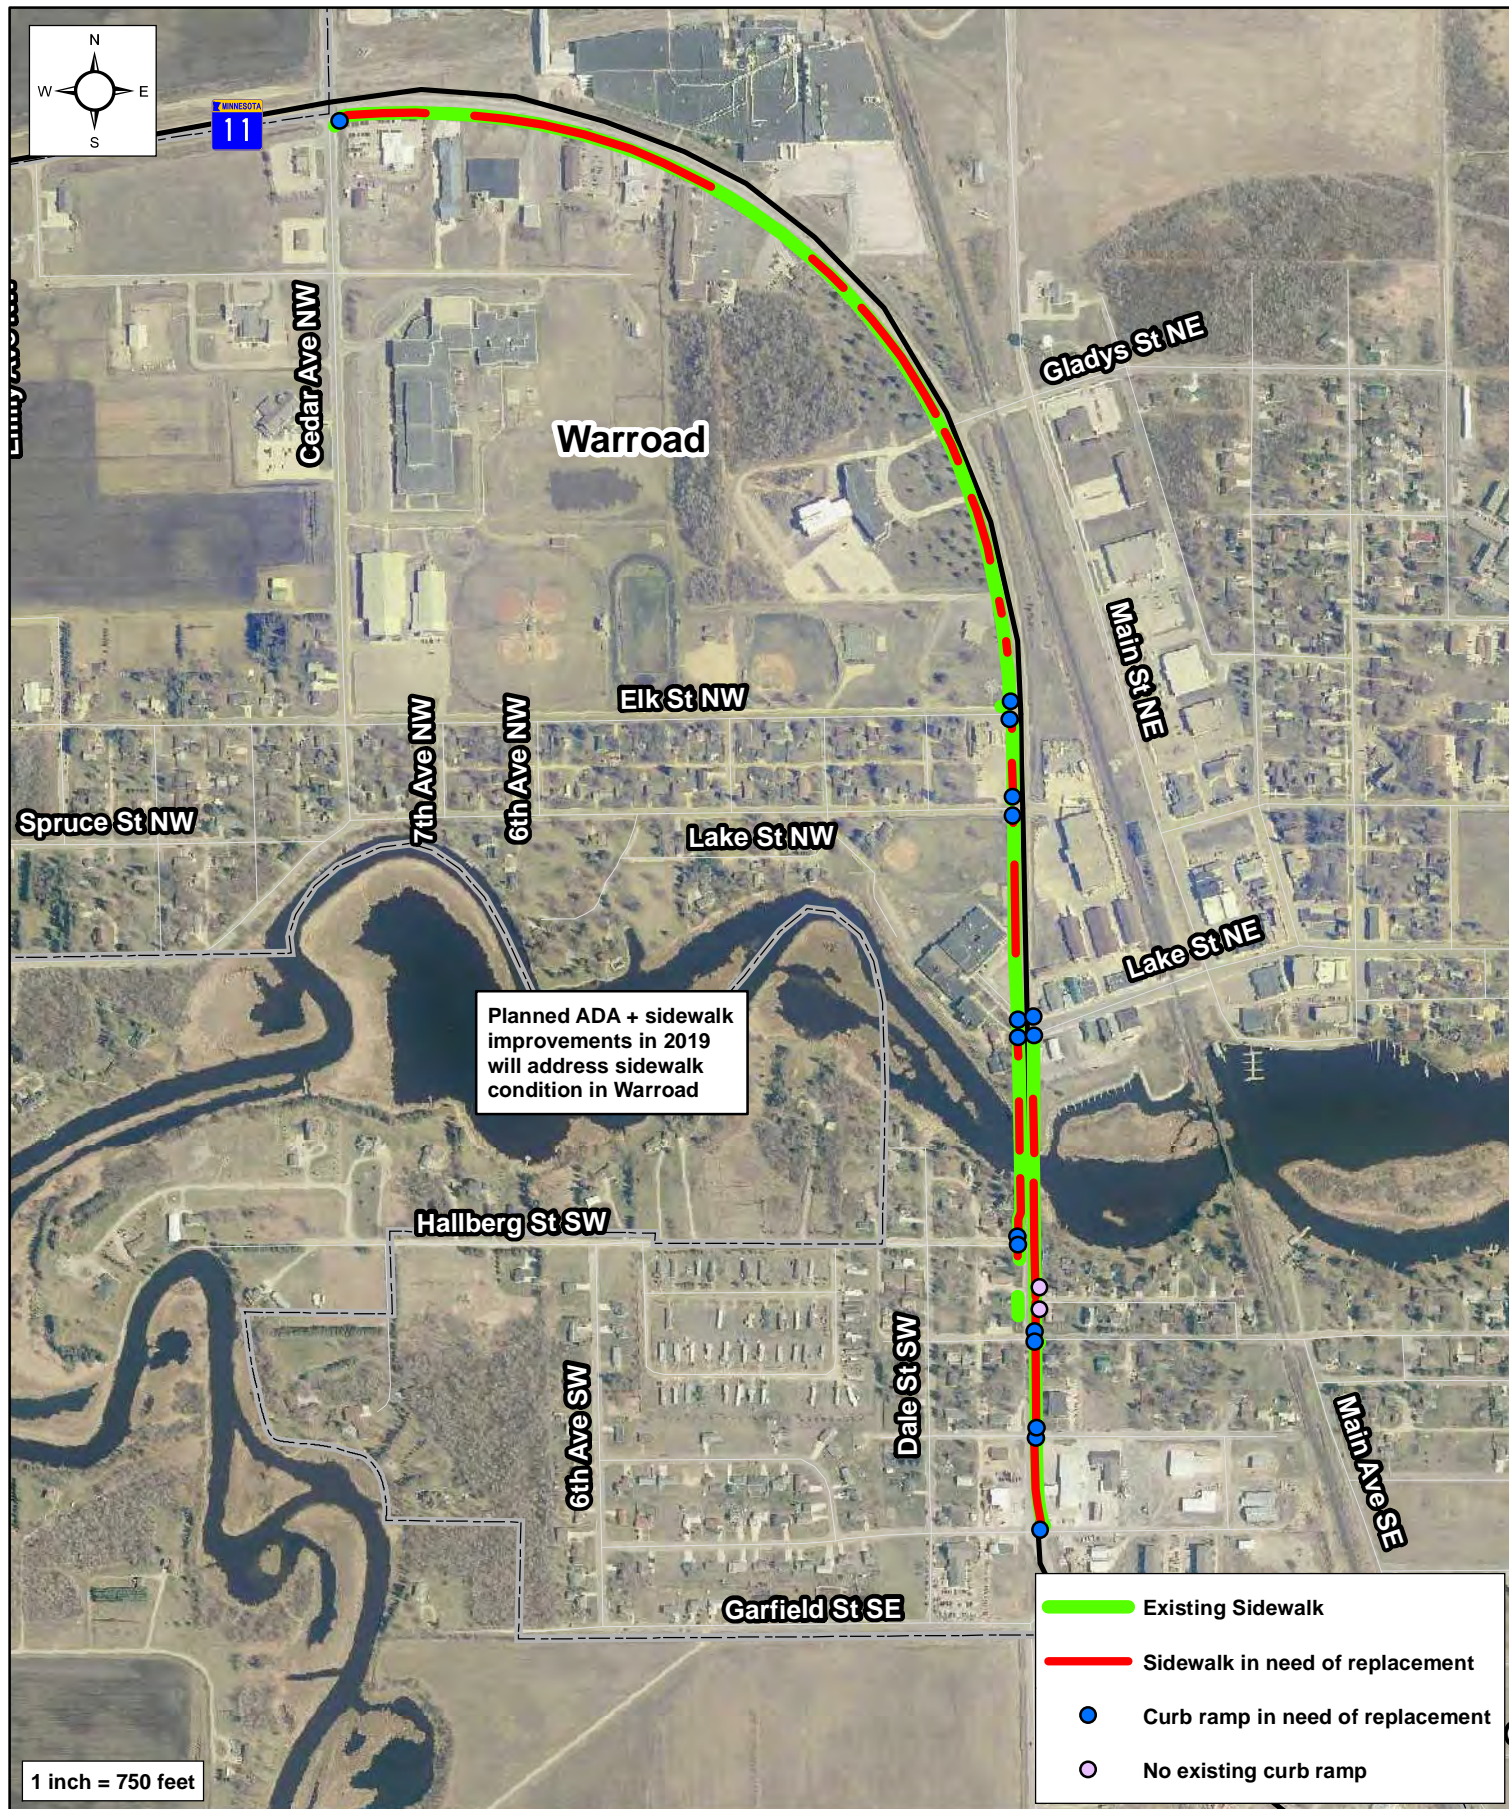
Figure 14
Existing Sidewalk and
Sidewalk Replacement Needs
Warroad

Figure 14 shows sidewalk condition and recommendations for replacement within the City of Warroad. There is continuous sidewalk along the south/west side of TH 11 from Cedar Avenue NW/TH 313 to Halberg Street SW. There is also sidewalk along the east side of TH 11 from Lake Street NE to Garfield Street SE.

Along TH 11 within the City of Warroad, sidewalk condition is generally fair. There are some short segments with sidewalk in good condition. On the east side of TH 11 south of the Warroad River, sidewalk condition is generally poor. Cross-slopes exceed 3 percent on the majority of sidewalk segments between Cedar Ave NW/TH 313 and Elk Street NW. Cross-slopes also exceed 3 percent on many segments south of Elk Street NW.

Approximately 4,960 feet of sidewalk are recommended for replacement due to condition and/or cross-slope. All 16 curb ramps in Warroad are recommended for replacement to comply with ADA standards. Additionally, two curb ramps will need to be constructed to be provided at corners where there are no existing curb ramps. **Figure 14** shows the location of sidewalks and curb ramps recommended for replacement. **Table 7** summarizes the sidewalk segments recommended for replacement.

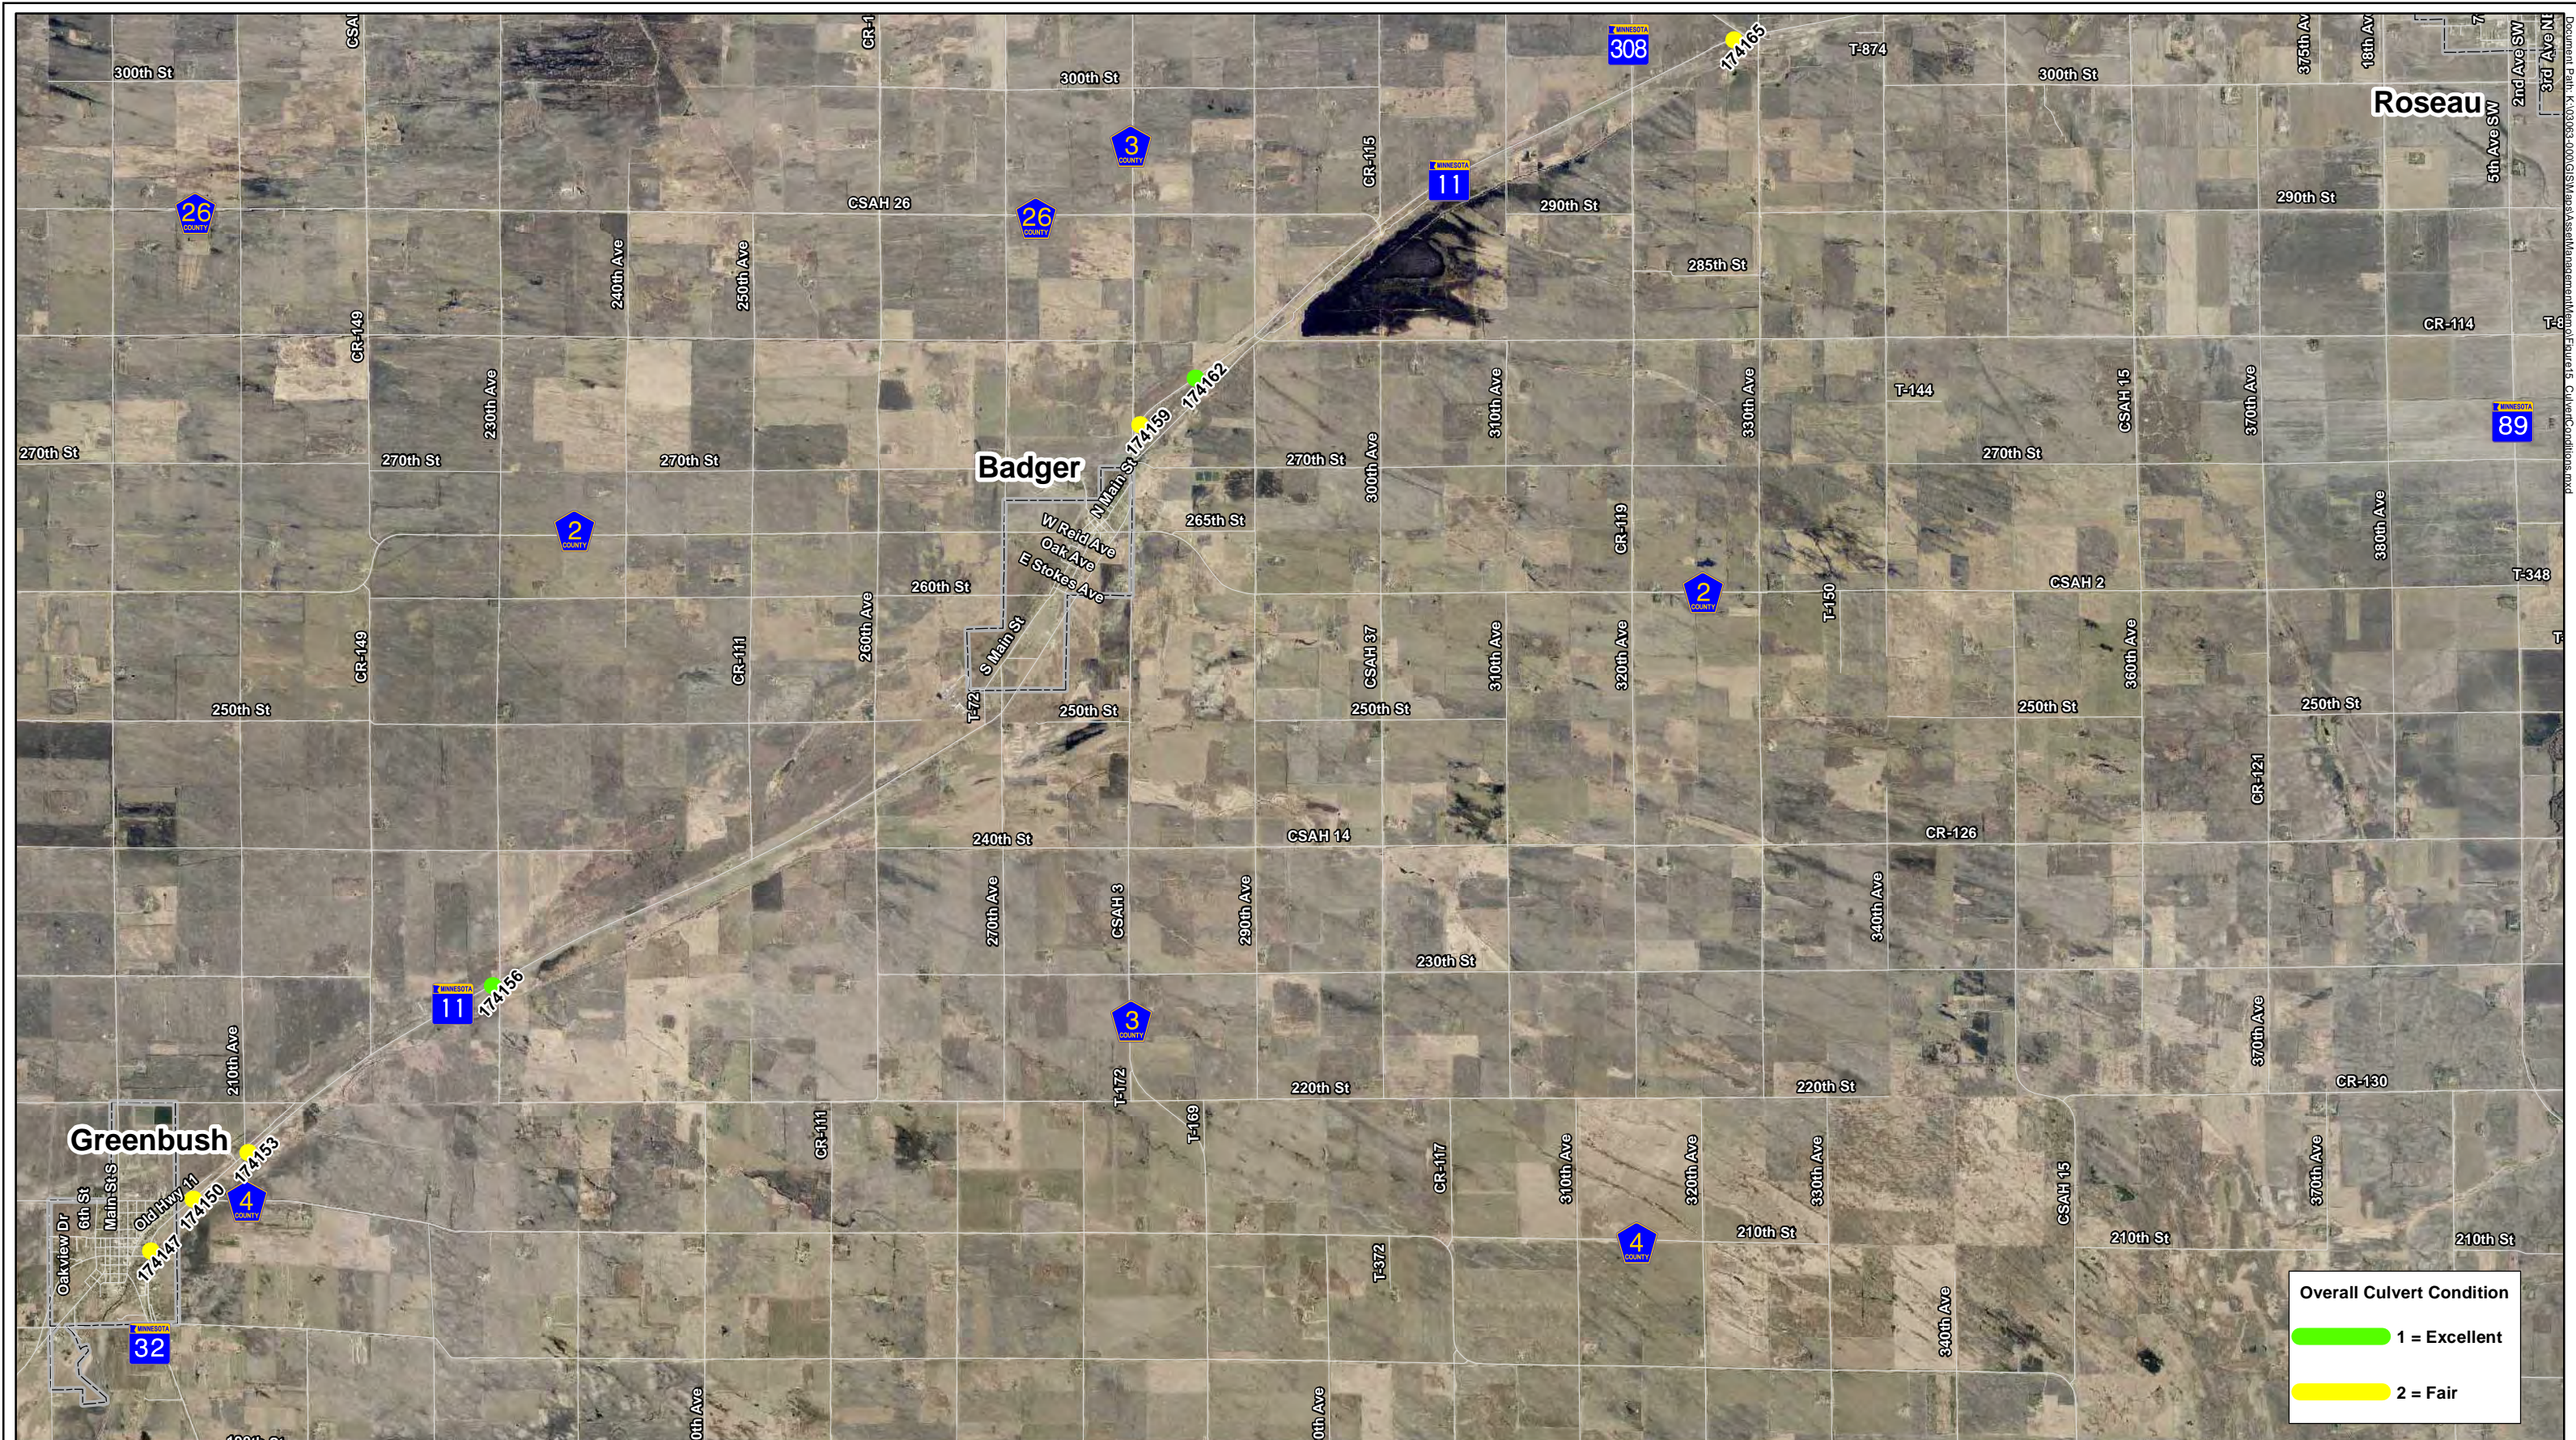
Figure 15
Current Culvert Conditions
Greenbush & Badger

There are a total of 57 culverts located on TH 11, as shown on **Figures 15-17**. Most culverts in the study area were inspected in 2009, with a few inspected as recently as 2014. MnDOT rates culvert condition on a scale of 1 to 4. A rating of 1 indicates a culvert in excellent, like-new condition. A rating of 2 indicates fair condition, with the culvert showing some wear but still structurally sound. Ratings of 3-4 indicate a need for repair or replacement.

All culverts in the study area are rated 1 or 2 indicating fair to excellent condition. The 15 culverts in good condition are scattered throughout the study area. The remaining 42 culverts are in fair condition. However, staff at MnDOT believes that an additional inspection of the culverts is warranted since many of them were last inspected in 2009 to ensure the accuracy of the rating. MnDOT will be conducting an inspection of the culverts in late summer or early fall in 2015 to update the condition reports. The final report with this study will include the updated information from the inspection. **Table 8** includes information about the location and condition of each culvert based on most recent inspections.

Based on MnDOT culvert inspection reports, there are no immediate needs for culvert rehabilitation or replacement within the study area. All culverts on the corridor are known to be in fair to good condition and will only need ongoing maintenance in the near-term. Culverts in fair condition may need rehabilitation in the prior to 2040 based on the results of future inspections. As noted above, MnDOT hydraulic engineers expect that there are some culverts that may be in poor condition and will require rehabilitation or replacement. These recommendations will be updated following 2015 inspections of culverts in the corridor. It is expected that some culverts will require cleaning, repair of separated joints, lining, or full replacement.

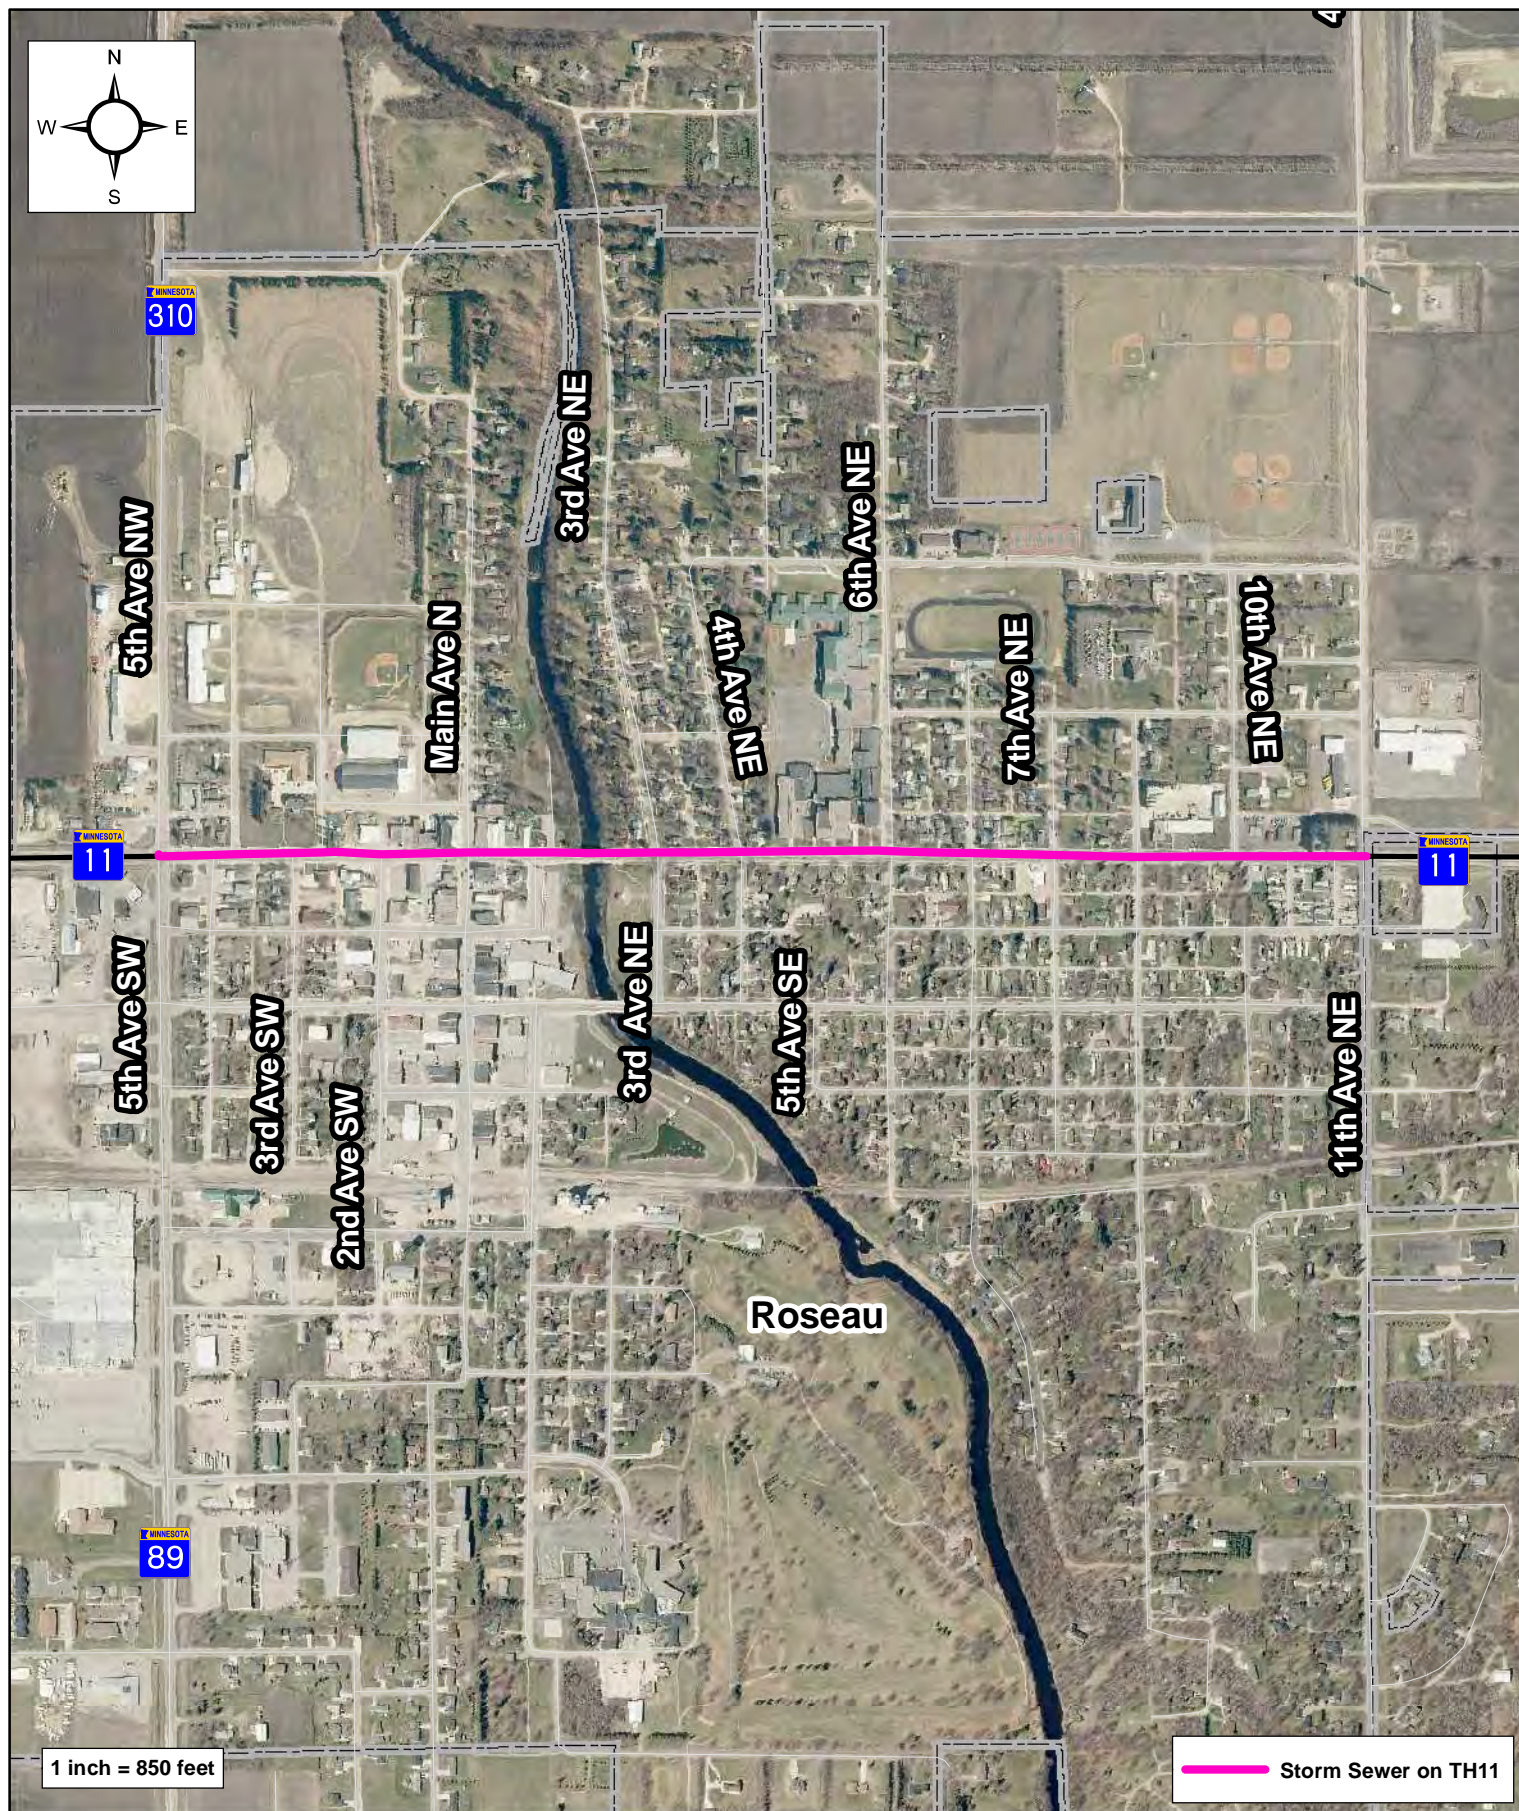
Figure 18
Existing Storm Sewer
Roseau

Within the study area, there is only storm sewer along TH 11 in Roseau and Warroad, as shown in **Figures 18-19**. Storm sewer in Roseau was constructed in 2005 and 2006 and is in good condition. Storm sewer in Warroad was constructed in 1989 and 1990 and will be inspected in late summer 2015. At this time the condition of the Warroad storm sewer system is unknown. Information from the inspection will be incorporated as appropriate into the final report.

Based on the recent installation of the storm sewer along TH 11 in Roseau, there is not a need for rehabilitation or replacement in the near- to mid-term. As noted above, the current condition of the storm sewer in Warroad is unknown. It is possible that the 2015 inspection may identify needs for rehabilitation or replacement of portions of the system, based on its age. Information from the inspection will be incorporated as appropriate into the final report.

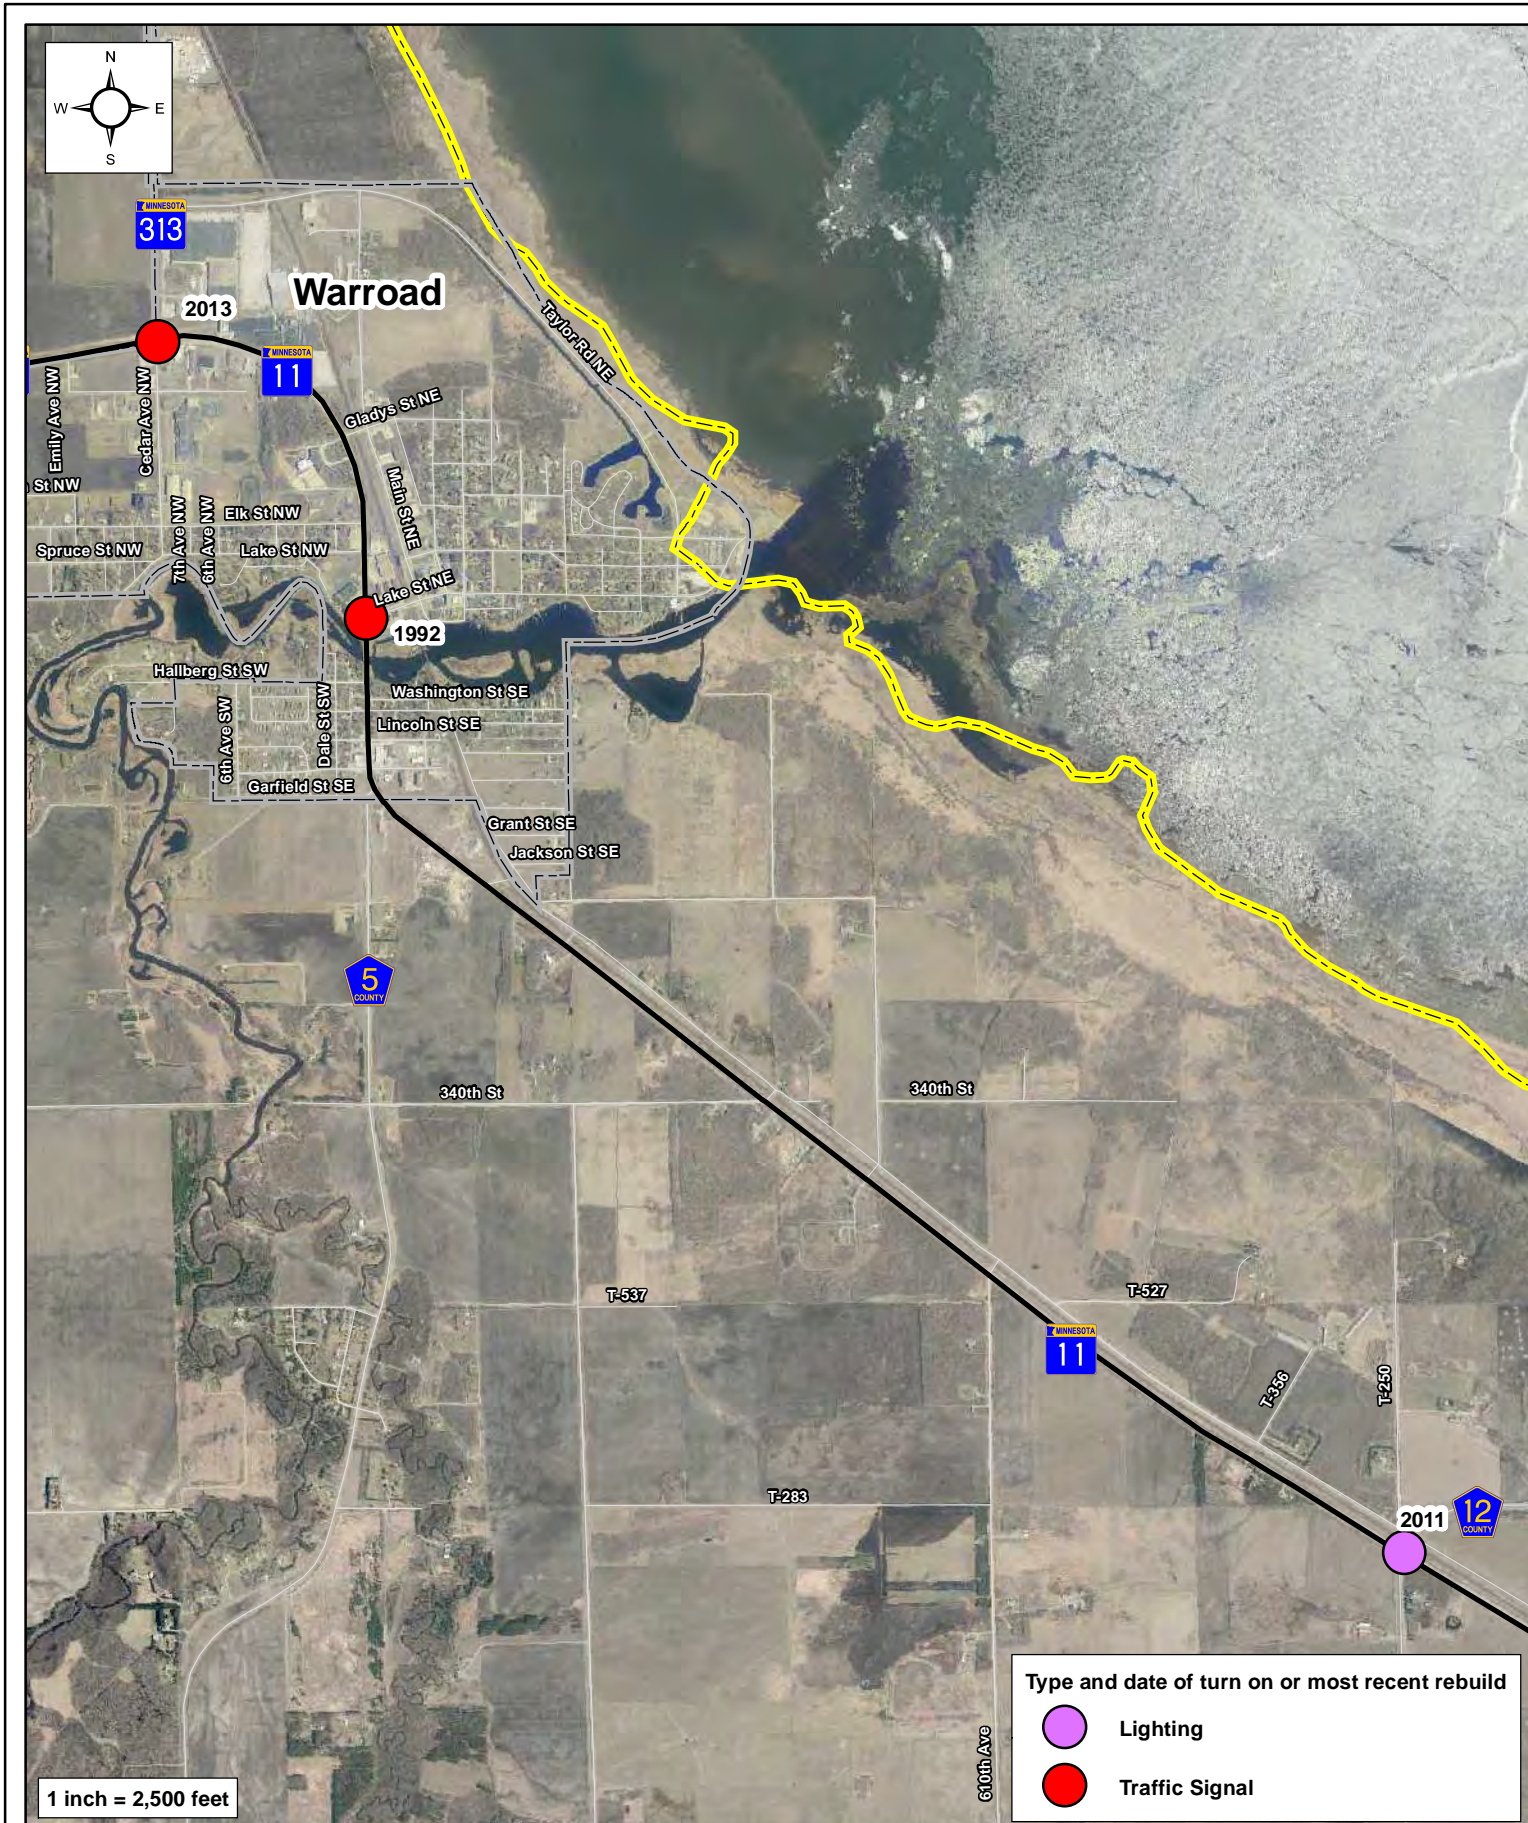
Figure 21
Traffic Signals and Lighting
Warroad

The signals in Warroad are located at the intersections with TH 313/Cedar Street NW and Lake Street. The signal at Lake Street was originally turned on in 1986. The signal at TH 313 was originally turned on in 1992. Both signals are scheduled for replacement in 2019. MnDOT plans to bring both signals into compliance with accessible pedestrian signal requirements.

Based on the current condition of traffic signals and lighting on TH 11, there is no immediate need for replacement or rehabilitation to keep the signals and lighting in working order. Signals should be painted every 10 years. Additionally, the signal at Main Street in Roseau should also be considered for accessible pedestrian signal updates prior to 2025.
