RE: TH 74 Bridges (Br. 8592, 8593, 8594, and 8595) in Whitewater State Park, Winona County
MnDOT District 6 Project SP 8508-38
SHPO Number 2017-2036

Historic Bridge Rehabilitation Alternatives Study for Bridges 8592, 8593, 8594, and 8595

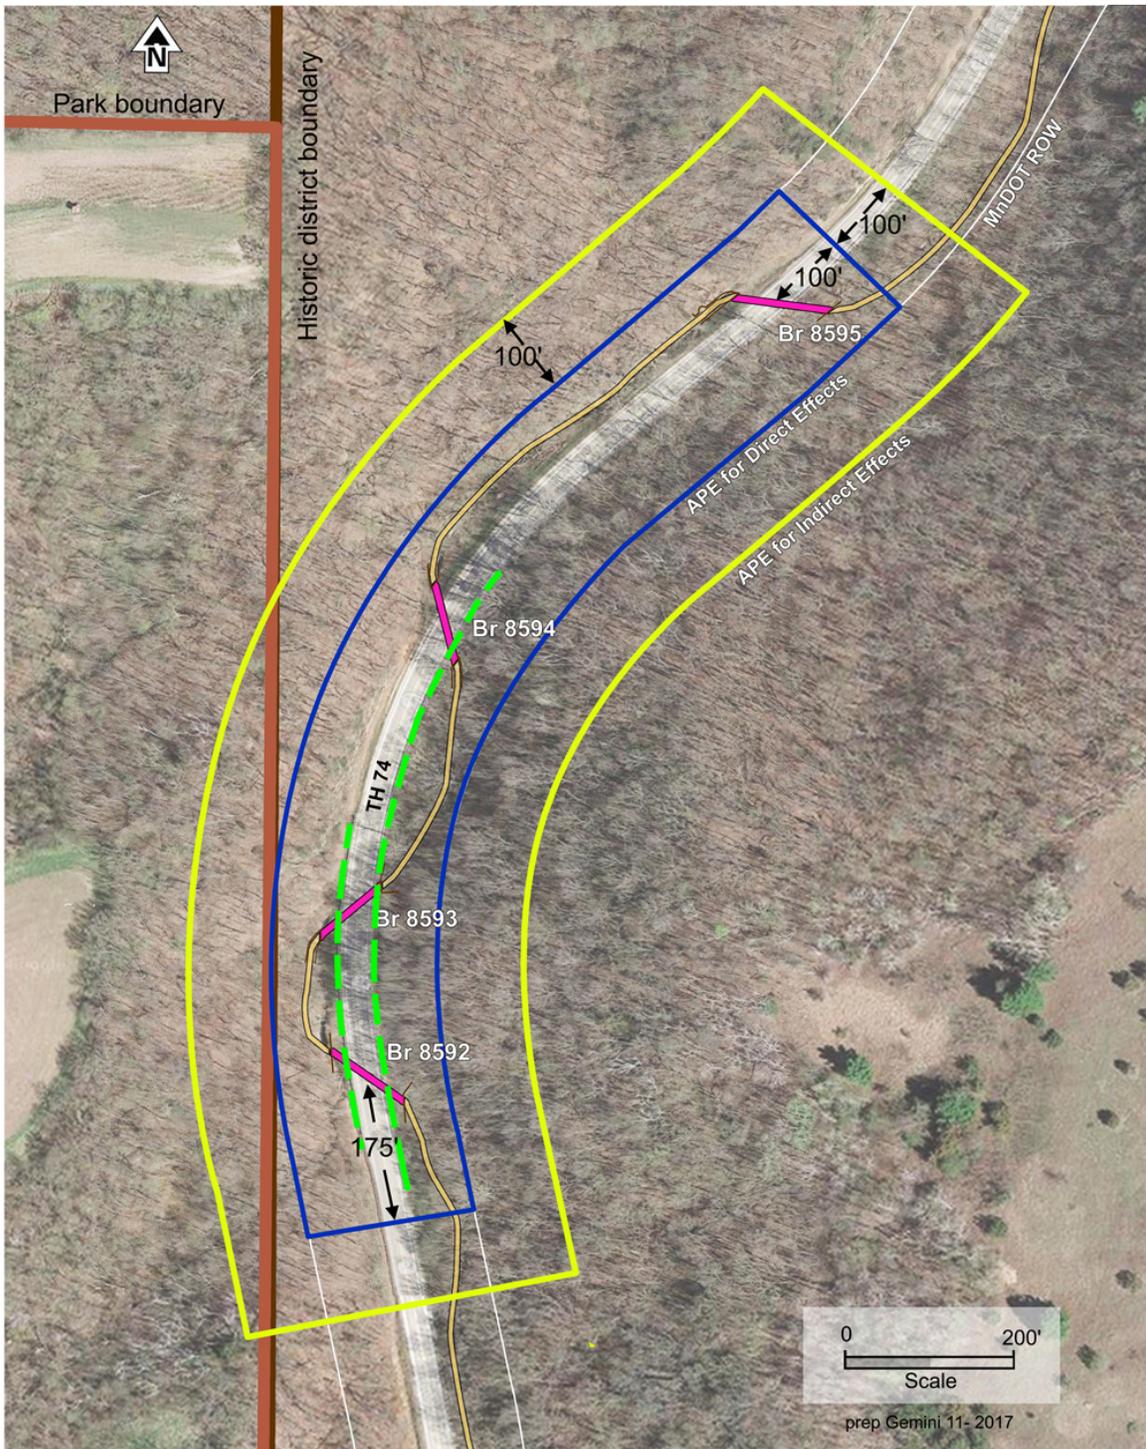
Figure 1. The dashed line on this APE map shows the approximate location of the existing guardrail. It is about 385 feet long on the west side of the road and about 770 feet long on the east side. The project would replace the guardrail, in the same location as existing, with an updated version that meets current design standards. The new guardrail would be 3 inches taller than it is today.

- Excavation would occur over the culvert ends. The road would be repaved with bituminous within the limits of the APE for direct effects (see Figure 1 below). The width of the pavement would be the same as existing.
- As noted above, the existing guardrail would be replaced with guardrail that is 3 inches taller. The guardrail would need a moment slab or similar anchoring system in locations where the geo-grid soil reinforcement would also be installed.
- There would no significant change to roadway signage.

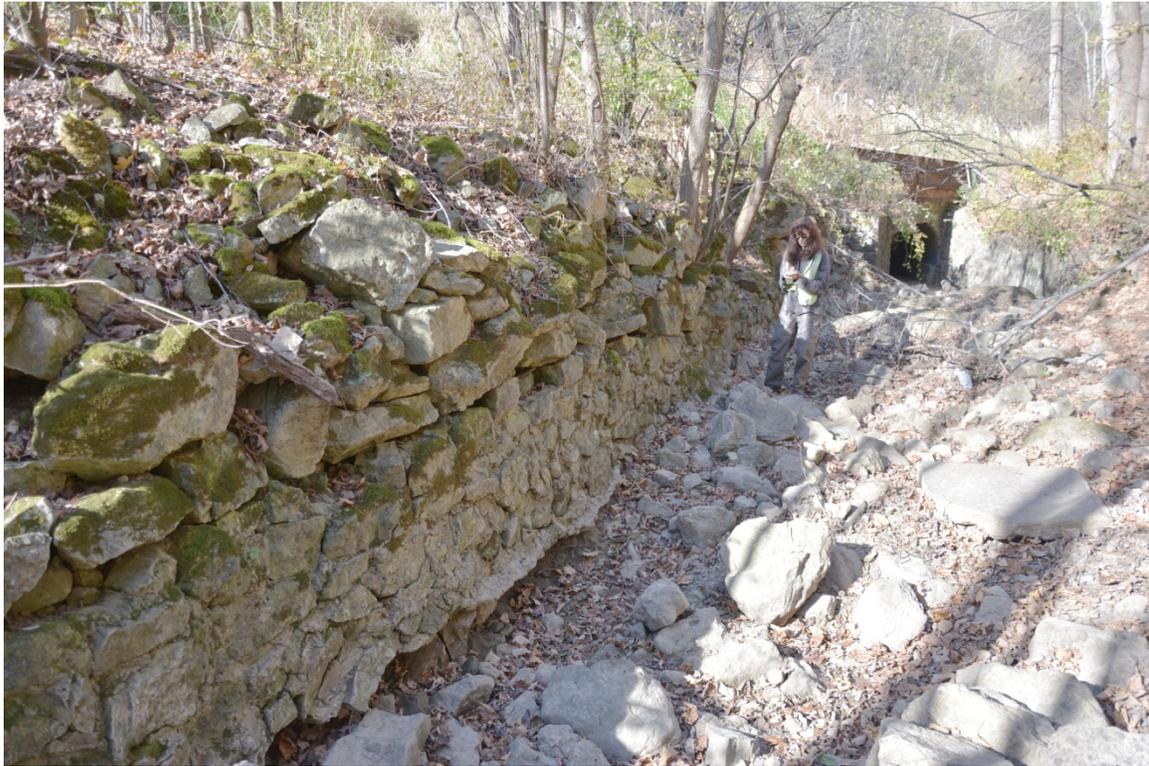
Figure 2. Surviving segment of dry-laid wall lining the drainage ditch southeast of the east headwall of Bridge 8594. Similar walls probably lined other parts of the ditches but have washed away.

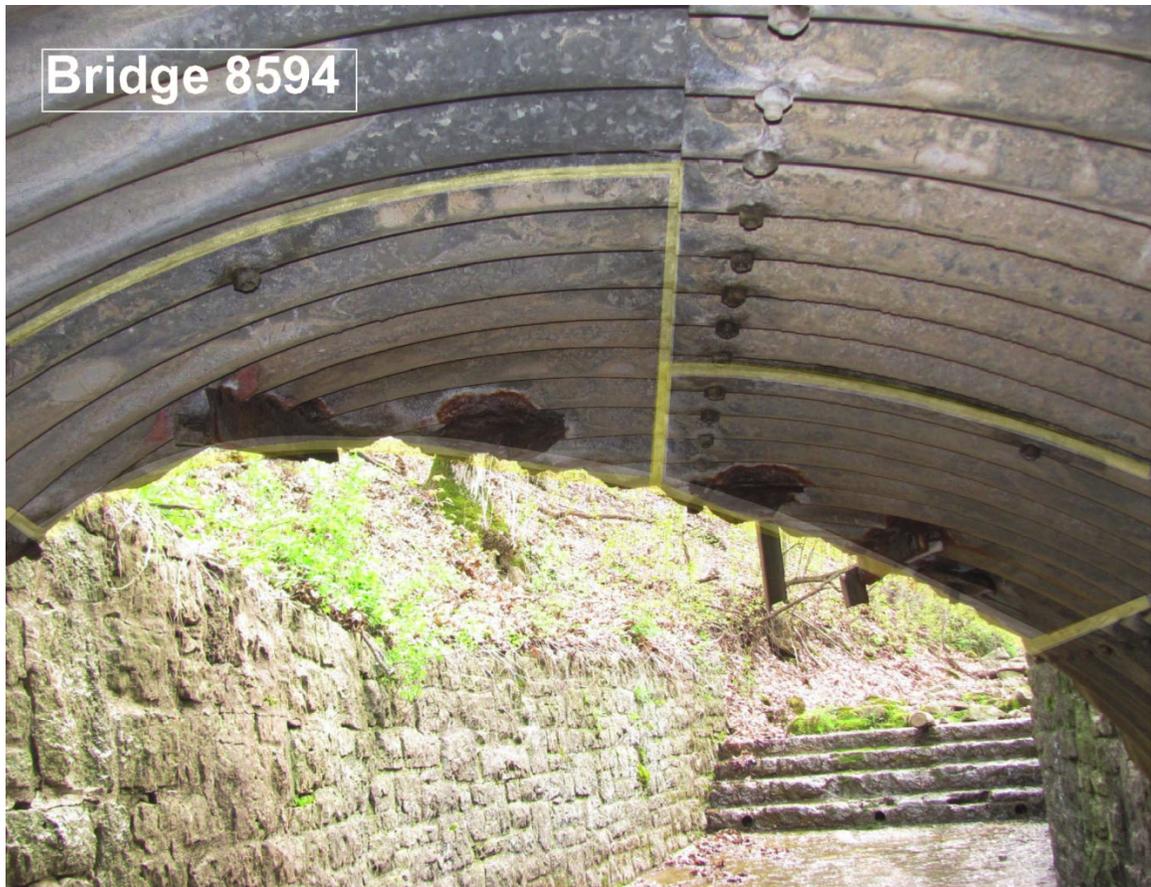
Figure 3. Sections of the multi-plate arches at the east ends of Bridges 8593 and 8594 are corroded where the steel I-beams were attached in the 1970s. As outlined in this photo, sections of the corrugated plates would be unbolted (at existing seams) and replaced. For both bridges the replacement would likely involve two partial plates. (The plates are partial because the skew.) The corrugation pattern of the new plates is not an exact match, so gaps at the plate edges would be unobtrusively sealed and a concrete “collar” cast on the hidden (buried) side of the repair area.

- The I-beam bolted to the east end of the arch would be removed, reversing this alteration.
- Two corroded partial plate sections (where the I-beam was attached) would be removed and replaced (see pages 61-62 in the Study, as well as Figure 3 below). Your February 7th letter expressed concern that plate replacement may damage too much historic fabric. As Figure 3 indicates, the affected area is located at the end of the arch and is modest in size (the plates are not full size due to the skew). The plates would be unbolted at existing seams. The process would not damage the rest of the arch and the repairs should be fairly inconspicuous. The surface of the new metal will initially be brighter than the existing metal, but the culvert sometimes fills completely with muddy water so the new metal will eventually be dulled.
