Minnesota Department of Transportation

Office of Materials & Road Research

SUBJECT: August 22nd, 23rd & 24th, 28th & 29th Flex-Patch Construction and Installation Notes

This memo is to document the Fahrner Asphalt installation of BCI Flex-Patch materials within the City of North Branch, MN. Onsite staff included Shawn Williams and Brian Fields (Field Inspector) for the City of North Branch, Travis for Fahrner Asphalt (and numerous crew members) and John Pantelis for Mn/DOT Materials and Road Research. Ed Johnson was onsite 8/28/12.

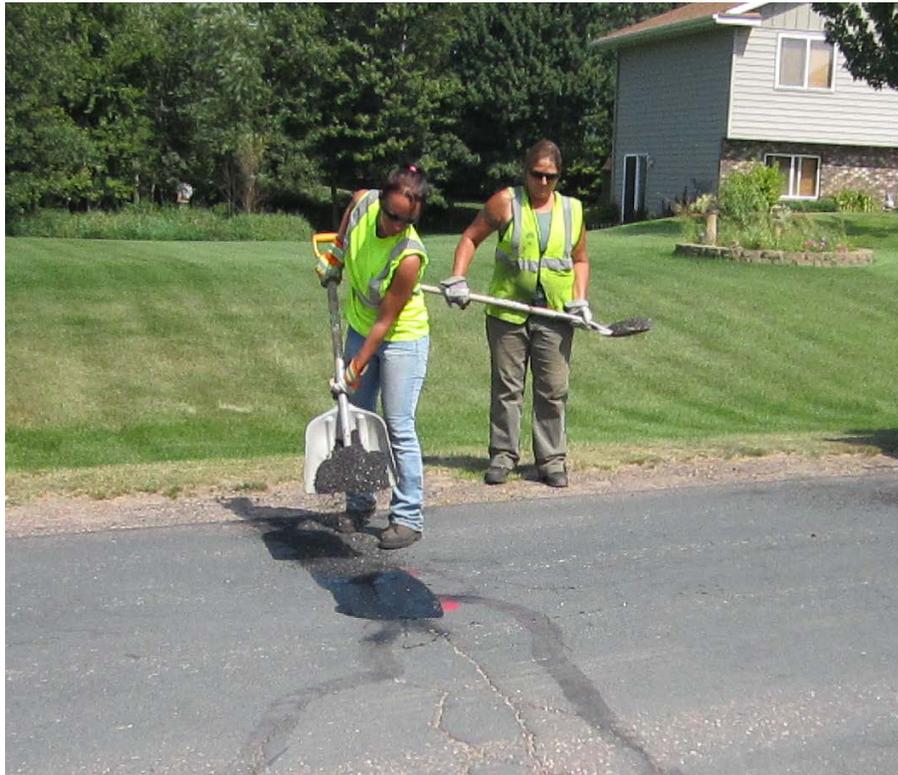
Shovel casting of cover aggregate proved time consuming. No reliable/verifiable aggregate coverage rates or controls. This can lead to increased waste of aggregate. Also, aggregate dropped from height pushes sealant up and bleeds over route reservoir.

Figure 3 – Shovel Casting of Cover Aggregate

Clean & Seal operations worked better with mechanical blower applications. City and State staff would not recommend shovel casting cover aggregate as standard practice. Mechanical placement should be part of the installation specification.

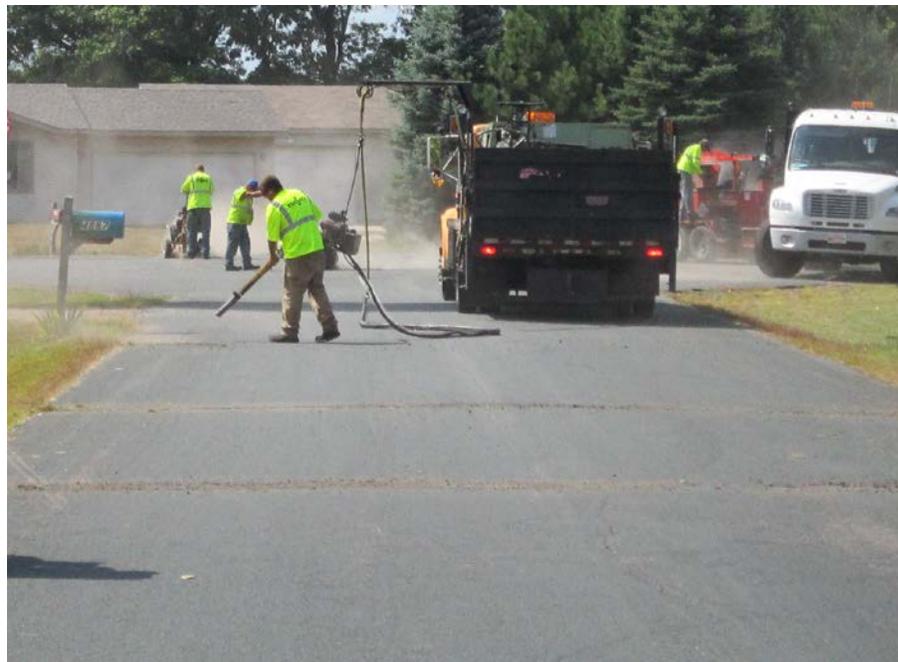
Figure 4 – Routing, Cleaning and Heat Lancing of Cul-de-sac

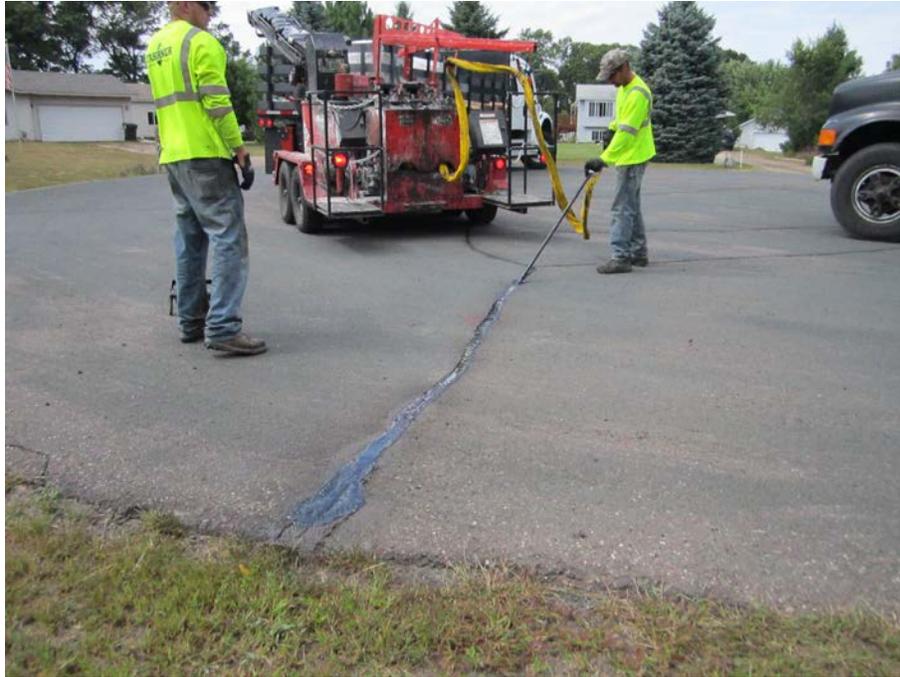
Figure 5 – Flush Filling of Routed Crack

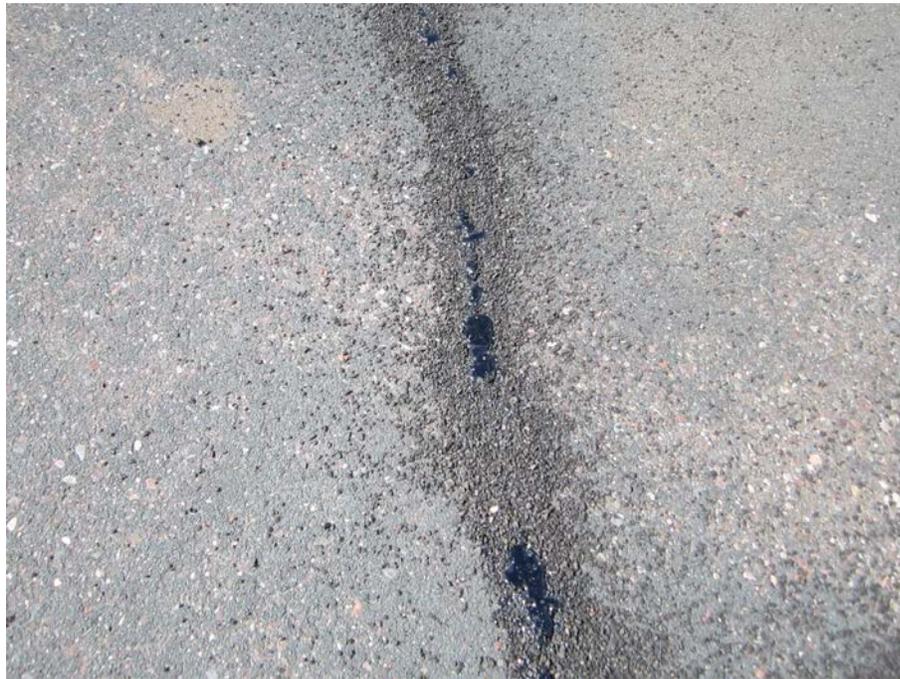
Some cracks were routed, and once shoved cast rock was applied material tended to overflow reservoir. No more routing was attempted. Only wide cracks will be treated with the Clean & Seal method with cover aggregate applied, as selected by City staff.

Figure 6 – Bleeding of Flush Filled, Routed Crack – Typical of Shoved Cast Rock

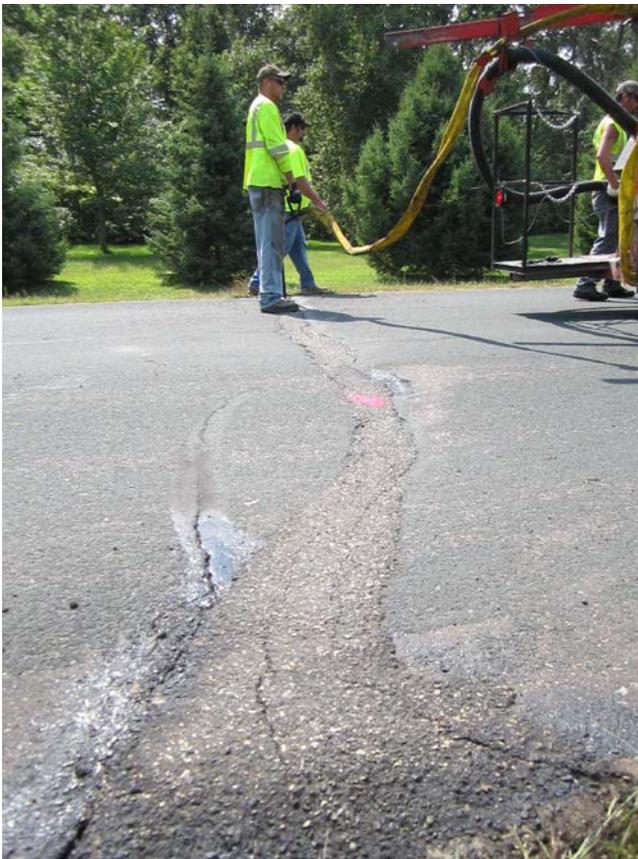
Figure 12 – Large Depression to be filled south view

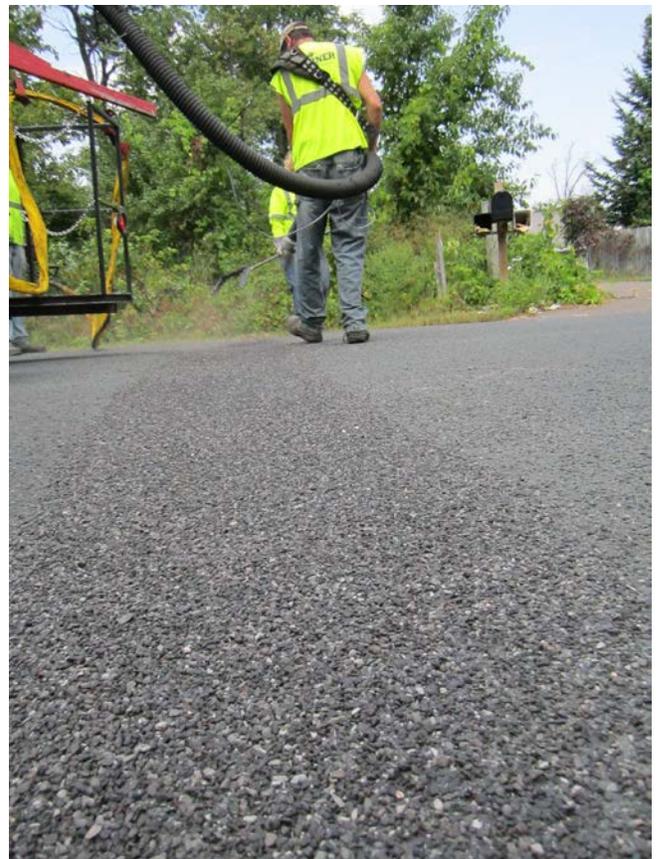
Figure 13 – Same Depression, as repaired north view

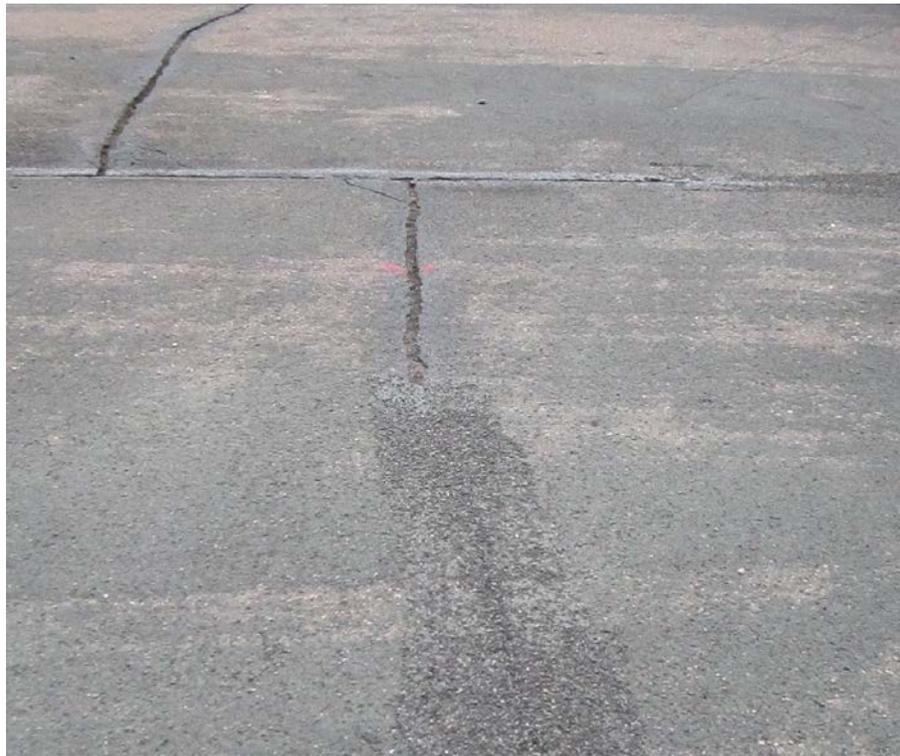
Figure 15 – Clean & Seal ½ completed – Note 3/4+ crack size

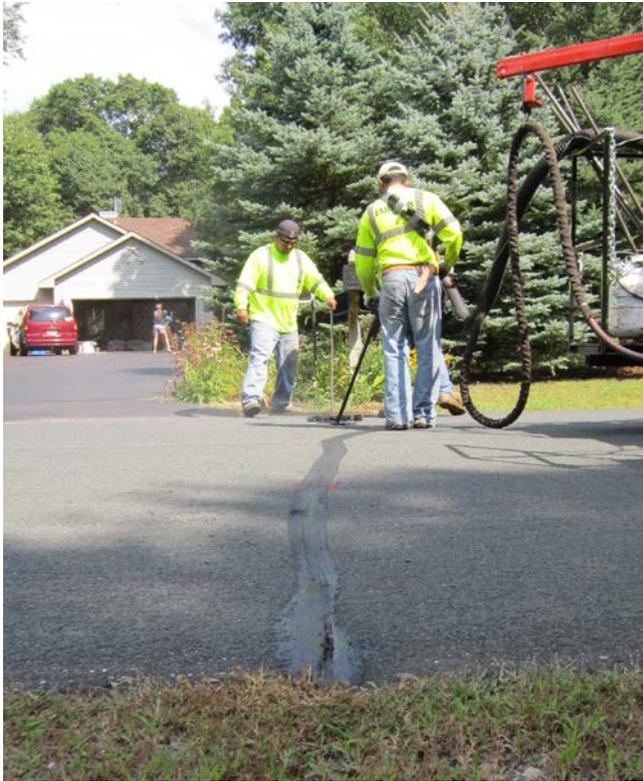
Figure 19 – To be repaired crack, heat lanced
