Observations on Recycling Partnership Test Sections

70th in Otsego and Albertville, Minnesota

3 January, 2020

E. Johnson – MnDOT MRR

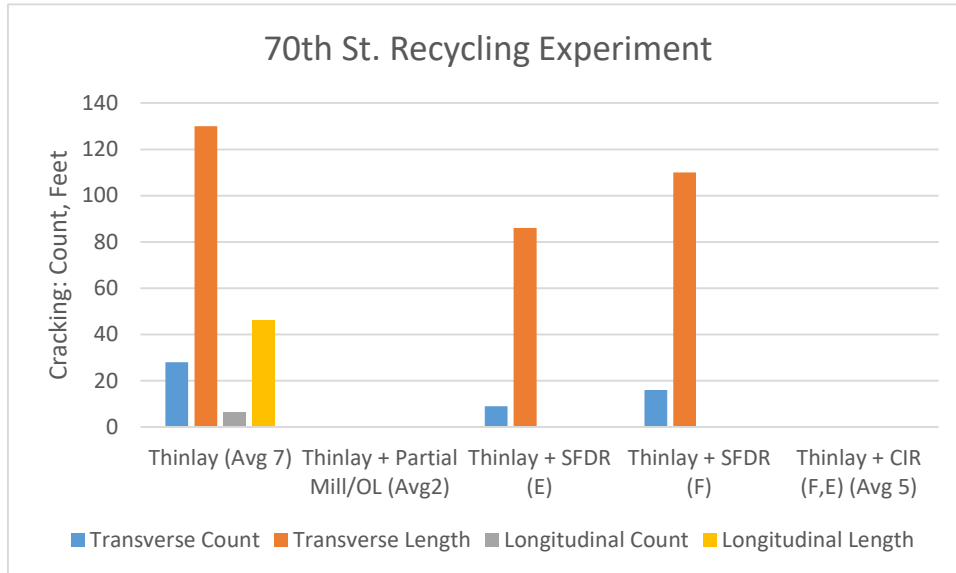
Figure 1 Average LOW Severity Cracking by Construction Type

No cracking was observed in cells built using CIR, CCPR, and Mill-Overlay techniques.

Transverse Cracking was observed in the SFDR cells.

Transverse and Longitudinal Cracking was observed in the Thinlay (Control) cells.
