Observation of Recycling Partnership Test Sections

70th in Otsego and Albertville, Minnesota

5 June, 2020

E. Johnson, P. Nolan, M. Vrtis – MnDOT MRR

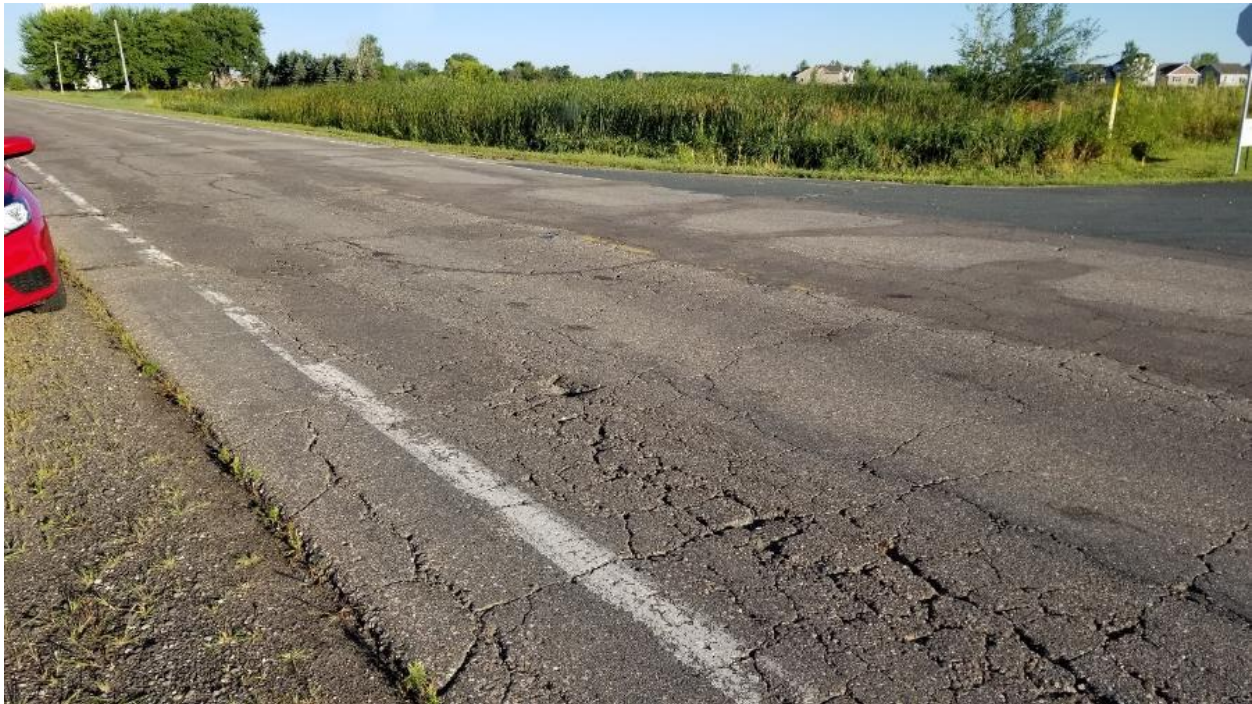
Figure 1 and Figure 2, photos of distress typical throughout the project, show closely spaced transverse cracking combined with fatigue and other longitudinal cracking.

Figure 1 70th St. August 2019. Eastbound (left), and westbound (right) lanes.

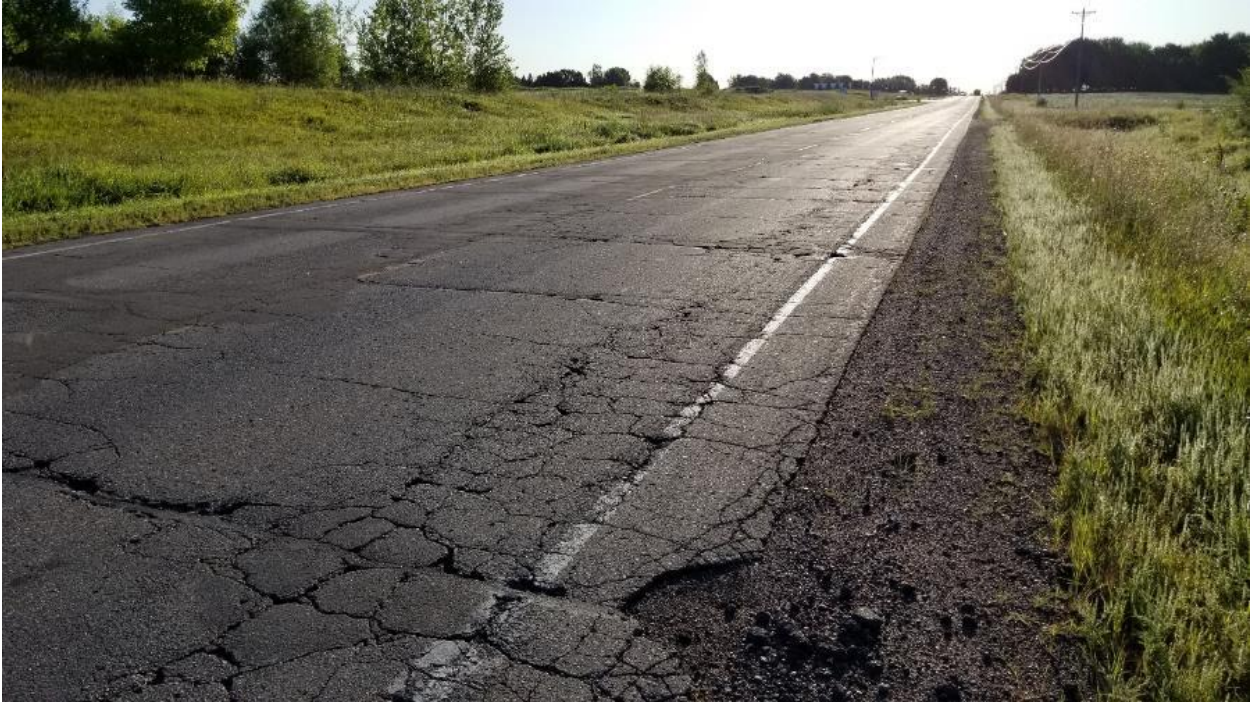
Figure 2 70th St. August 2019. Westbound (left) and eastbound (right) lanes.

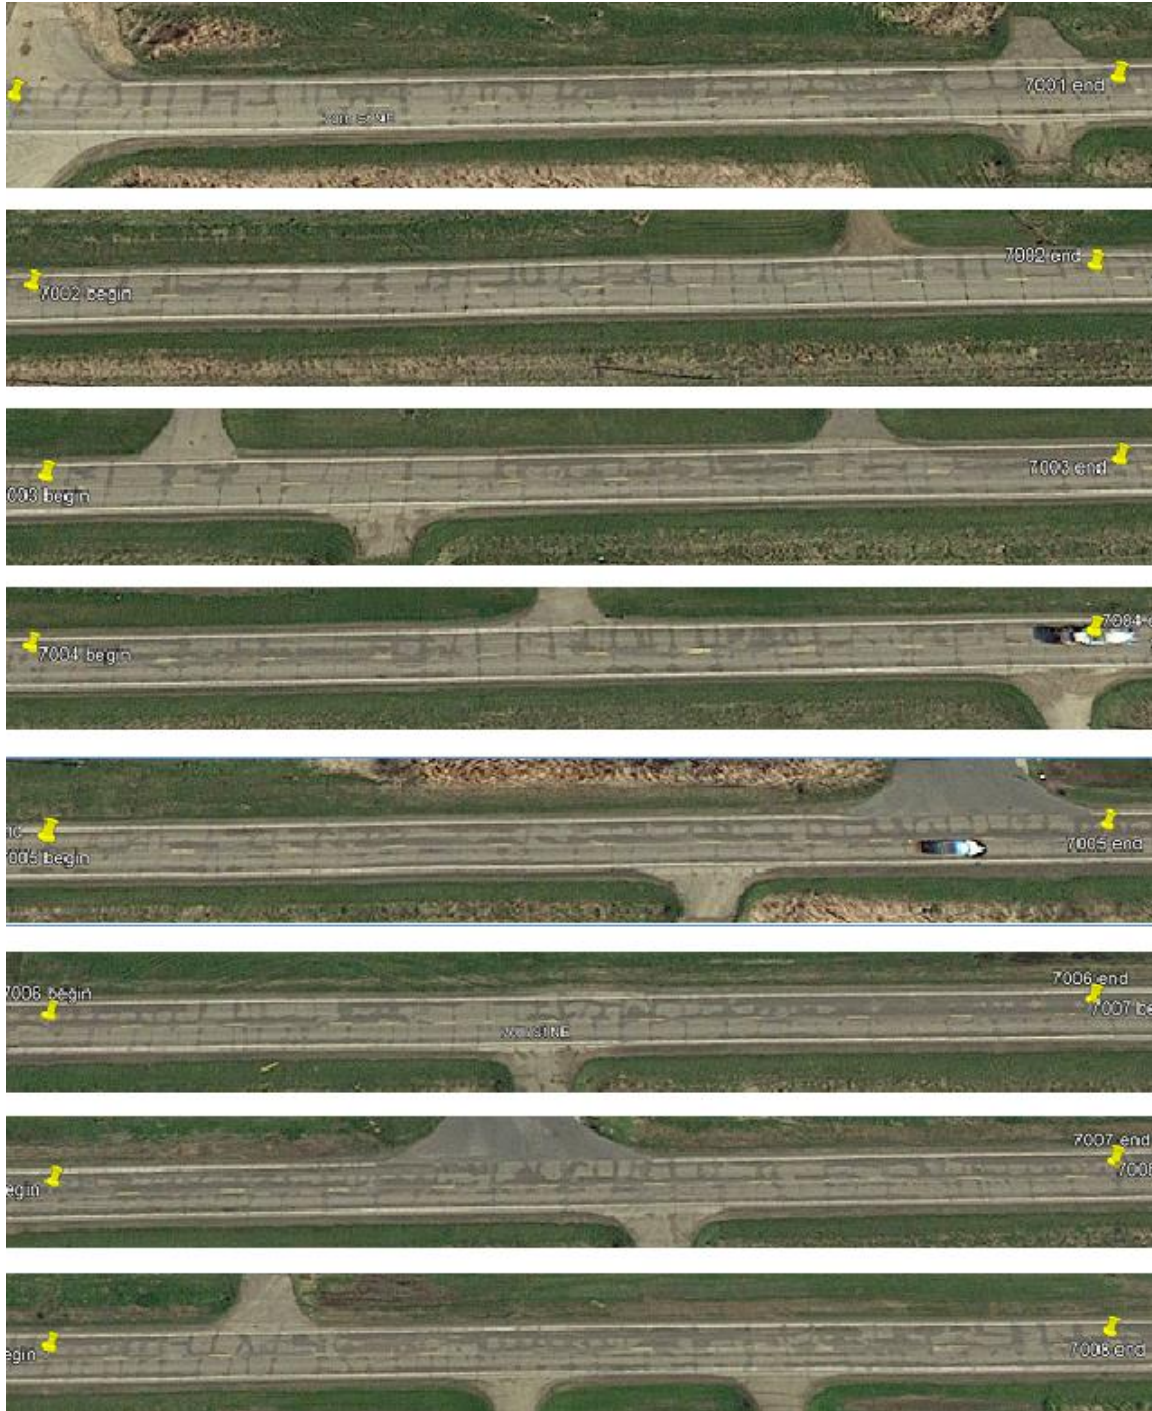
The westbound lane contained more bituminous patching and leveling material than the eastbound. The difference can be seen in Figure 3.

Figure 3 Preconstruction view of 70th St. sections 7001 (top) through 7008 (bottom). Google Earth date 5/14/2018.

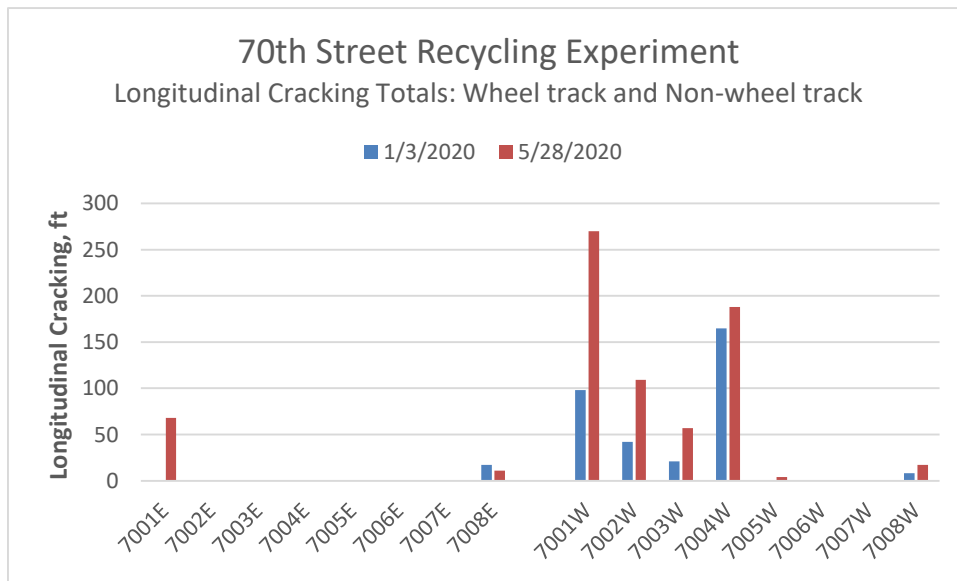
Figure 5 Longitudinal cracking history.

On 5/28/2020 five sections remained free of cracks: Thinlay over CCPR-emulsion, Thinlay over 3-in. overlay, Thinlay over 2-in. overlay, and two cases using Thinlay over CCPR-foam.

Information in Table 1, Figure 5, and Figure 6 shows an increase in longitudinal and transverse cracking occurred during the first five months of 2020. Severity level remained LOW with the exception of a single MED 12-ft transverse crack.

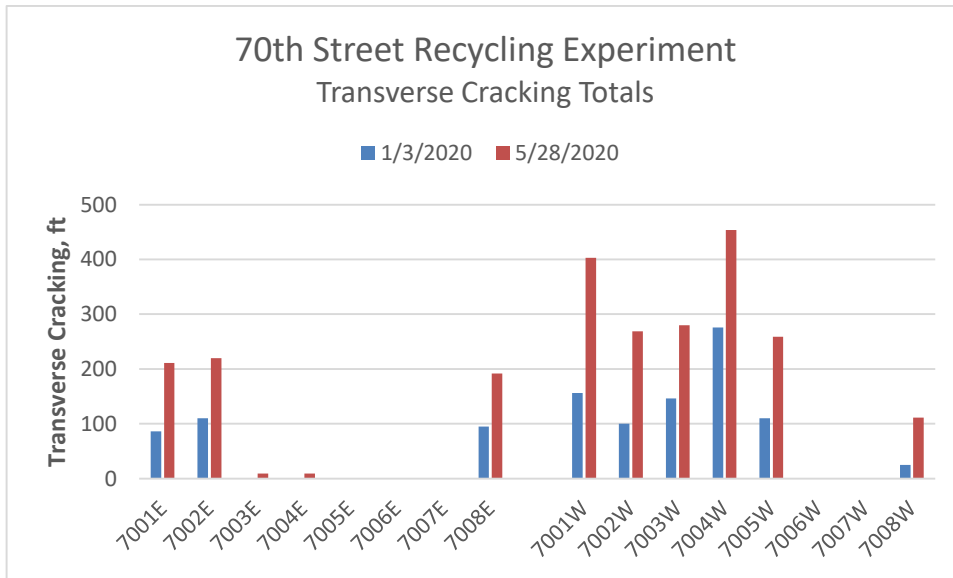
Figure 6 Transverse cracking history.

On 1/3/2020 no cracking was observed in sections built using CIR, CCPR, and Mill-Overlay techniques. Transverse Cracking was observed in the SFDR sections. Transverse and Longitudinal Cracking was observed in the Thinlay (Control) sections.

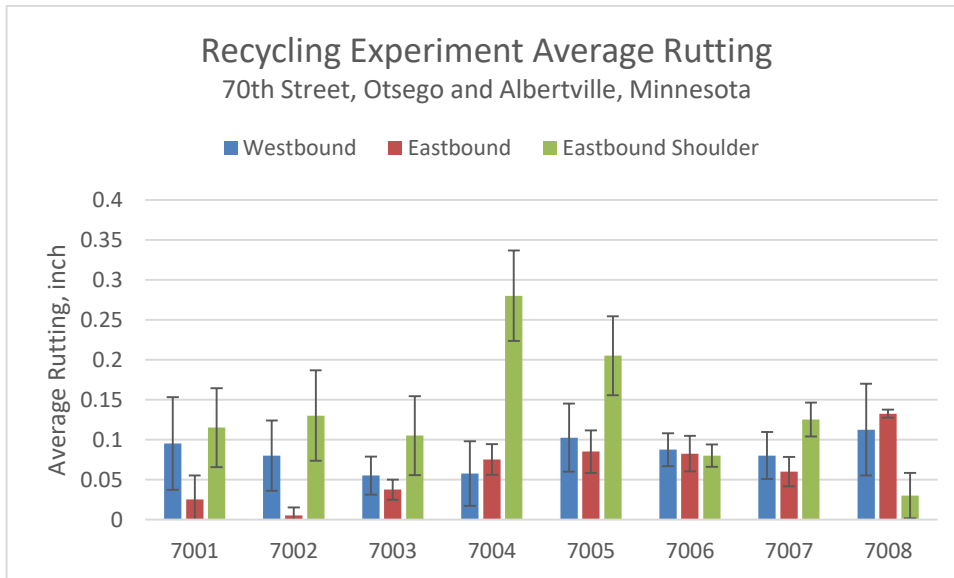
Figure 7 Average Rutting on 6/5/2020.

During the 5/28/2020 crack mapping inspection it was found that rutting had developed in the eastbound lane at an area from the right wheel track to a point outside the edge stripe, ending about 1-ft from the edge of the bituminous surface. Sections affected were #7004, 7005, and 7007; sections that otherwise have been relatively distress-free. This was the most serious rutting found on the test sections.

Measurements were subsequently performed on 6/5/2020 without traffic control. Measurements were obtained in each wheel path using a 6-ft straight-edge and a digital measuring gauge. The results are given in Table 2, and current performance is given in Figure 7 and Figure 8.

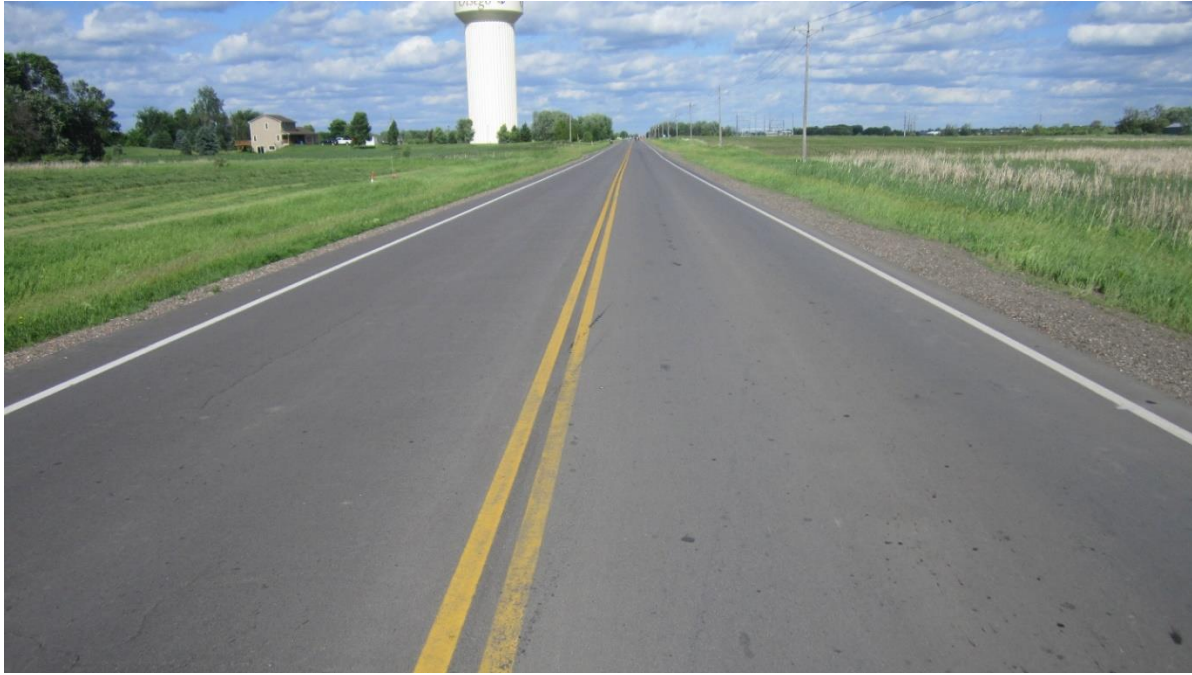
Figure 9 and Figure 10 are examples of the typical condition of the test sections in June, 2020. The image shows some cracking in the westbound lane of 7001.

Figure 9 View eastbound into sections 7001E and 7001W, June 2020.

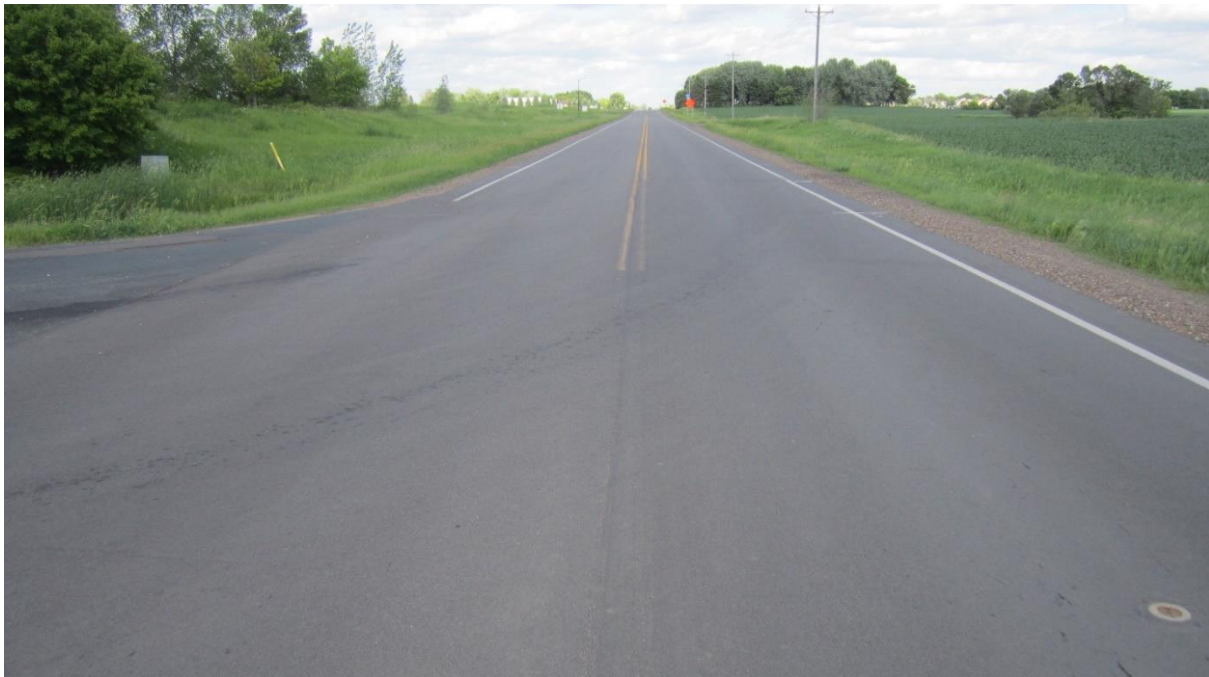
Figure 10 View eastbound into sections 7006E and 7006W, June 2020.
