GARRISON CONCOURSE

SHPO INV. # CW-GRC-001

Architect's Survey Date: October 7, 1999

CW-GRC-001
CS 1804
Garrison Concourse

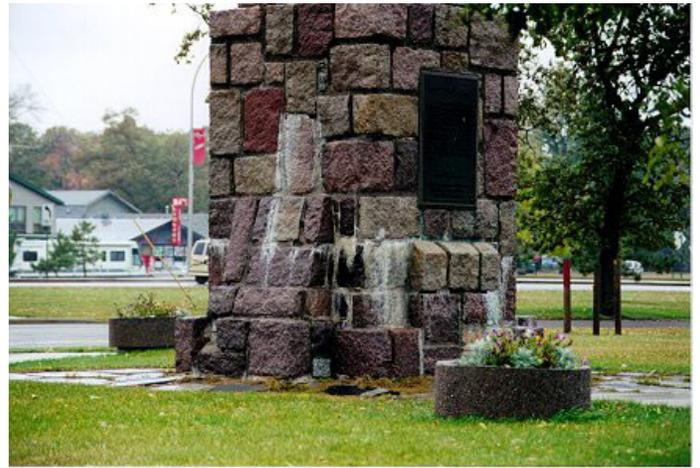
14. SE view of monument, flagstone walk and repairs?

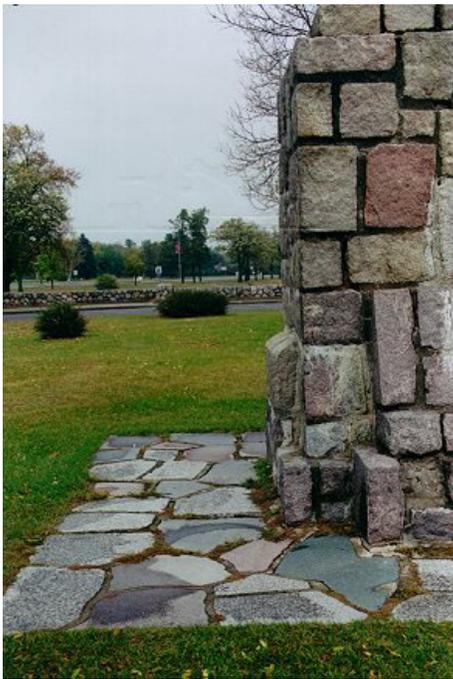
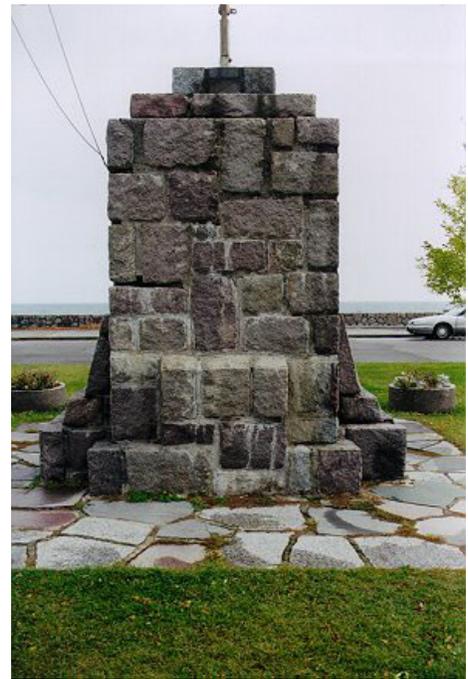
- **Assessment:** The 16'-0" x 16'-0" pink and gray granite flagstone plaza around the base of the flagpole marker is the only area of flagstone on the island installed as originally designed. It has settled unevenly and requires repair. The general condition of the stones is good.
- **Recommendations:**
Stabilization/Preservation/Restoration: Remove all stone and clean thoroughly. Number each piece for reinstallation in the same location and configuration. Regrade and install new compacted sand sub-base as required. Reinstall the flagstone in the same general pattern and grout full the joints as originally specified. **Work Period:** 1 - 3 years.

15. Close-up of flagstone walk at monument

16. Close-up of flagstone walk at monument

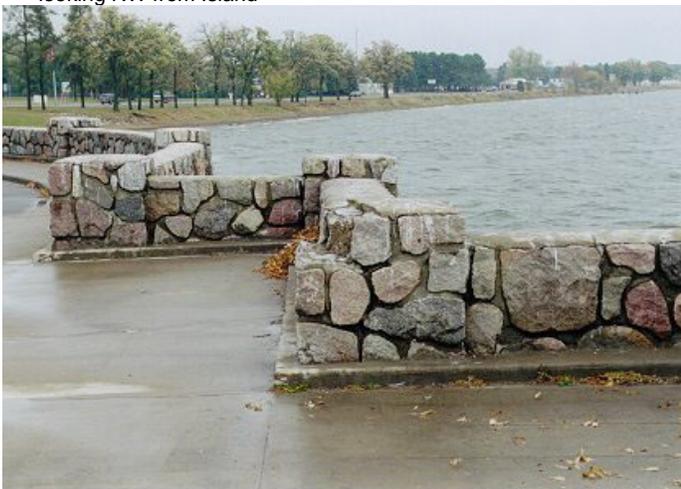
23. View of concrete walk and interior wall showing missing stones at pier—looking NW

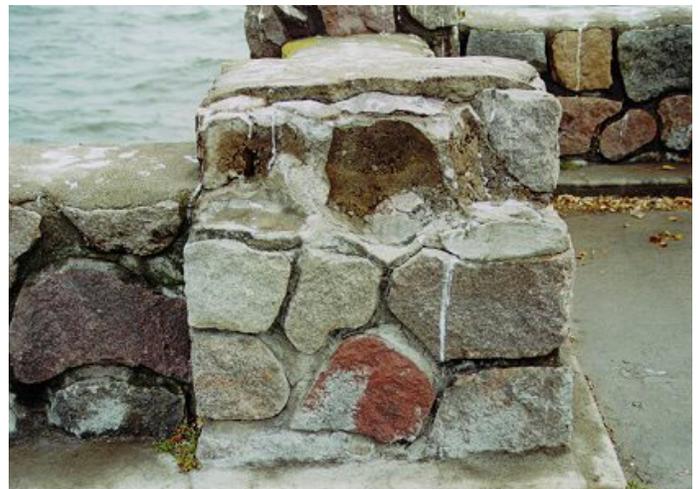
24. Close-up of pier missing stones

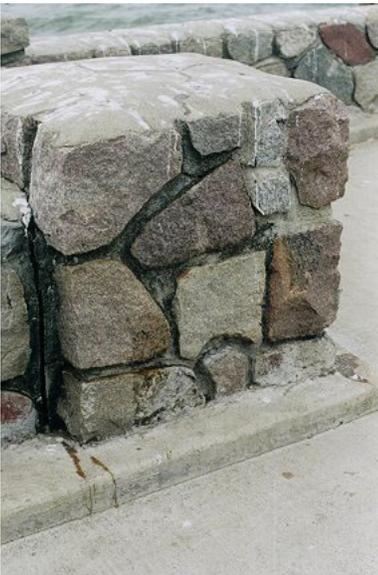
25. Close-up of existing wall and concrete conditions

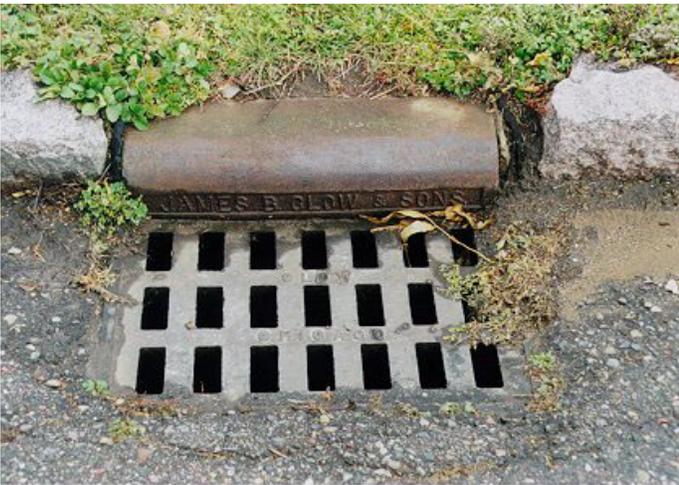
28. Original Catch Basin/granite curb—note excessive turf and asphalt

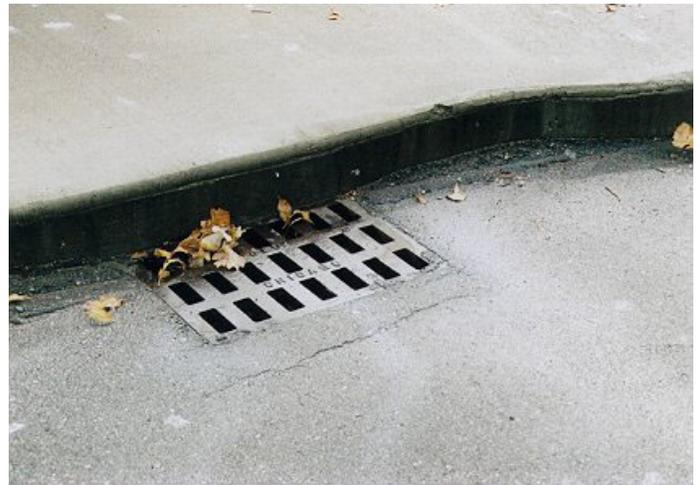
29. Original catch basin at new concrete walk's edge—original steel head is covered with concrete

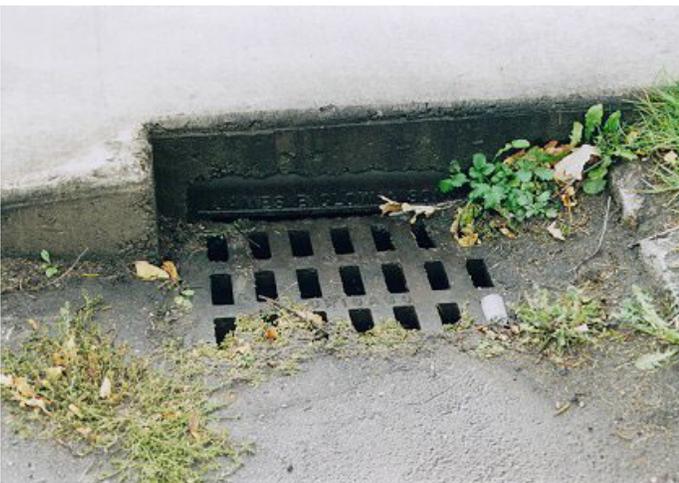
30. Original Catch Basin @ SW Walk and Wall
(Granite Curb is only about 1" above asphalt surface)

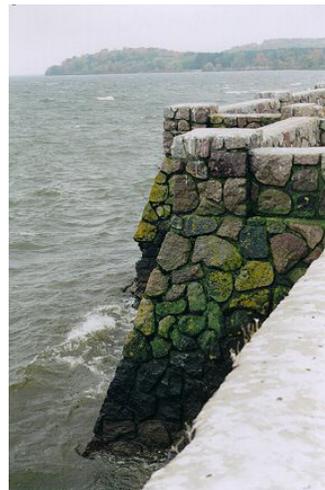
31. North Outer Wall Condition
(Far pier is missing stones)

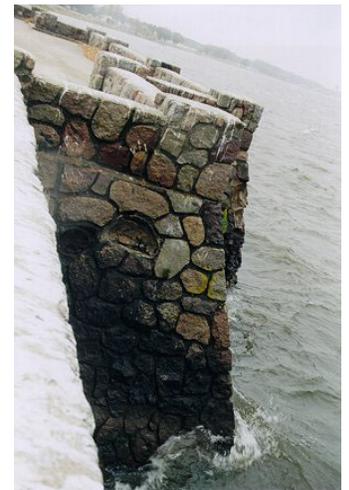
32. South Outer Wall Condition
(Missing stones visible)

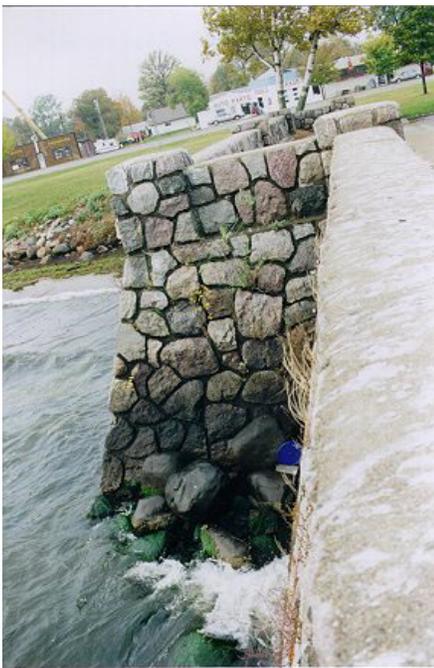
35. Base of South Wall (Note--vegetation)

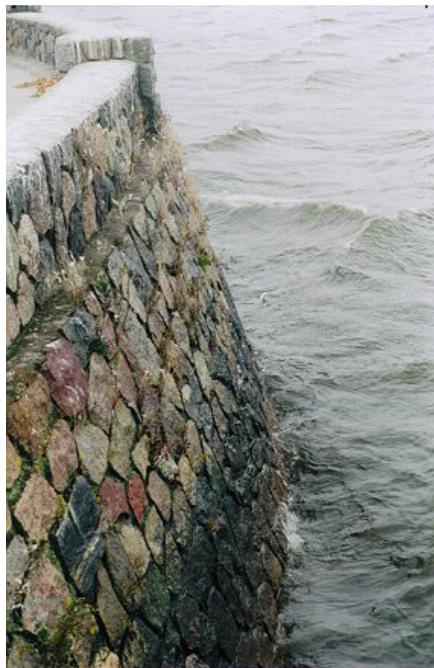
36. Outer Wall Condition (Note—ledge & joints)

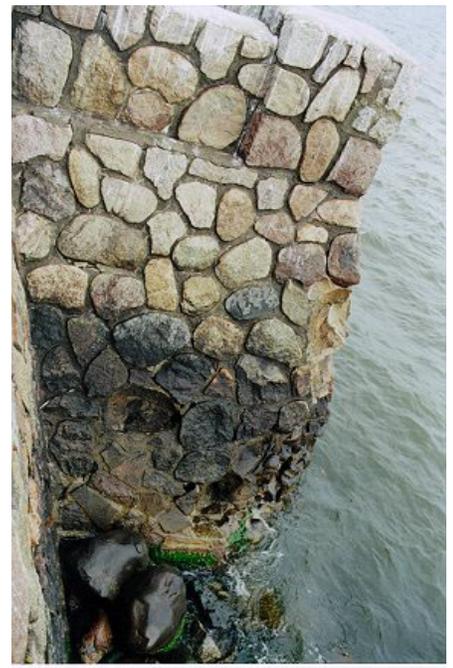
37. South Wall Pier (Note—missing stones)

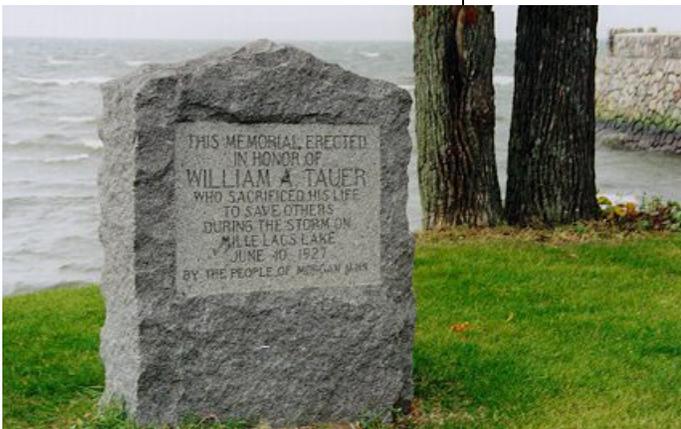
h. Marker (Tauer Monument): This is located to the north of the concourse; this marker is in good condition and needs no work. Refer to Spatial Organization above for additional information.

38. Tauer Monument located on Northern part of Site

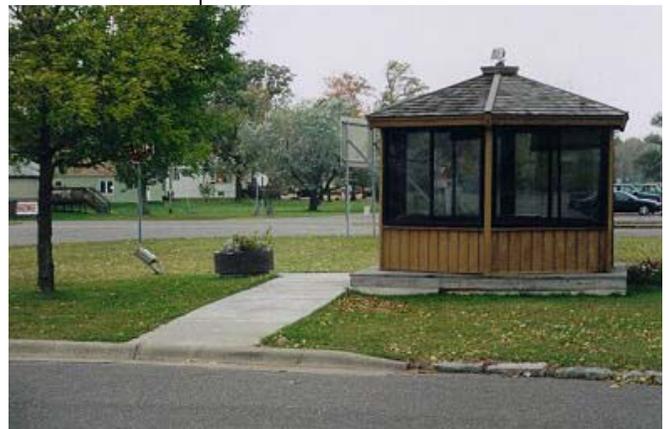
39. Visitor's Information Booth & Walk (Note—granite curb; handicap access; tilted electrical service box)

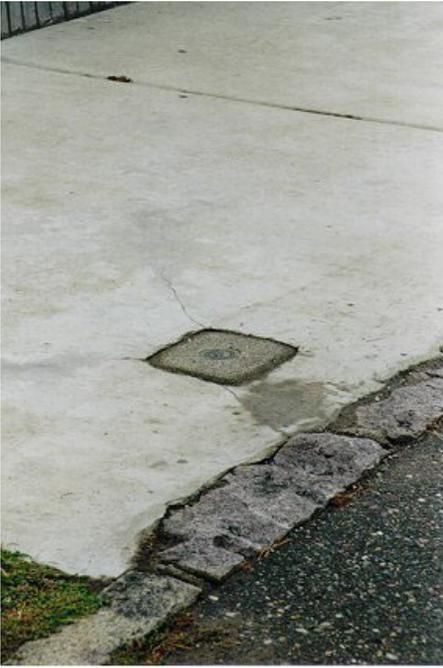
40. Geophysical Elevation Marker @ Fish Plaza
(Note—granite curb elevation is nearly flush with the newer asphalt drive and parking area)
