GARRISON PED UNDERPASS (BRIDGE 5265)

SHPO INV. # CW-GRC-005

Architect's Survey Date: October 6, 1999

**MNDOT HISTORIC ROADSIDE DEVELOPMENT
STRUCTURES INVENTORY**

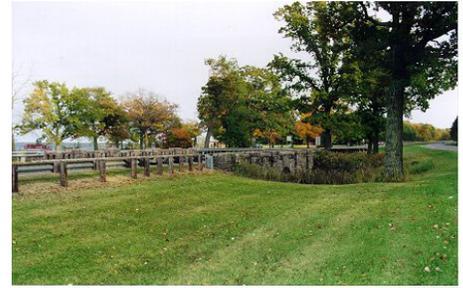
- **Assessment:** The site is gently rolling except along the lakeshore and the bridge headwalls. Water levels are much higher now than when the underpass was built. The walking surface is covered with water obliterating any view of the walking surface, its condition and/or its location.
- **Recommendations:** None.

2. Underpass looking South in Median

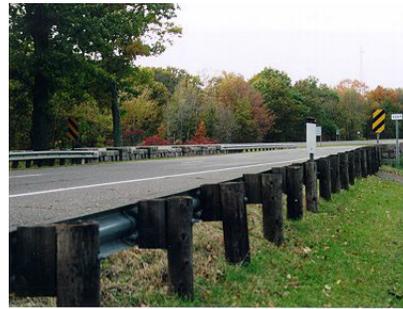
5. East side Guardrail looking North

- **Assessment:** The recent metal guardrail extensions overwhelm the bridge visually and negatively impact its historic prominence and value.
- **Recommendations:**

Stabilization: Replace timber/steel guardrails with historically appropriate designs.
Work Period: 1 - 3 years.
Preservation/Restoration: Replace metal guardrails with historically appropriate designs. **Work Period:** 1 - 5 years.

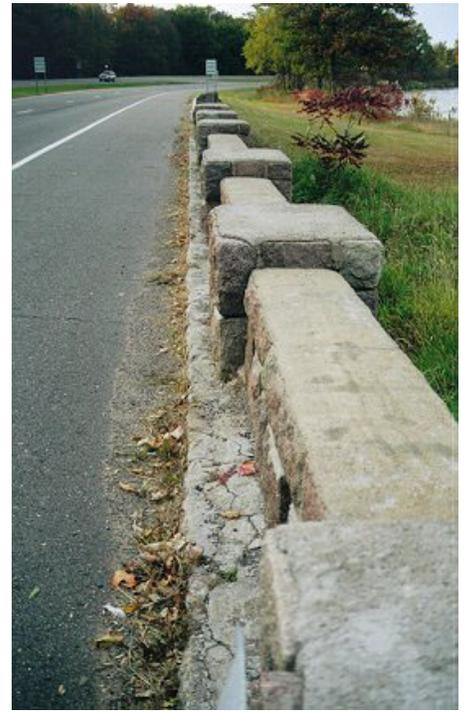
All stone joints are in poor condition—most are cracked; some are missing; some have been recently patched inappropriately, etc. Mortar topping is in poor condition. A section on the north end of the east wall was loose and easily removed exposing the poor mortar condition of the joints underneath. Without proper attention the stones in this part of the wall will begin to fall out.

7. North end of West side Wall (Note: condition of curb and mortar)

- **Recommendations:**
Stabilization/Preservation/Restoration: Remove all mortar topping and joints, including vegetation; do not replace mortar topping; repoint all joints and reset those stones that require it; repair and restore stone curbing along east and west headwalls and at the pedestrian walkway below; stabilize corrosive action on the culvert and provide means for preventing further decay; restore and stabilize the granite base and concrete walkway in the culvert. Work Period: 1 - 3 years.

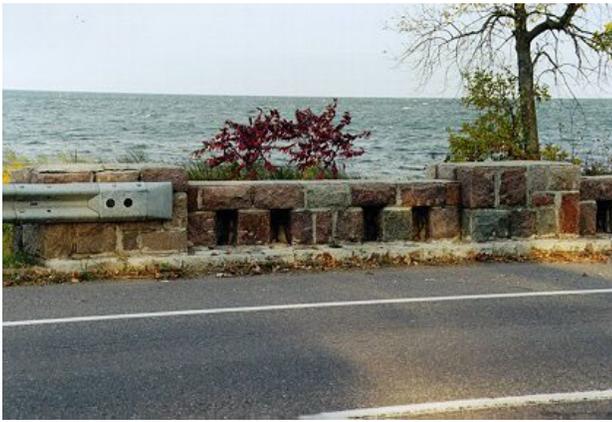
8. North end of East Wall looking East

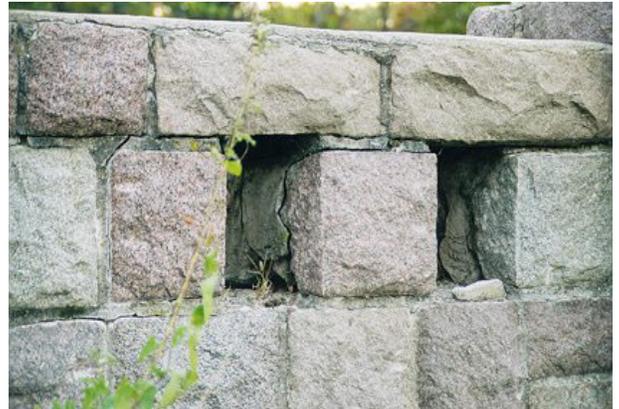
13. Close-up of Joints and Openings in Wall

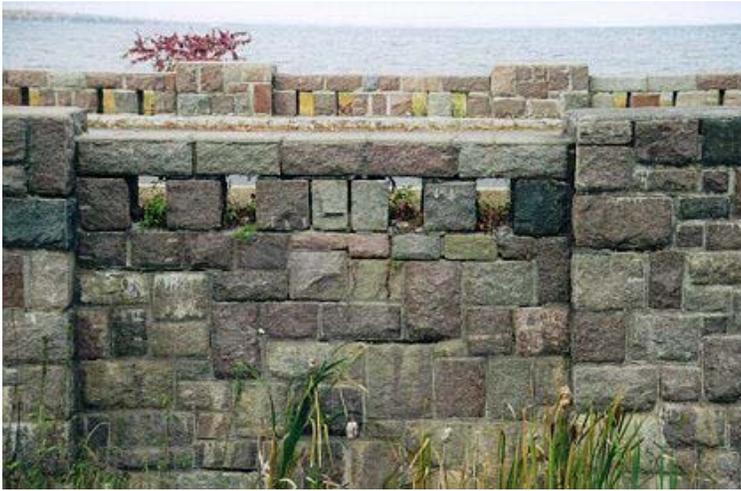
Today grassy highway ditches, overgrown weeds and brush in the creek bed, and mature deciduous and evergreen trees surround the bridge. Weeds are encroaching on the bridge's stonework. The northern end of the Garrison Rest Area south of the bridge has mowed grass and deciduous and evergreen trees.

14. Midsection of West Wall looking East (Note Vegetation)

Stabilization and Preservation: Cut back weeds and brush from the bridge to a distance of 6' and keep it trimmed back. Establish and follow a regular schedule of mowing and trimming. **Work Period:** ASAP.

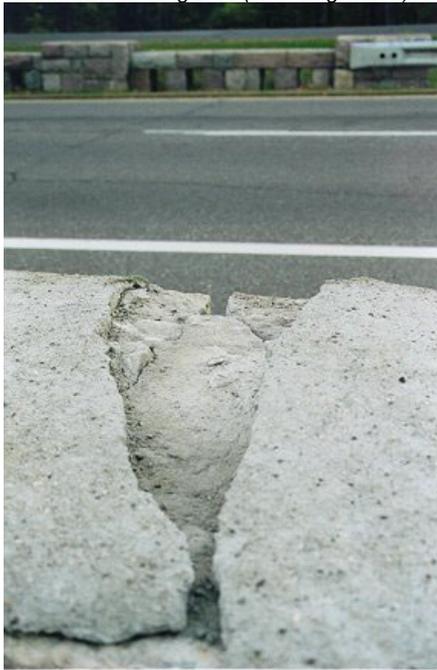
16. Missing Mortar Topping

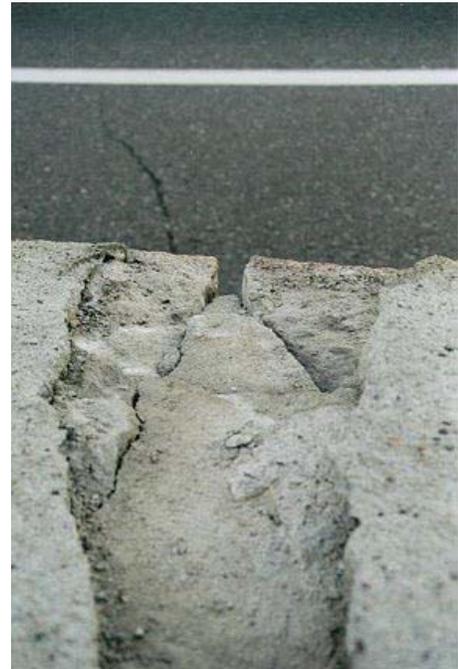
17. Close-up View of Missing Mortar and Condition of Underlying Stone Joint
