UNDERWATER BRIDGE INSPECTION REPORT

STRUCTURE NO. 31509
CSAH NO. 63
OVER THE
MISSISSIPPI RIVER
DISTRICT 1 - ITASCA COUNTY

PREPARED FOR THE
MINNESOTA DEPARTMENT OF TRANSPORTATION
BY
COLLINS ENGINEERS, INC.
JOB NO. 3512 (CEI 28)

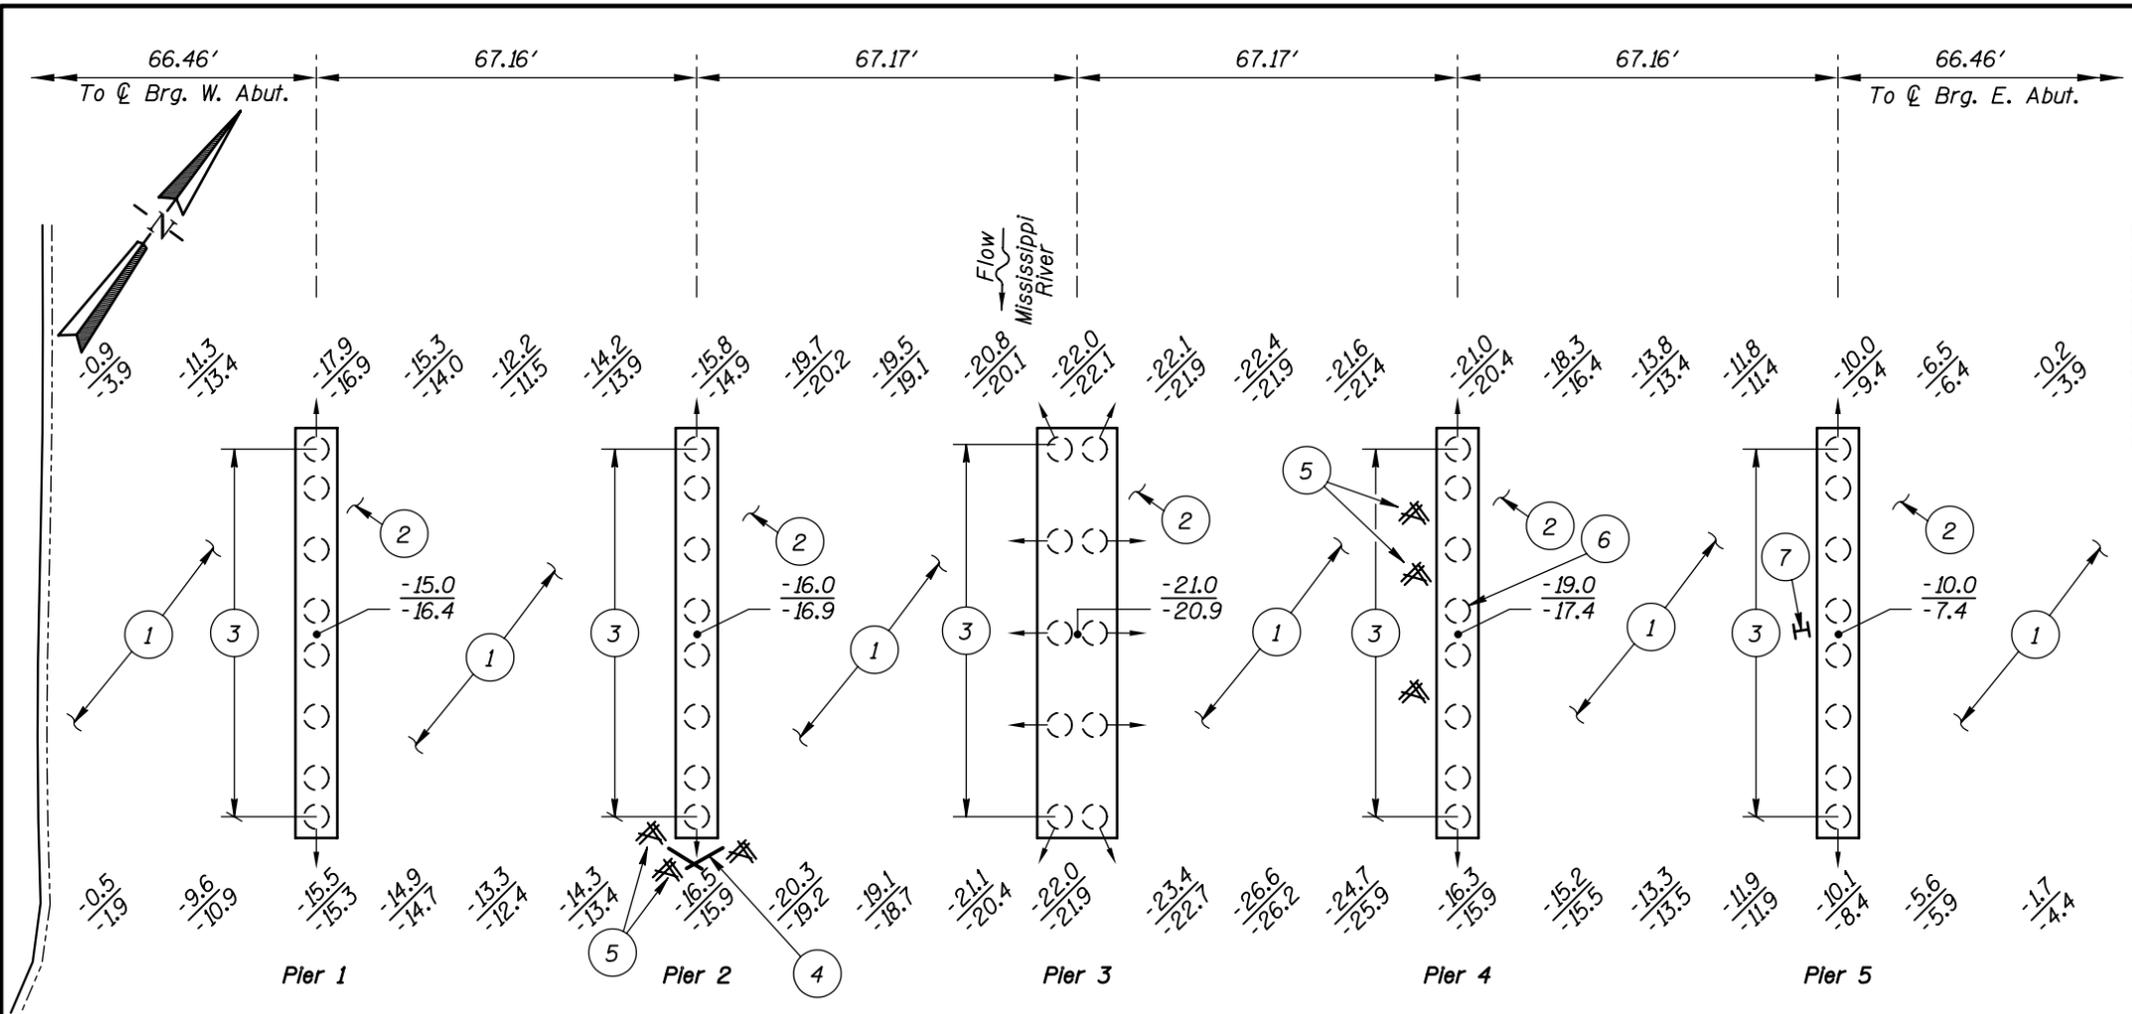
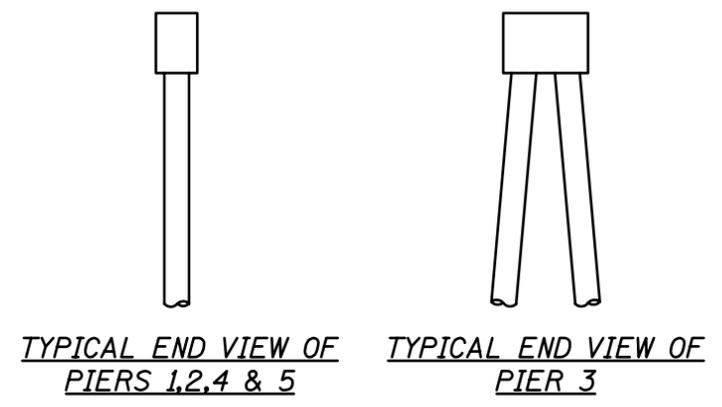
INSPECTION AND SOUNDING PLAN

- Channel bottom consists of soft silty sand with gravel and cobbles, with up to 6 inches of penetration.
- Heavy plant growth and weed accumulation at the upstream third of the piers extending from the waterline to the channel bottom. Random timber debris was also present on the channel bottom between Piers 4 and 5.

- Coating failure, corrosion, and rust nodules, were observed from 6 inches above the waterline to the channel bottom on approximately 80 to 100 percent of the surface area of all piles. Typical penetrations of the rust nodules were 1/32 inch, with infrequent instances of 1/16 inch and 1/8 inch penetration observed on the steel shell piles.

- Large steel plate debris.
- Timber drift consisting of 1 foot diameter and smaller logs observed at the mudline.
- 3/4 inch diameter steel cables were observed to be wrapped around the pile.

- A steel H-pile was sticking 8 feet out of the channel bottom and angled toward the downstream.

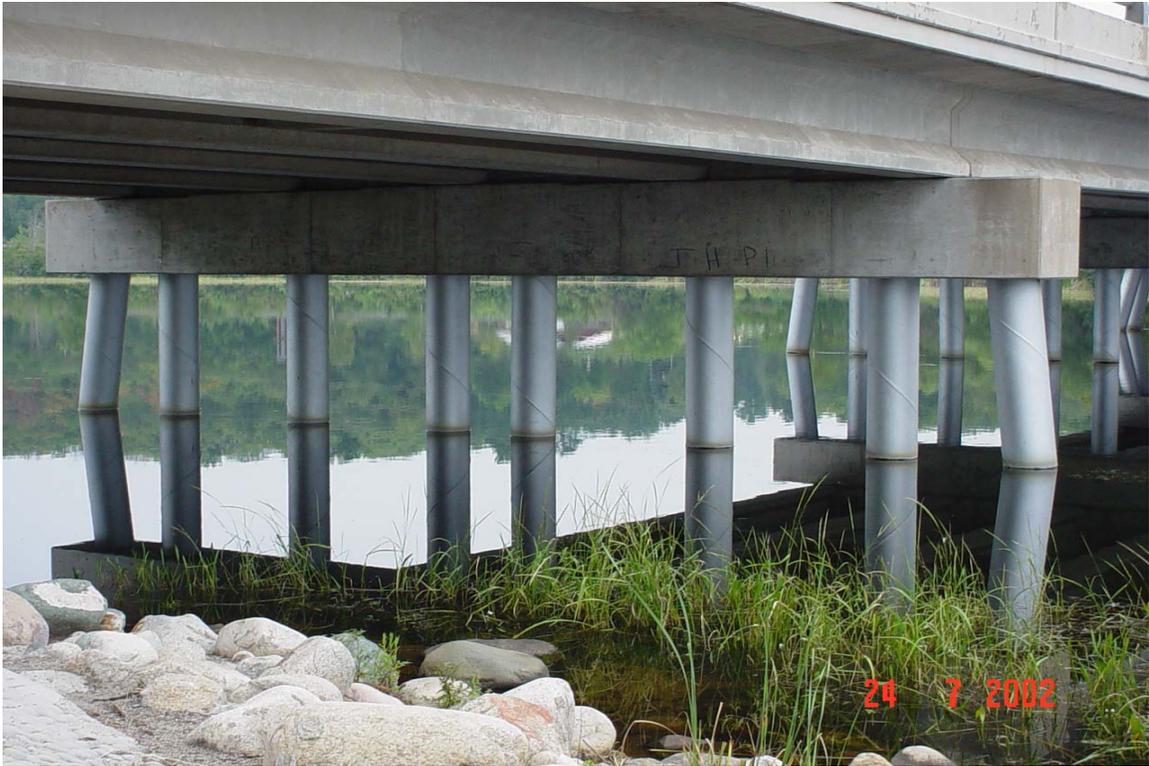
Photograph 2. View of Pier 1, Looking North.

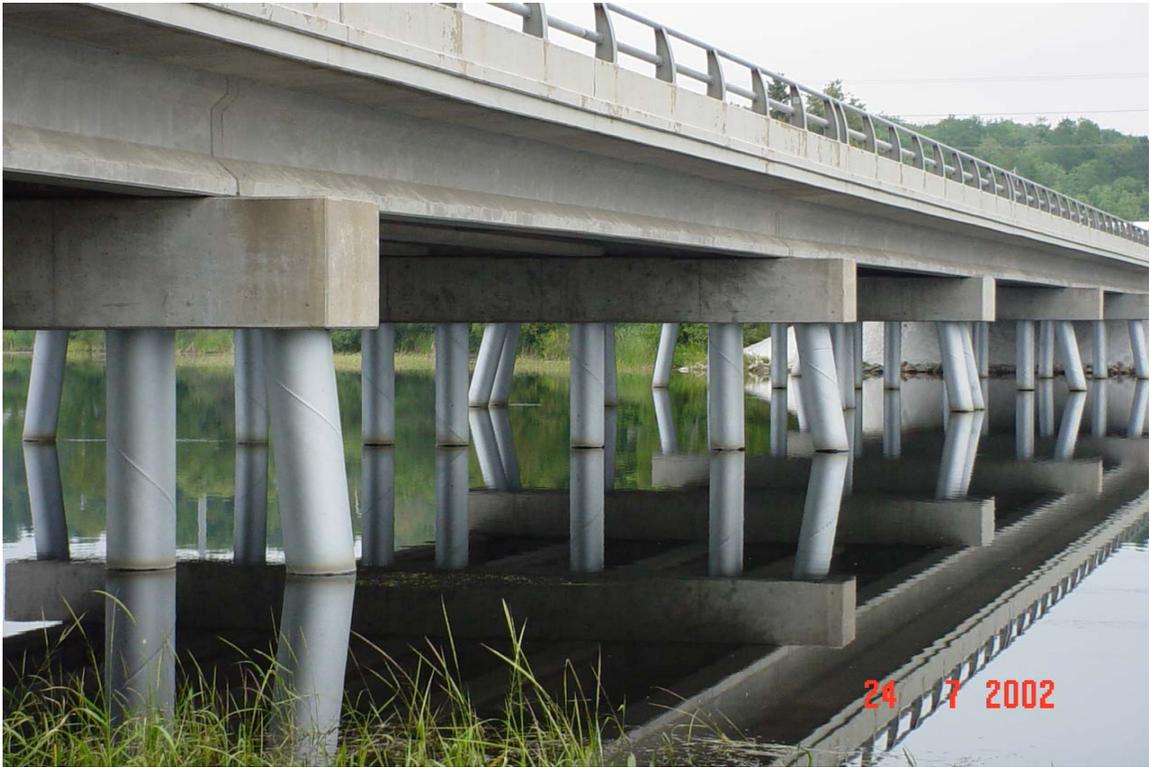
Photograph 3. View of Piers 2, 3, and 4, Looking North.

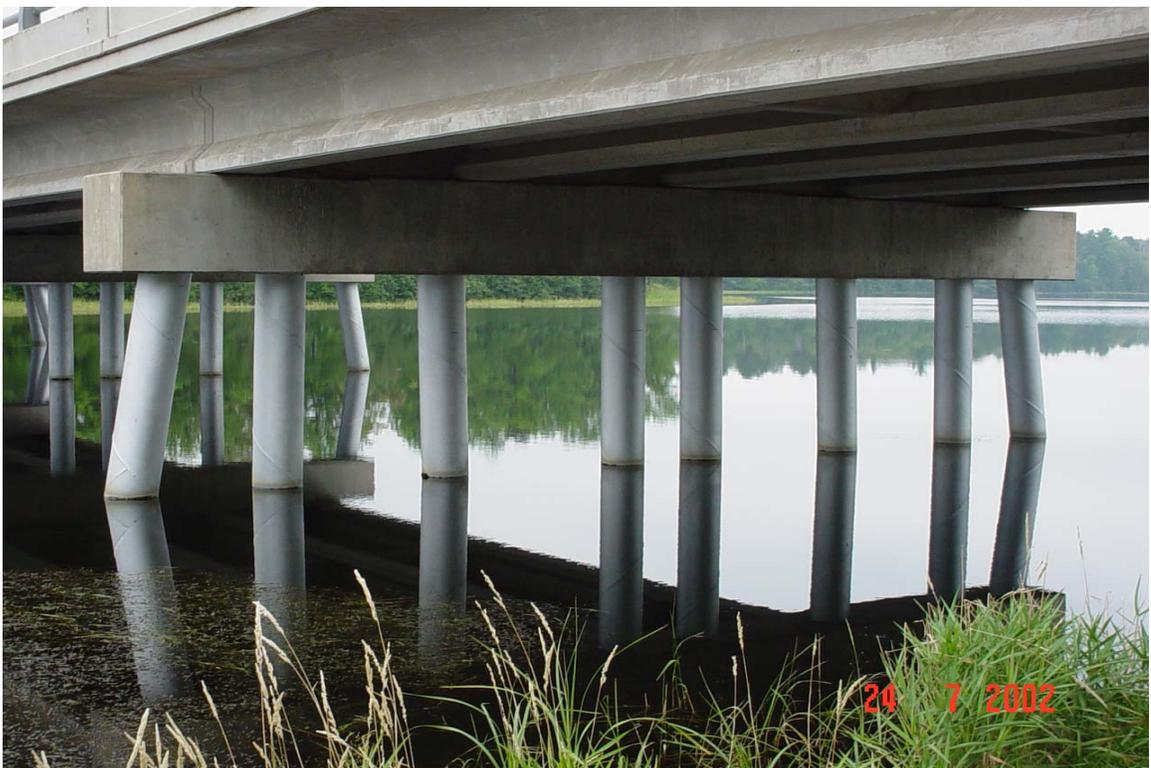
Photograph 4. View of Pier 5, Looking West.
