UNDERWATER BRIDGE INSPECTION REPORT

STRUCTURE NO. 58525
CSAH NO. 46
OVER THE
KETTLE RIVER
DISTRICT 1 - PINE COUNTY

PREPARED FOR THE
MINNESOTA DEPARTMENT OF TRANSPORTATION
BY
COLLINS ENGINEERS, INC.

JOB NO. 5221

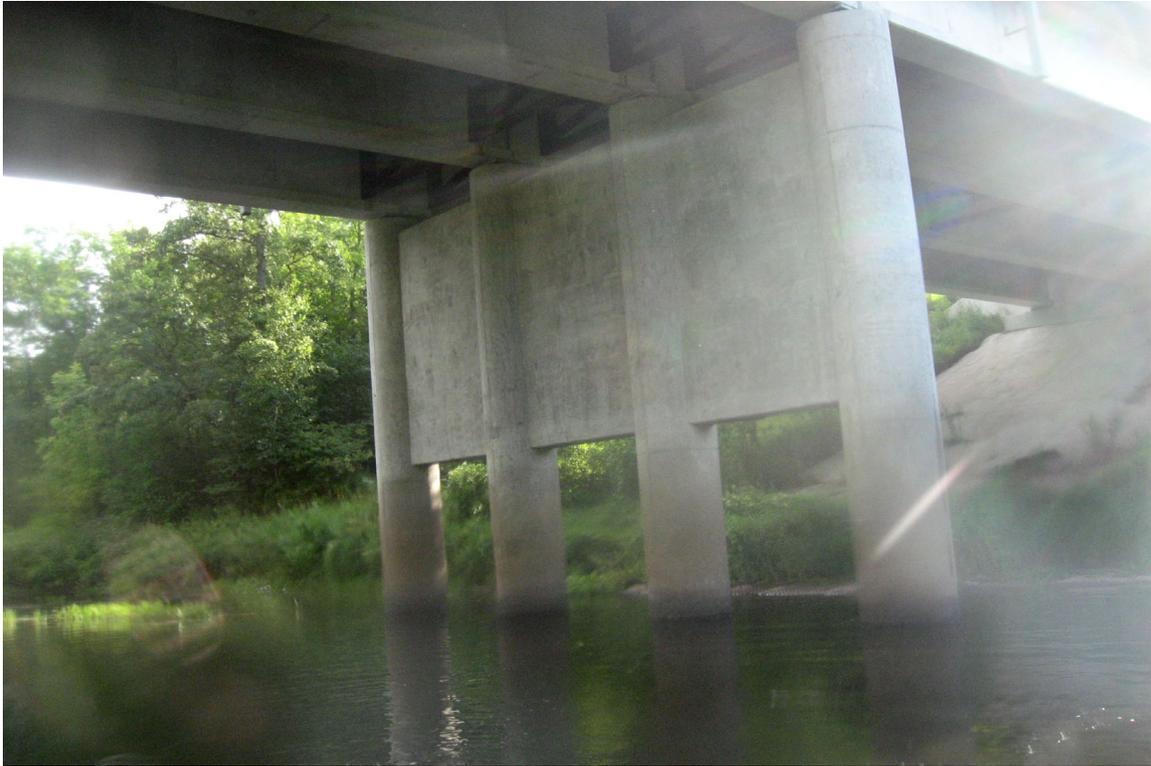
Photograph 1. View of Pier 1, Looking Southwest.

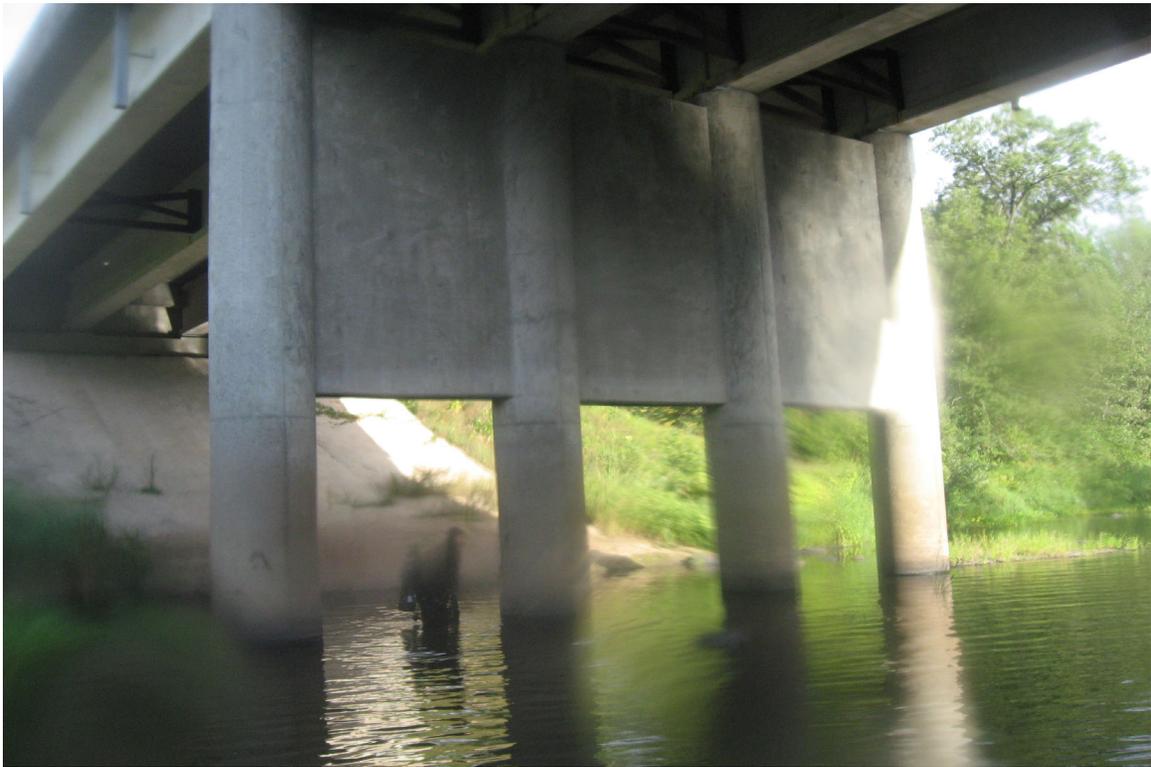
Photograph 2. View of Pier 2, Looking Southeast.

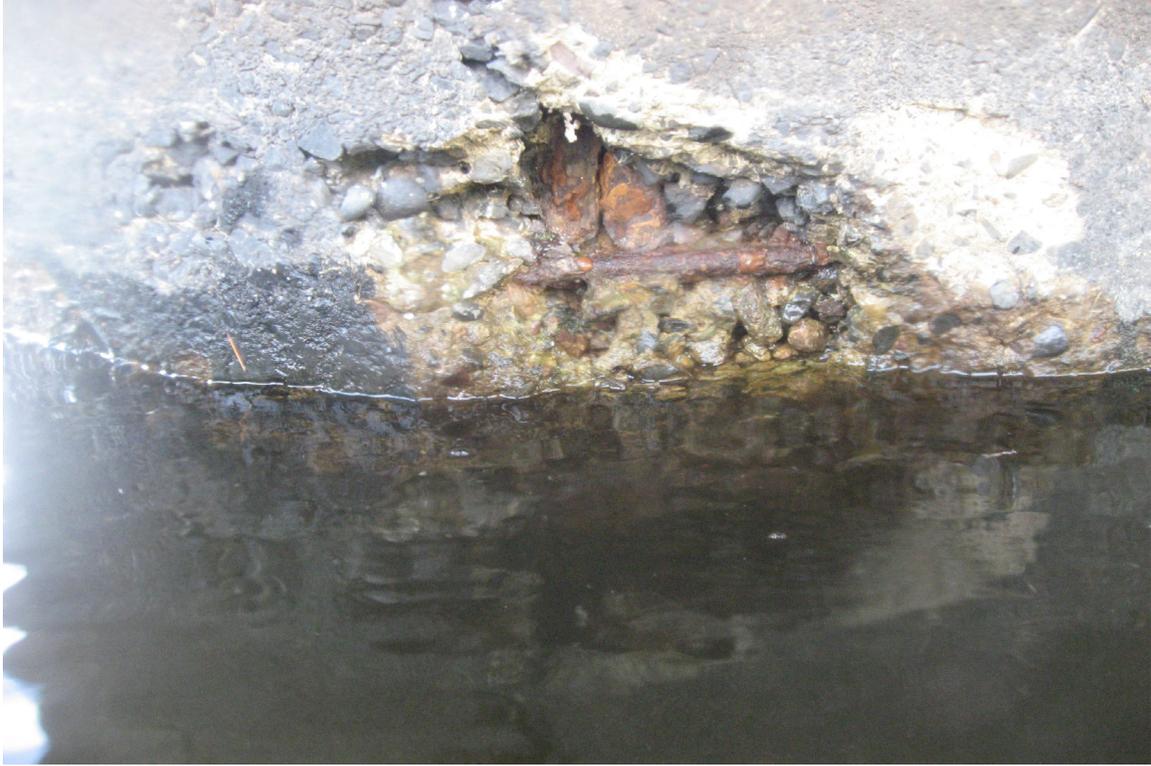
- (D) An area of poorly consolidated concrete was observed 3 feet above the waterline and measured 2 foot high by 1 foot wide with up to 1.5 inches of penetration at both upstream and downstream ends of the second column from the upstream end of Pier 2.

- (E) Two areas of poorly consolidated concrete and section loss with reinforcing steel exposed and 2 to 3 inches of penetration were observed at the second column from the downstream end of Pier 2 at the waterline.

Photograph 3. View of Typical area of poor consolidation and exposed reinforcing steel on the second column from the upstream end of Pier 2, Looking North.

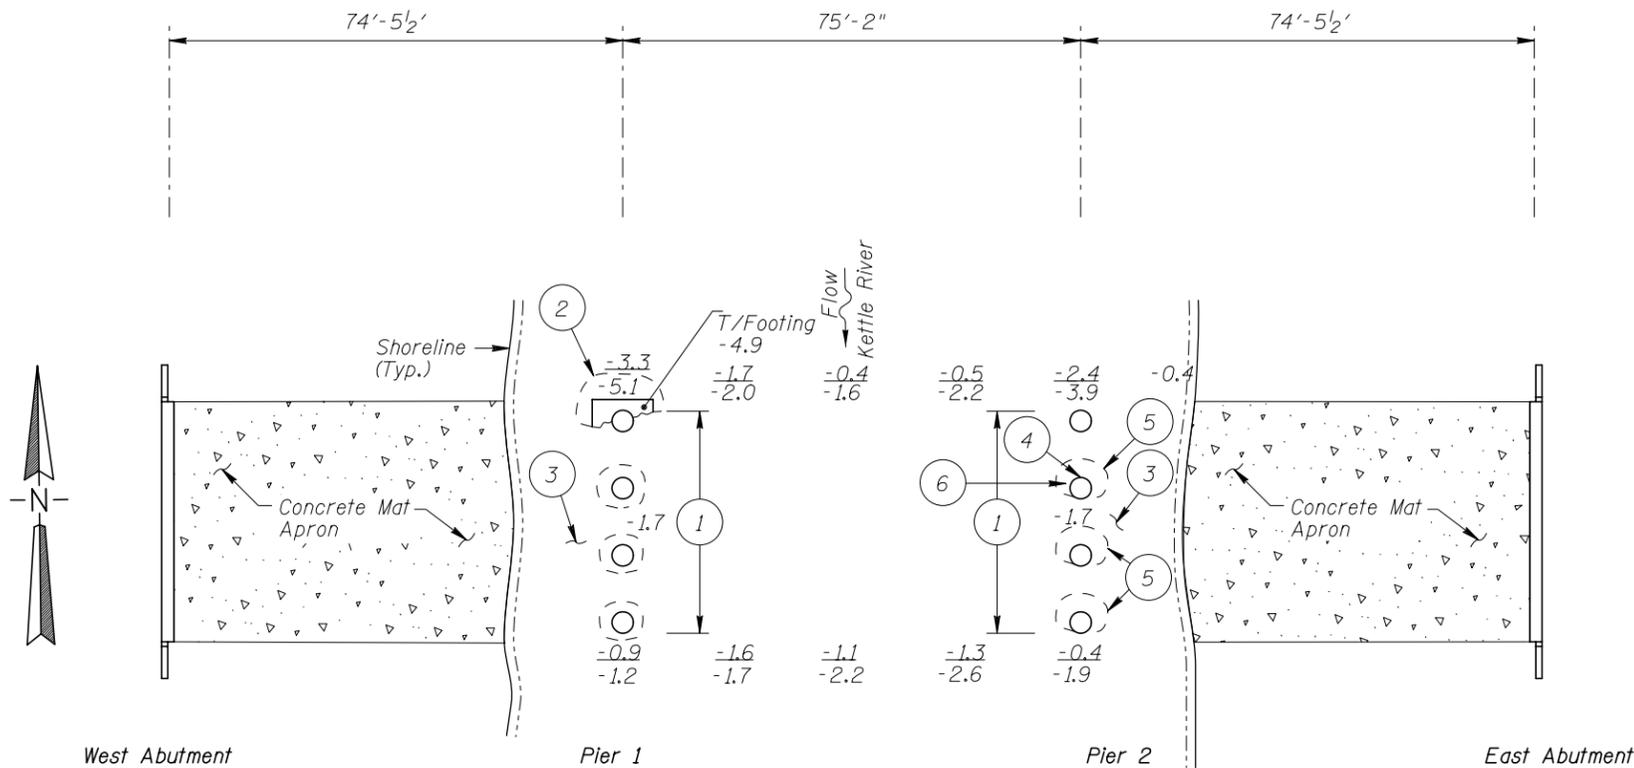
INSPECTION AND SOUNDING PLAN

- 1 The concrete columns exhibited moderate scaling from 1 foot above the waterline to 1 foot below the waterline with up to 1/2 inch penetrations.
- 2 A scour depression, measuring 3 feet in radius and 1 foot deep, was observed at the upstream end of Pier 1. The scour depression has exposed the top of the footing at the upstream end of the pier with no vertical face exposure.

- 3 The channel bottom consisted of sandy gravel with cobbles up to 6 inches in diameter.
- 4 An area of poorly consolidated concrete was observed 3 feet above the waterline and measured 2 foot high by 1 foot wide with up to 1.5 inches of penetration at both upstream and downstream ends of the 2nd column from upstream end of Pier 2.

- 5 Scour depressions, measuring up to 2 feet in radius and up to 1 foot deep, were observed at each of the three downstream columns of Pier 1 and 2.
- 6 An area of poorly consolidated concrete and section loss was observed at waterline, 9 inches in diameter with 3 inch maximum penetration at the upstream end of second the column from upstream end of Pier 2. Also at waterline, an area of poorly consolidated concrete and section loss 1 foot high by 2.5 feet wide with 2 inch maximum penetration was observed at the downstream end of the second column from upstream end of Pier 2. Reinforcing steel was exposed in both places.
