UNDERWATER BRIDGE INSPECTION REPORT

STRUCTURE NO. 58520

KETTLE RIVER

MINNESOTA DEPARTMENT OF TRANSPORTATION
UNDERWATER BRIDGE INSPECTION

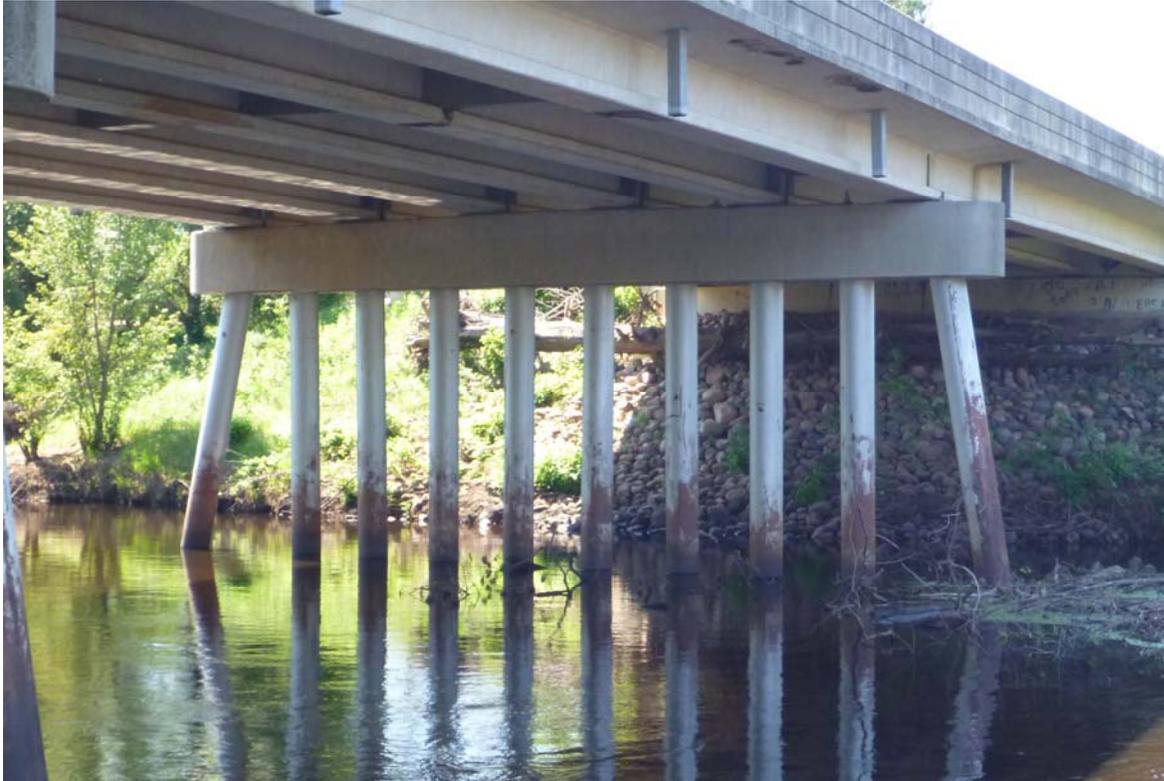
Photograph 2. View of Pier 1, Looking South.

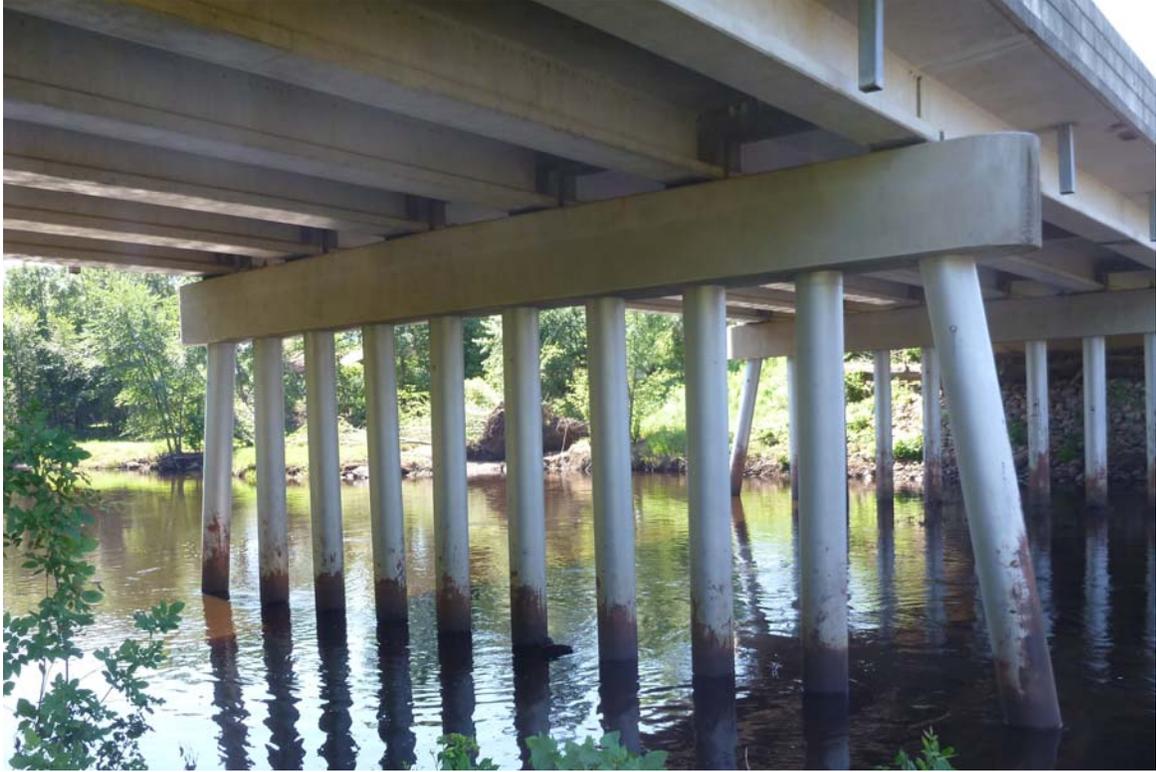
Photograph 3. View of Pier 2, Looking South.

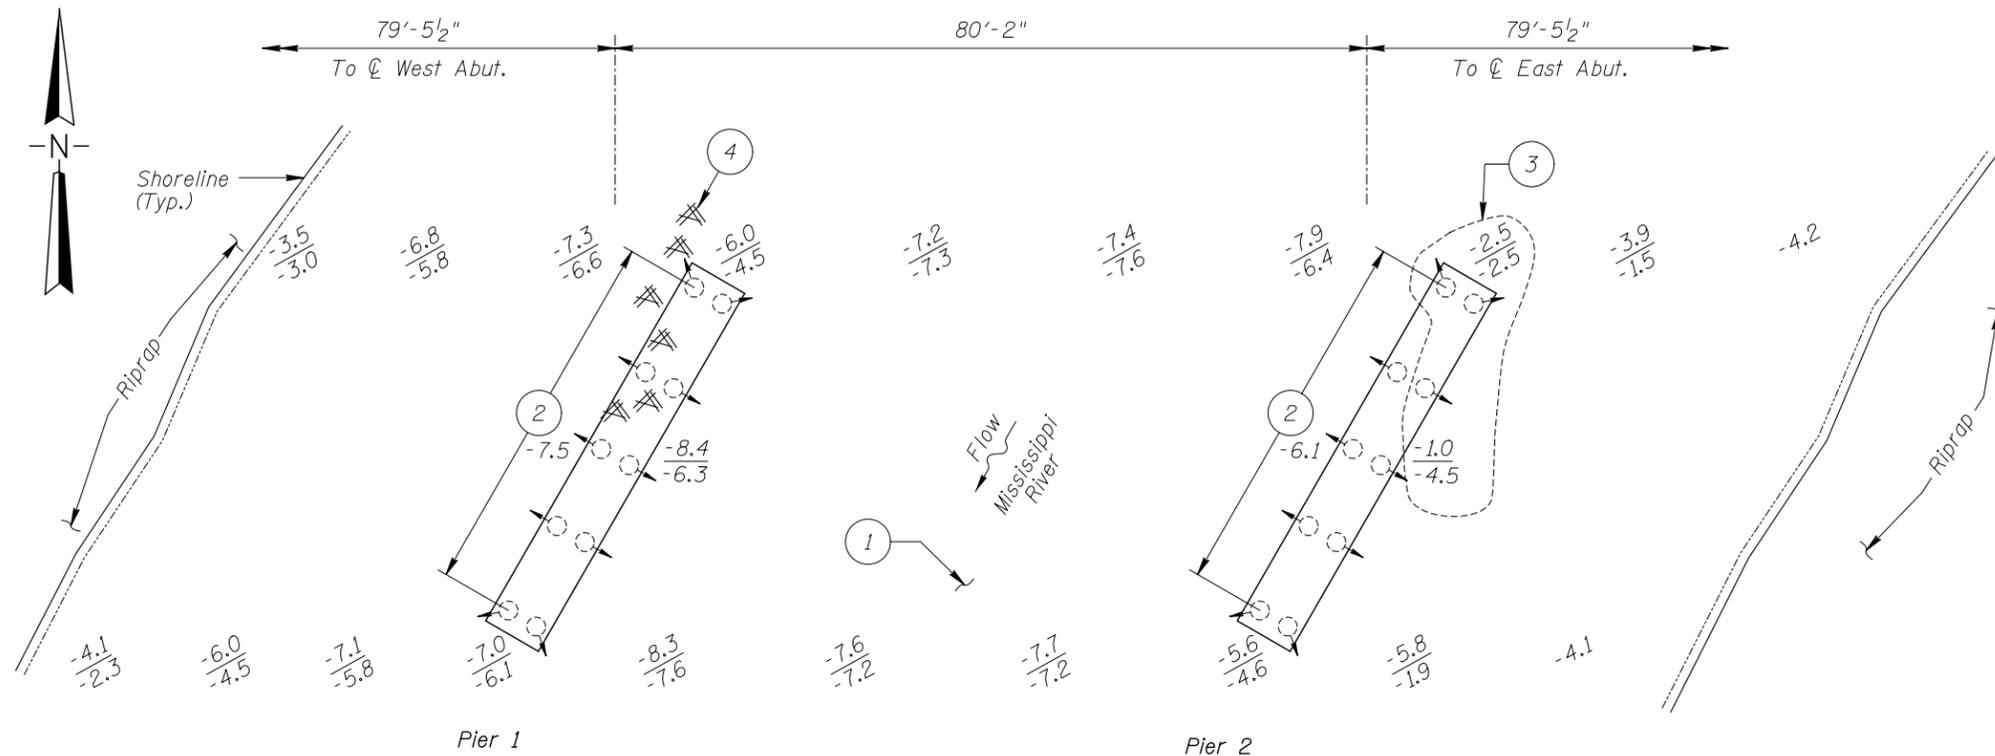
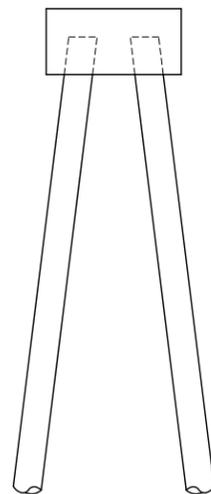
SOUNDING PLAN

- 1 The channel bottom material typically consisted of firm sandy gravel with scattered 6 inch cobbles and a maximum probe rod penetration of approximately 2 inches.

- 2 All piles exhibited coating failure, corrosion, and rust nodules covering 50 to 100 percent of the surface area, from 3 feet above the waterline to the channel bottom. The heaviest corrosion (+/- 100 percent) was located from 3 feet above to 2 feet below the waterline with random pitting up to 1/32 inch deep.

- 3 There was a moderate accumulation of silted in aquatics/organics and small branchy material, approximately 4 to 5 feet high allowing a maximum probe rod penetration of 1 foot, mounded up at the upstream end and upstream half of the east face of Pier 2 extending from approximately 1 to 2.5 feet below the waterline to the channel bottom.

- 4 A 6 inch diameter tree trunk with branches was observed at the upstream end of Pier 1 and extended from the channel bottom to the waterline.

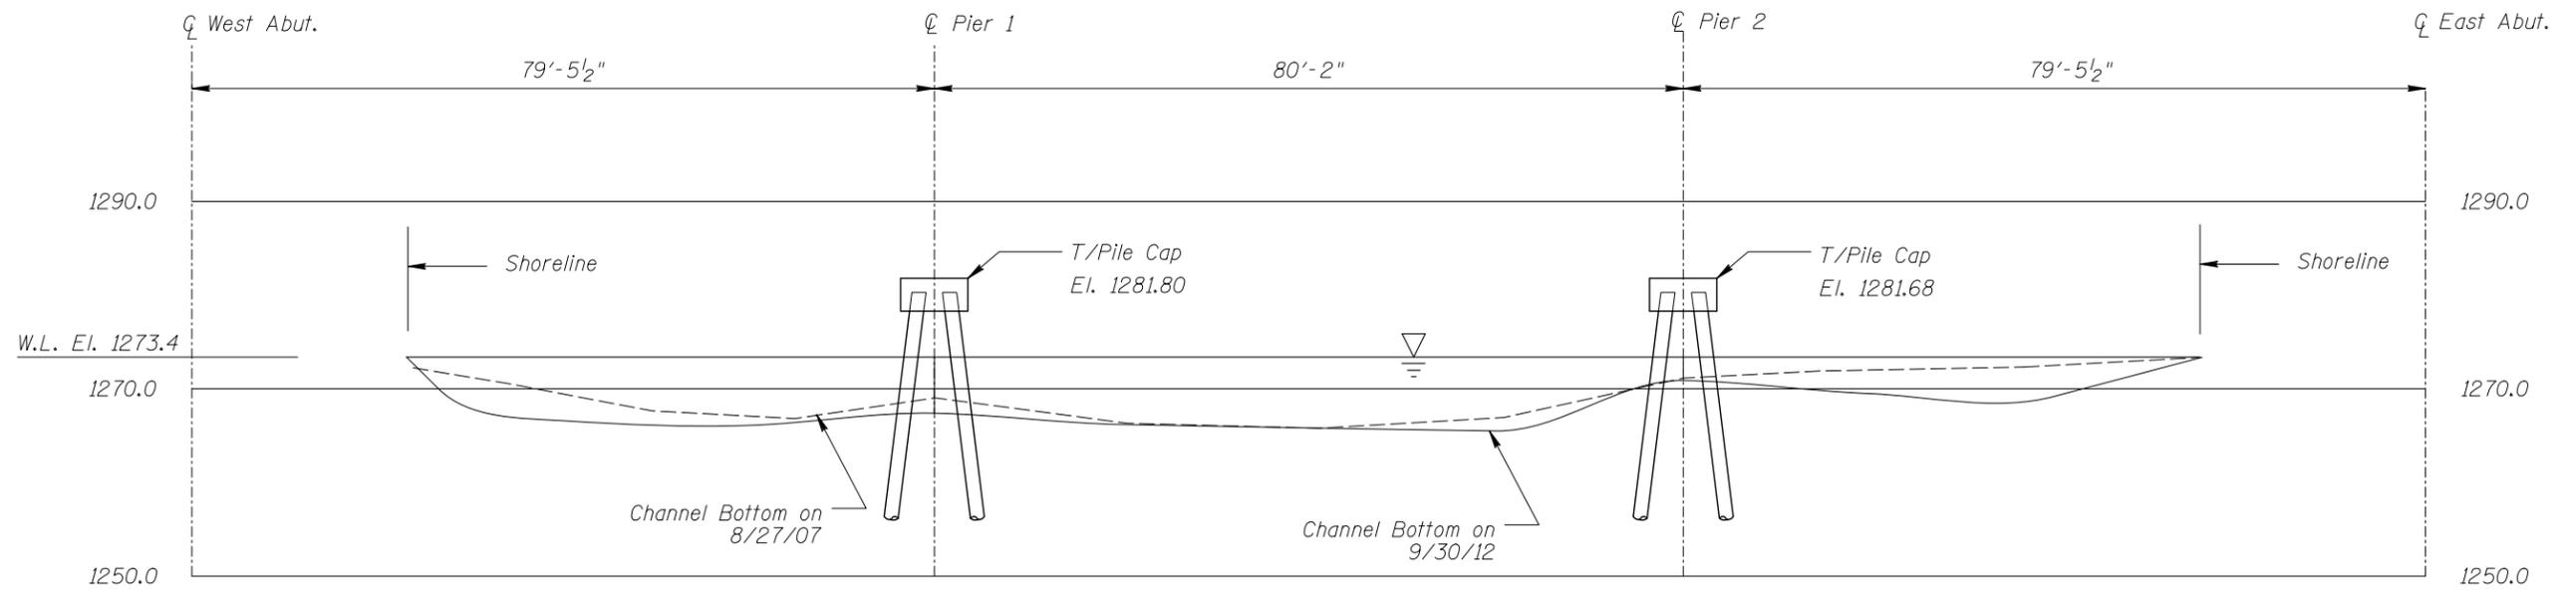
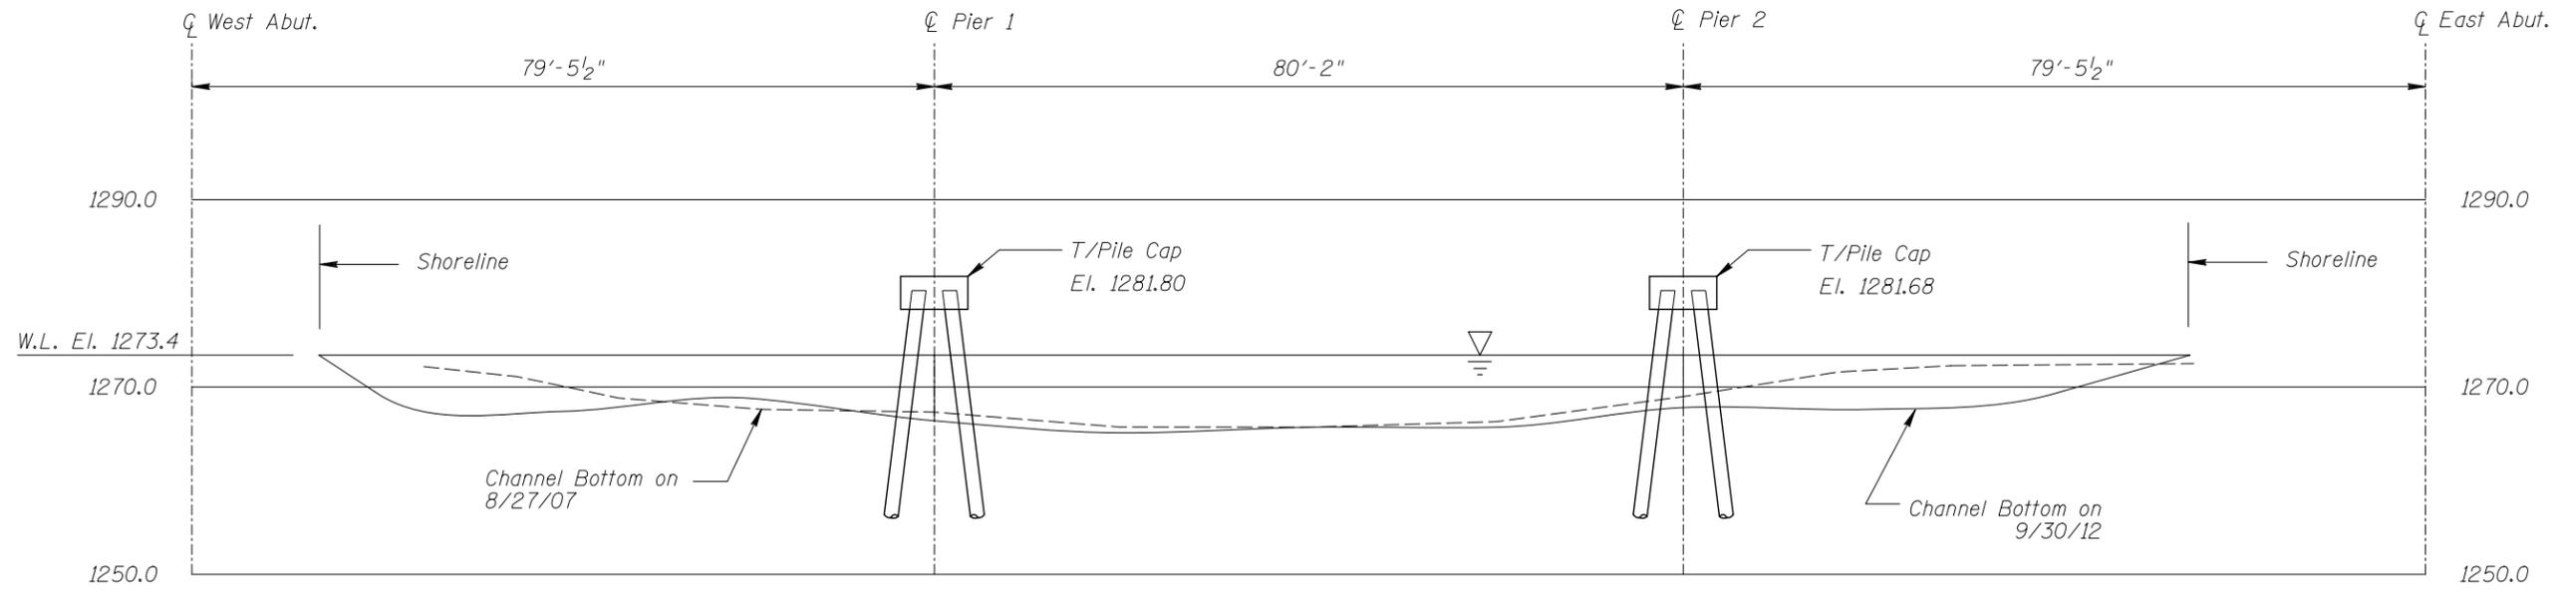
UPSTREAM FASCIA PROFILE

The substructure units inspected at Bridge No. 58520, Piers 1 and 2, were found to be generally in good to satisfactory condition with no structurally significant defects observed. The steel piles exhibited coating failure with light surface corrosion and some minor pitting. A moderate accumulation of timber debris was observed at the upstream end of Pier 1, and along the south side of Pier 2. The comparison of soundings to the pervious underwater inspection show evidence of general minor channel bottom degradation within the channel between the two piers, as the channel bottom profile appeared to be 2 to 3 feet lower. See Figure 2 for upstream and downstream fascia profiles.
