UNDERWATER BRIDGE INSPECTION REPORT

STRUCTURE NO. 69J13

RAILROAD STREET

STORM SEWER

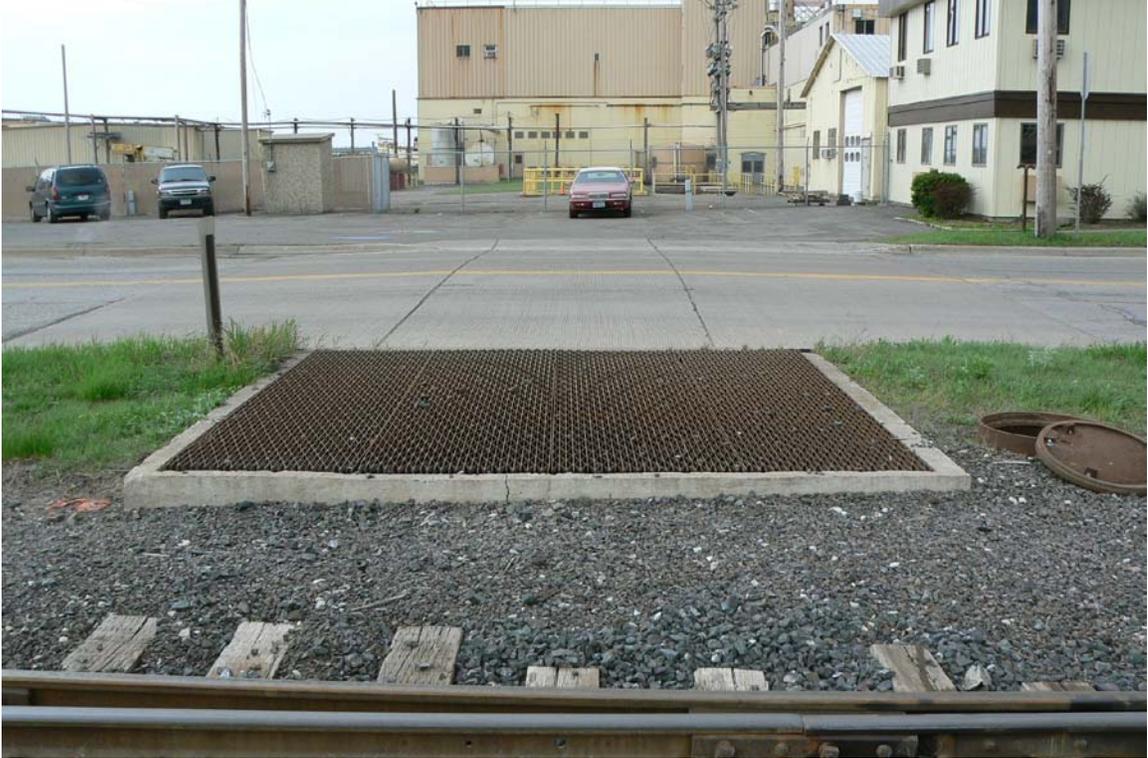
Photograph 1. View of Roadway Above Culvert and Grating Covering Culvert Opening, Looking East.

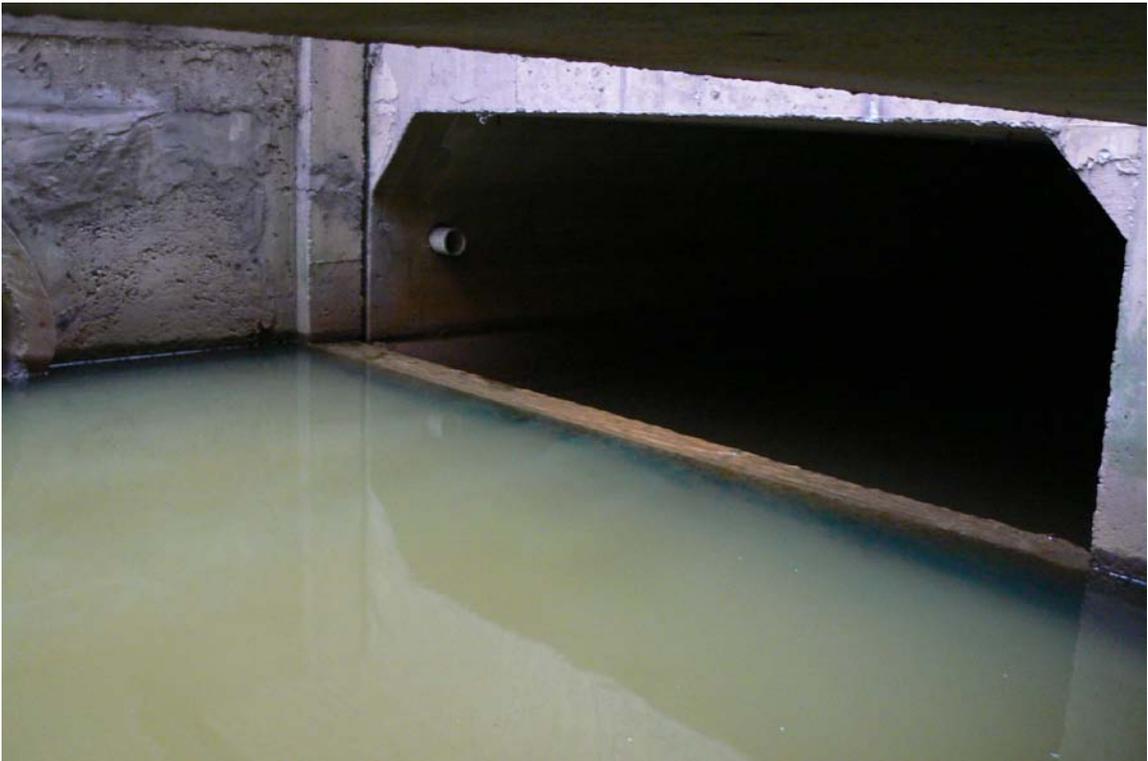
Photograph 2. View of Upstream End of Culvert, Looking Northeast.

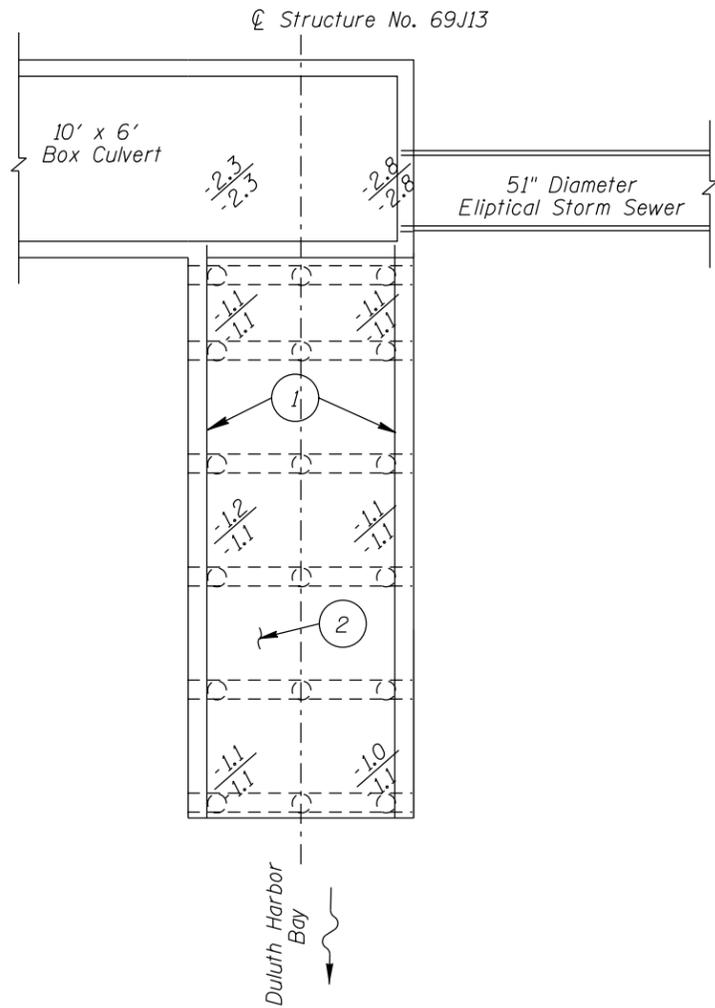
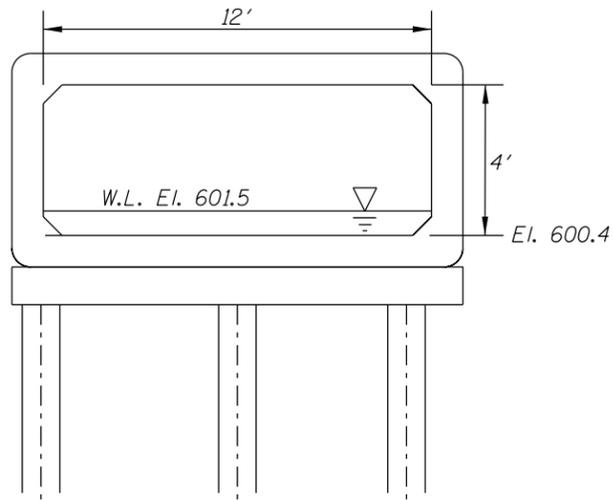
SOUNDING PLAN

1. The concrete was smooth and sound with no notable deterioration. The joints between culvert segments exhibited 1/4- to 1-inch-wide gaps (at tongue and groove arrangement with no complete separations of joints) and up to 1/2 inch differentials between faces across joints.
2. A 6-inch-thick layer of soft silt covered most of the concrete floor of the culvert.
