UNDERWATER BRIDGE INSPECTION REPORT

STRUCTURE NO. 7635

CSAH 4

BEAVER RIVER

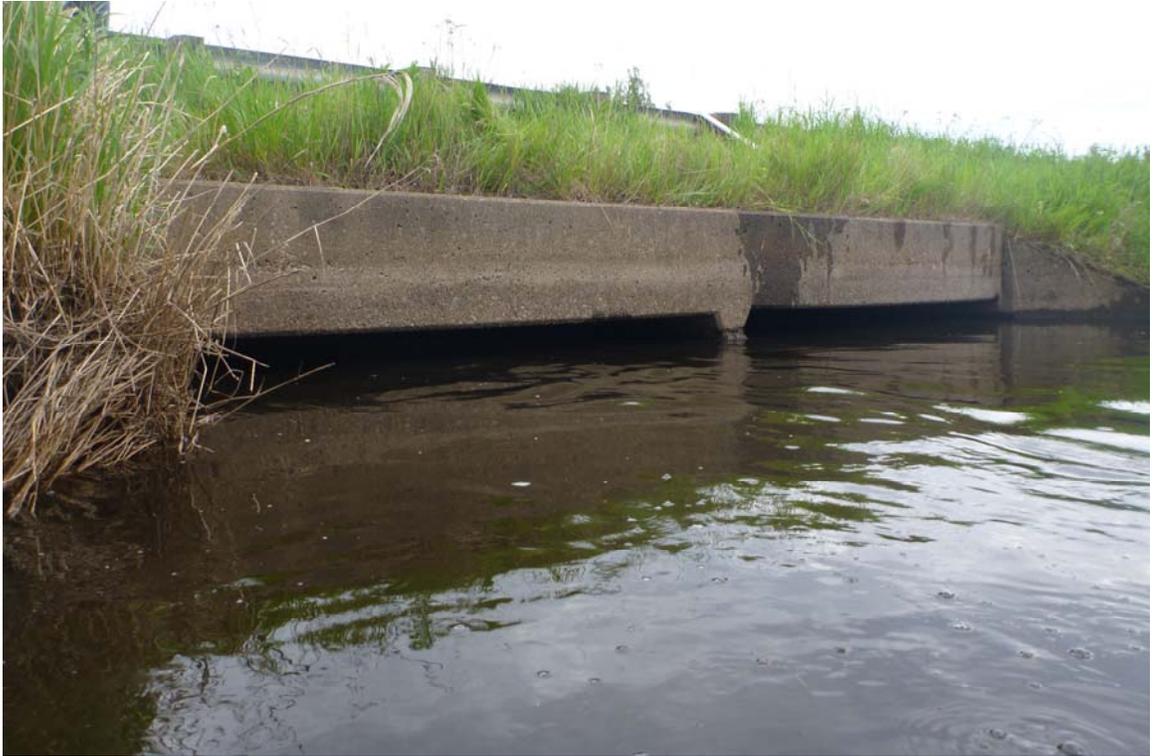
Photograph 1. View of the Upstream headwall, Looking Northeast.

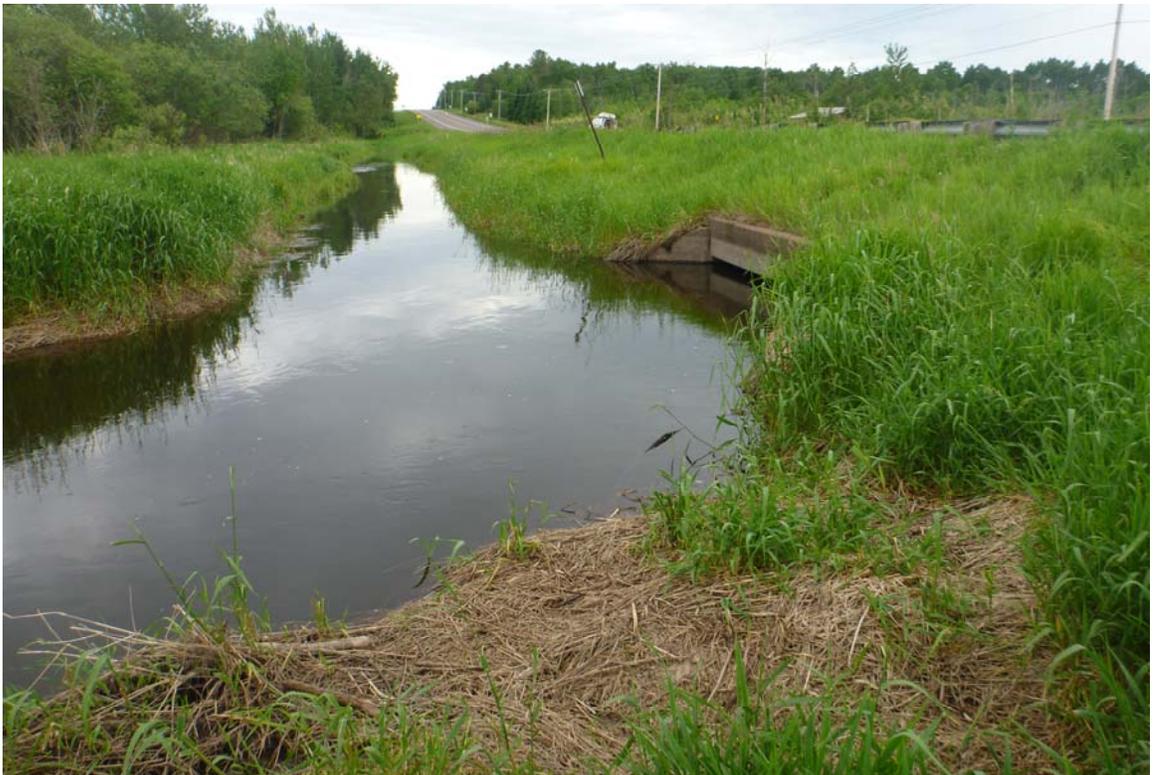
Photograph 2. View of the Downstream Headwall, Looking Southeast.

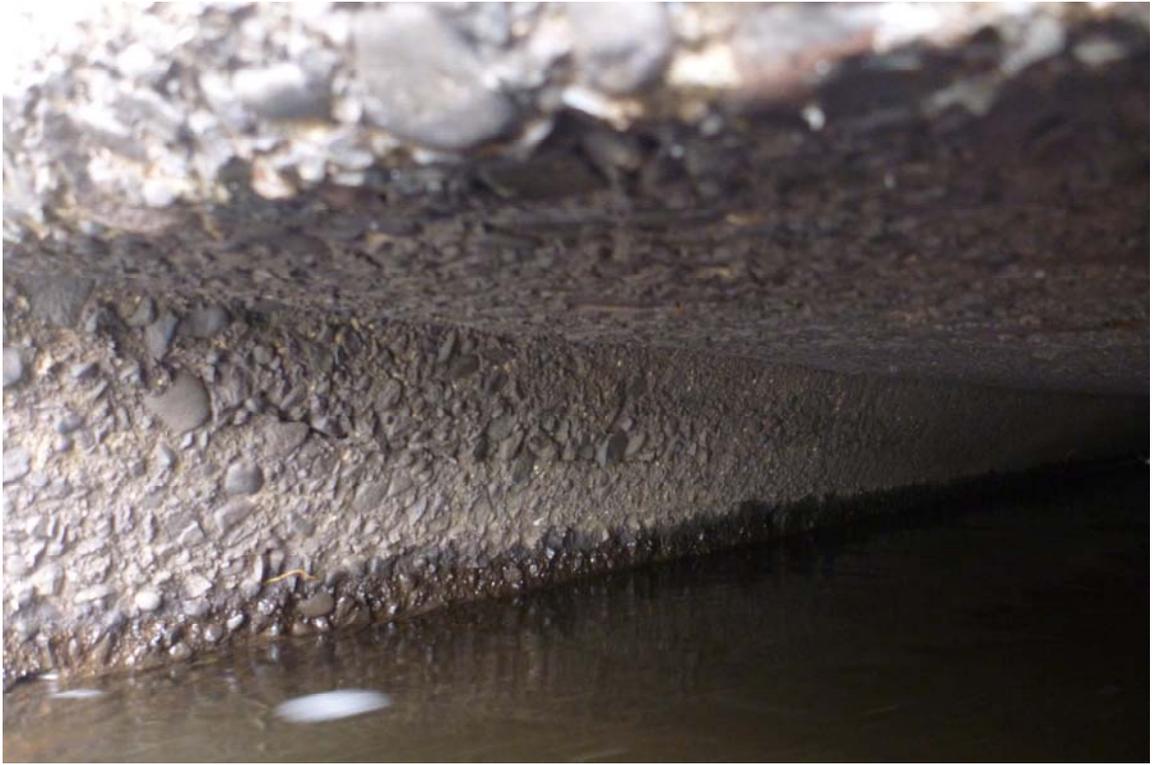
- (A) The concrete of the culvert was typically sound with no significant defects or loss of section.
- (B) Light to moderate scaling was observed on the culvert walls extending from 1 foot below the waterline to the culvert ceiling and on the entire ceiling with a typical penetration of 1/4 inch and a maximum penetration of 1/2 inch.

Photograph 3. View of Typical Scaling at the West Wall of Box 1, Looking West.

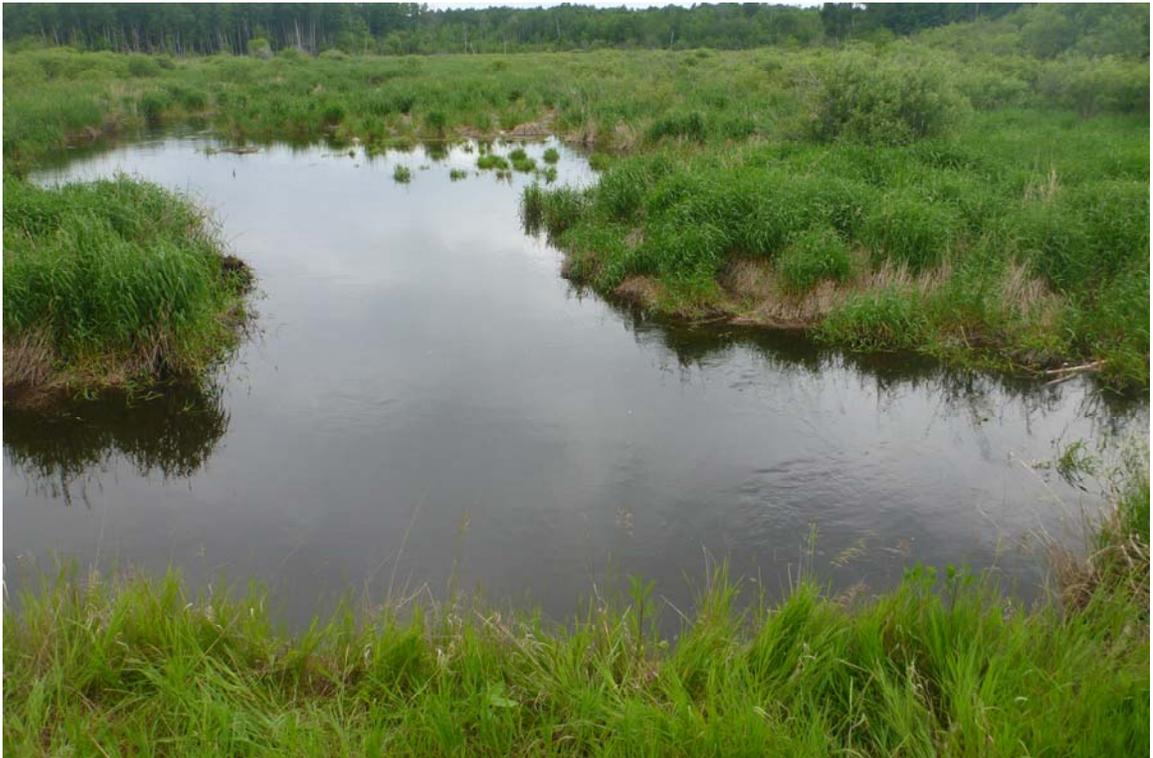
- (E) The channel bottom material upstream of the structure consisted of a firm mixture of sand and gravel with up to 6 inch diameter cobbles allowing no probe rod penetration.

Photograph 4. View of Upstream Channel, Looking South.

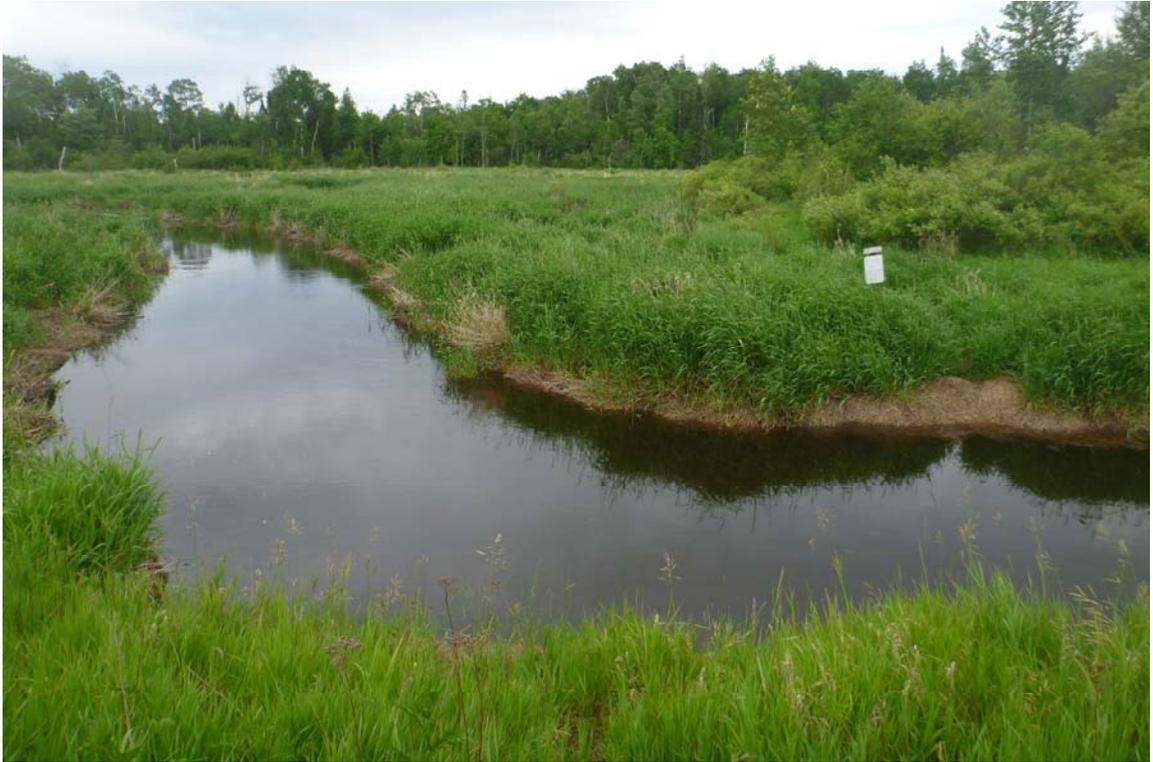
- (F) The channel bottom material downstream of the structure consisted of sandy gravel allowing up to 2 inches of probe rod penetration.

Photograph 5. View of Downstream Channel, Looking North.

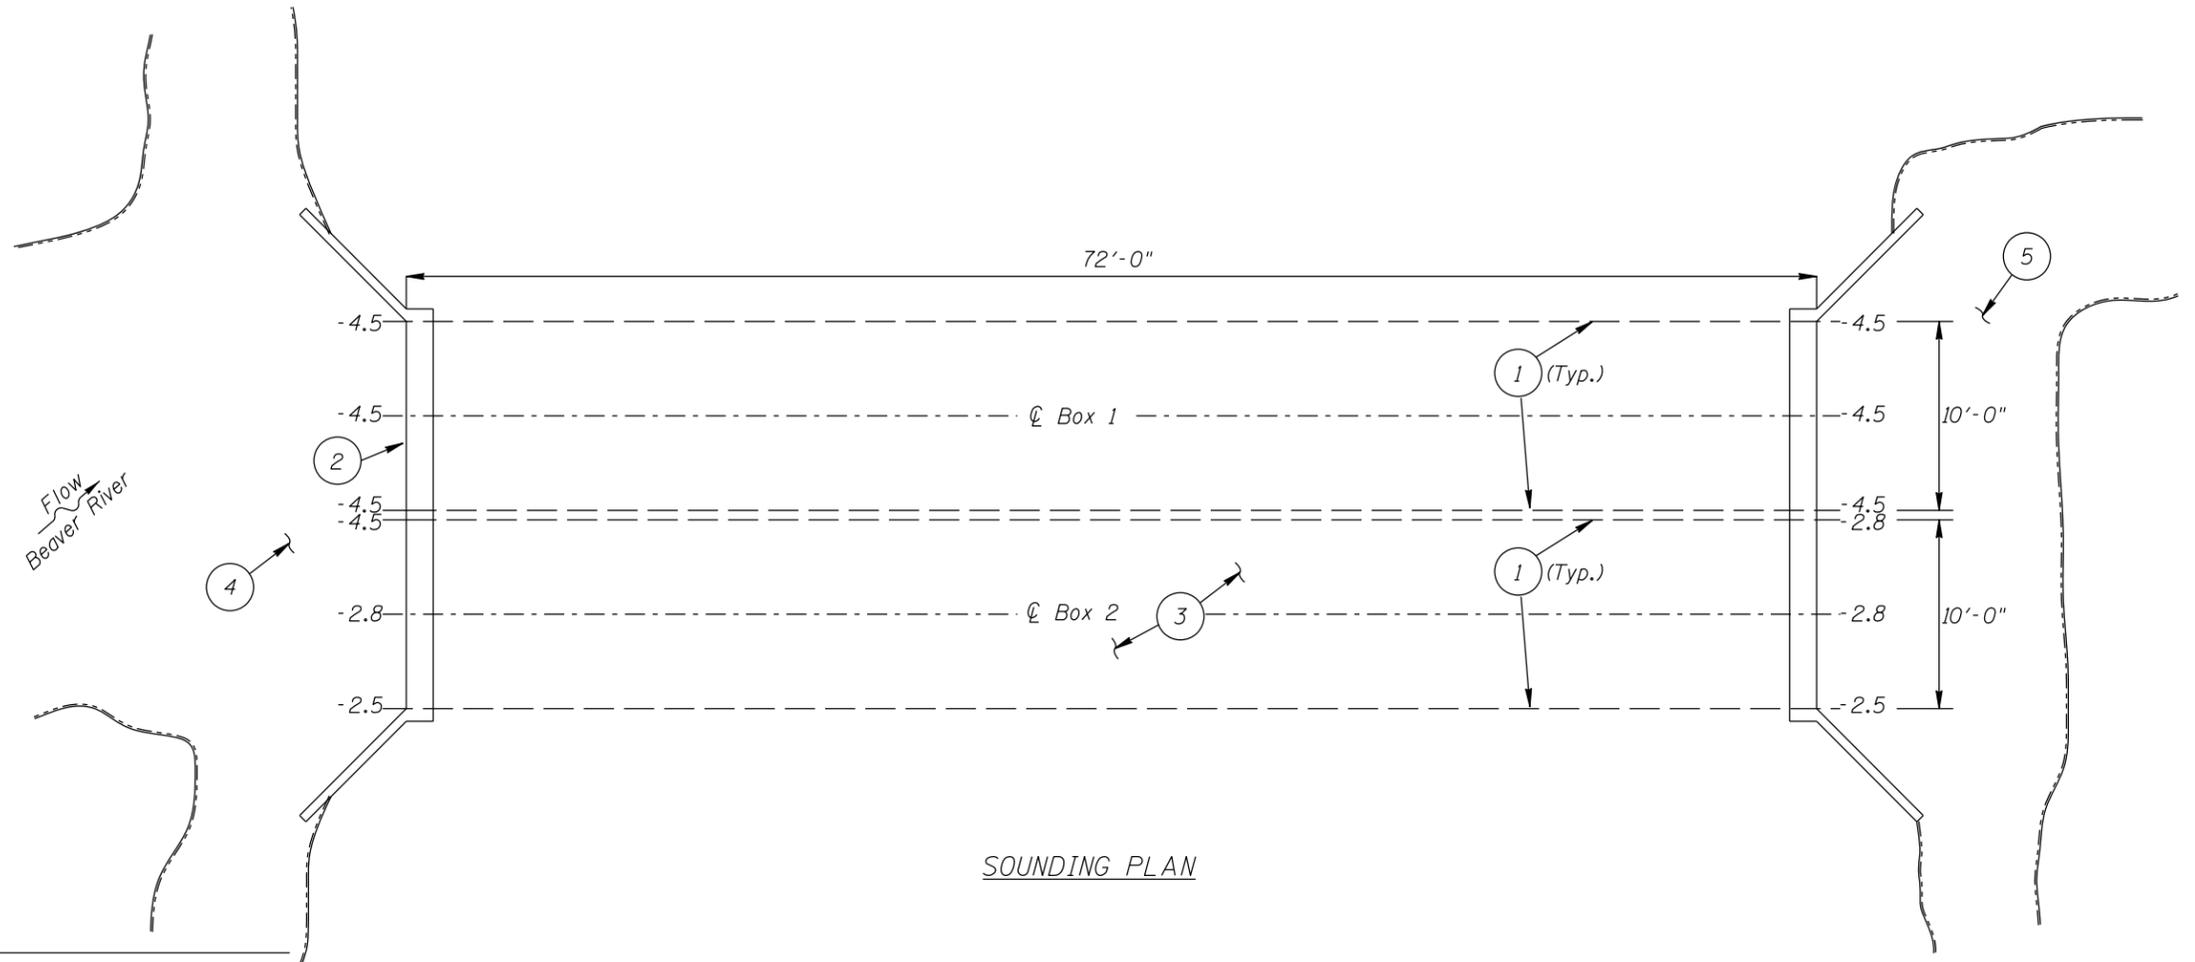
SOUNDING PLAN

- 1 Light to moderate scaling was observed on the culvert walls extending from 1 foot below the waterline to the culvert ceiling and on the entire ceiling with a typical penetration of 1/4 inch and a maximum penetration of 1/2 inch.

- 2 The concrete floor was exposed in Box 1 along the entire length of the culvert box. The culvert apron was exposed along Box 1 at the upstream opening of the culvert with up to 6 inches of apron toe vertical exposure. No undermining was observed at the upstream toe.

- 3 The eastern half of the box 2 culvert floor was typically covered by a approximately 2 feet thick layer of soft silty infill accumulation with typical probe rod penetration of 1 foot. A light timber drift accumulation was scattered throughout the box consisting of 3 inch diameter and smaller branches.

- 4 The channel bottom material upstream of the structure consisted of a firm mixture of sand and gravel with up to 6 inch diameter cobbles allowing no probe rod penetration.

- 5 The channel bottom material downstream of the structure consisted of sandy gravel allowing up to 2 inches of probe rod penetration.
