UNDERWATER BRIDGE INSPECTION REPORT

STRUCTURE NO. 7799

CR NO. 547

WOLF CREEK

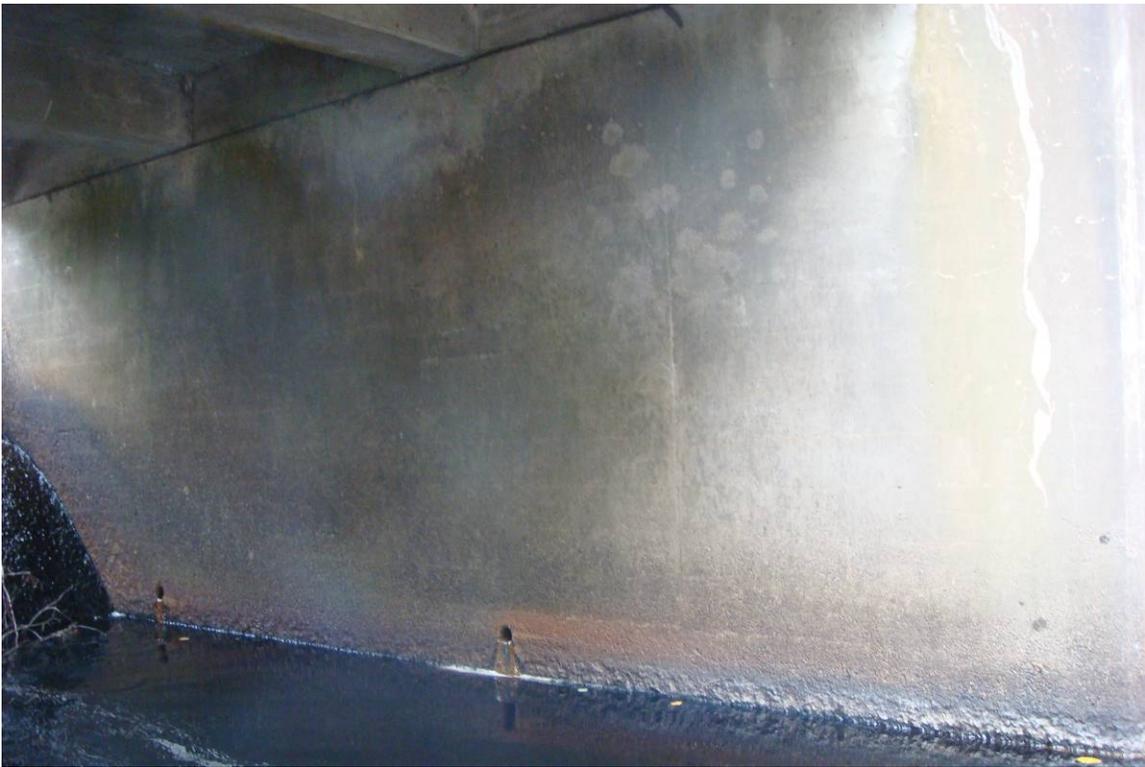
Photograph 2. View of the East Abutment, Looking Northeast.

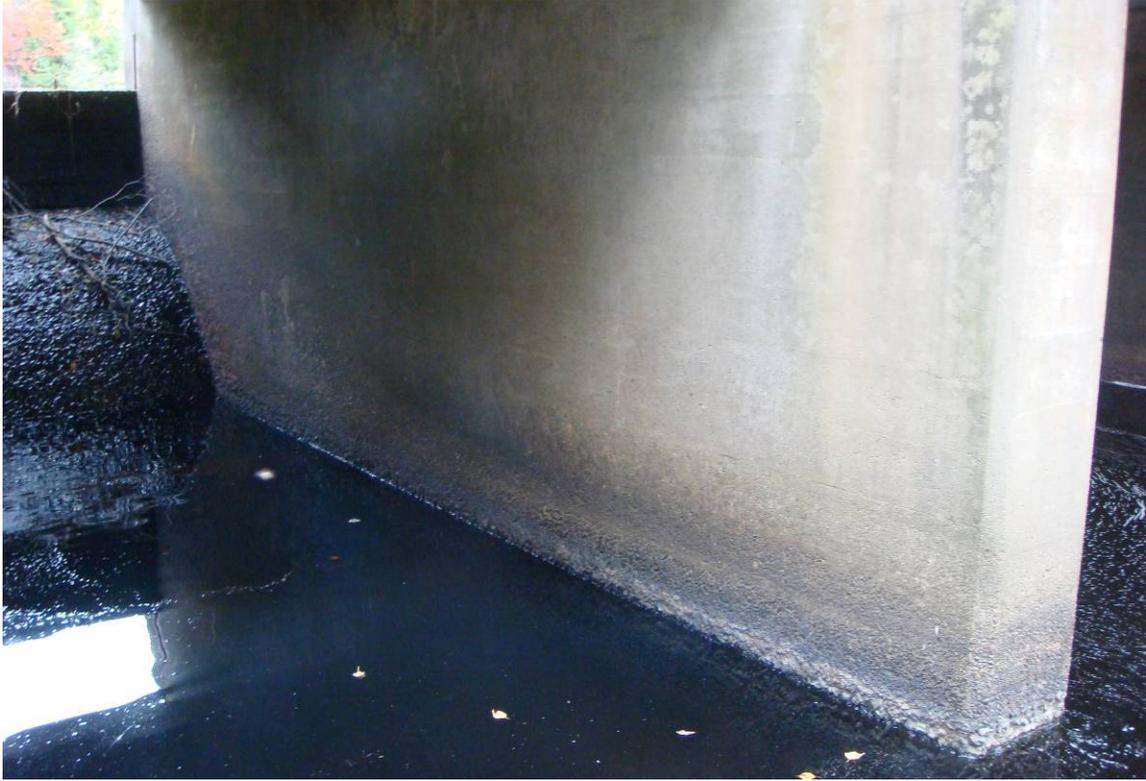
Photograph 3. View of the Center Pier, Looking Northeast.

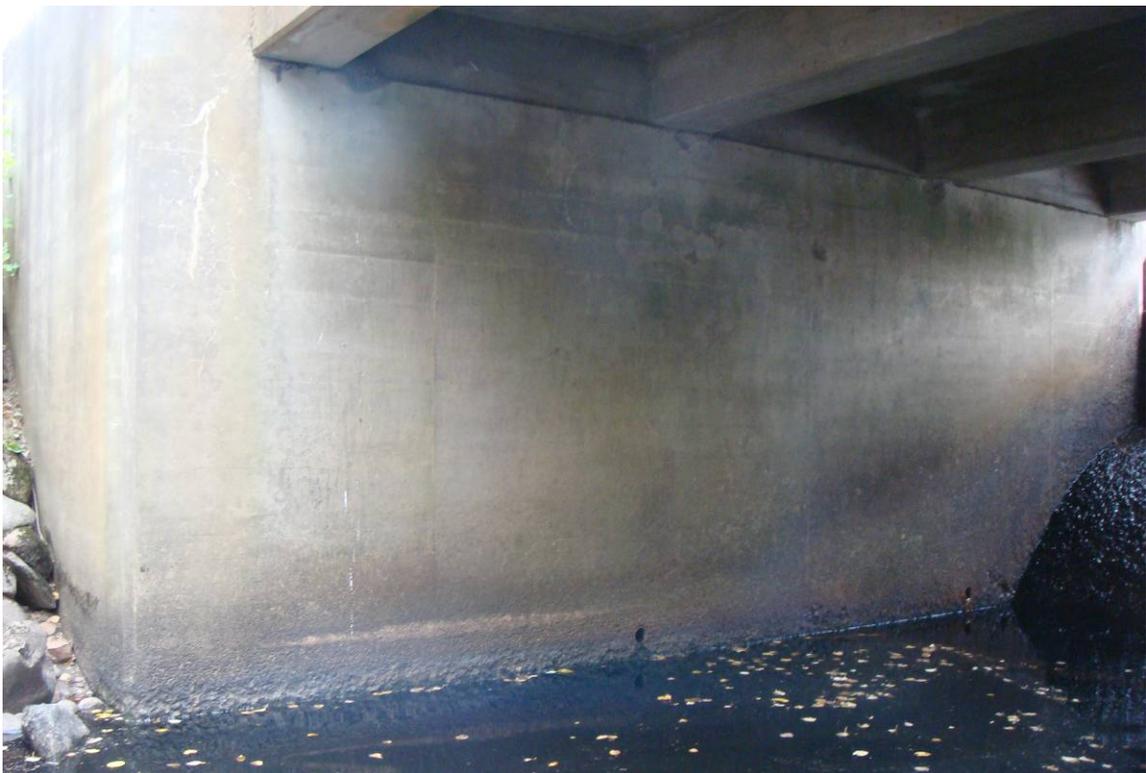
Photograph 4. View of the West Abutment, Looking Northwest.

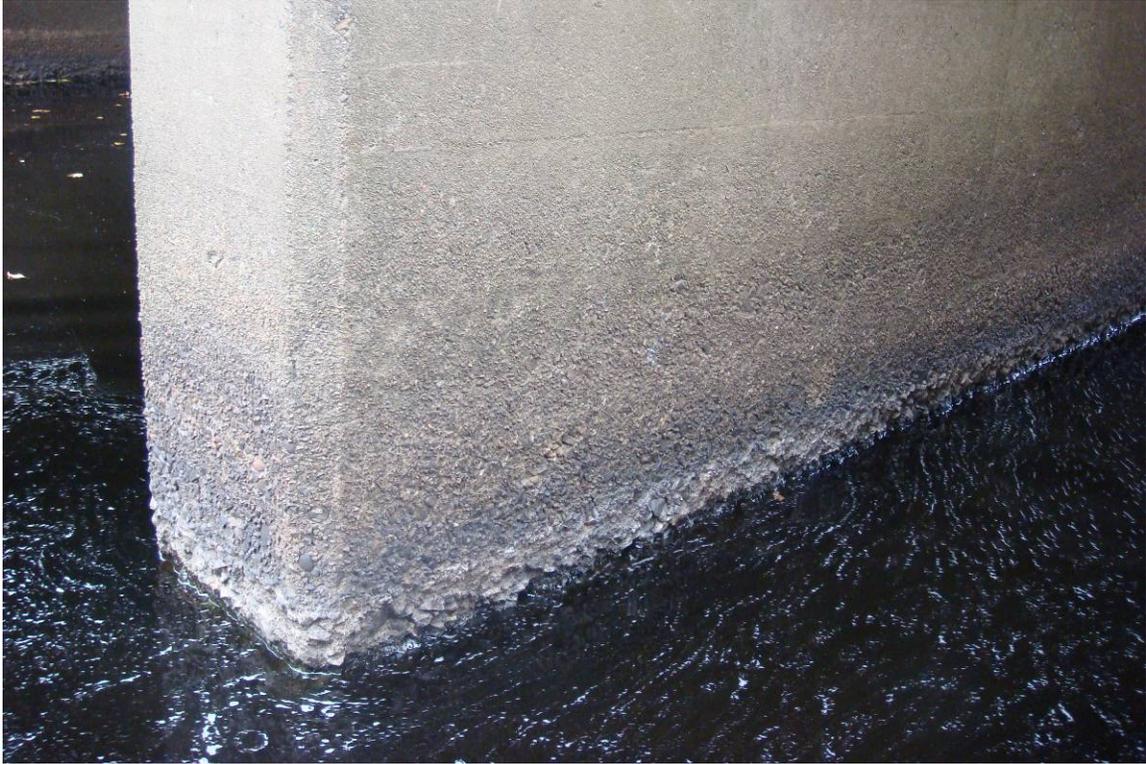
- (B) Moderate to heavy scaling was observed on all substructure units from 1.5 feet above the waterline to 6 inches below the waterline with up to 1 inch of penetration.

Photograph 5. View of the Typical Concrete Scaling Around the Waterline at Center Pier, Looking Northwest.

- 1 Moderate to heavy scaling was observed on all substructure units from 1.5 foot above the waterline to 6 inches below the waterline with up to 1 inch of penetration.

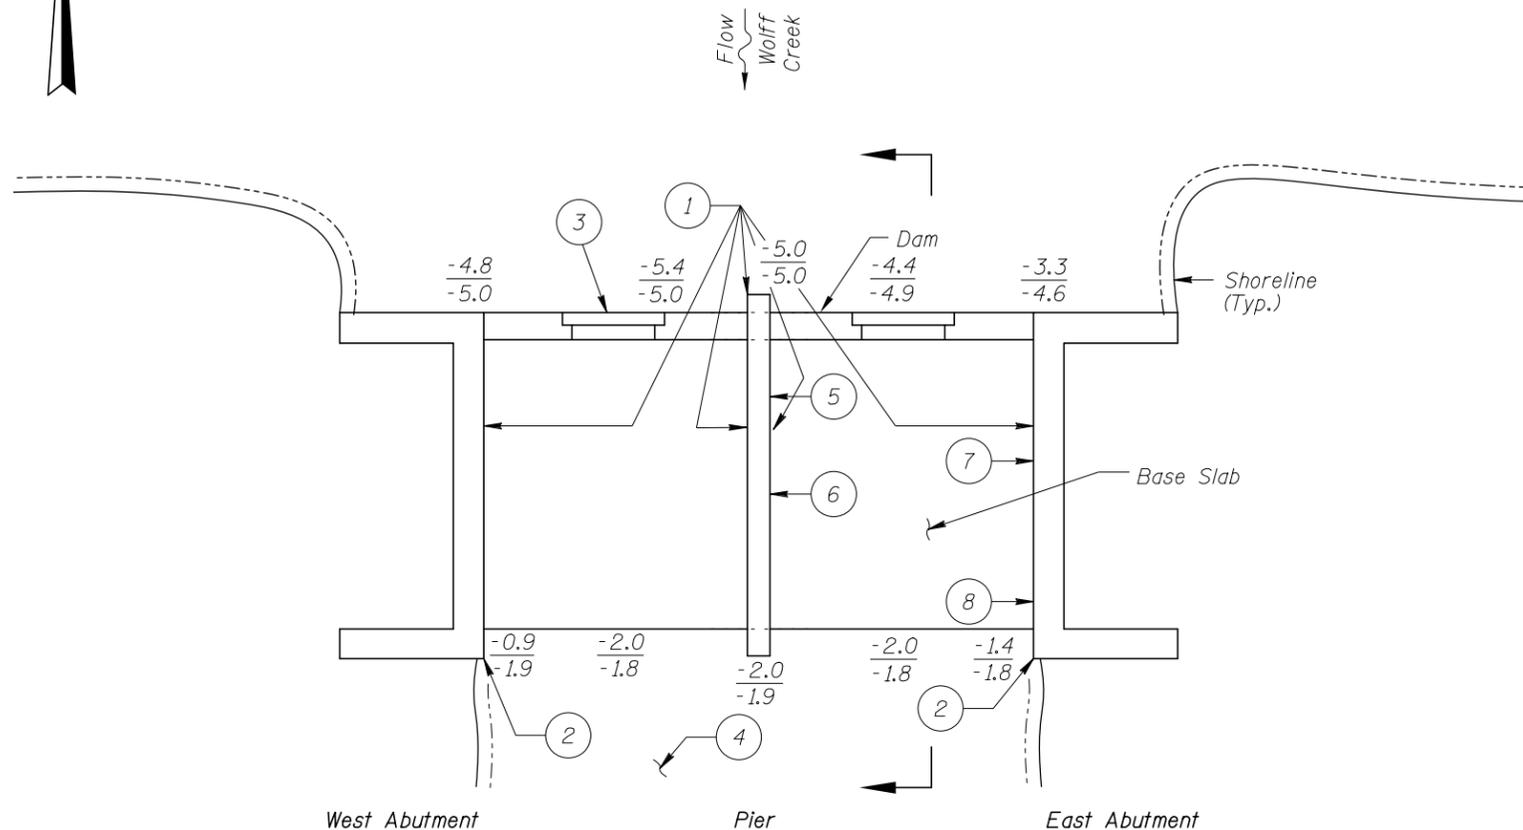
SOUNDING PLAN

- 2 Hairline vertical crack, extending from the top corner of the wingwall down full height of wall, with associated minor spalling up to 1/2 inch wide.

- 3 The concrete sill at the base of the upstream dam was observed 4.2 feet below the waterline and was typically covered with a 6 inch layer of silt and a heavy accumulation of 6-inch-diameter and smaller timber debris against the face of the base slab. At the west face of the center wall the face of the sill was exposed up to 1.3 feet vertically.

- 4 Channel bottom consisted of sandy gravel and 0.5- to 1-foot-diameter riprap allowing less than 1 inch of probe rod penetration.
- 5 A hairline vertical crack with efflorescence extended from the bottom of the bridge deck to the lip of the spillway.

- 6 A hairline vertical crack extended from the bottom of the bridge deck to the base slab.
- 7 A vertical crack up to 1/16 inch wide extended from the bottom of the bridge deck to the base slab.

- 8 A vertical crack up to 1/32 inch wide with efflorescence extended from the bottom of the bridge deck to 3 feet above the waterline.

- (A) Monitor timber debris accumulation against the upstream dam sill during future inspections and if found to be increasing, removal operations may need to be considered.
