UNDERWATER BRIDGE INSPECTION REPORT

STRUCTURE NO. 7836

CR 737

HELLEWAGS CREEK

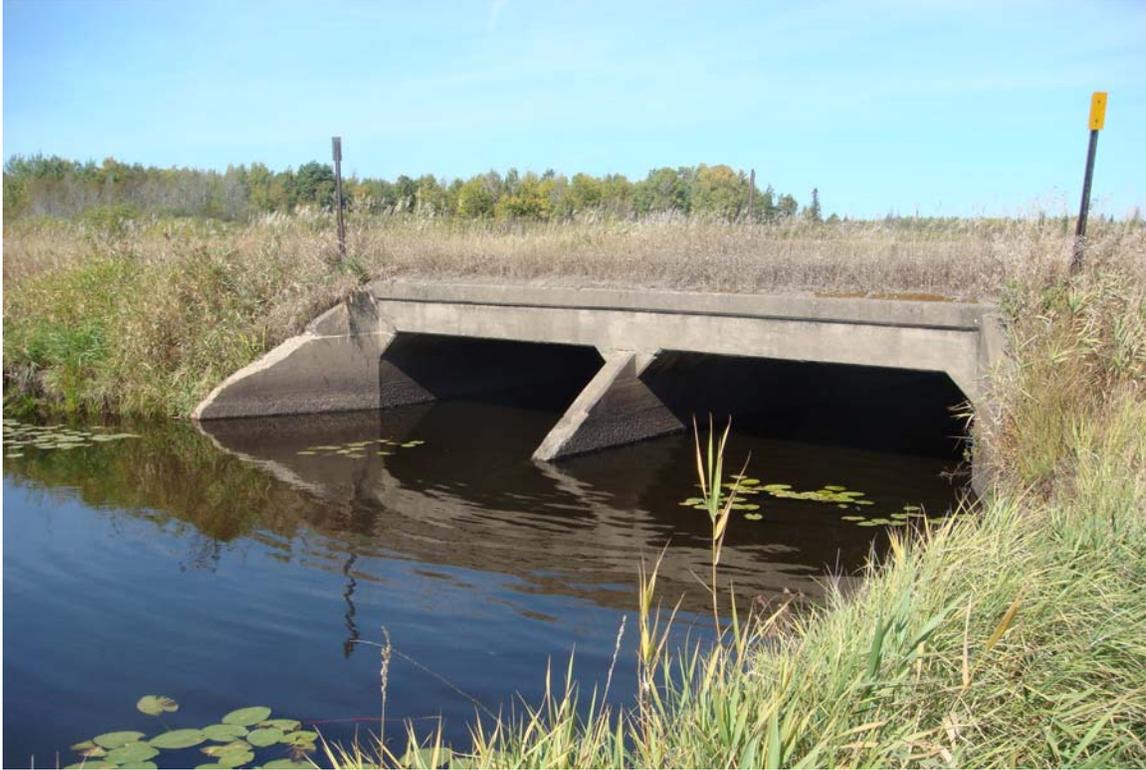
Photograph 1. Overall View of the Culvert, Looking Northwest.

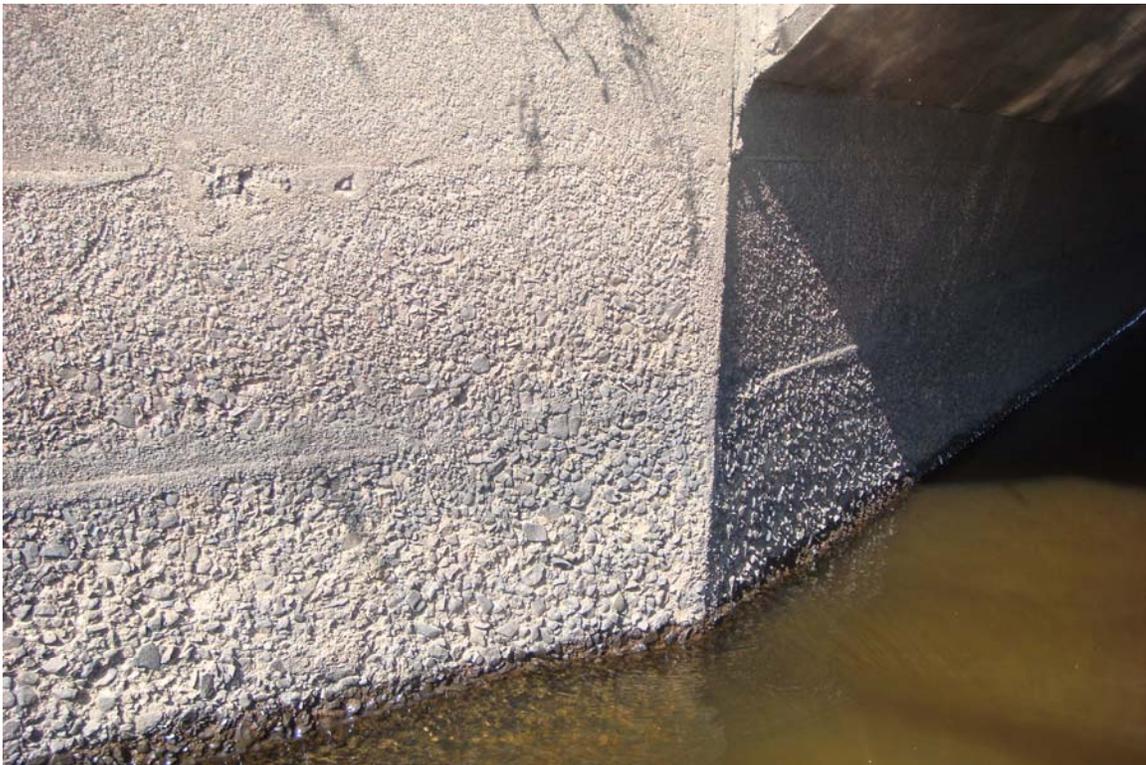
- (C) A band of heavy scaling, extending from 1.5 feet above the waterline to the culvert floor was observed on all exposed concrete walls. The scaling had a typical penetration of 1/2 inch with a maximum penetration of 1 inch on the east and west walls and 2 inches on the center wall.

Photograph 2. View of the Typical Band of Scaling on the Culvert Walls, Looking Northwest.

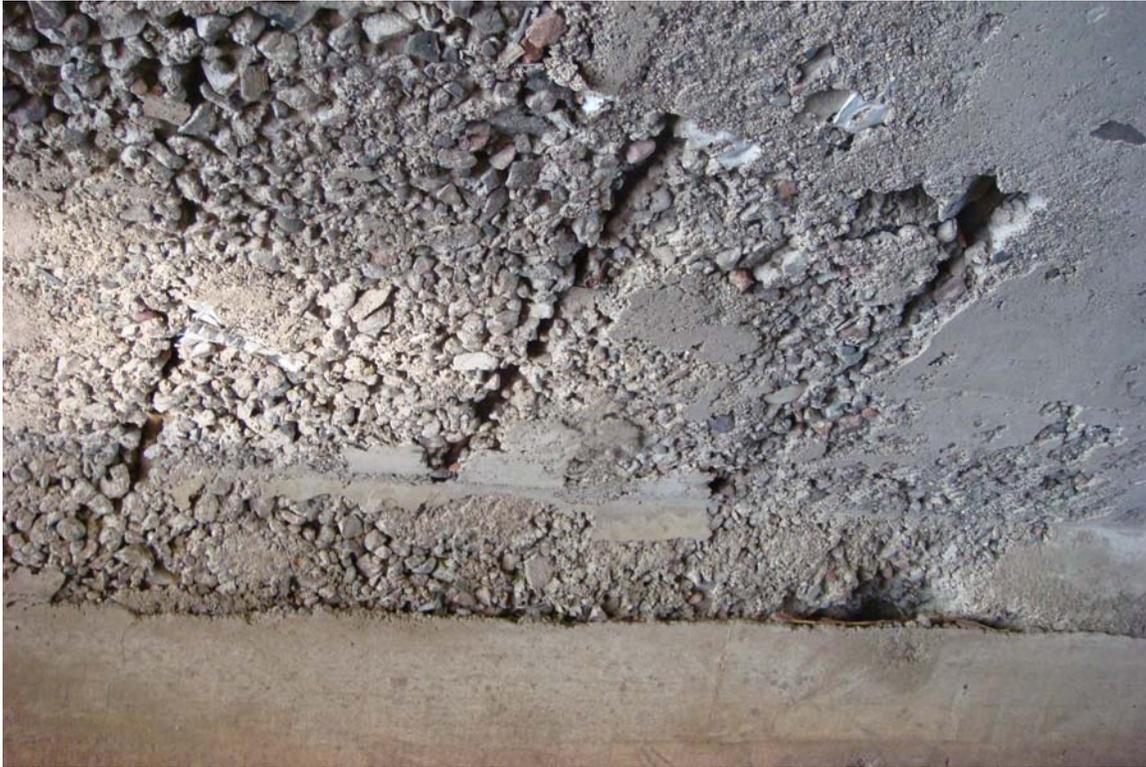
- (J) An area of poor concrete consolidation and concrete section loss was observed on the ceiling and east haunch of Box 2 at approximately 15 feet from the downstream opening. The area on the ceiling measured 4 feet long by 4 feet wide with a maximum penetration of 2 inches and the area on the haunch measured approximately 4 feet long by 3 inches high with a maximum penetration of 3 inches and several exposed reinforcing bars with no appreciable loss of section.

- (K) An area of poor concrete consolidation and concrete section loss was observed at the midpoint of the ceiling at the downstream opening of Box 2. The area measured 1.5 feet long by 6 inches wide with a maximum penetration of 2 inches and one exposed reinforcing bar with no appreciable loss of section.

Photograph 3. View of an Area of Concrete Section Loss and Poorly Consolidated Concrete on the Ceiling of Box 2, Looking West. Note the Exposed Reinforcing Steel Bars.

- (A) The areas of concrete section loss and poor concrete consolidation with exposed reinforcing steel are not structural concerns at this time; however, they should be repaired to prevent further deterioration. The repairs should include removal of concrete to a minimum of 1 inch behind the reinforcing steel, cleaning and replacing reinforcing steel as required, and placing concrete designed to provide high durability with low permeability.

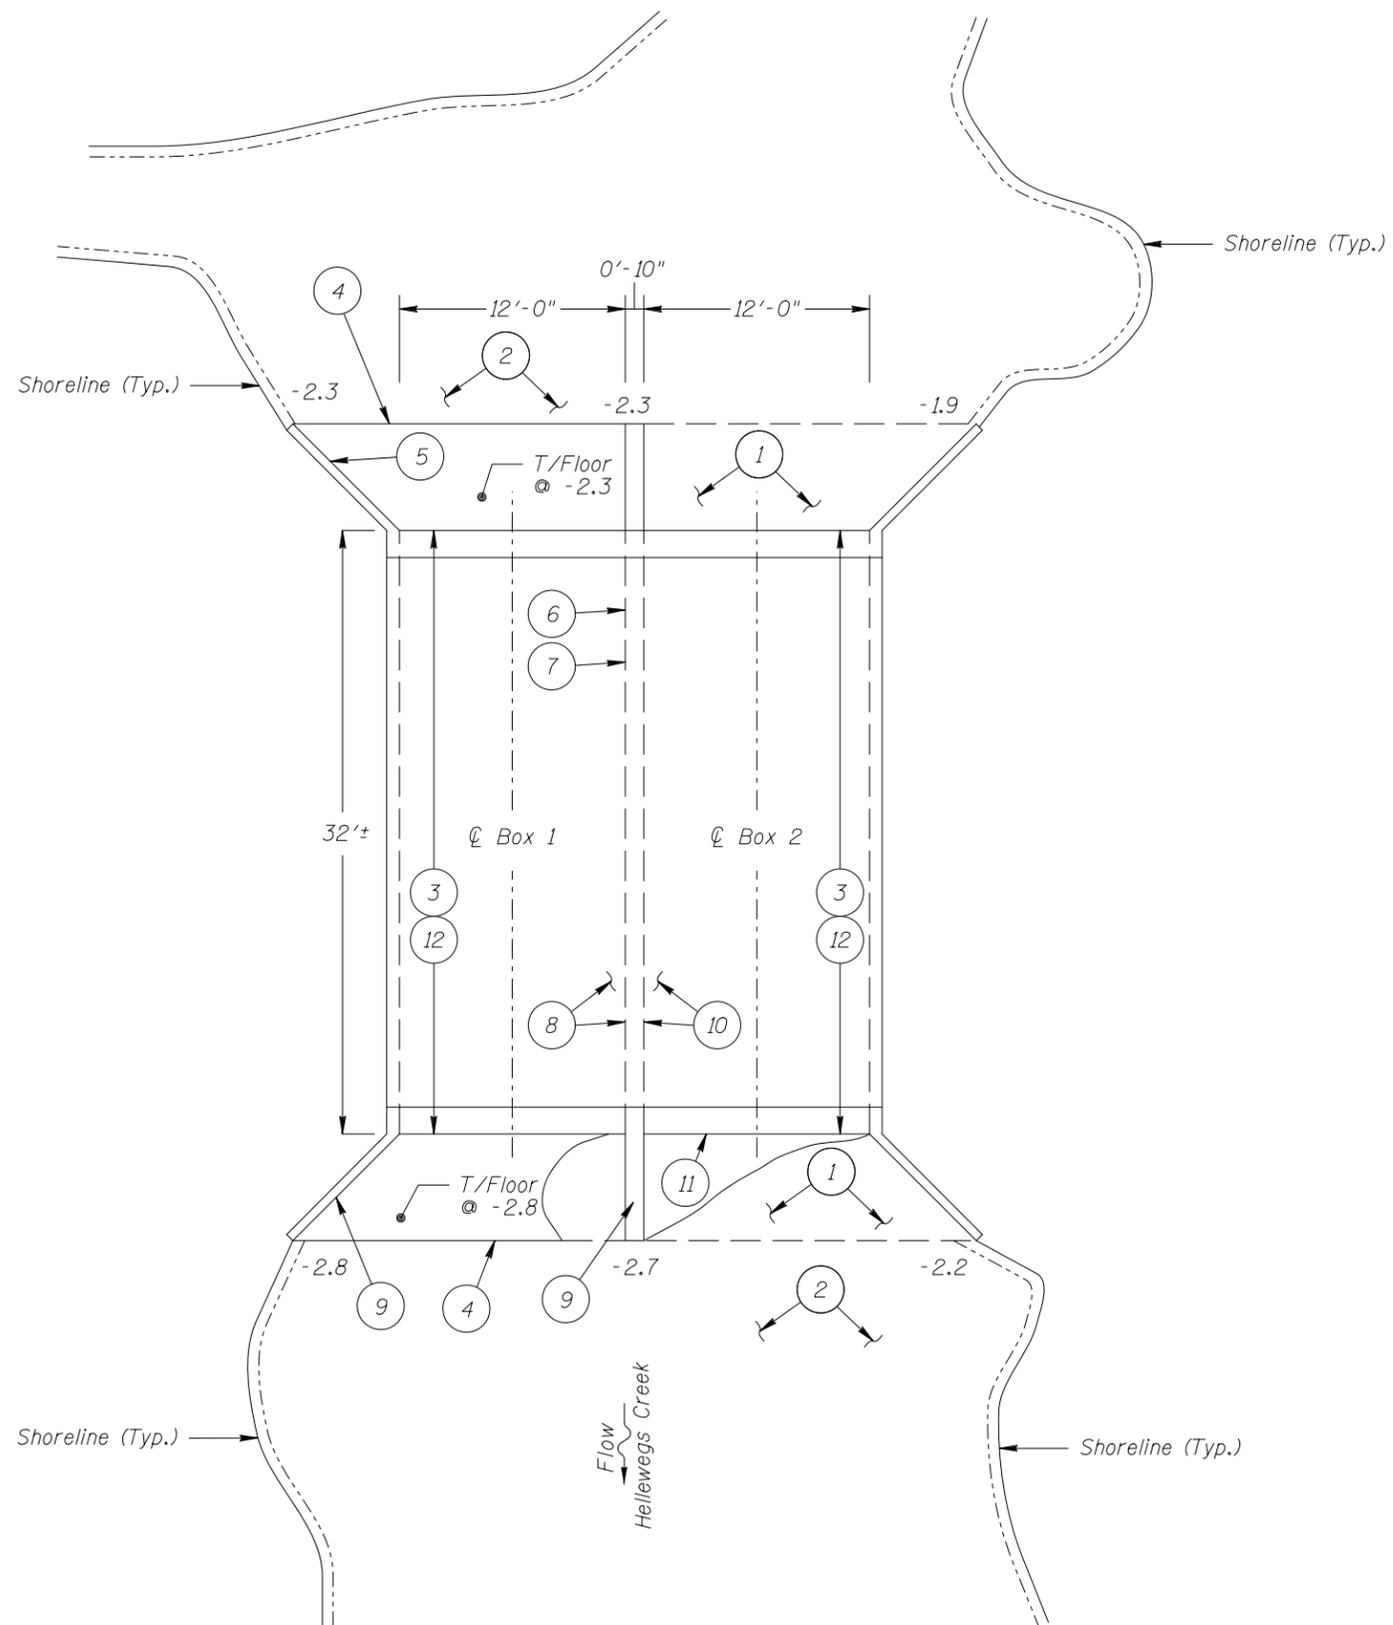
INSPECTION AND SOUNDING PLAN

- 1 The culvert floor was typically clear of any debris or silt build up. There was a layer of silty sand and gravel allowing up to 3 inches probe rod of penetration covering a portion of the concrete apron at the upstream and downstream openings of Box 2.

- 2 The channel bottom material upstream and downstream of the culvert apron consisted of soft silt allowing a maximum probe rod penetration of 1 foot.

- 3 A band of heavy scaling, extending from 1.5 feet above the waterline to the culvert floor was observed on all exposed concrete walls. The scaling had a typical penetration of 1/2 inch with a maximum penetration of 1 inch on the east and west walls and 2 inches on the center wall.

- 4 The apron floor was flush with the channel bottom at the upstream and downstream openings of Box 1 with no vertical face exposure.
- 5 A diagonal crack was observed on the northwest wingwall with a maximum width of 1/4 inch.

- 6 An area of concrete section loss measuring 2 feet long and 6 inches high with a maximum penetration of 6 inches was observed 2 feet above the waterline and 4 feet from the upstream opening on the west face of the center wall.

- 7 An area of concrete section loss measuring 1 foot long and 3 inches high with a maximum penetration of 3 inches was observed 1.5 feet above the waterline and 6 feet from the upstream opening on the west face of the center wall. One horizontal reinforcing bar was exposed with no appreciable loss of section.

- 8 An area of poor concrete consolidation and concrete section loss was observed on the ceiling and east haunch of Box 1 at approximately 15 feet from the downstream opening. The area on the ceiling measured 4 feet long by 4 feet wide with a maximum penetration of 2 inches and the area on the haunch measured approximately 4 feet long by 3 inches high with a maximum penetration of 6 inches and one exposed reinforcing bar with no appreciable loss of section.

- 9 Areas of concrete section loss with up to 2 inches of penetration were observed on the top of the southwest wingwall and the south center wall extension.

- 10 An area of poor concrete consolidation and concrete section loss was observed on the ceiling and east haunch of Box 2 at approximately 15 feet from the downstream opening. The area on the ceiling measured 4 feet long by 4 feet wide with a maximum penetration of 2 inches and the area on the haunch measured approximately 4 feet long by 3 inches high with a maximum penetration of 3 inches and several exposed reinforcing bars with no appreciable loss of section.

- 11 An area of poor concrete consolidation and concrete section loss was observed at the midpoint of the ceiling at the downstream opening of Box 2. The area measured 1.5 feet long by 6 inches wide with a maximum penetration of 2 inches and one exposed reinforcing bar with no appreciable loss of section.

- 12 The concrete of the walls from 1.5 feet above the waterline to the ceiling and the ceiling and haunches was generally smooth and sound. The ceiling and haunches had numerous random areas of poor concrete consolidation and associated areas of concrete section loss with up to 1 inch of penetration.
