UNDERWATER BRIDGE INSPECTION REPORT

STRUCTURE NO. 7865

CR 315

MINNESOTA DEPARTMENT OF TRANSPORTATION  
UNDERWATER BRIDGE INSPECTION

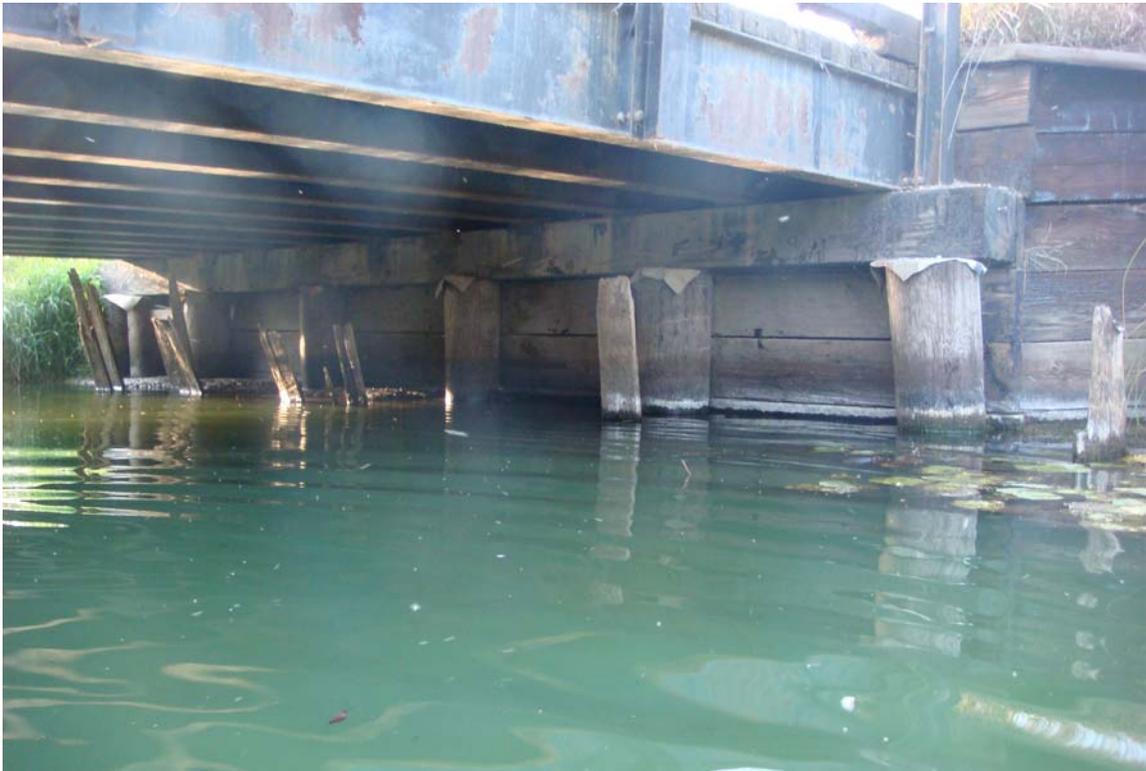
Photograph 2. View of the North Abutment, Looking Northwest.

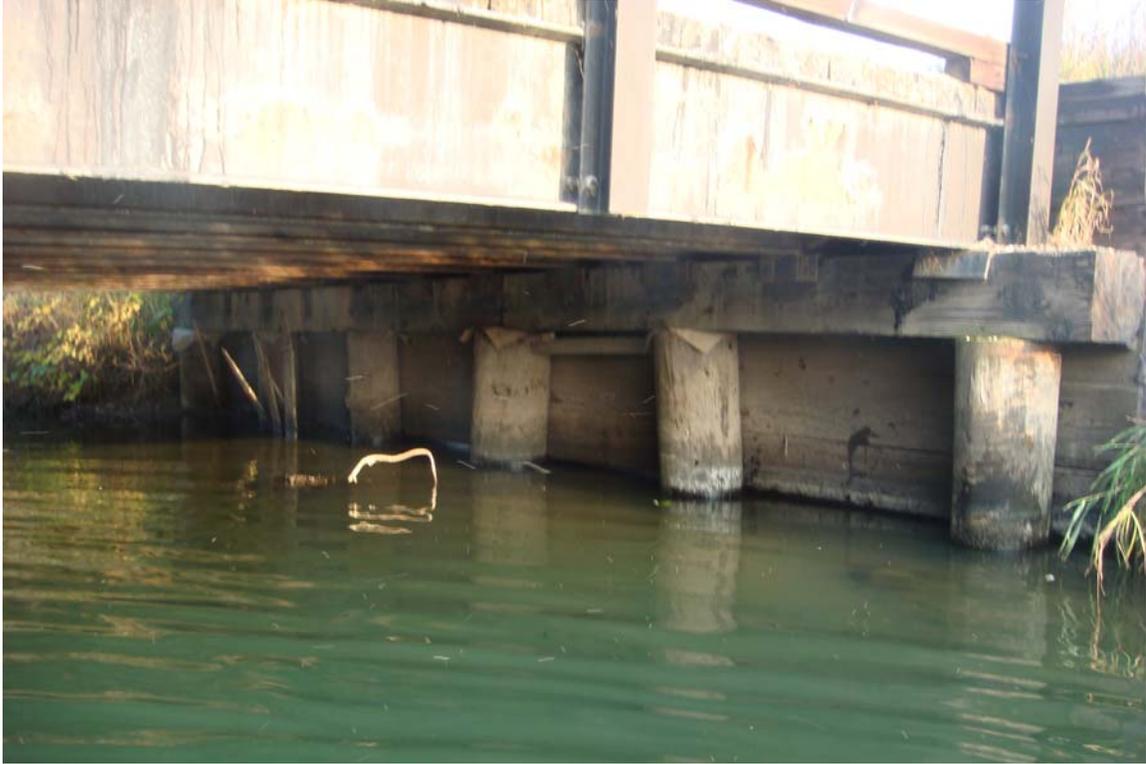
Photograph 3. View of the South Abutment, Looking Southeast.

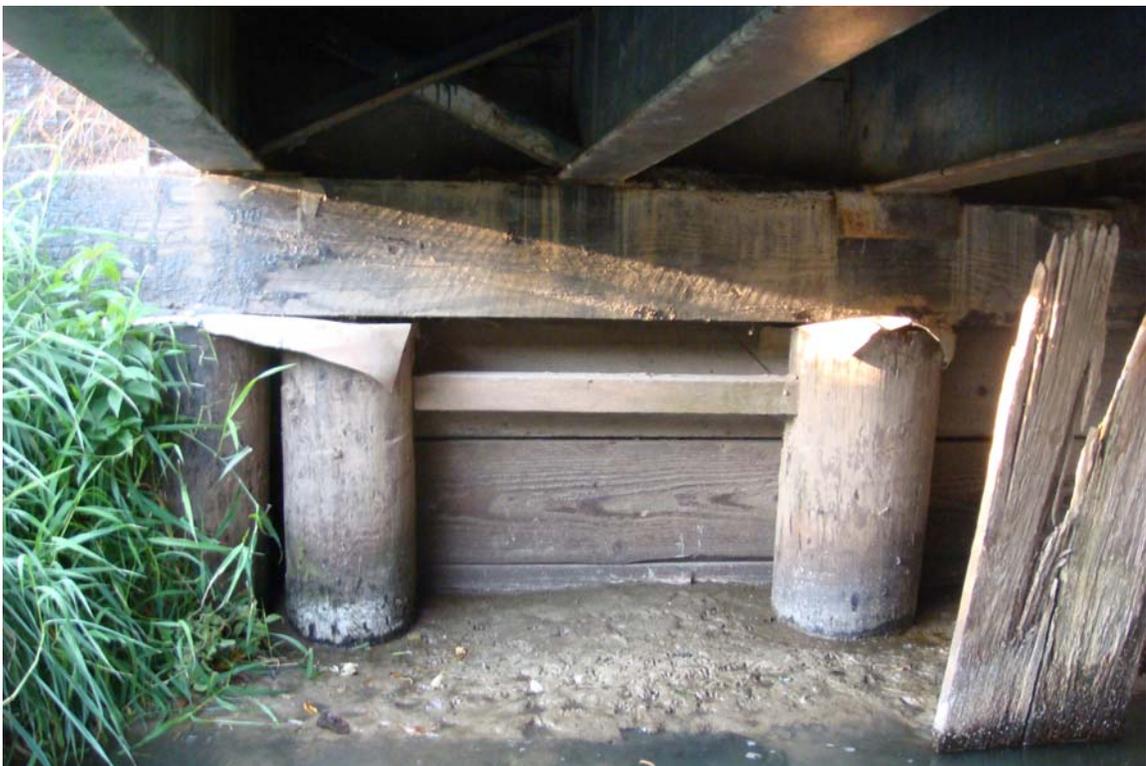
Photograph 4. View of Piles A, A' and B of the North Abutment, Looking North.

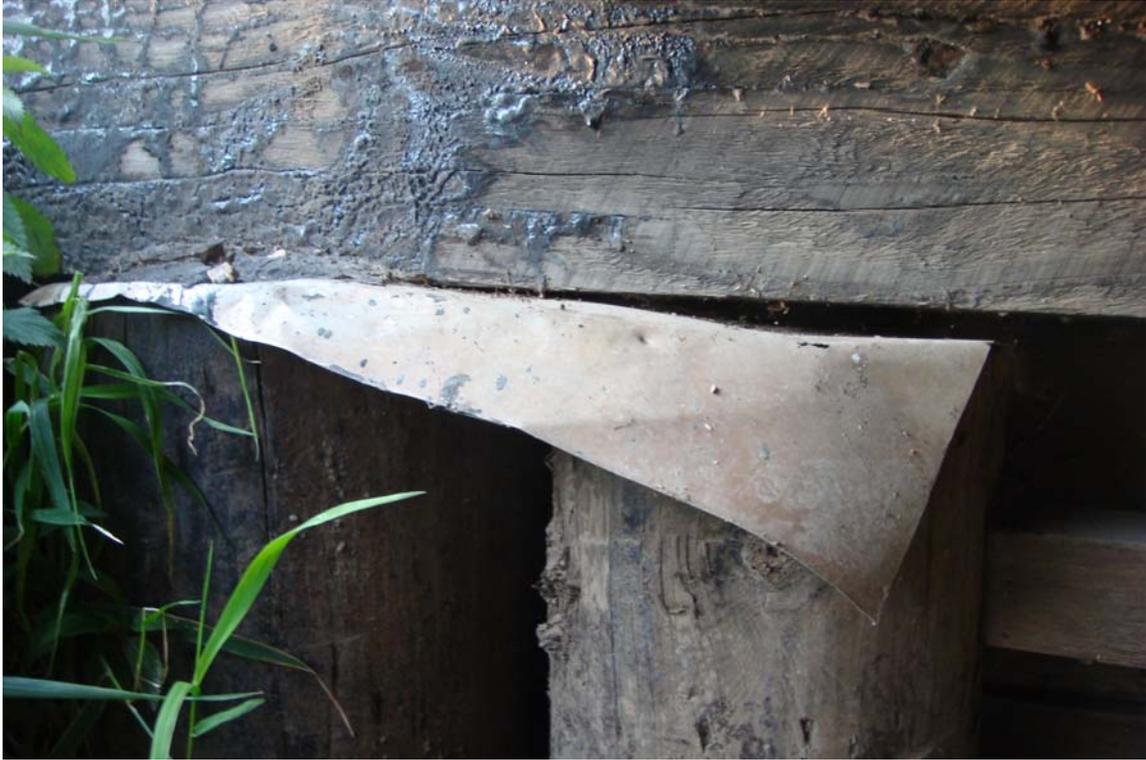
- (D) The timber backwall at the both abutments was typically sound and in good condition. No significant gaps or loss of backfill was observed.
- (E) A gap, up to 1/4 inch wide, was observed between the top of the pile and the bottom of the pile cap at Piles A' and B of the North Abutment resulting in complete loss of bearing at both piles.

Photograph 5. View of the Gap between the Top of Pile A' and the bottom of the Pile Cap, Looking North.

- (A) Place shims between the top of Piles A' and B of the North Abutment and the pile cap to restore full bearing of both piles.
- (B) Reinspect the submerged substructure at the normal maximum recommended (NBIS) interval of sixty (60) months.

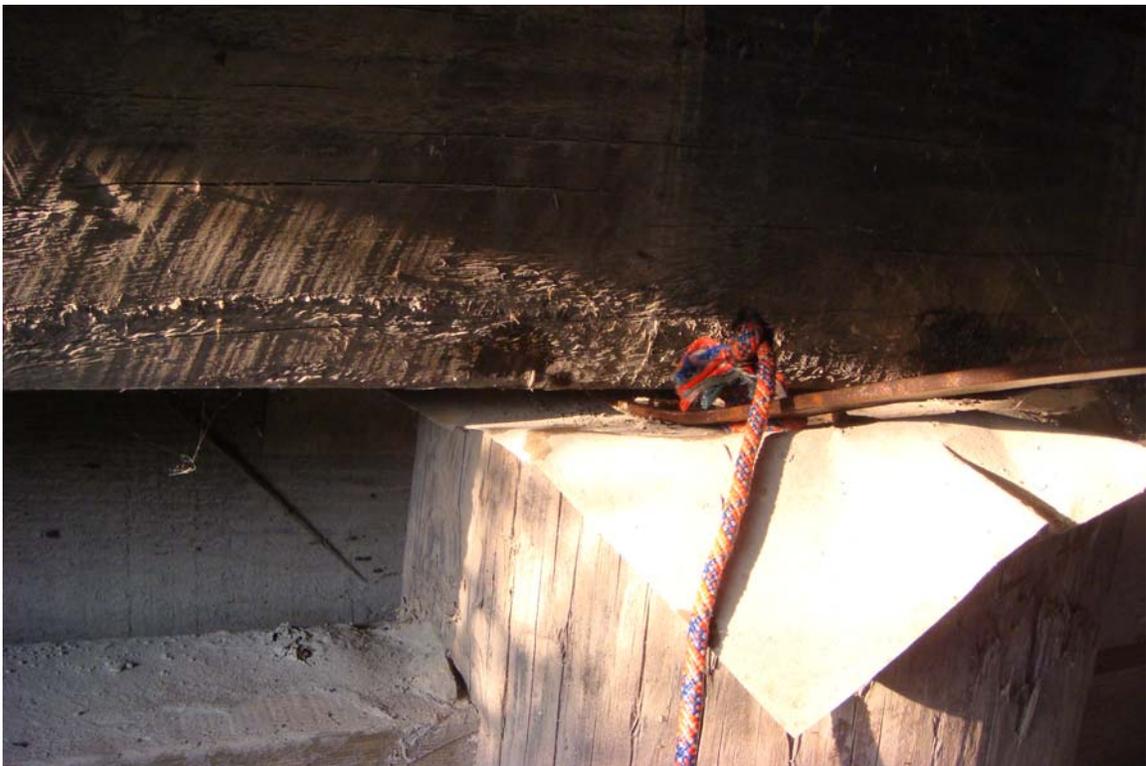
Photograph 6. View of the Gap between the Top of Pile B and the bottom of the Pile Cap, Looking North.

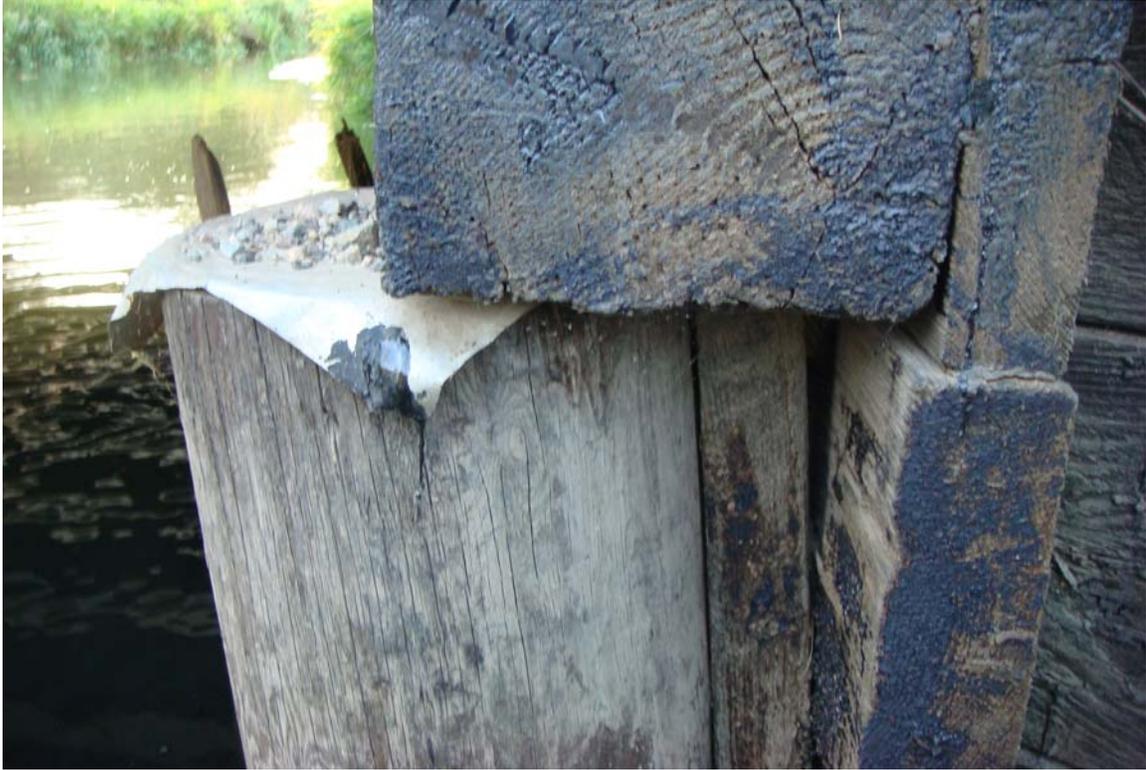
- (G) Pile F of the North Abutment extends out from the face of the pile cap by roughly half a pile diameter resulting in approximately 50 percent bearing. A vertical 2 inch by 8 inch timber was placed between Pile F of the North Abutment and the backwall. The pile cap is partially bearing on the 2 inch by 8 inch timber.

Photograph 7. View of Pile F of the North Abutment and the 2 inch by 8 inch Vertical Backing Board, Looking West.

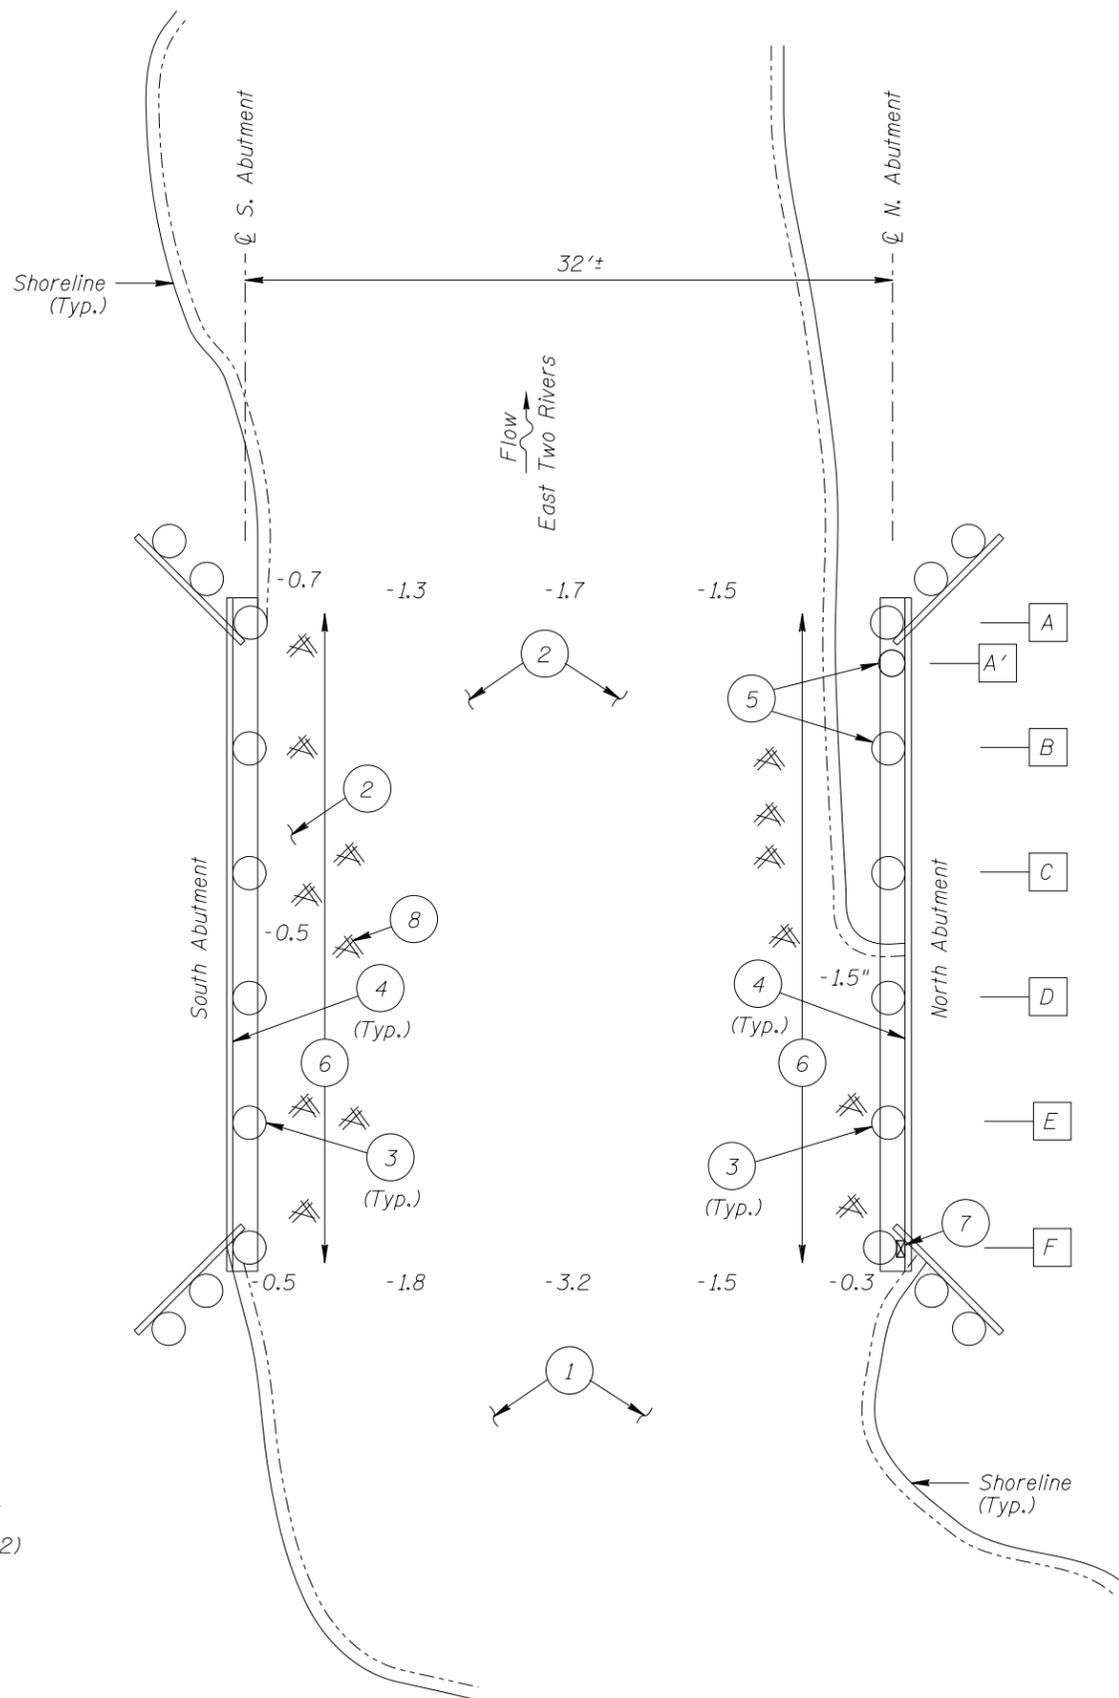
SOUNDING PLAN

- ① The channel bottom material in the upstream channel and along both abutments typically consisted of sandy silt allowing up to 4 inches of probe rod penetration.

- ② The channel bottom material in the downstream half of the channel consisted of firm gravel and rocks allowing no appreciable probe rod penetration.

- ③ The timber piles were typically sound allowing a typical timber awl penetration of 1/8 inch. No significant decay, splitting or checking was observed.

- ④ The timber backwall at the both abutments was typically sound and in good condition. No significant gaps or loss of backfill was observed.
- ⑤ A gap, up to 1/4 inch wide, was observed between the top of the pile and the bottom of the pile cap at Piles A' and B at the North Abutment resulting in complete loss of bearing at both piles.

- ⑥ Vertical planking was observed along the length of both abutments extending from the channel bottom to roughly 2 feet above the waterline at approximately 2.5 feet off the backwall and running parallel to both abutments.

- ⑦ Pile F of the North Abutment extends out from the face of the pile cap by roughly half a pile diameter resulting in approximately 50 percent bearing. A vertical 2"x8" timber was placed between Pile F of the North Abutment and the backwall. The pile cap is partially bearing on the 2"x8" timber.

- ⑧ Scattered concrete rubble with reinforcing steel protruding was observed along both abutment faces.
