UNDERWATER BRIDGE INSPECTION REPORT

STRUCTURE NO. 88631

CR 958

STREAM

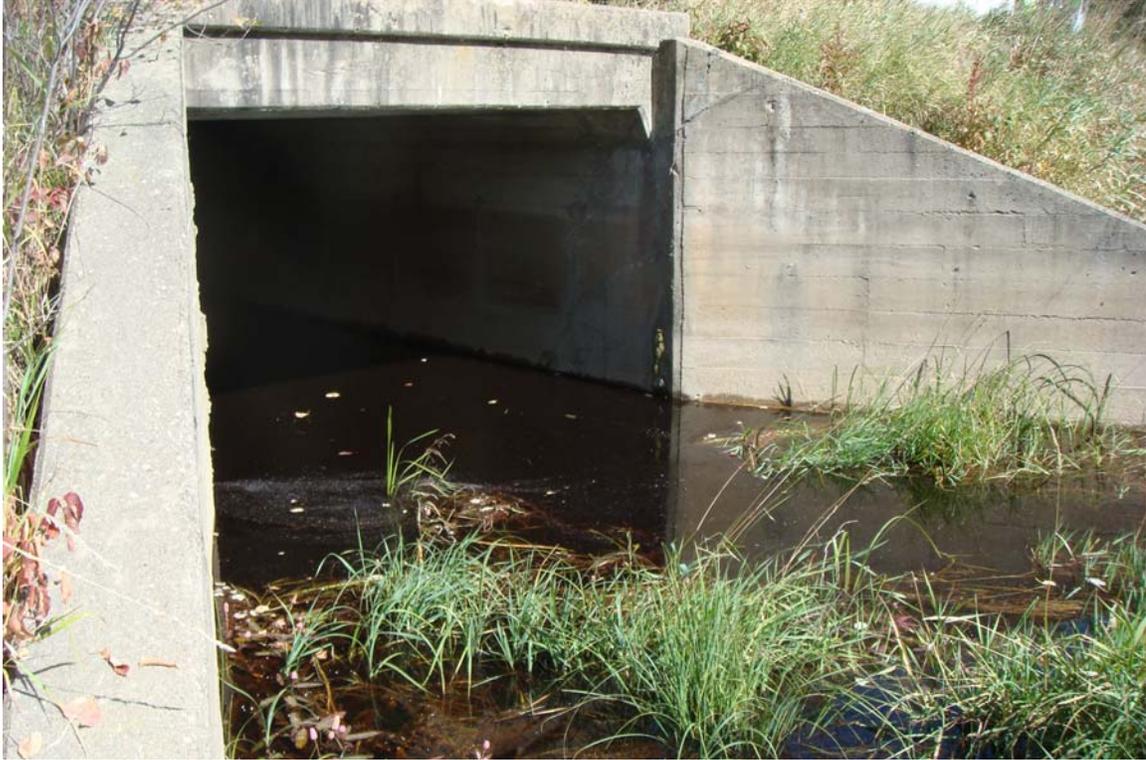
Photograph 1. Overall View of the South Opening, Looking Northeast.

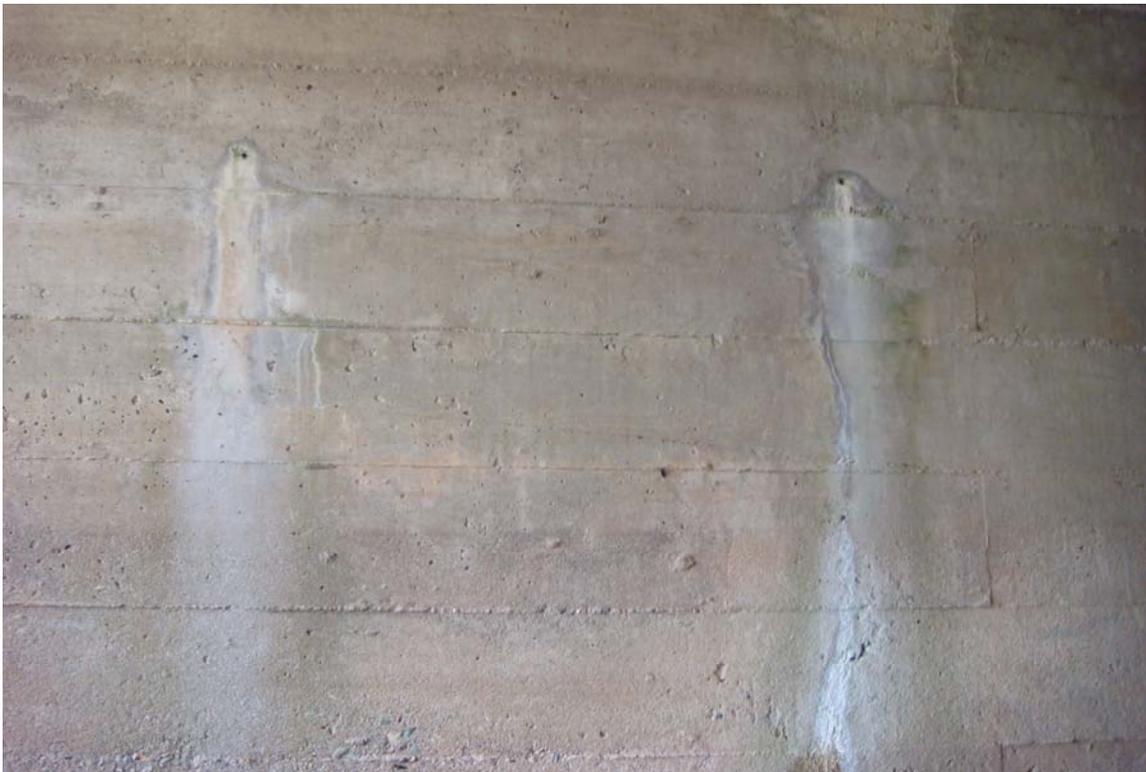
- (C) Voids with efflorescence (1/2 inch diameter holes) were observed throughout the culvert spaced at approximately 5 feet on center, at 3 feet above the waterline on both walls. The voids appeared to be formed.

Photograph 2. View of Voids in Concrete With Efflorescence, Looking West.

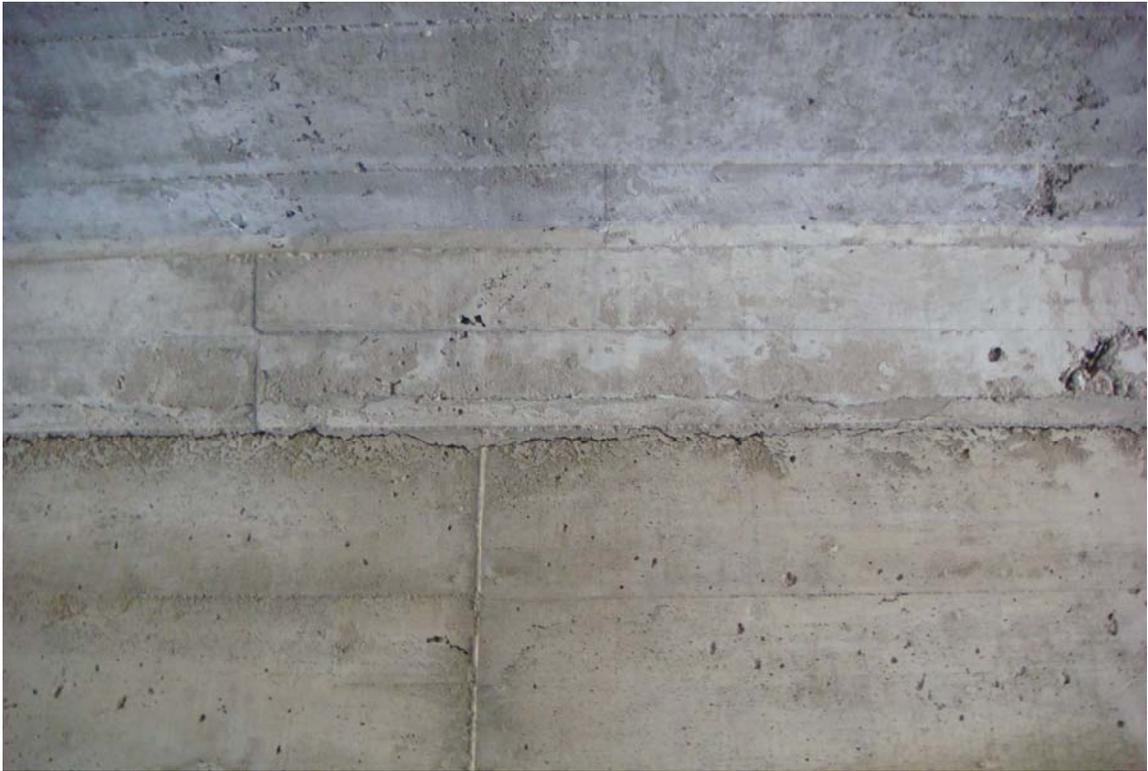
- (E) A longitudinal crack was observed at the bottom of the haunch on both sides of the culvert. The cracks were up to 1/32 inch wide and ran the entire length of the culvert.

Photograph 3. View of Longitudinal Crack at the Bottom of the Concrete Haunch, Looking East.

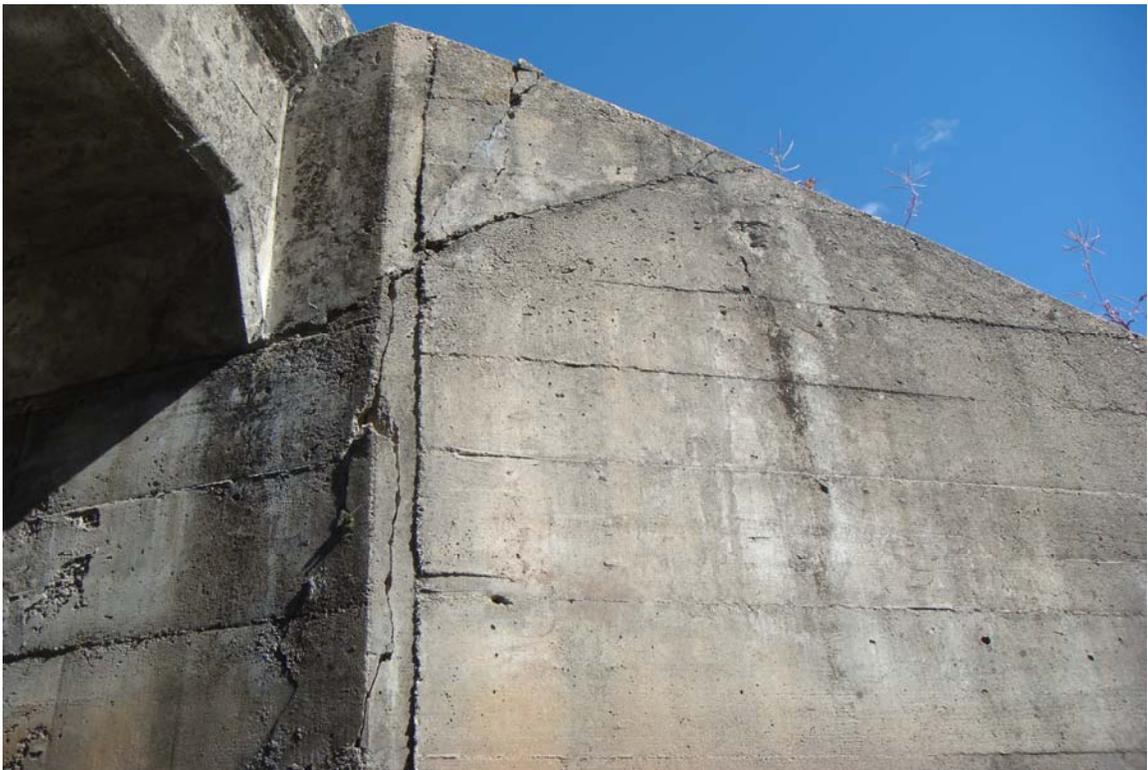
- (D) Vertical cracks with efflorescence, up to 1/8 inch wide, were observed on both walls of the culvert extending from the channel bottom to the ceiling at the upstream end, the midpoint, and the downstream end of the culvert. The cracks had areas of associated concrete section loss up to 2 inches wide with 1 inch of penetration.

Photograph 4. View of Vertical Crack at Southeast Corner of the Culvert, Looking East and Up.

- (A) Monitor vertical cracks and associated areas of concrete section loss.
- (B) Reinspect the submerged substructure units at the normal maximum recommended (NBIS) interval of sixty (60) months.

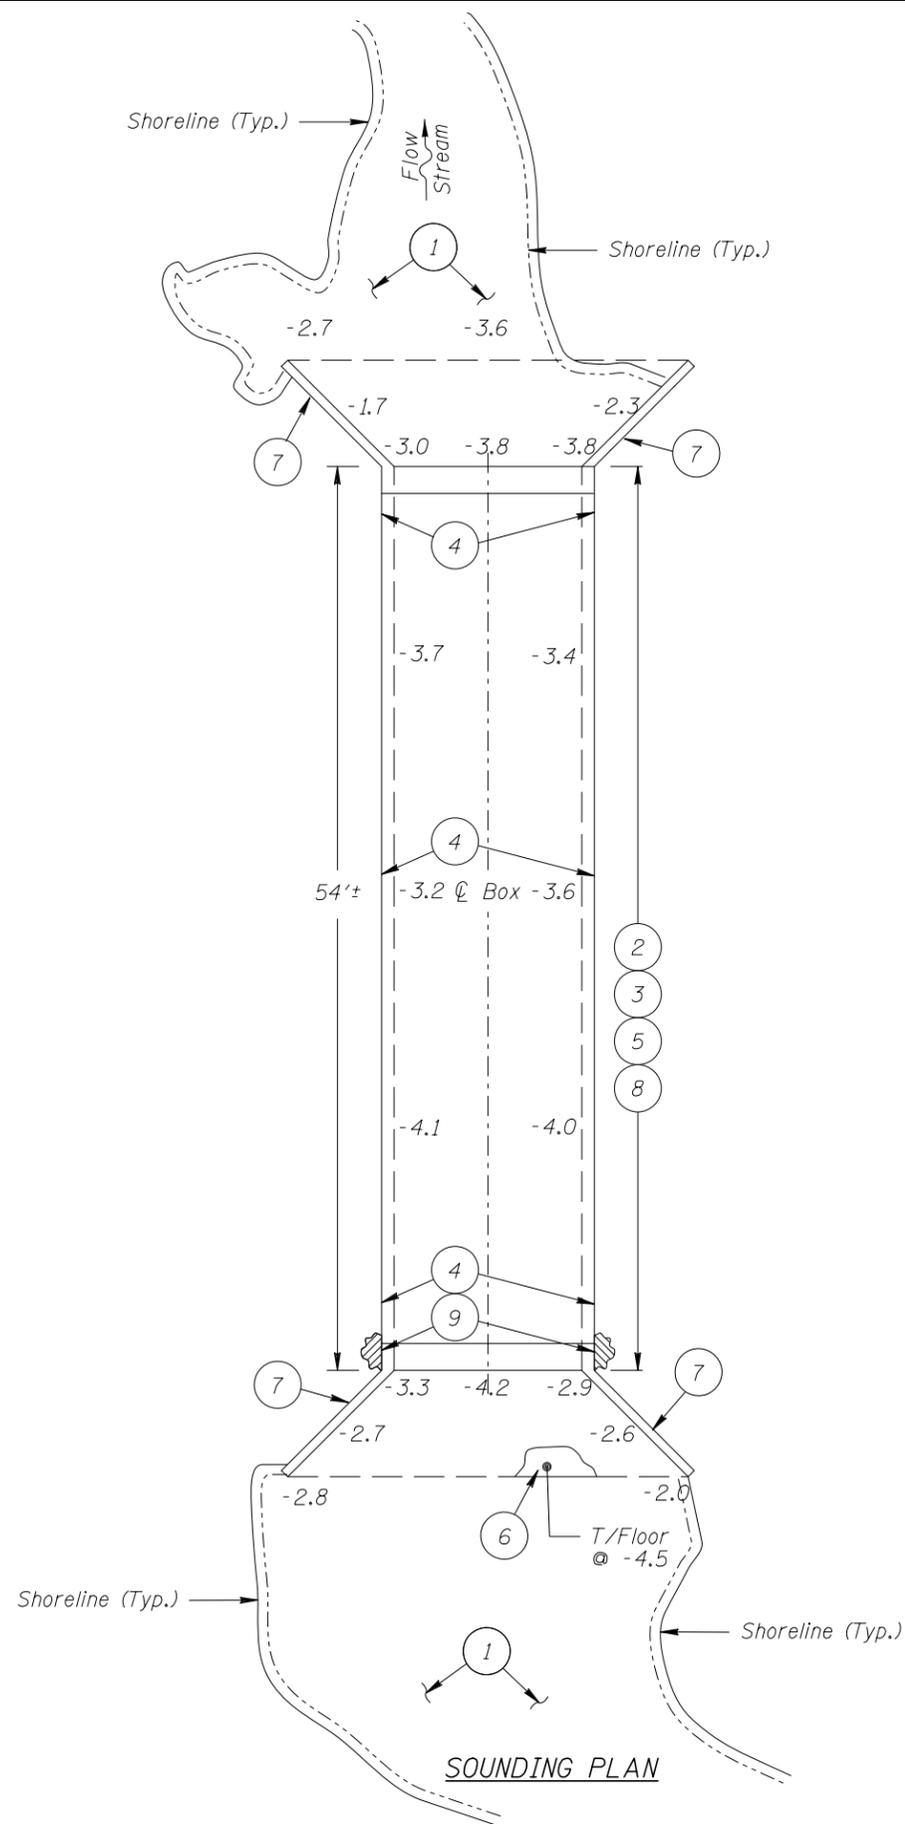
- 1 The channel bottom material consisted of soft silt with a maximum probe rod penetration of 1 foot.
- 2 The concrete of the culvert was typically smooth and sound.

- 3 Voids with efflorescence ( $\frac{1}{2}$  inch  $\phi$  holes) were observed throughout the culvert spaced at approximately 5 feet on center, at 3 feet above the waterline on both walls. Voids appeared to be formed.

- 4 Vertical cracks with efflorescence, up to  $\frac{1}{8}$  inch wide, were observed on both walls of the culvert extending from the channel bottom to the ceiling at the upstream end, the midpoint, and the downstream end of the culvert. The cracks had areas of associated concrete section loss up to 2 inches wide with 1 inch of penetration.

- 5 A longitudinal crack was observed at the bottom of the haunch on both sides of the culvert. The cracks were up to  $\frac{1}{32}$  inch wide and ran the entire length of the culvert.

- 6 A 3 foot diameter area of apron was exposed at the upstream end of the culvert. Only the top of the apron was exposed, no vertical exposure was observed.

- 7 All four wingwalls exhibited random vertical cracks with efflorescence extending from the channel bottom to the top of the wingwall. The cracks had a maximum width of  $\frac{1}{16}$  inch.

- 8 Scattered timber debris, consisting of small branches, was observed throughout the culvert length.
- 9 There were two areas of minor erosion behind the south headwall measuring approximately 2 feet deep and 3 feet long.
