UNDERWATER BRIDGE INSPECTION REPORT

STRUCTURE NO. 92277 H, I, J, and K

MILLER CREEK

JULY 26, 2012

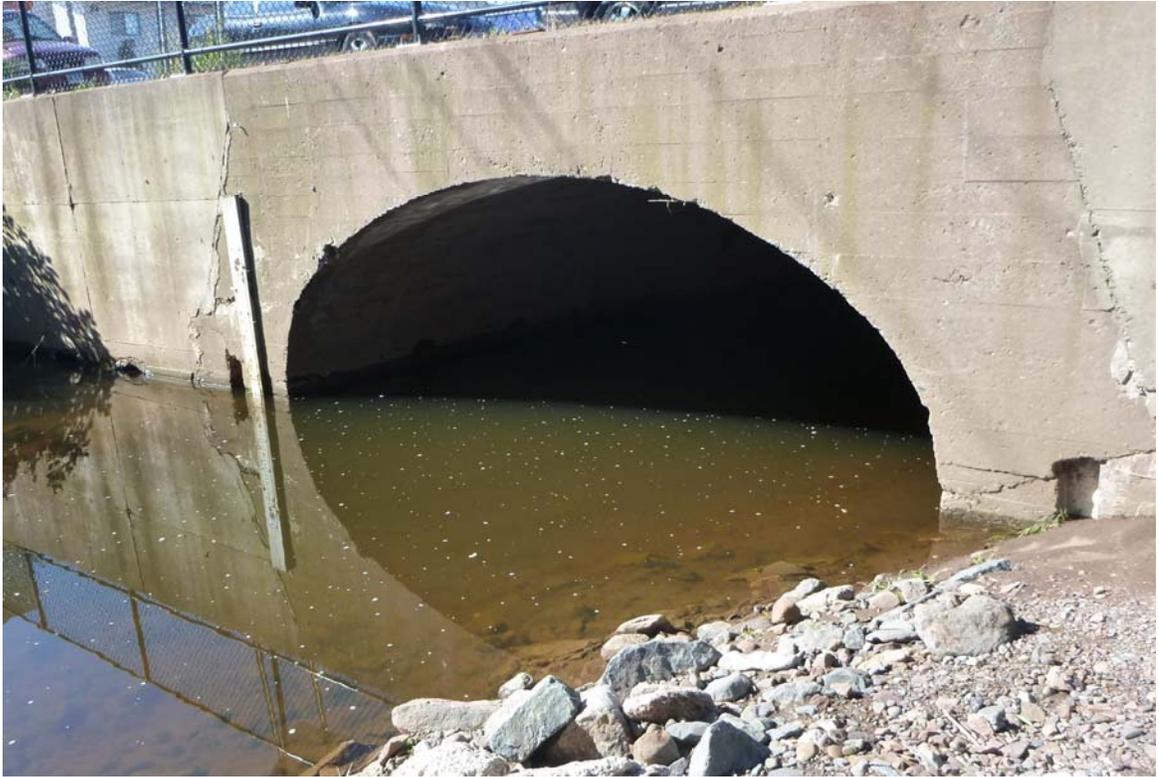
Photograph 1. View of Downstream End of Culvert, Looking Southwest.

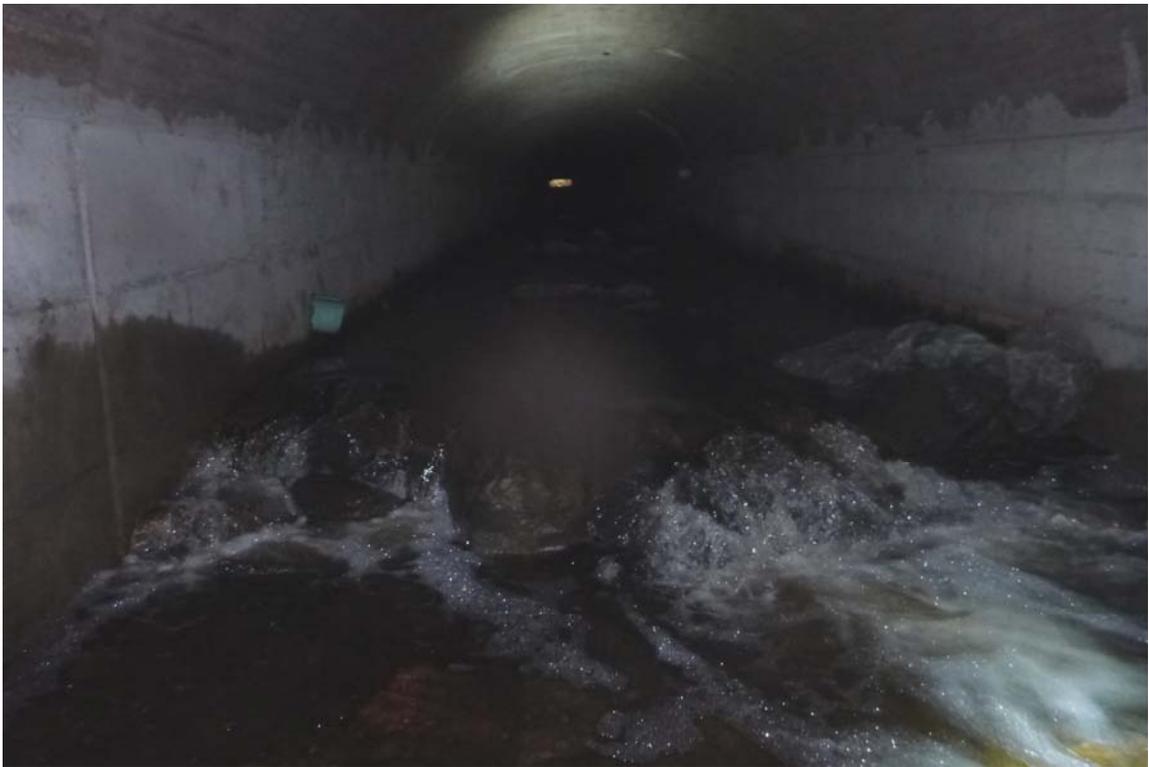
- (A) Overall, concrete surfaces of all culvert sections exhibited minor scaling. Masonry structures exhibited minor scaling and minor grout deterioration..
- (B) Undermining of the culvert walls was observed at multiple locations throughout the structure ranging from 4 to 14 inches vertically and 5 inches to 3 feet deep. At structure 92277 J the entire south wall of the culvert (approximately 80 feet) was undermined.
- (C) Timber and other industrial debris were found hanging on a cross pipe within the inspected structure.

Photograph 2. View of Culvert Interior, Looking West.

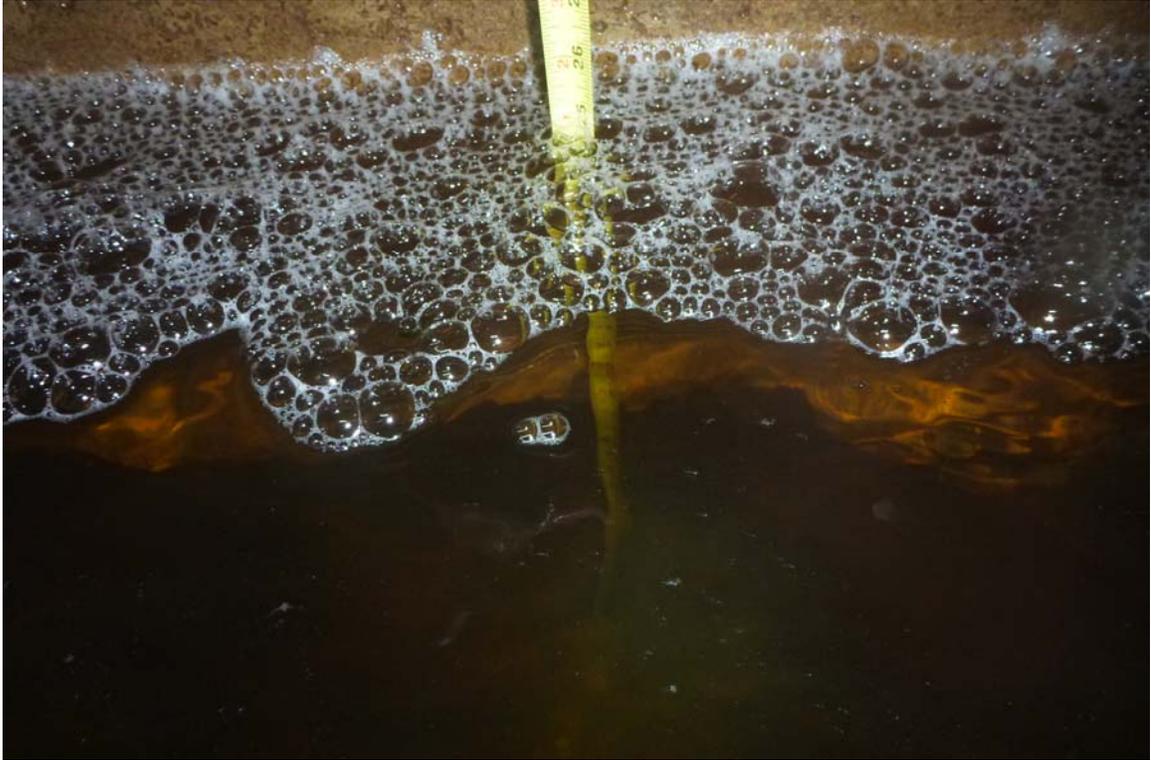
Photograph 3. Typical Undermining, Looking North.

REMARKS: Overall, the concrete surfaces of the culverts exhibited minor scaling. The masonry of the culvert walls and ceilings was found to be in satisfactory condition with joint mortar typically intact. However, a significant extent of undermining was observed throughout the structure ranging from 4 to 14 inches vertically and up to 3 feet of maximum penetration.

Repair undermining throughout the structure.

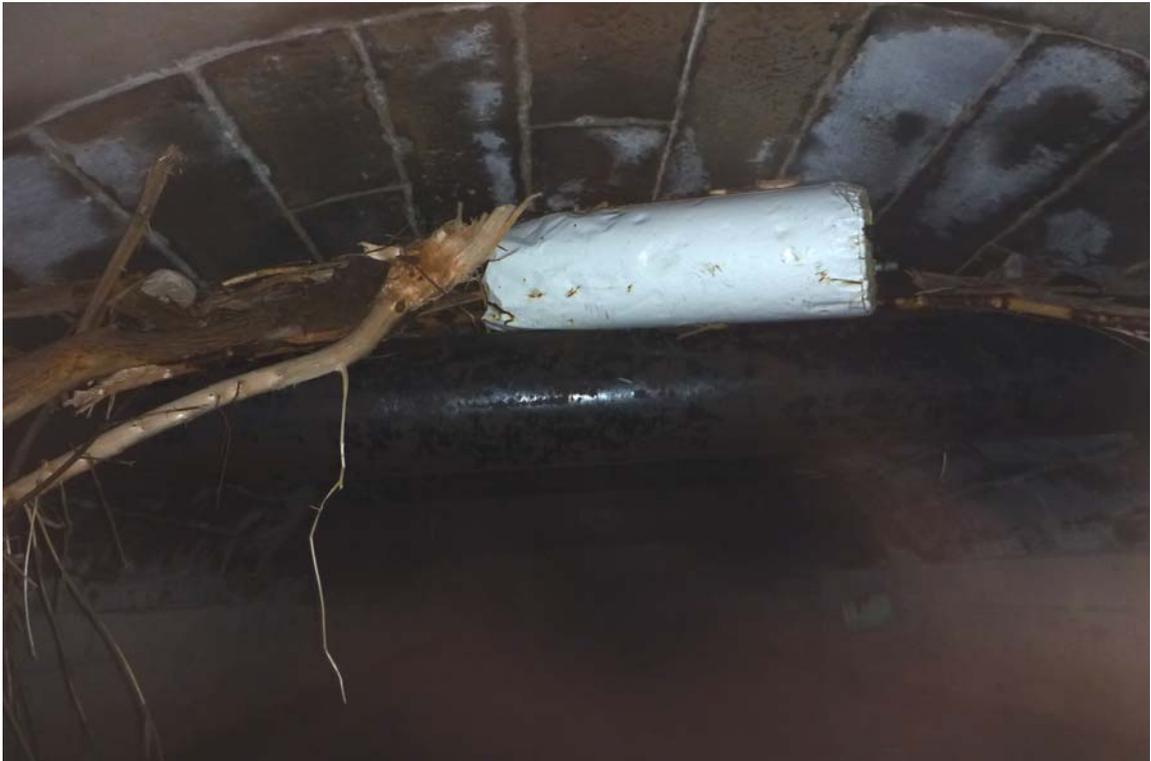
Photograph 4. View of Debris near the Cross Pipe within the Culvert, Looking East.

Remove debris in culvert.

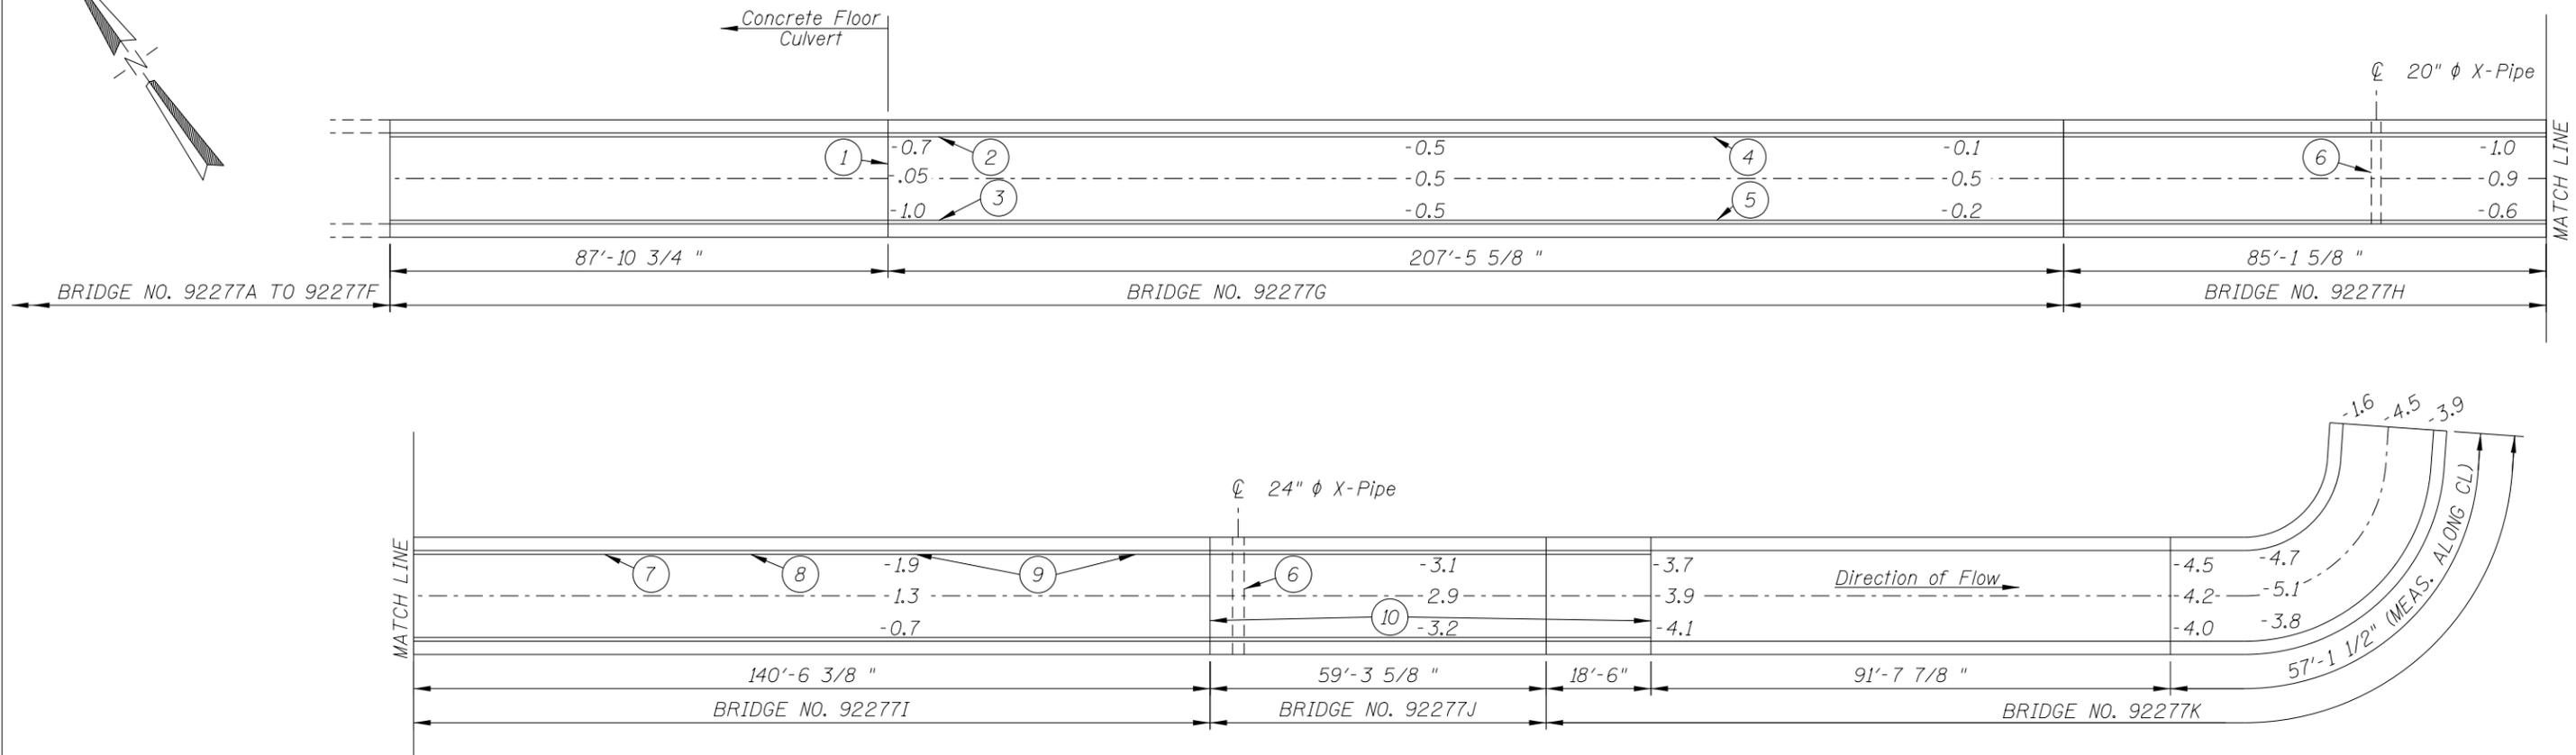
**INSPECTION AND SOUNDING PLAN**

- ① The concrete surfaces were smooth and sound with no notable deterioration.
- ② Undermining was observed for a area of 5 feet long, 14 inch vertical and 14 inch of penetration.
- ③ Undermining was observed for a area of 15 feet long, 14 inch vertical and 3 feet of penetration.
- ④ Undermining was observed for a area of 4 feet long, 4 inch vertical and 4 inch of penetration.
- ⑤ Undermining was observed for a area of 10 feet long, 14 inch vertical and 1 feet of penetration.
- ⑥ Light timber debris was hung up on the cross pipe.
- ⑦ Undermining was observed for a area of 3 feet long, 5 inch vertical and 5 inch of penetration.
- ⑧ Undermining was observed for a area of 10 feet long, 4 inch vertical and 6 inch of penetration.
- ⑨ Undermining was observed for a area of 40 feet long, 6 inch vertical and 1 foot of penetration.
- ⑩ The entire south wall of Structure No. 92277J was undermined.
