UNDERWATER BRIDGE INSPECTION REPORT

STRUCTURE NO. 96026
MSAS 119 (RAILROAD ST.)
OVER
POND OUTLET
CITY OF DULUTH

MAY 17, 2012
PREPARED FOR THE
MINNESOTA DEPARTMENT OF TRANSPORTATION
BY
COLLINS ENGINEERS, INC.
JOB NO. 7423

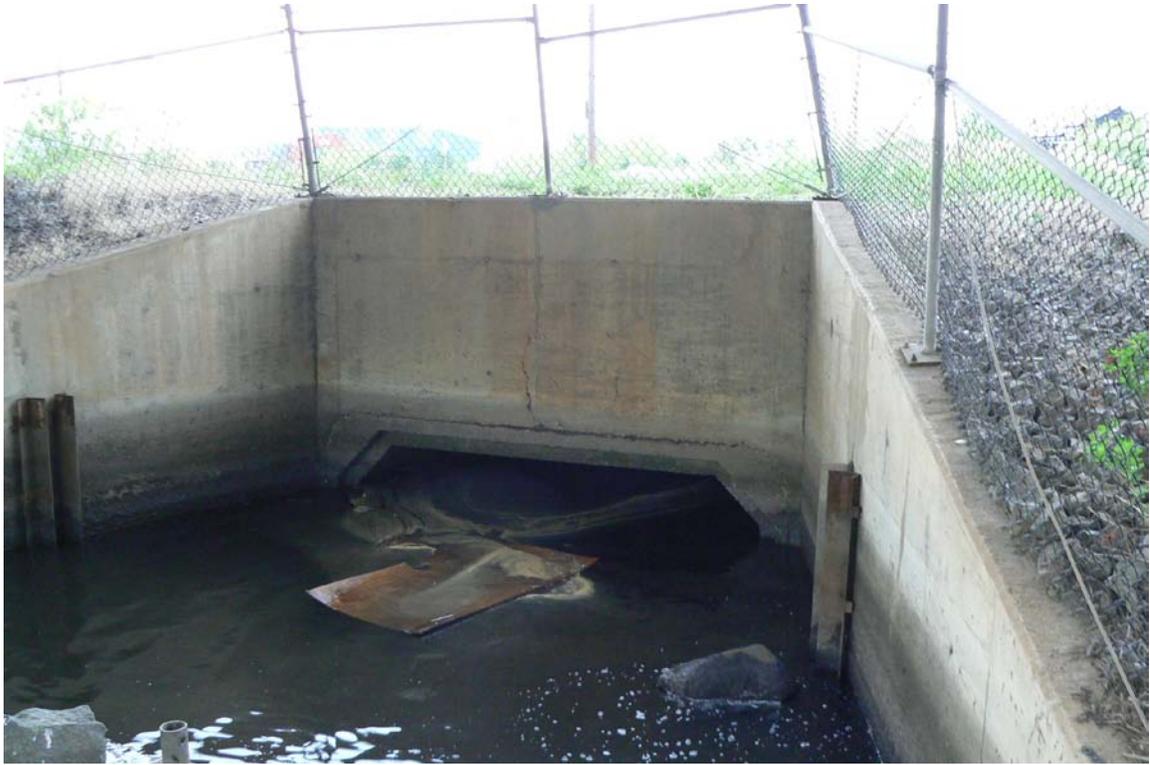
Photograph 1. View of West Opening, Looking Northeast.

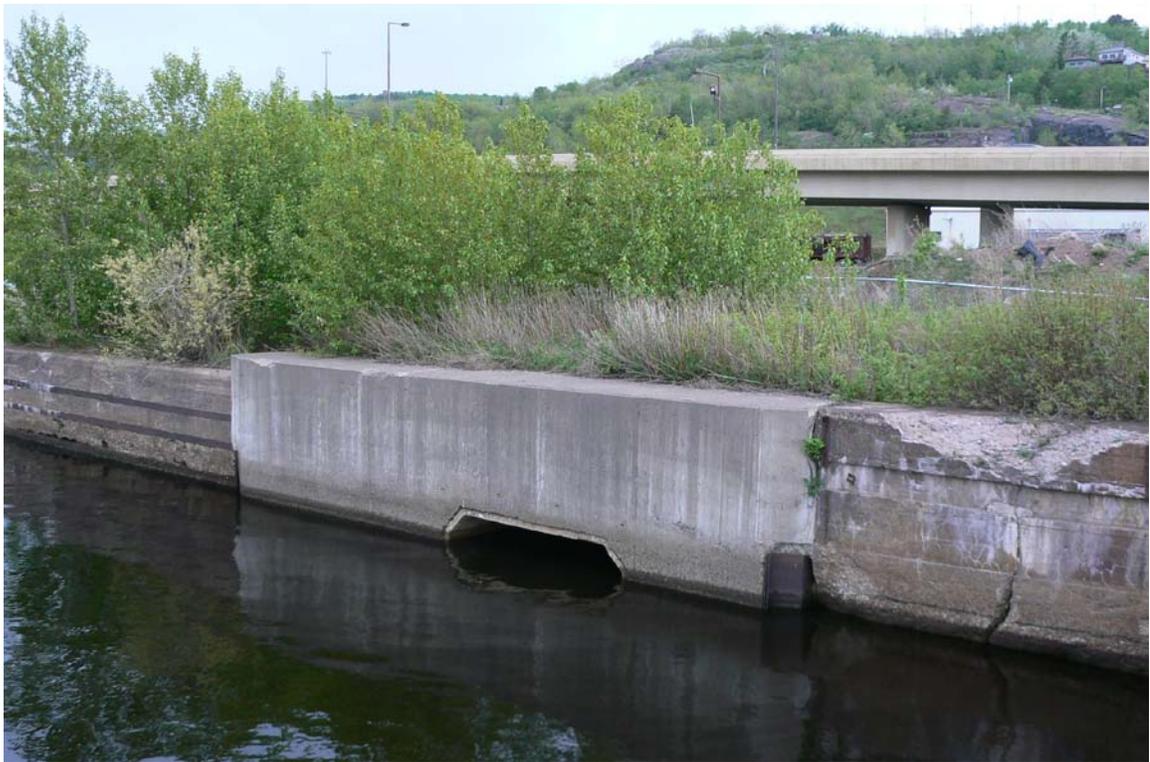
Photograph 2. View of East Opening, Looking Southwest.

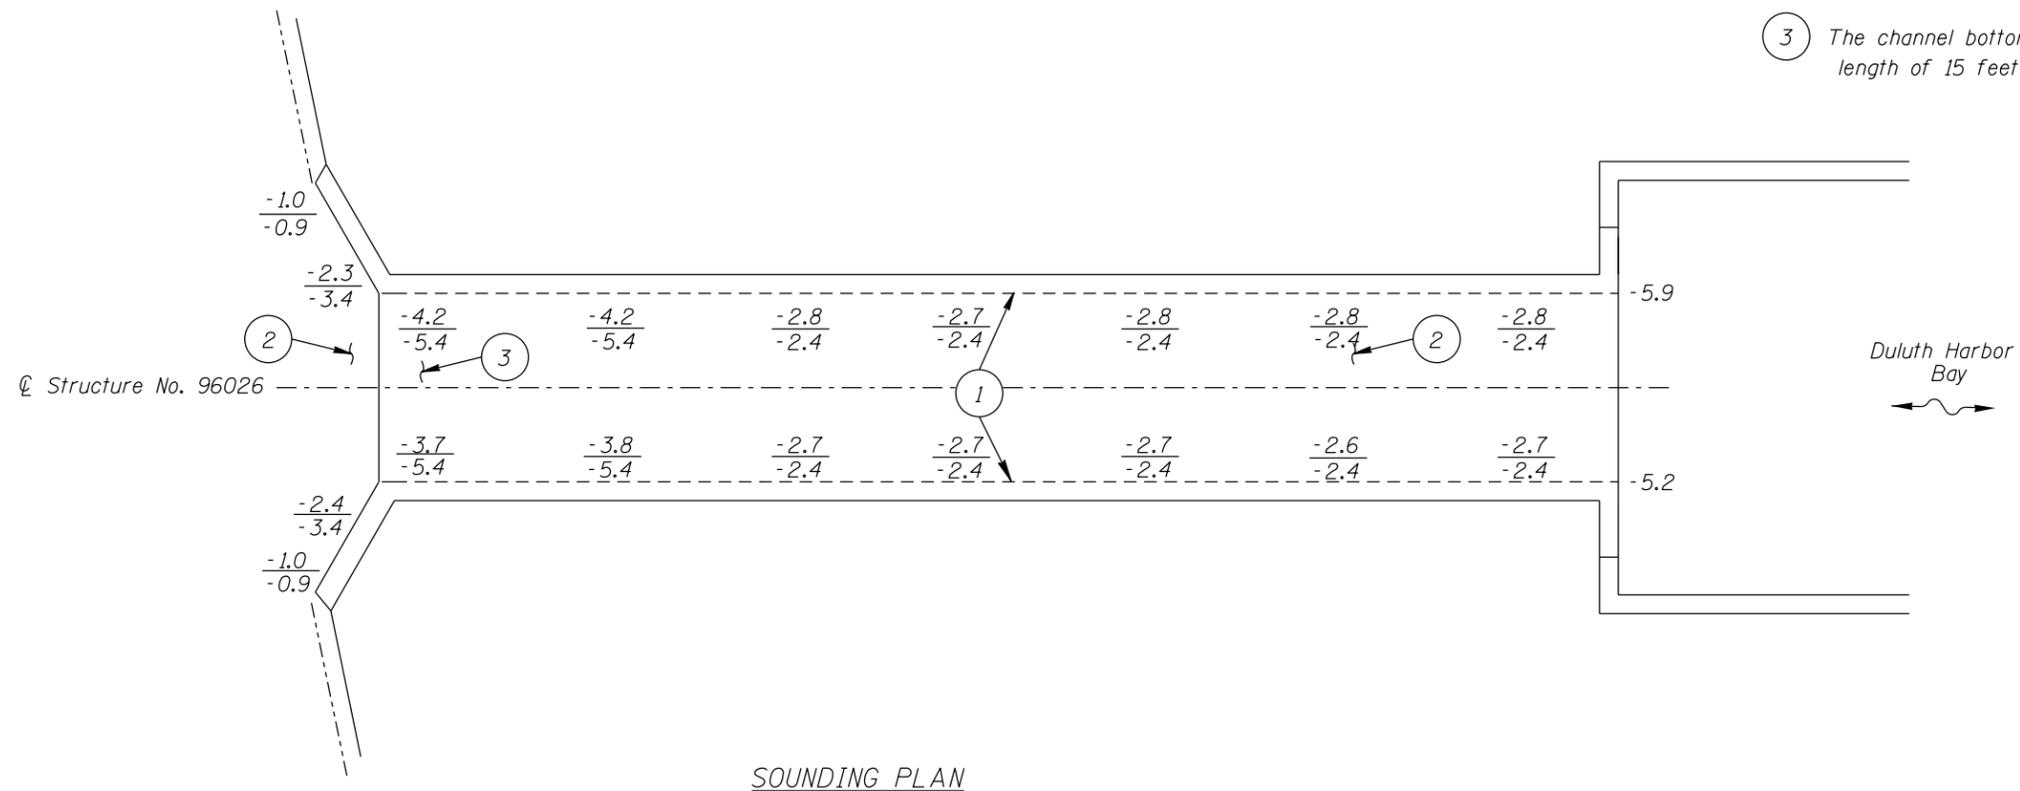
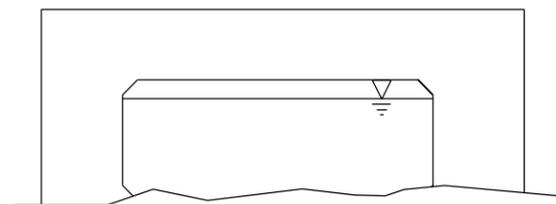
MINNESOTA DEPARTMENT OF TRANSPORTATION UNDERWATER BRIDGE INSPECTION		
STRUCTURE NO. 96026 MSAS 119 (RAILROAD STREET) OVER STREAM CITY OF DULUTH		
INSPECTION AND SOUNDING PLAN		
Drawn By: MBP	COLLINS ENGINEERS	Date: June, 2012
Checked By: DGS		Scale: NTS
Code: 742396026		Figure No.: I

- 1 The concrete was generally smooth and sound. The joints between culvert segments exhibited 1/4- to 1-inch-wide horizontal gaps (acceptable for tongue and groove joint arrangement) and up to 1/2-inch differentials across adjacent faces at various joints.
- 2 The channel bottom consisted of sand infill (up to 3 feet deep) on culvert floor.
- 3 The channel bottom consisted of riprap with no probe rod penetration for a length of 15 feet along the western end of the box culvert.
