UNDERWATER BRIDGE INSPECTION REPORT

STRUCTURE NO. L8542

MUN ROUTE 10

LITTLE FORK RIVER

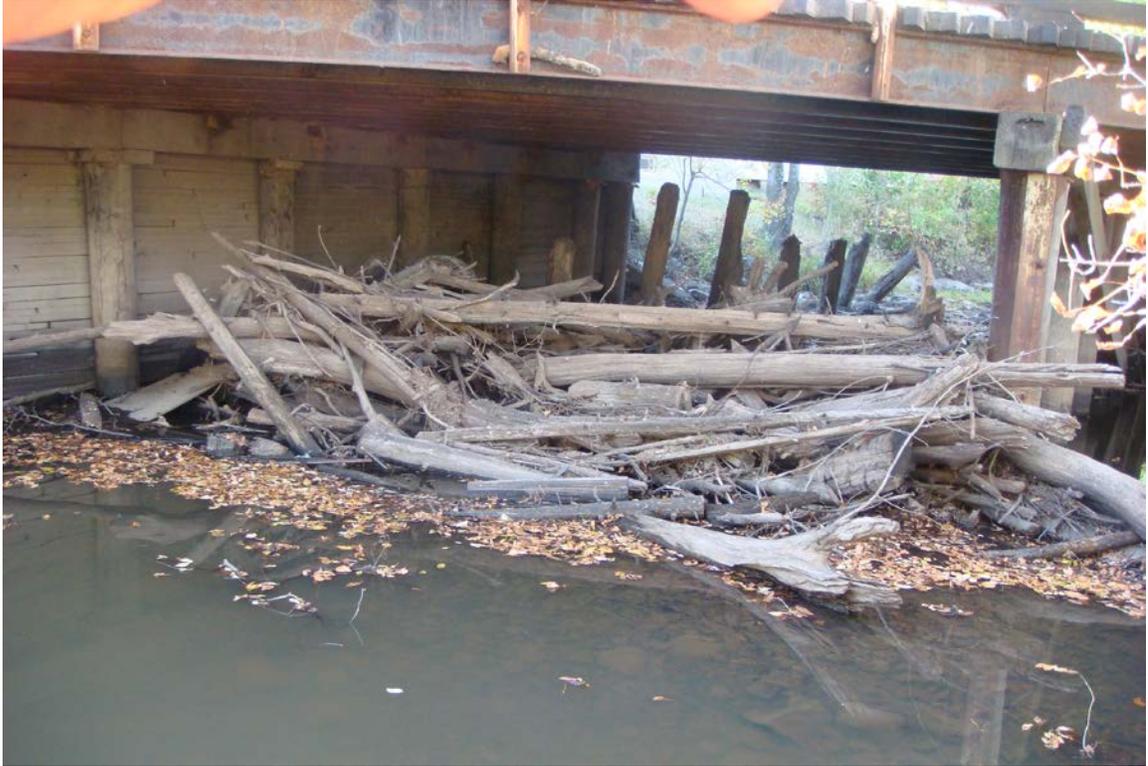
Photograph 5. View of Heavy Timber Debris Accumulation between the South Abutment and Bent 1, Looking Southwest.

- (A) The timber debris accumulations between the South Abutment and Bent 1 and throughout the channel is obstructing majority of the channel and should be removed at this time. Removal of the timber debris will reduce excessive lateral loads on the bent, limit further debris accumulation, and reduce the likelihood of channel bottom degradation resulting from obstructed flow.

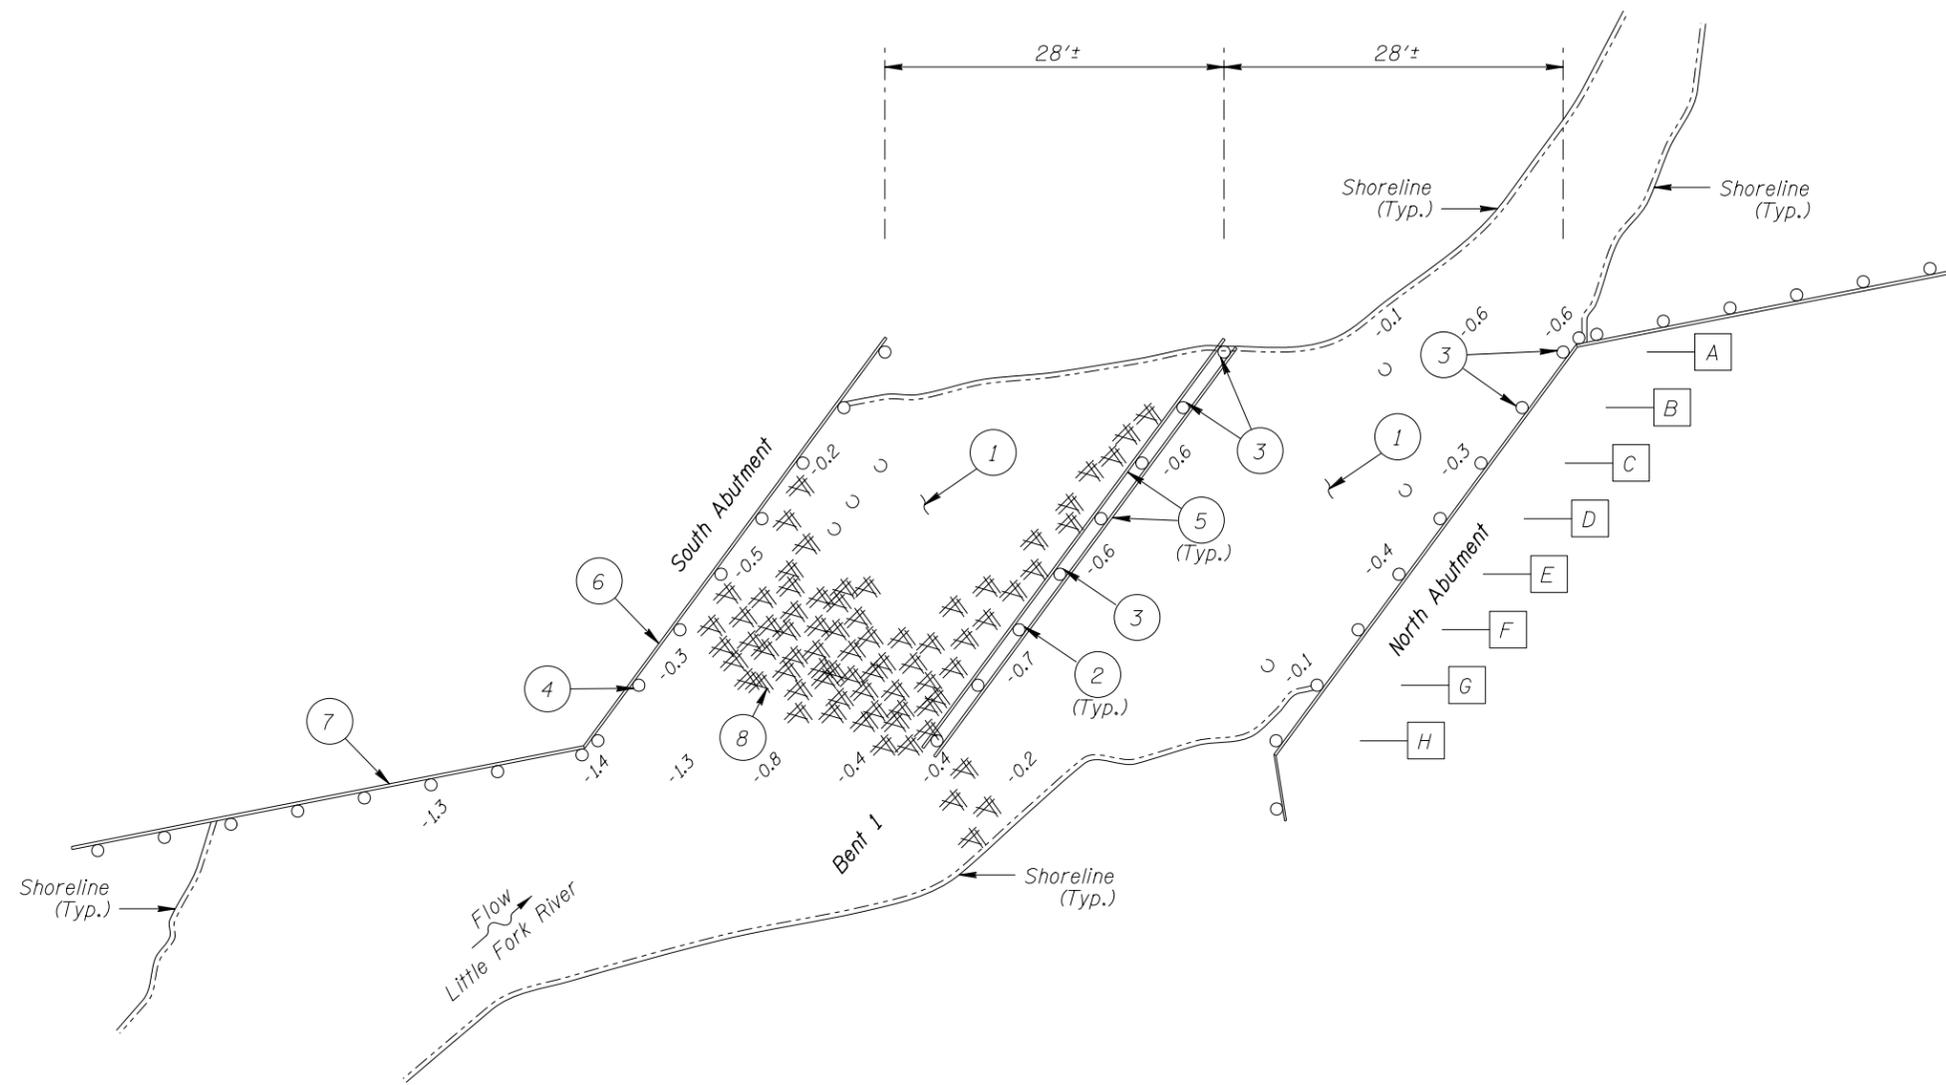
SOUNDING PLAN

- 1 The channel bottom material typically consisted of rocks, gravel and silt with a maximum probe rod penetration of 2 inches. Random debris was scattered throughout the channel.

- 2 The timber piles typically exhibited external decay from the channel bottom to 1 foot above the waterline. The timber typically allowed an awl penetration of 1/4 inch and a maximum penetration of 1/2 inch. From 1 foot above the waterline to the top of the piles, the timber was sound with random splitting or checking up to 3/8 inch wide and 1 inch deep.

- 3 Heavier timber deterioration and decay, allowing a maximum awl penetration of 1 inch, was observed on the west side of Piles A, B and E of Bent 1 and Piles A and B of the North Abutment. The area of deterioration and decay typically extended from the channel bottom to 1 foot above the waterline.

- 4 Pile G of the South Abutment had cap bearing only on the southern 2 inches of the pile.
- 5 The timber cross-bracing was typically sound with random splitting at the connections up to 1/2 inch wide.

- 6 A 1 inch gap was observed in the 2"x4" backwall boards at approximately 4 feet above the waterline extending from Pile H to Pile F of the South Abutment. No significant loss of backfill was observed.

- 7 A slight rotation towards the channel was observed at the southeast wingwall. The wall showed no signs of structural inadequacy.
- 8 A heavy accumulation of timber debris consisting of 1 foot diameter and smaller logs and branches was observed extending from Bent 1 to the South Abutment as shown. The debris extended from the channel bottom to 4 feet above the waterline. Random steel and old tires debris was scattered throughout the timber debris.
