UNDERWATER BRIDGE INSPECTION REPORT

STRUCTURE NO. L9571

PELICAN RIVER

MINNESOTA DEPARTMENT OF TRANSPORTATION
UNDERWATER BRIDGE INSPECTION

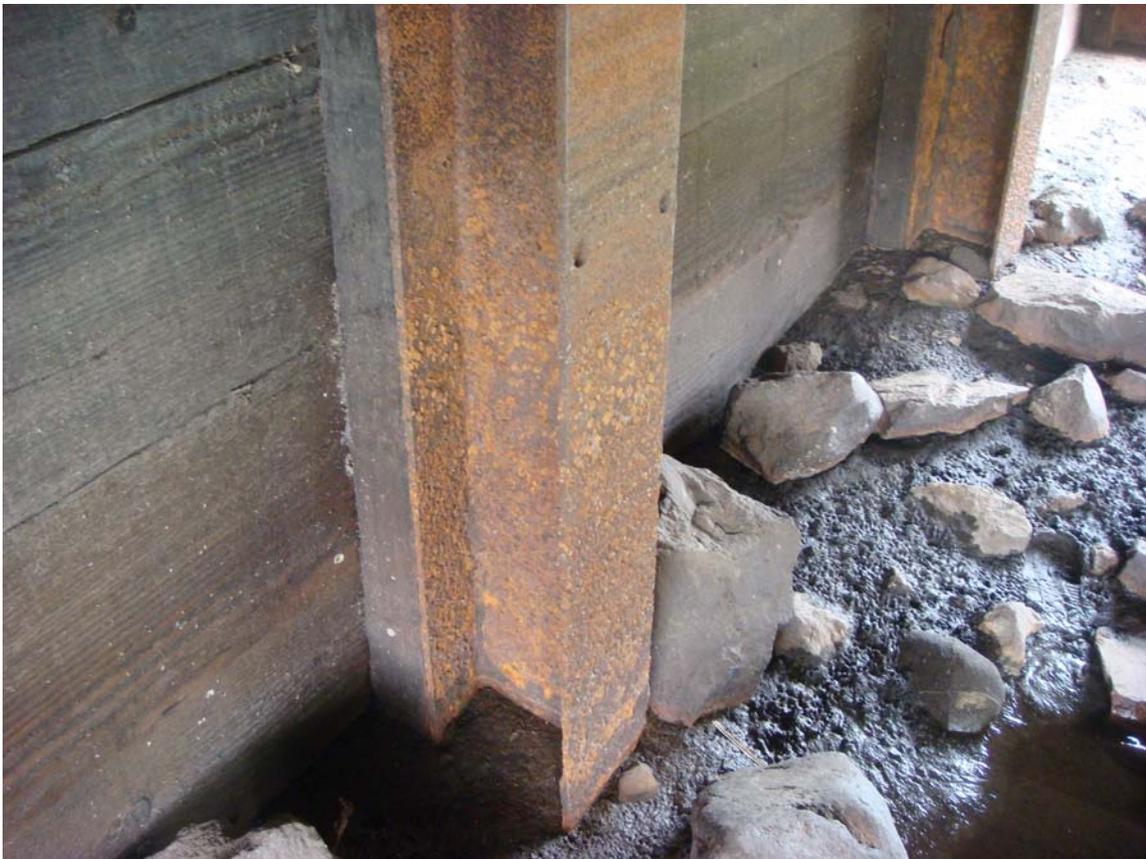
- (A) The channel bottom material typically consisted of riprap, up to 2 feet in diameter, with sand infill having a maximum probe rod penetration of 1 foot.
- (B) The steel H-Piles typically exhibited light surface corrosion with pitting up to 1/32 inch deep extending from the top of the pile to 2 feet above the waterline. From 2 feet above the waterline to the channel bottom the H-Piles exhibited moderate corrosion with pitting up to 1/8 inch deep and up to 1/8 inch thick rust delaminations.
- (C) The timber backwall and wingwalls of the both abutments appeared sound and tight with no noticeable loss of backfill material or structural deficiencies.

Photograph 4. View of the Typical Steel Condition near the Channel Bottom, Looking Northeast.

Monitor the extent of corrosion and associated section loss on the steel H-Piles.

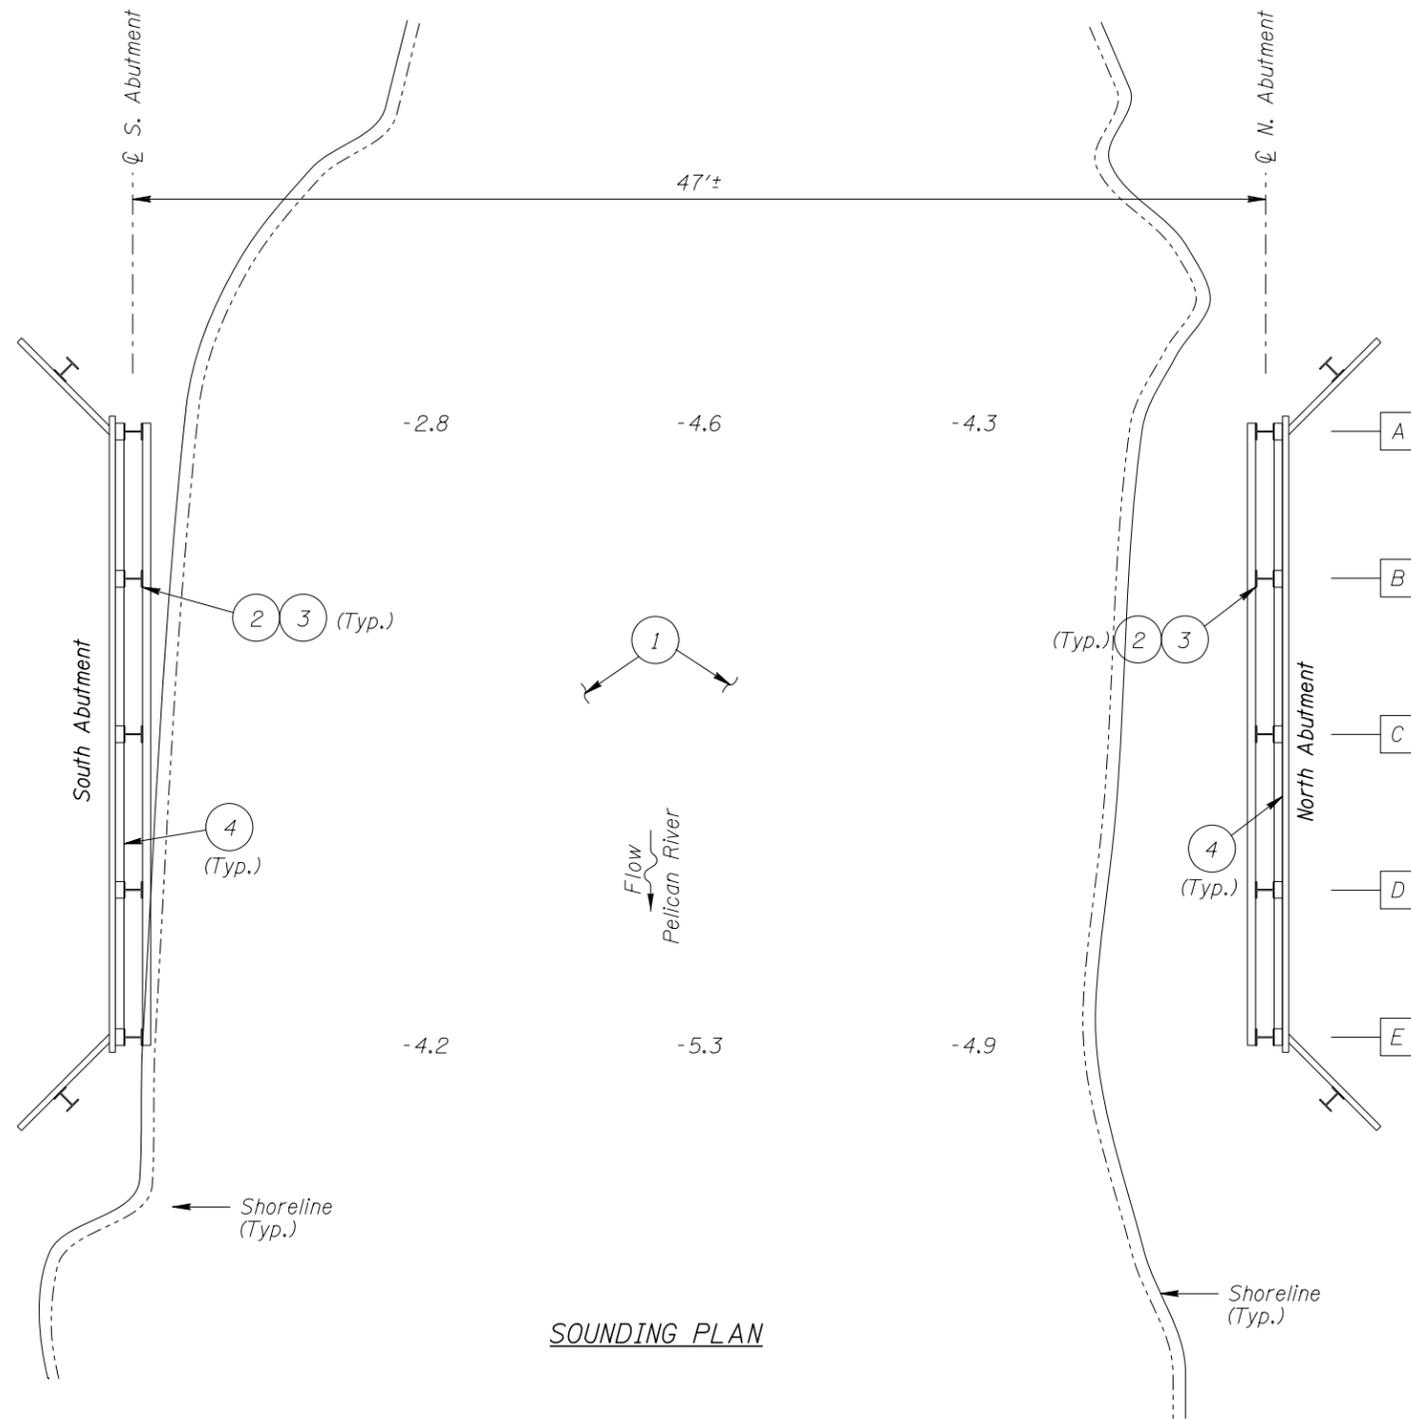
TYPICAL END VIEW OF ABUTMENTS

- ① The channel bottom material typically consisted of riprap up to 2 feet in diameter with sand infill having a maximum probe rod penetration of 1 foot.
- ② The steel H-Piles typically exhibited light surface corrosion with pitting up to 1/32 inch deep, extending from the top of the pile to 2 feet above the waterline.
- ③ The steel H-Piles typically exhibited moderate corrosion with pitting up to 1/8 inch deep and rust delaminations up to 1/8 inch thick, extending from 2 feet above the waterline to the channel bottom.
- ④ The timber backwall was typically sound and well aligned with no noticeable loss of backfill or notable defects.
