# 2017 UNDERWATER BRIDGE INSPECTION REPORT

## BRIDGE # 31510 CSAH 62 over MISSISSIPPI RIVER

Date of Inspection: 09/29/2016

Contractor: Collins Engineers, Inc.

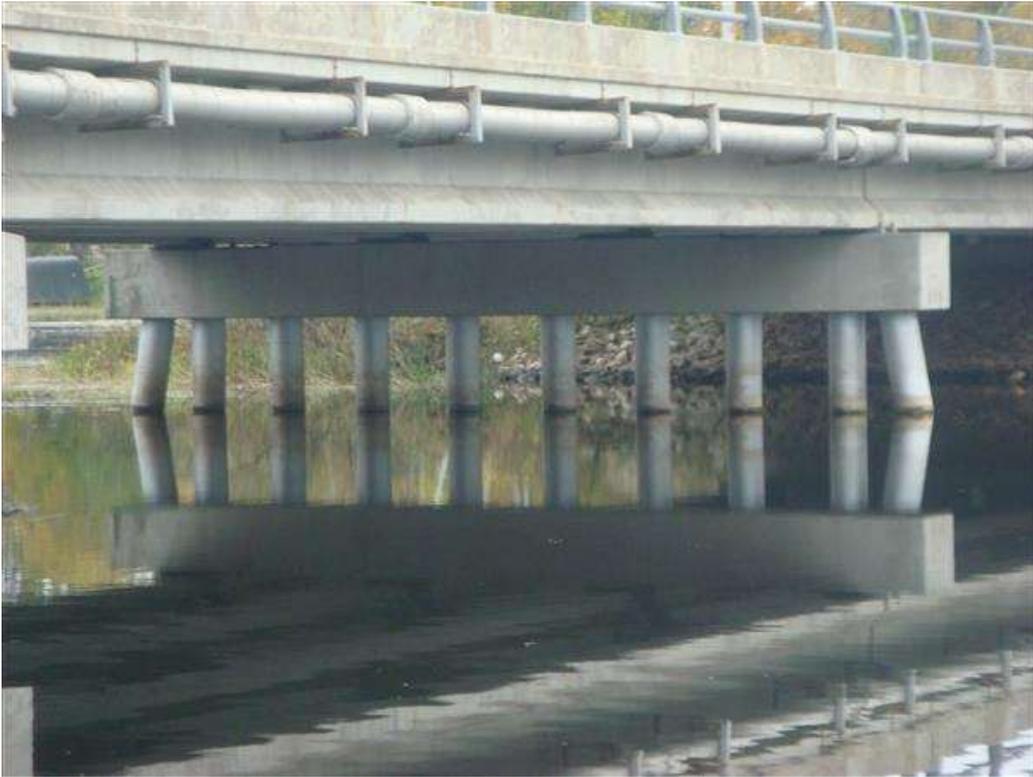
Photo 3 - View of Pier 1, Looking Southeast

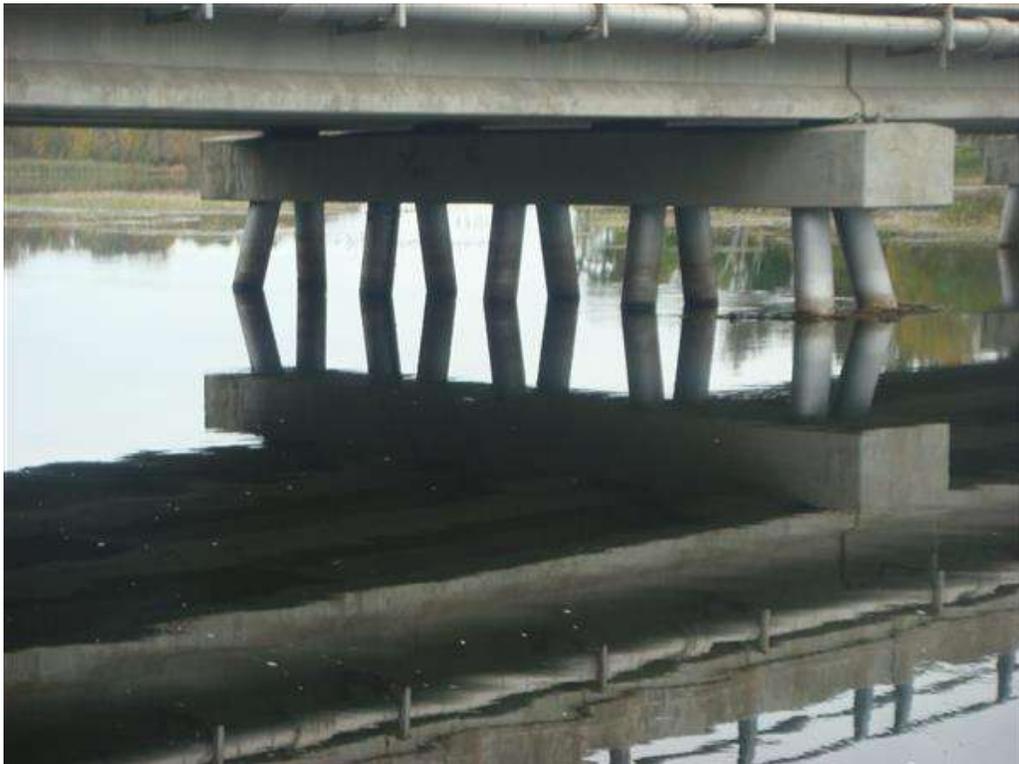
Photo 4 - View of Pier 2, Looking Southeast

- 5 Minor scour depressions, up to 2 feet deep with up to 5 feet radius, were observed around the upstream piles of Pier 2.
- 6 Moderate accumulation of organics/vegetation and two 1 foot diameter logs extended from the channel bottom up 2 feet at the upstream nose of Pier 3.

- 7 Timber debris consisting of a 2 foot diameter by 5 foot long log was observed on the channel bottom against the middle pile on the south side of Pier 2.

- 8 Area of reeds/grass from the waterline down 4 feet measured 3 feet in diameter at the upstream end of Pier 2.
- 9 Timber debris consisting of an 18 inch diameter log was observed on the channel bottom along the two downstream piles on the north side of Pier 2.

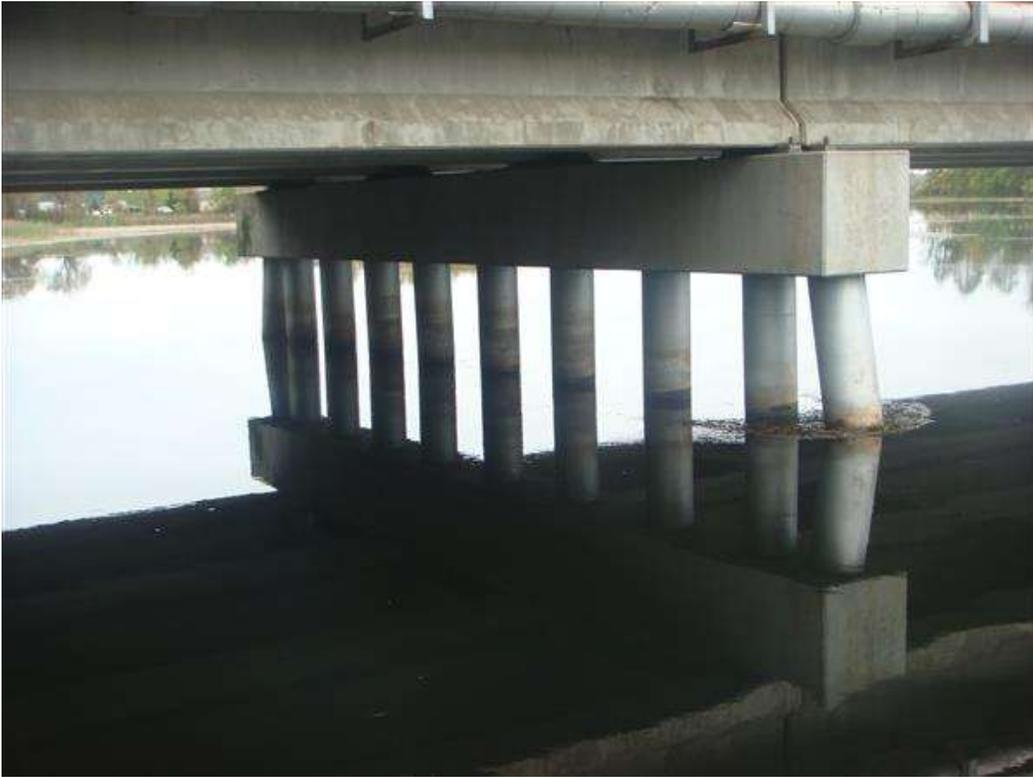
Photo 5 - View of Pier 3, Looking Southeast

- 10 The downstream battered pile of Pier 3 exhibited a 15 degree bend (deformation) 5 feet below the waterline where the pile then extended vertically into the channel bottom. (Bend appears to be due to driving the pile during original bridge construction.)

- 11 Timber debris consisting of three 1 foot diameter logs was observed on the channel bottom along the downstream three vertical piles on the north side of Pier 3.

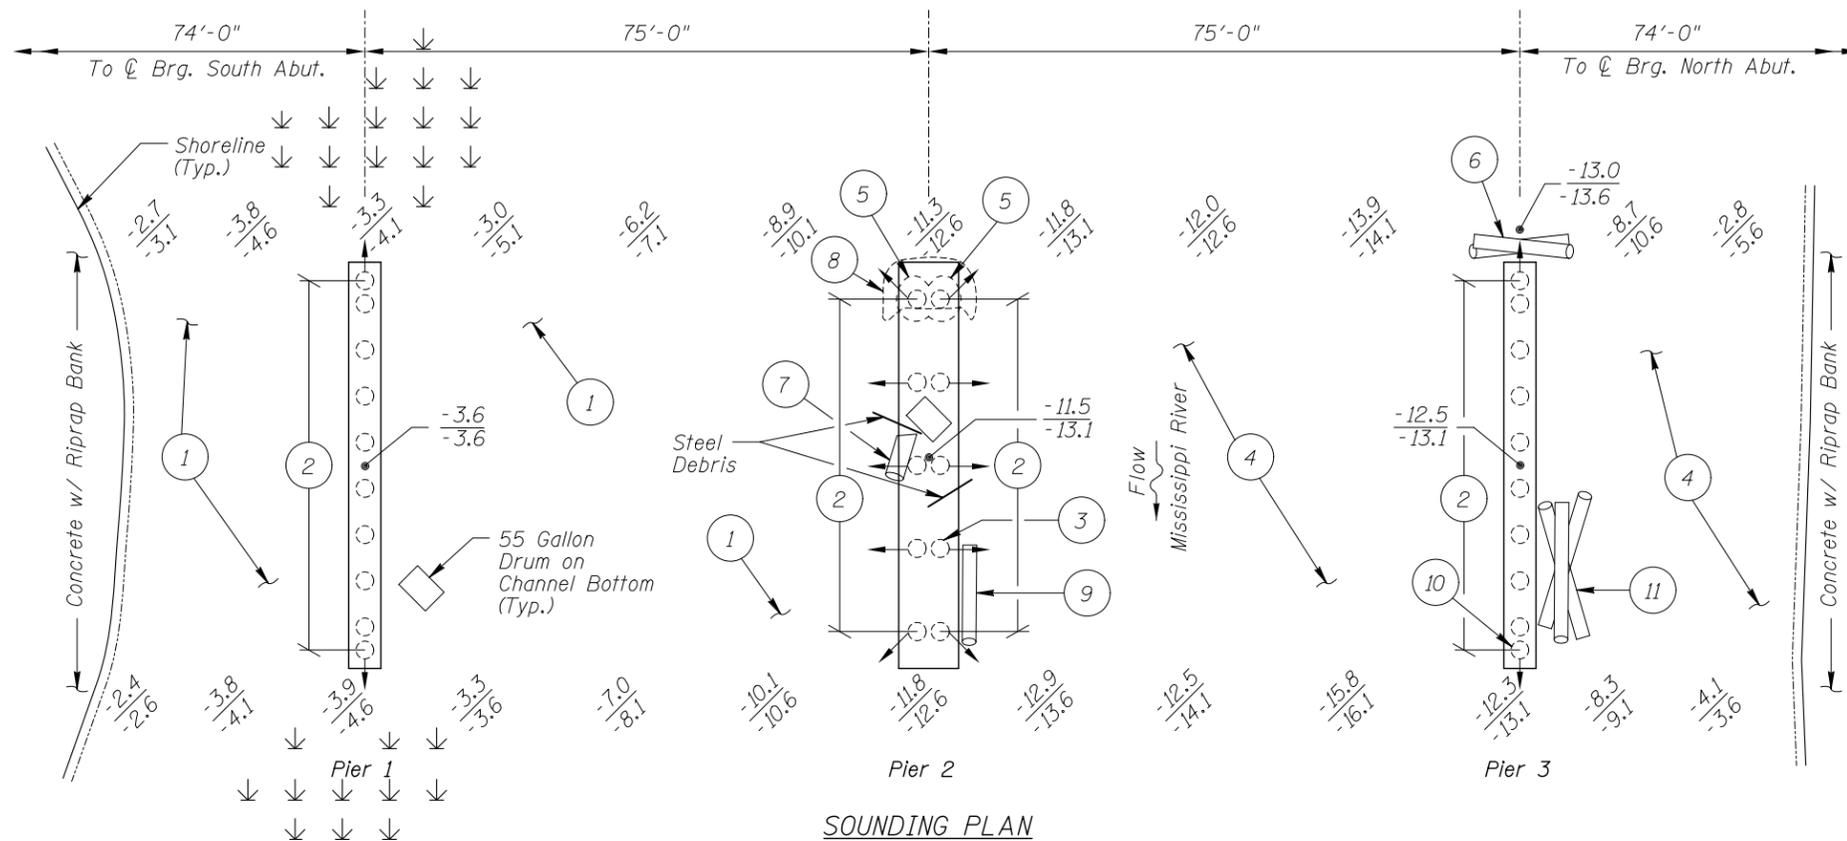
**SOUNDING PLAN**

- 1 The channel bottom material around Piers 1 and 2 consisted of soft silty sand allowing maximum probe rod penetrations of 1 to 1.5 feet.
- 2 Light to moderate corrosion with rust nodules covered 75% to 100% of the pile surfaces from the waterline to the channel bottom. Minimal section loss was observed with typical pitting up to 1/32 inch deep and maximum pitting in random instances up to 1/16 inch deep near the waterline.

- 3 Vertical crack along welded joint noted in previous inspection, August 27, 1997, has been repaired with a bolted steel collar extending from the underside of the pile cap to 3 feet below the waterline. The repair was in good and sound condition.

- 4 The channel bottom material around Pier 3 consisted of firm sandy gravel with 6 inch to 2 foot diameter rocks allowing probe rod penetrations of 2 to 4 inches.
