2016 UNDERWATER BRIDGE INSPECTION REPORT

BRIDGE # 36013 US 71 over LITTLE FORK RIVER

Date of Inspection: 06/03/2016

Contractor: Collins Engineers, Inc

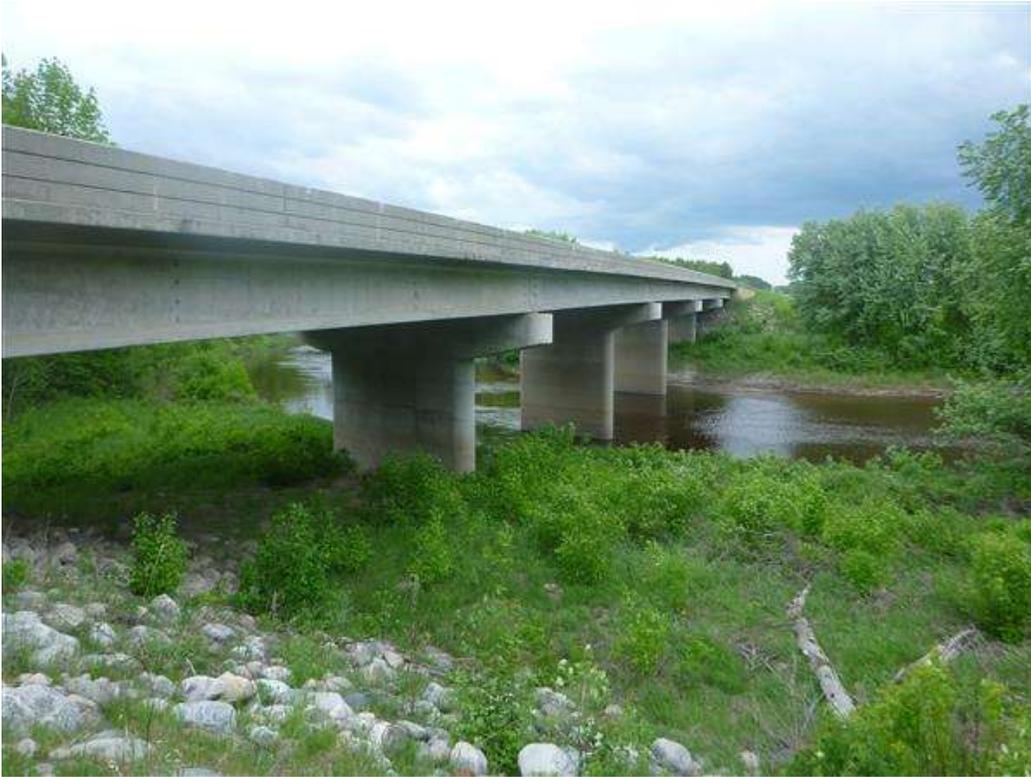
Photo 1 - Overall View of Downstream Fascia, Looking Southeast.

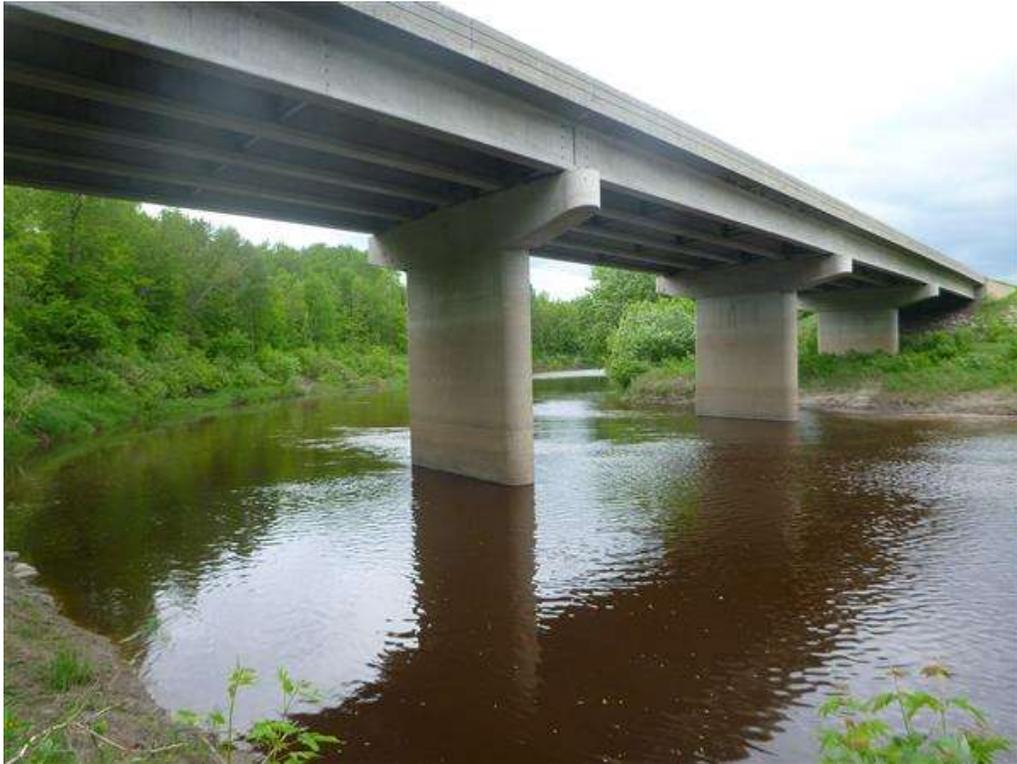
Photo 2 - Overall View of Upstream Fascia, Looking Northwest.

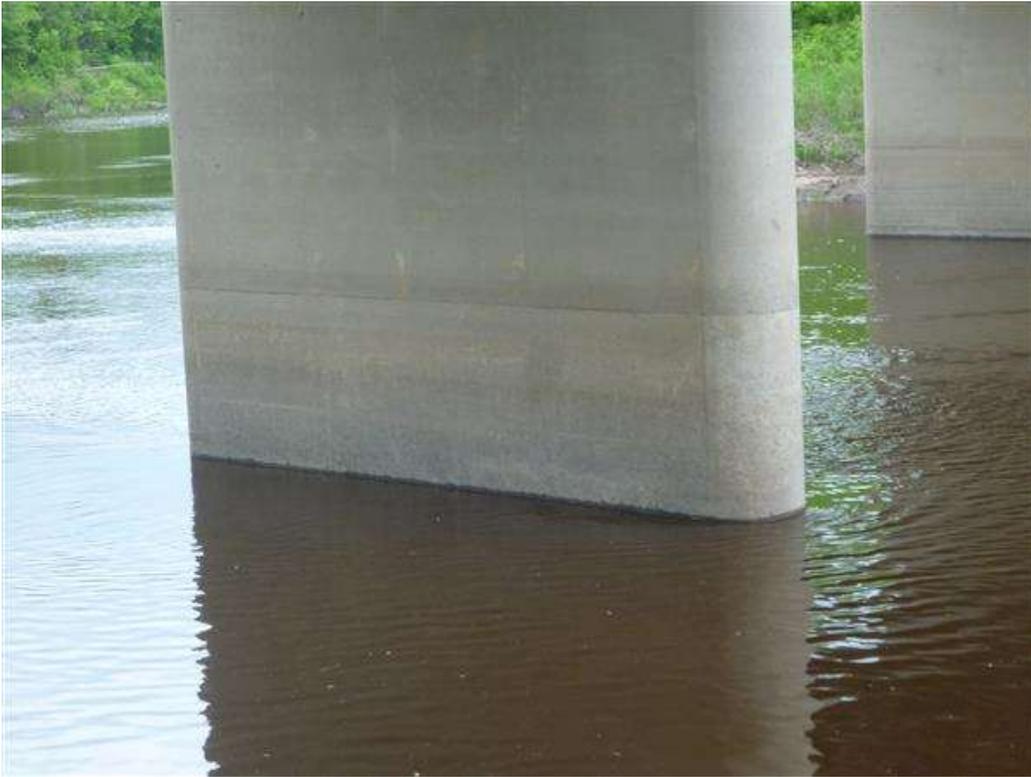
The substructure units inspected at Bridge No. 36013, Piers 2 and 3, were found to be generally in good condition with no defects of structural significance observed. A minor scour depression was observed beginning at the upstream nose of Pier 2, and running along entire north face ending at the downstream nose. Light accumulations of timber debris were noted at the upstream nose both piers. No significant changes have occurred to the substructure condition or the channel bottom configuration since the 2012 inspection.

Photo 3 - Overall View of Pier 2, Looking Northwest.

Monitor accumulations of timber debris during future inspections, and consider removal operations if debris is found to be increasing excessively in the future. Reinspect the submerged substructure units at the normal maximum recommended (NBIS) interval of sixty (60) months.

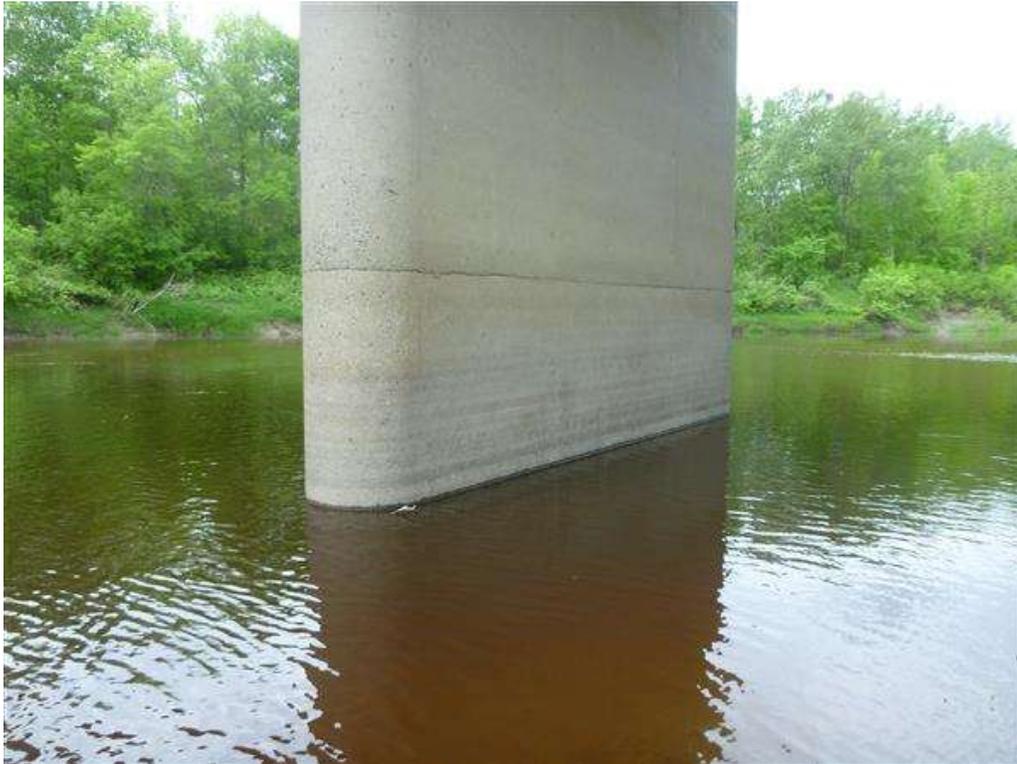
Photo 4 - Overall View of Pier 3, Looking Southwest.

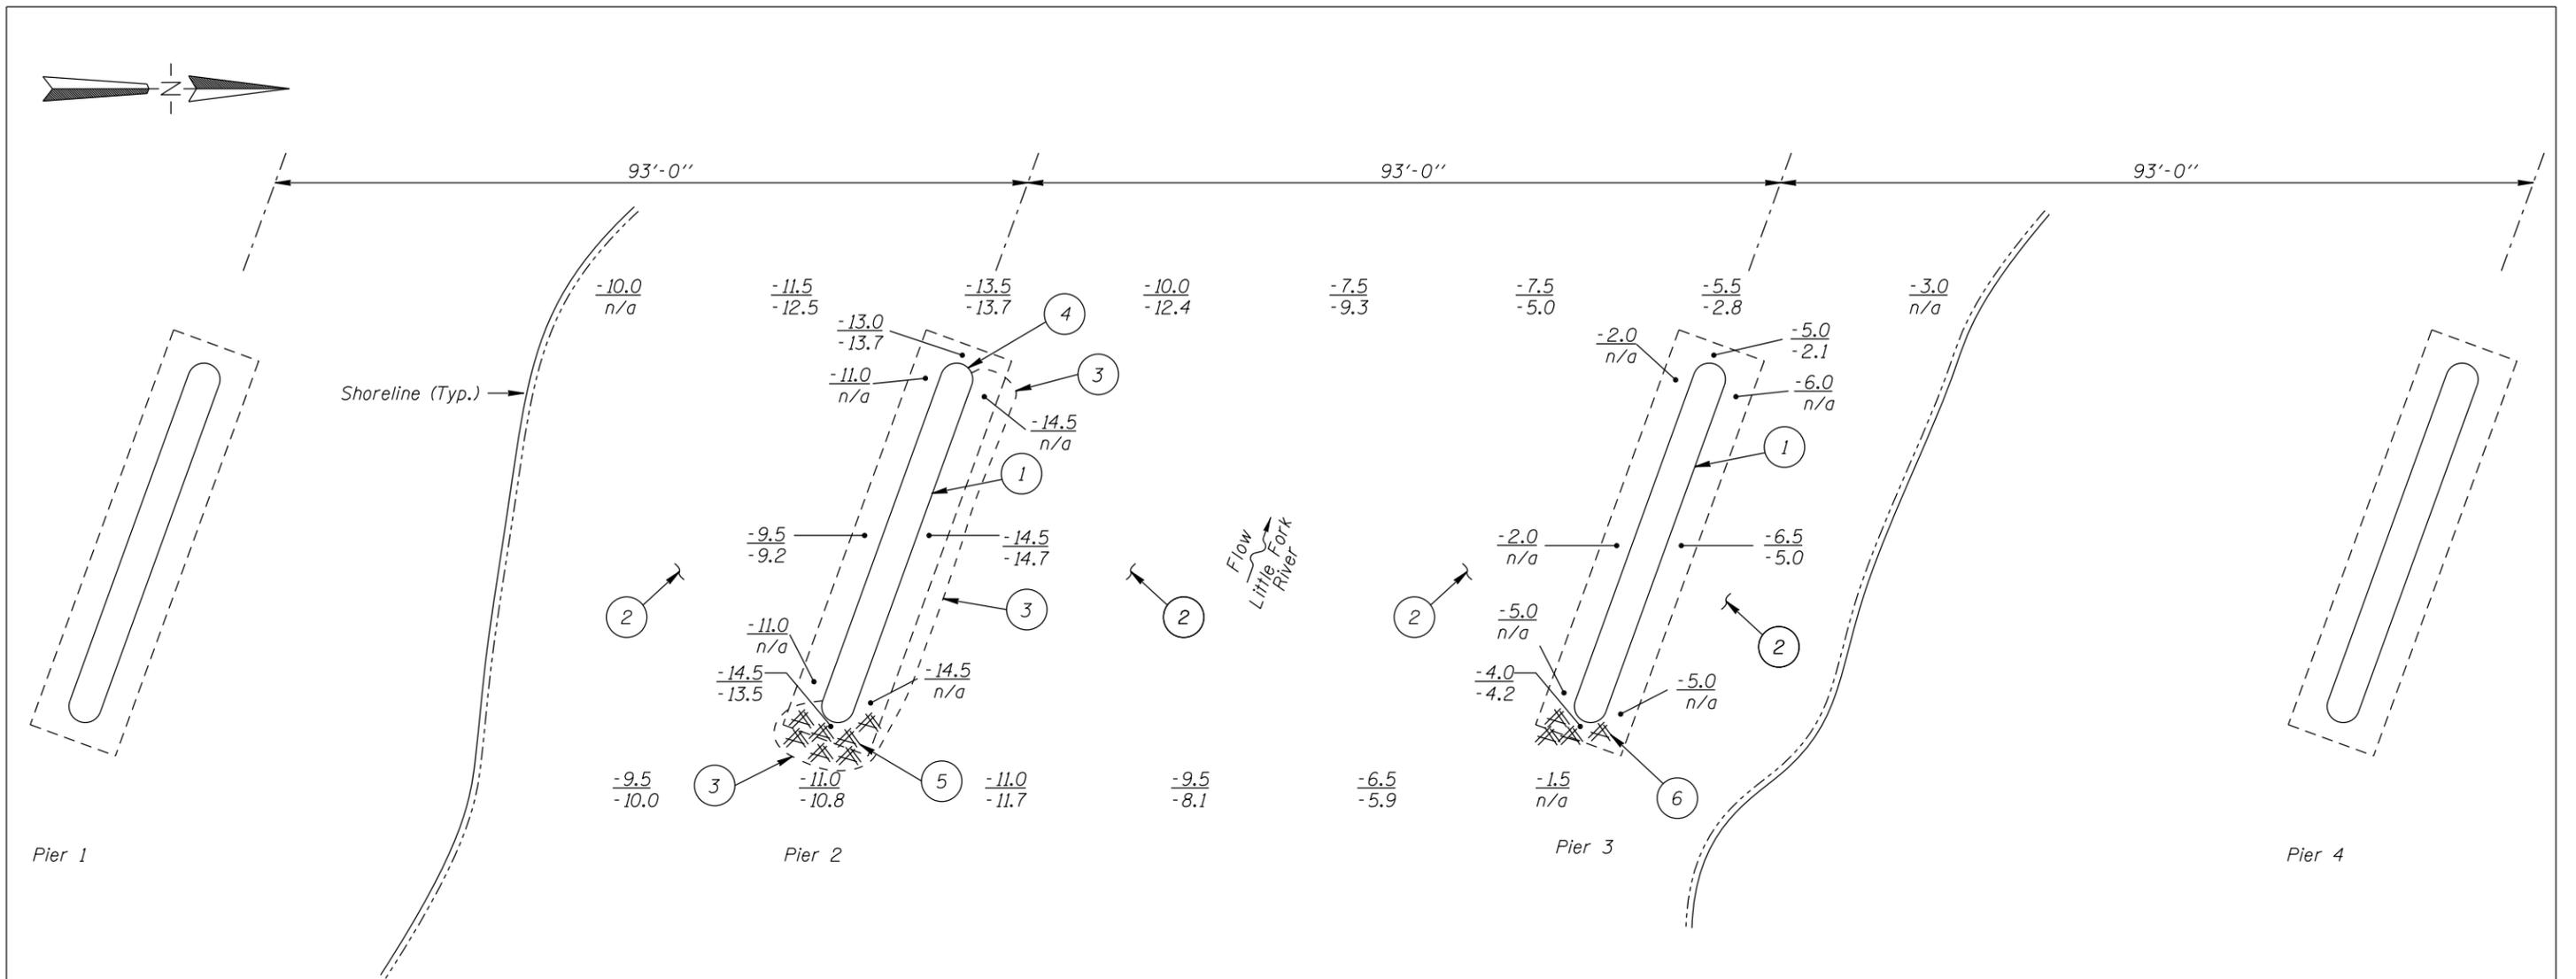
- ① The concrete of both piers was typically smooth and sound, except for some minor scaling from 4 feet above to 1 foot below the waterline with 1/4 inch maximum penetration.

- ② The channel bottom at Piers 2 and 3 typically consisted of silty sand, with some gravel, and allowed up to 6 inches of maximum probe rod penetration.

- ③ A 4 foot radius scour depression was observed at the upstream nose and along the north side of Pier 2. The depression was 3 feet deep relative to the adjacent channel bottom.

- ④ An 8 inch by 4 inch and 1 inch deep spall was observed at the downstream end of Pier 2 located approximately 10 feet below the waterline.
- ⑤ A light accumulation of timber debris, consisting of up to 6 inch diameter branches, was observed from the channel bottom up to the waterline, at the upstream end of Pier 3.

- ⑥ Moderate accumulation of timber debris, consisting of a 1 foot diameter log and 6 inch diameter and smaller branches, was observed around upstream nose of Pier 2 extending from channel bottom up 2 feet.
