# 2017 UNDERWATER BRIDGE INSPECTION REPORT

## BRIDGE # 58510 CSAH 61 over SNAKE RIVER

Date of Inspection: 09/22/2016

Contractor: Collins Engineers, Inc.

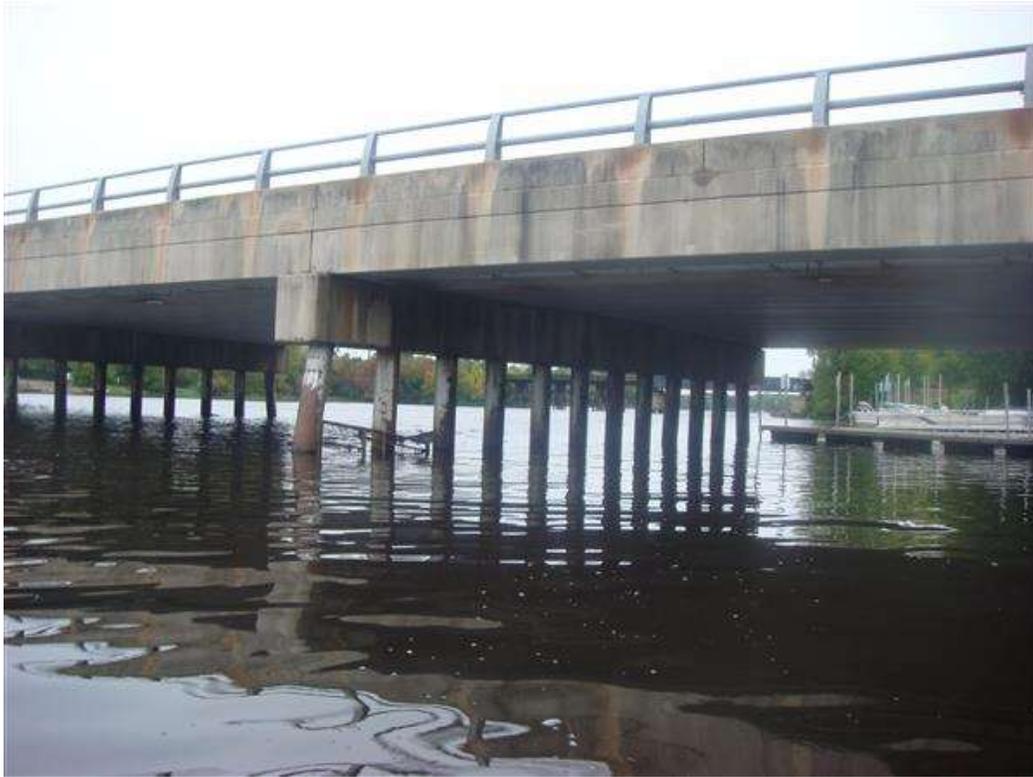
Photo 3 - View of Pier 1, Looking Northeast

- ⑥ Metal dock framing debris was observed around the two upstream piles of Pier 1.

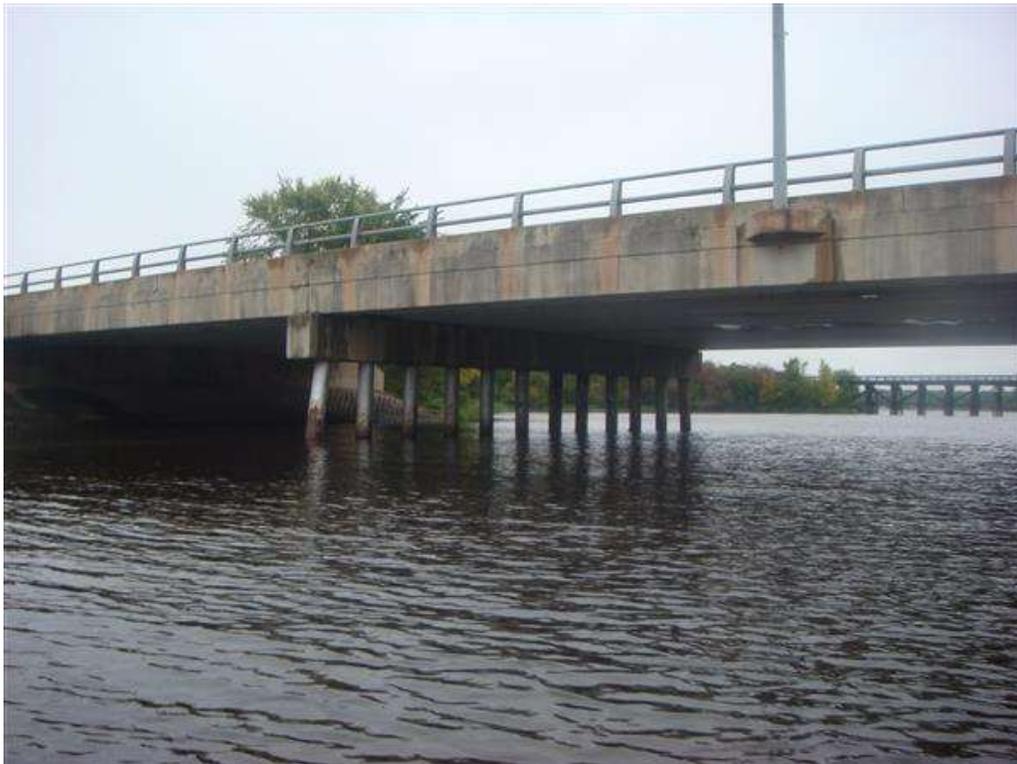
Photo 6 - View of Pier 4, Looking Northeast

- ② Four deformations were present on the east and south side of the easternmost pile of Pier 4:
  - A. A 6 inch wide by 3 inch high by 2 inch deep dent was located 4 feet below water on the south face.

- B. A 6 inch wide by 3 inch high by 1 inch deep dent was located at 3 feet below the waterline.
  - C. A 6 inch diameter by 2 inch deep dent was located at the waterline. This dent was accompanied by 1/8 inch deep corrosion pitting.

- D. An 8 inch diameter by 1 inch deep dent was located at 1.5 foot below the waterline.
- ③ Timber piles from an earlier structure were located along the north side of each pier. The tops of the piles were located at 2 feet above channel bottom.

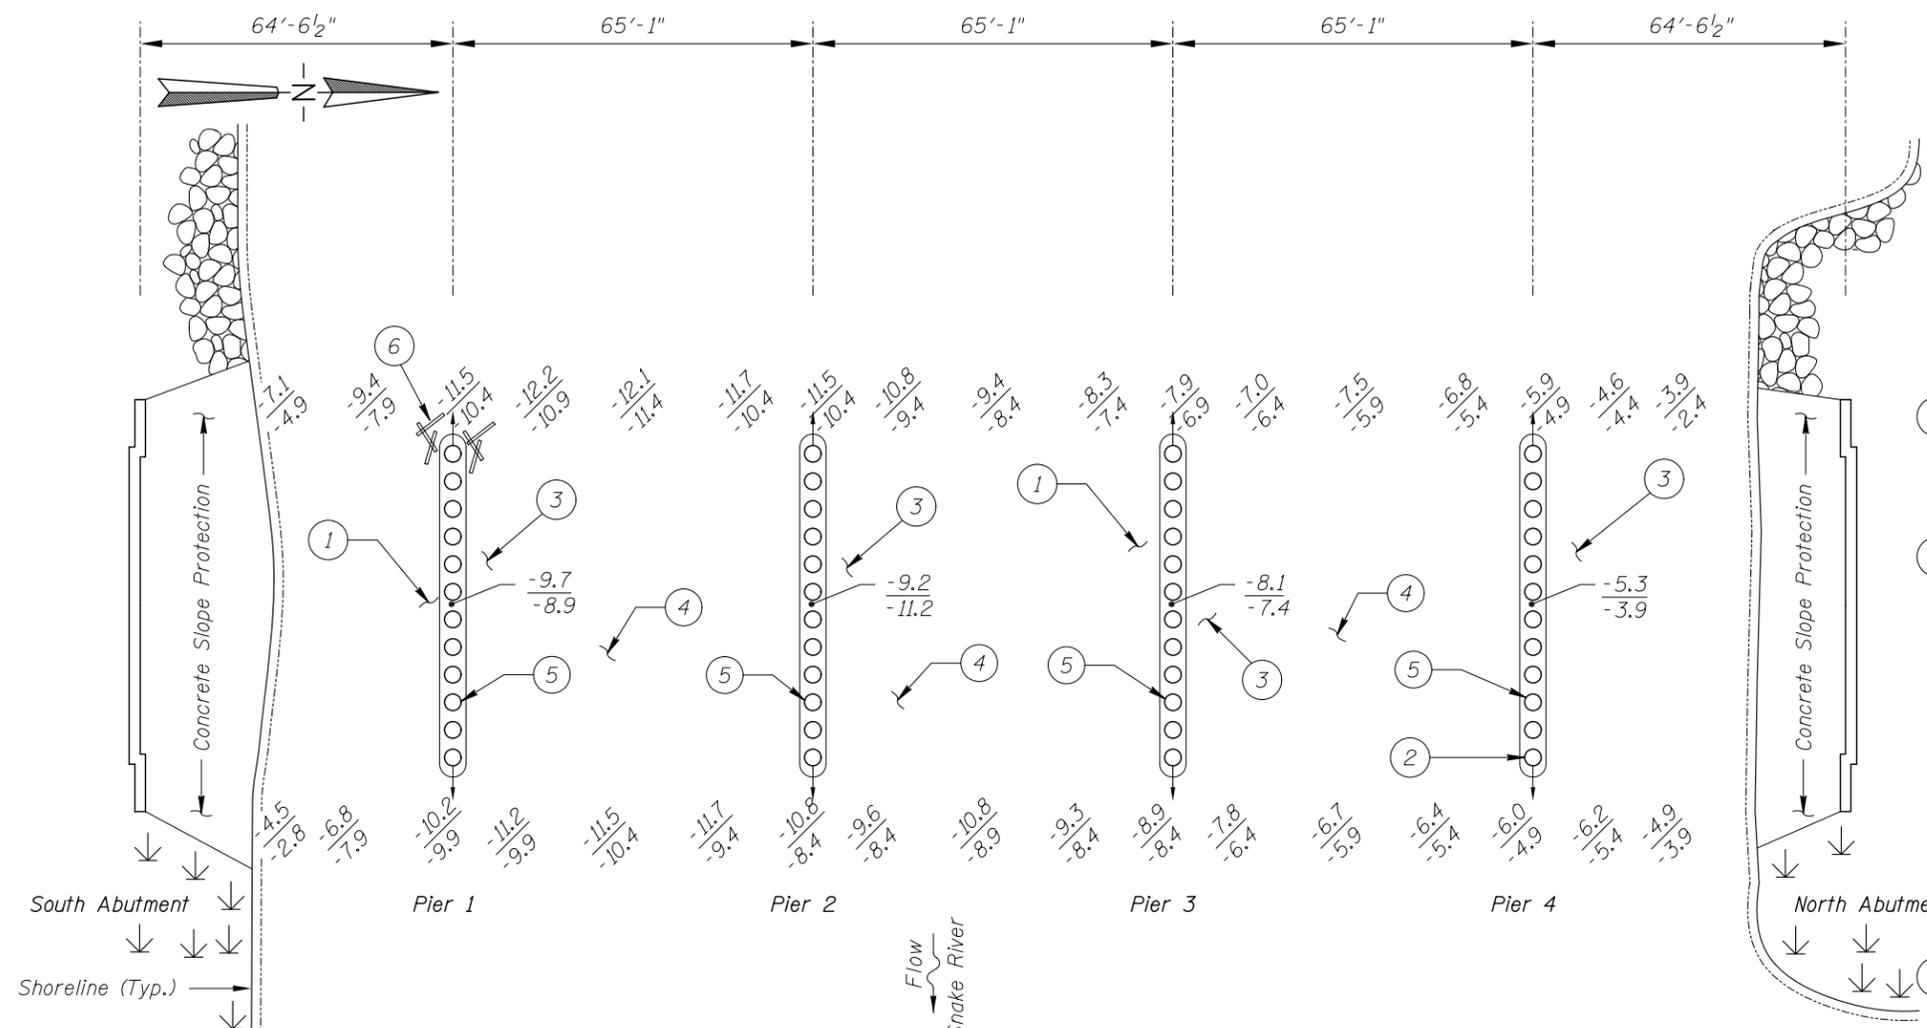
**SOUNDING PLAN**

- ① A light amount of scattered timber debris, 3 inch diameter and smaller, was observed along the south side of Piers 1 and 2. A light to moderate accumulation of timber debris, 6 inch diameter and smaller, was observed along the upstream half of Pier 3 extending from channel bottom to 3 feet below the waterline.

- ④ Channel bottom material consisted of gravelly sand with scattered riprap and cobbles allowing 2 inches of maximum probe rod penetration.
- ⑤ Light to moderate corrosion on all piles from bottom of cap to the channel bottom, with up to 1/2 inch diameter rust nodules below water covering up to 100% of the surface area of the piles, and with a maximum of 1/8 inch deep pitting from 1 foot below waterline to channel bottom.
