# 2016 UNDERWATER BRIDGE INSPECTION REPORT

## BRIDGE # 58520 CSAH 61 over KETTLE RIVER

Date of Inspection: 09/23/2016

## TABLE OF CONTENTS

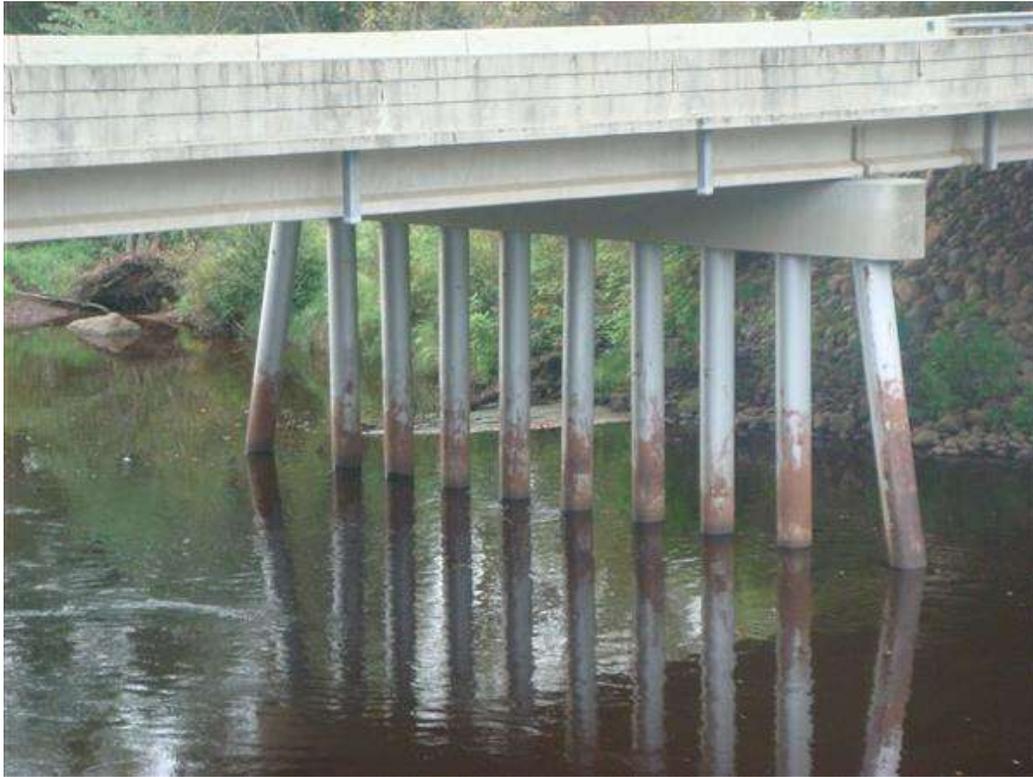
- E. Timber debris consisting of a 9 inch diameter log located on the on the channel bottom extended along the north side of Pier 1 from the upstream nose to the fourth from upstream pile.

- F. Minor accumulation of timber debris consisting of sticks and branches extended from the channel bottom up 3 feet located west of the upstream nose of Pier 1.

Photo 3 - View of Pier 1, Looking Southeast

- (A) Monitor timber debris accumulations at Piers 1 and 2 for any significant increases in size or extent. If timber debris accumulation increases removal may be warranted at that time to reduce excessive lateral loads on the pier, limit further debris accumulation, and reduce the likelihood of channel bottom degradation resulting from obstructed flow.
- (B) Reinspect the submerged substructure units at the normal maximum recommended (NBIS) interval of sixty (60) months.

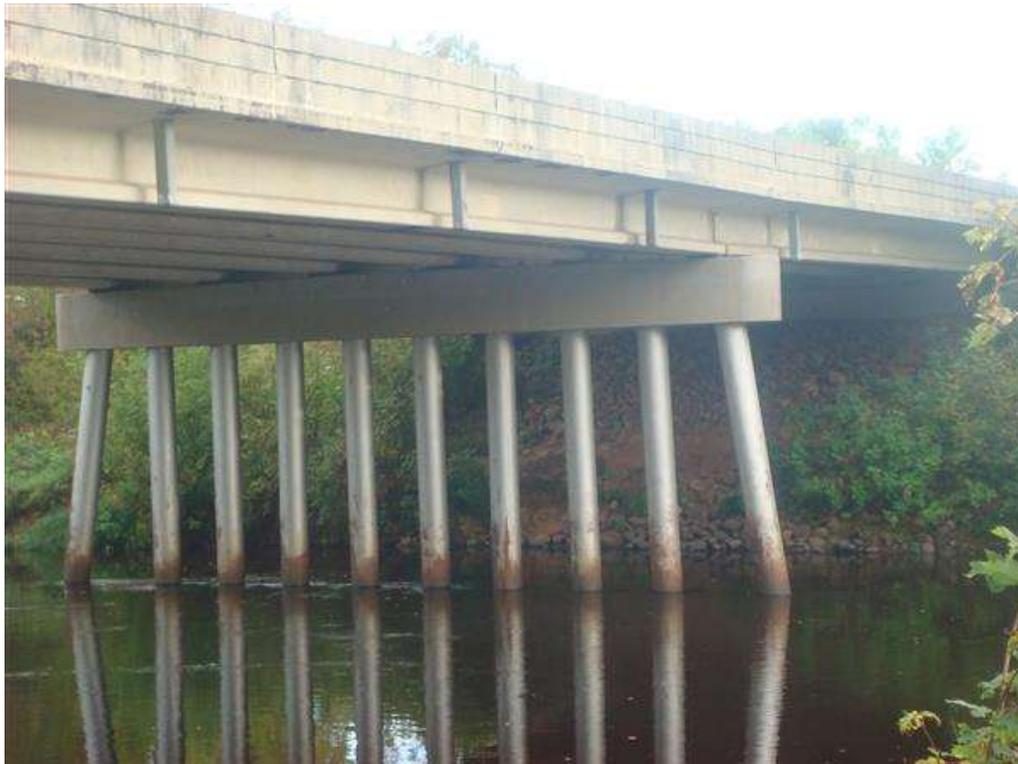
- D. Timber debris with pieces up to 9 inches in diameter extended from the channel bottom up 4 feet at the upstream nose and along the south side of Pier 2.

Photo 4 - View of Pier 2, Looking Northwest

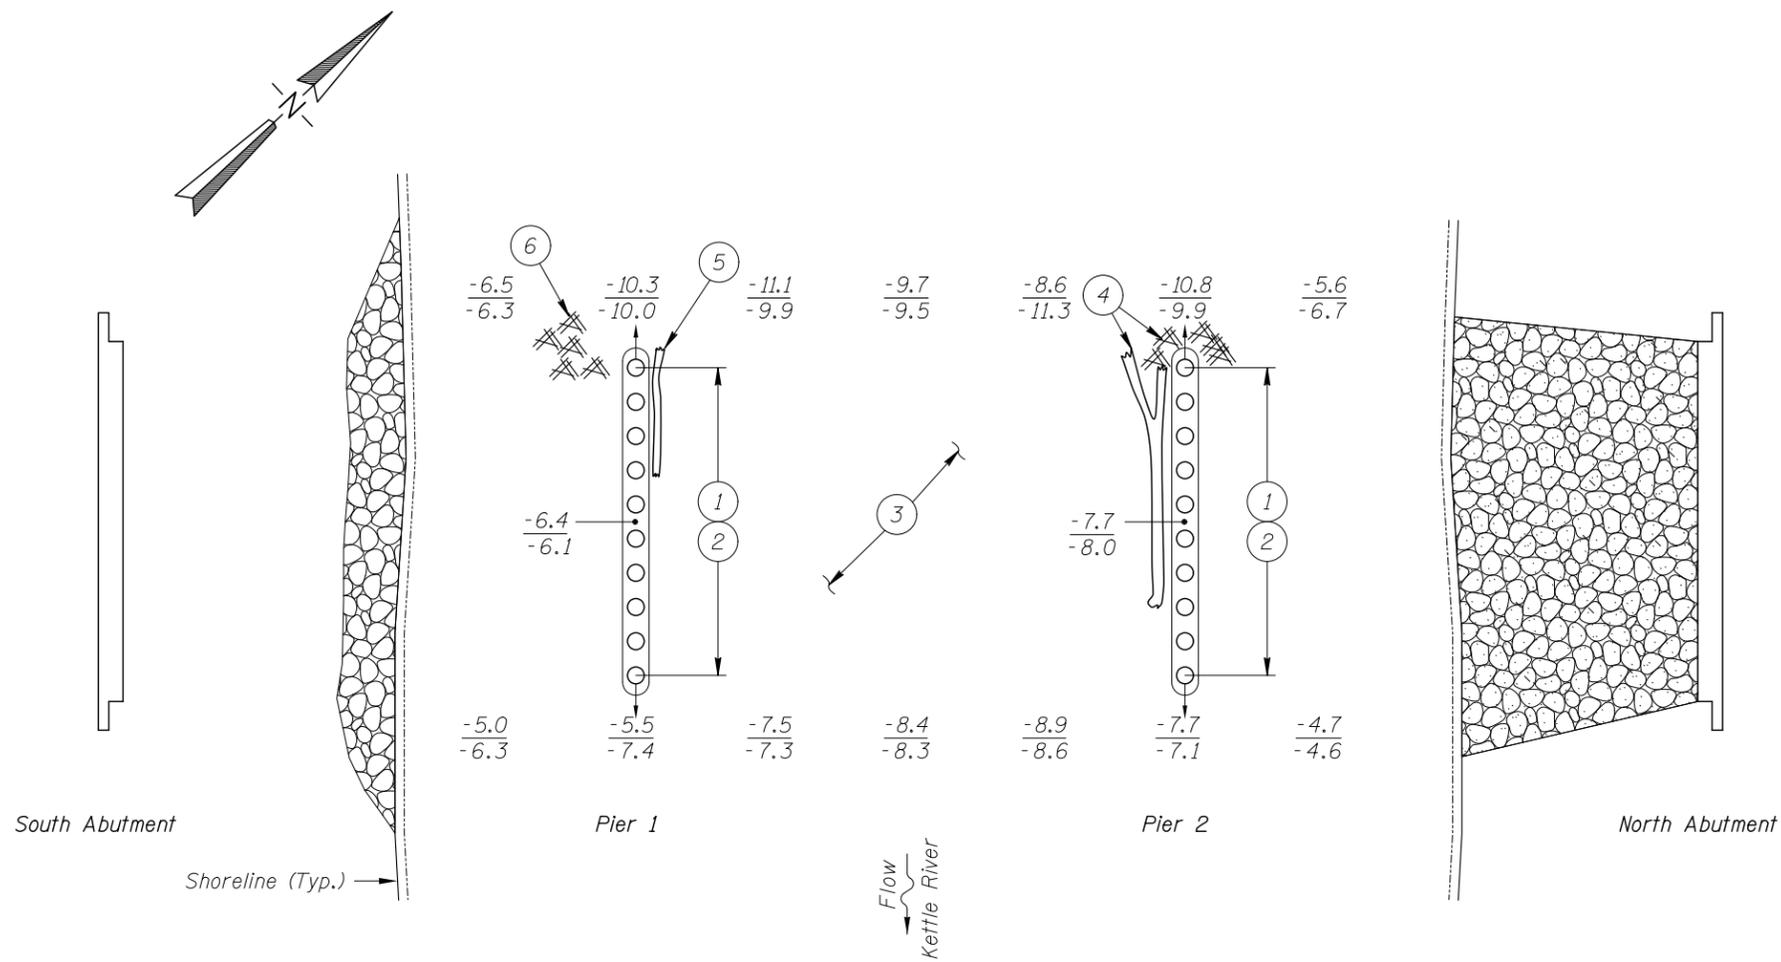
**SOUNDING PLAN**

- The steel piles exhibited coating failure on 80% to 100% of the surface area from 5 feet above the waterline to the channel bottom.
- The steel piles exhibited mostly light to at times moderate corrosion with rust nodules and up to 1/8 inch deep pitting on up to 50% of the surface area from 3 feet above the waterline to the channel bottom. Deterioration was heaviest from 1 foot below waterline to 5 foot below waterline.

- The channel bottom material consisted of sandy gravel and approximately 4-inch-diameter cobbles with random larger rocks on the banks allowing up to 2 inches of probe rod penetration.

- Timber debris with pieces up to 9 inches in diameter extended from the channel bottom up 4 feet at the upstream nose and along the south side of Pier 2.

- Timber debris consisting of a 9 inch diameter log located on the on the channel bottom extended along the north side of Pier 1 from the upstream nose to the fourth from upstream pile.

- Minor accumulation of timber debris consisting of sticks and branches extended from the channel bottom up 3 feet located west of the upstream nose of Pier 1.
