# 2017 UNDERWATER BRIDGE INSPECTION REPORT

## **BRIDGE # 58524 TWP 605 over KETTLE RIVER**

**Date of Inspection:** 09/23/2016

Contractor: Collins Engineers, Inc.

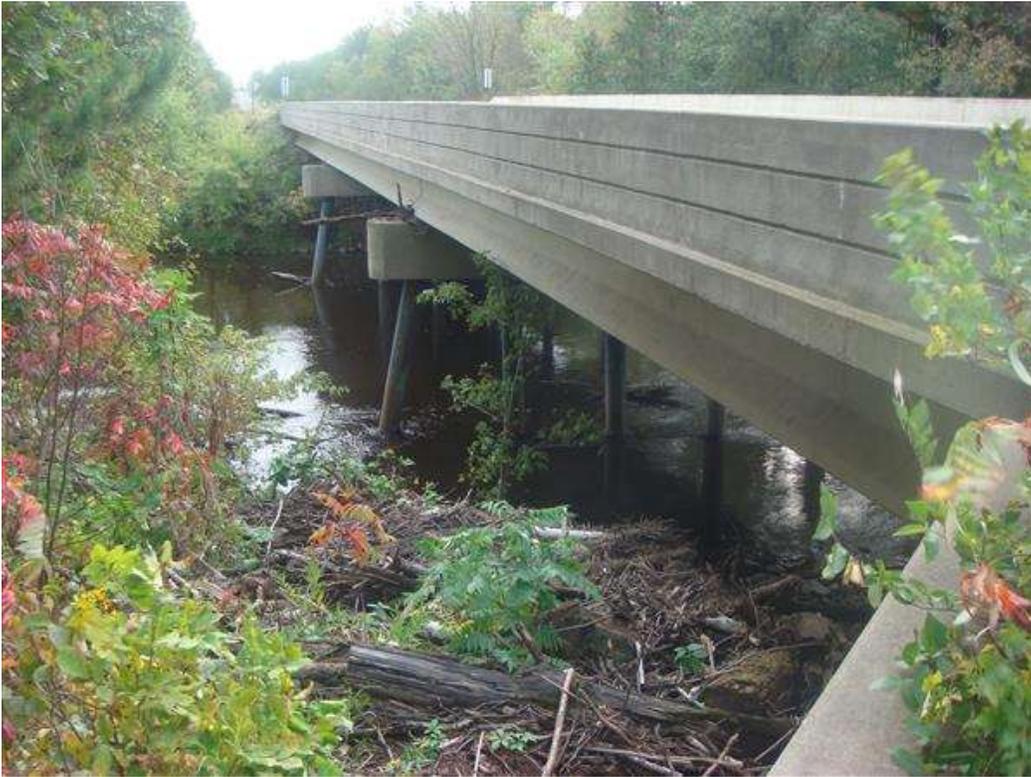
Photo 1 - Overall View of Upstream Fascia, Looking Southeast

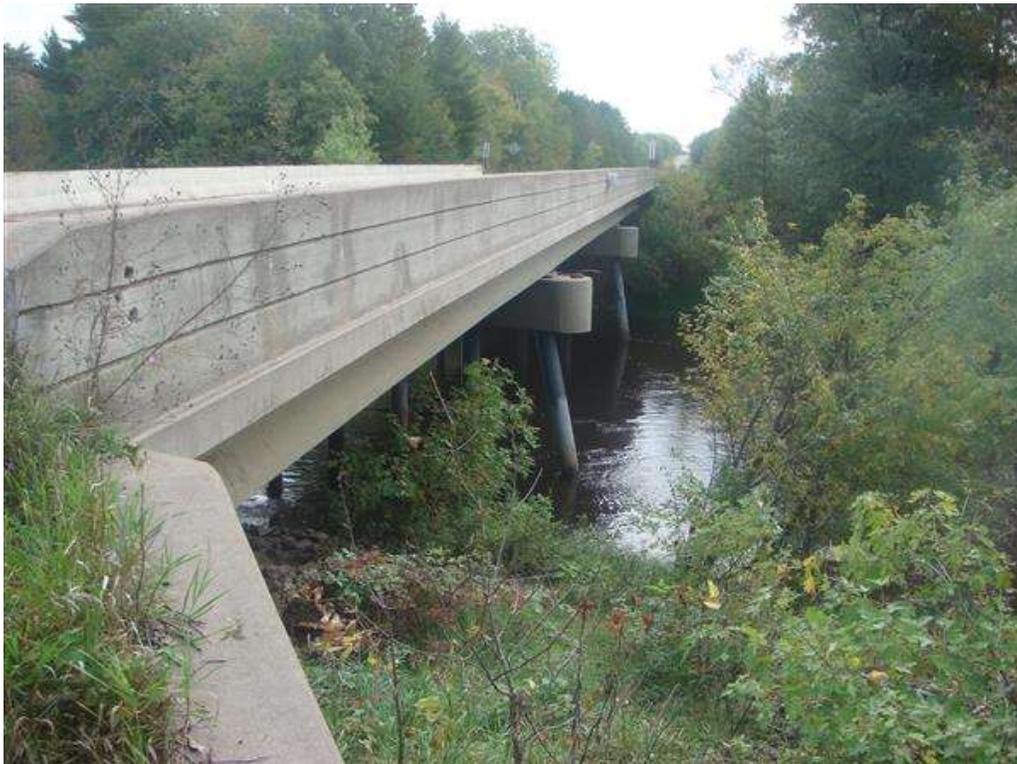
Photo 2 - Overall View of Downstream Fascia, Looking Northeast

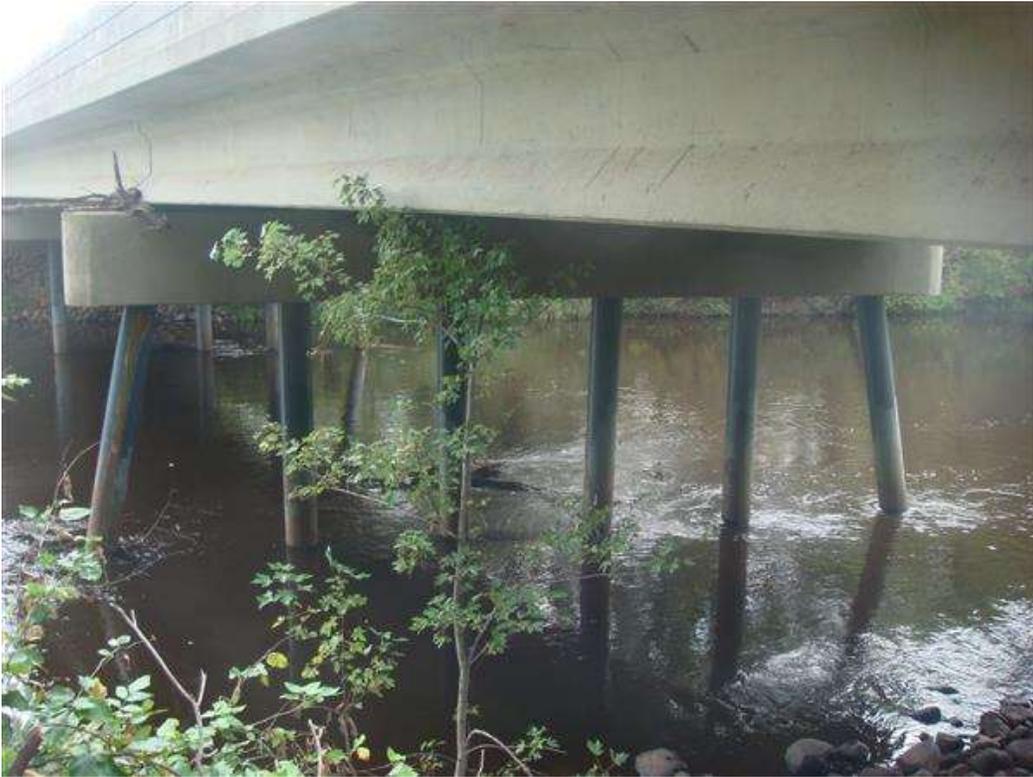
Photo 3 - View of Pier 1, Looking Southeast

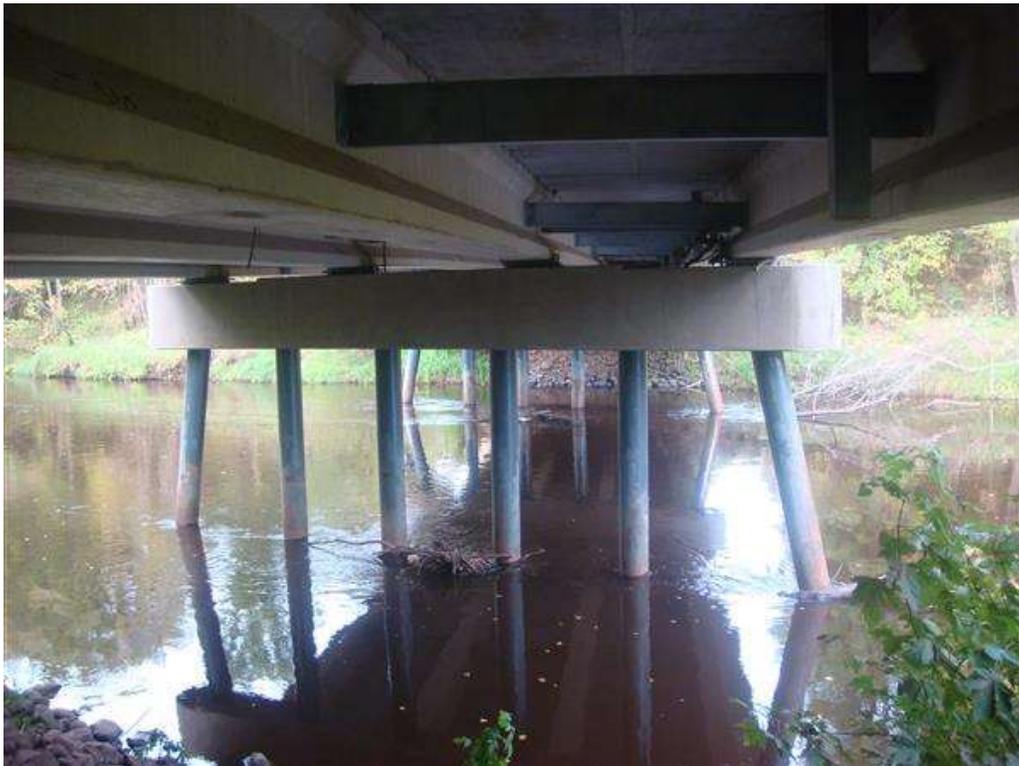
Photo 4 - View of Pier 2, Looking West

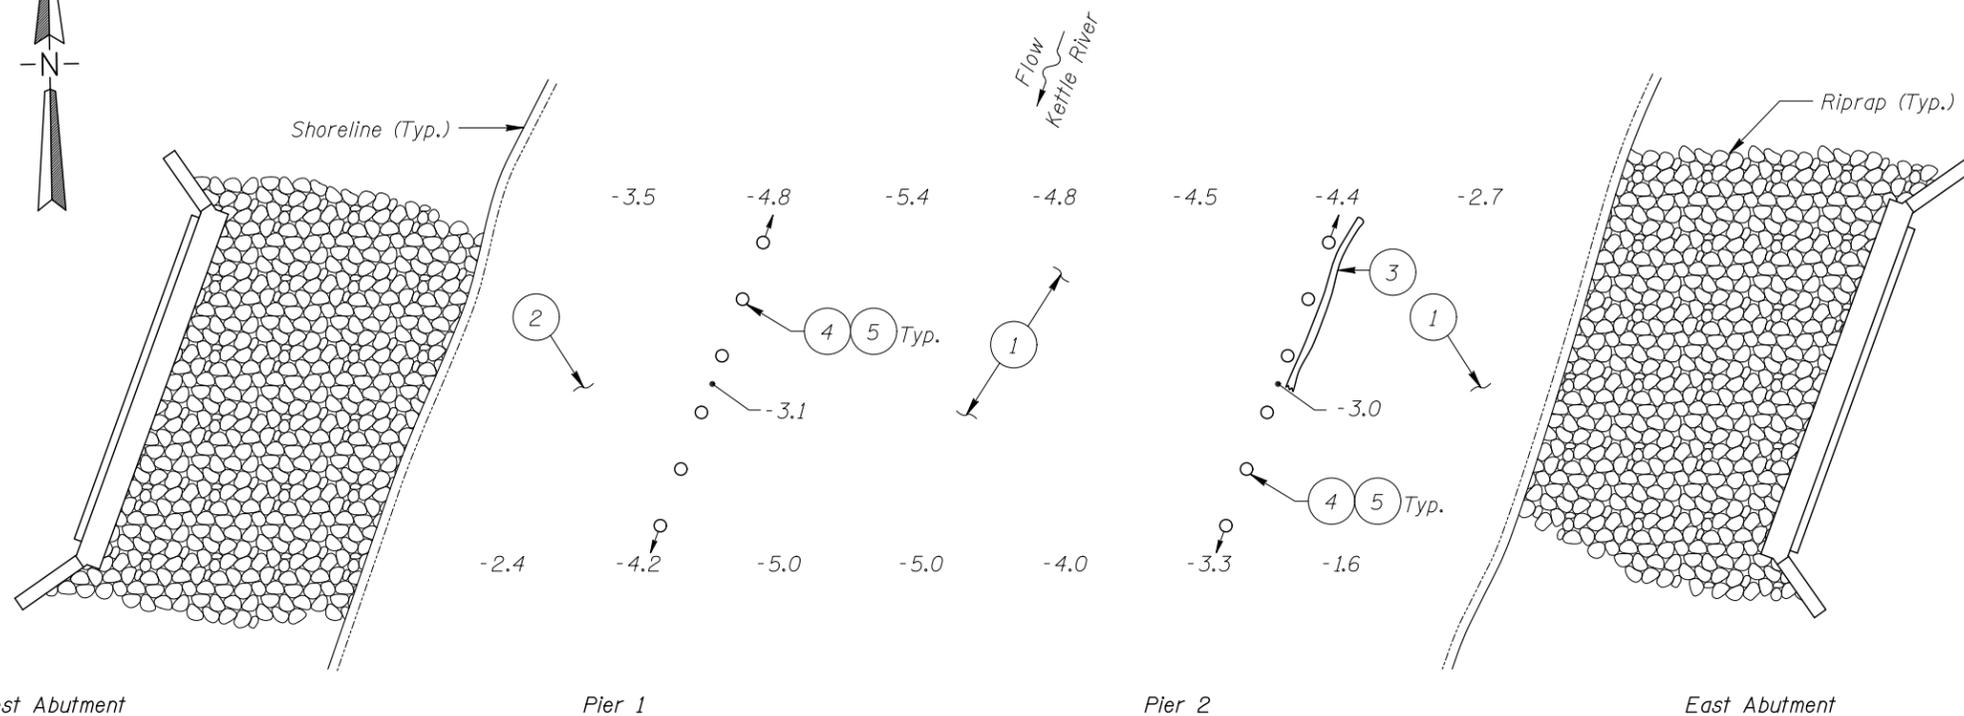
SOUNDING PLAN

- ① Channel bottom material consisted of sand and gravel allowing no probe rod penetration.
- ② Channel bottom material consisted of cobbles up to 6 inches in diameter with sand infill allowing no probe rod penetration.
- ③ Timber debris consisting of a 10 inch diameter log located at the waterline extended along the east side of Pier 2 from 3 feet upstream of the upstream nose to the midpoint of the pier.
- ④ Surface area of the steel shell encasement of all piles exhibited 70% to 100% coating loss from 4 feet above the waterline to the channel bottom.
- ⑤ Steel encasement of all piles exhibited corrosion with negligible loss of section from 1 foot below the waterline to the channel bottom.
