# 2017 UNDERWATER BRIDGE INSPECTION REPORT

## BRIDGE # 69592 CSAH 29 over WHITEFACE RIVER

Date of Inspection: 09/13/2016

Contractor: Collins Engineers, Inc.

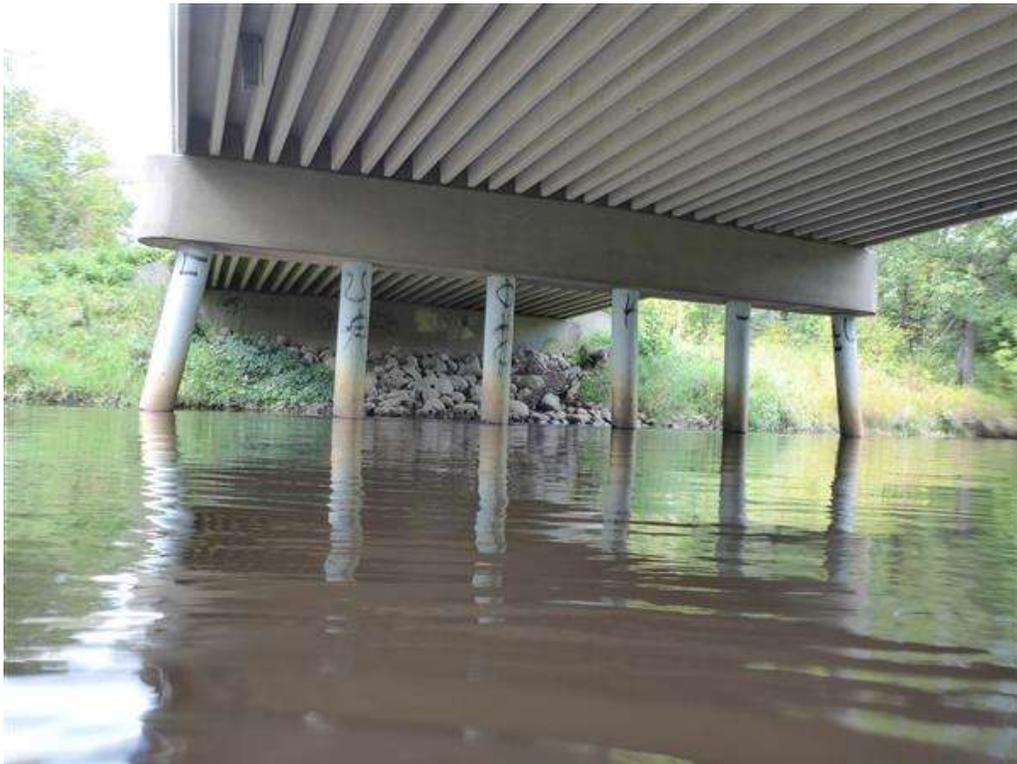
Photo 2 - Pier 1, Looking West

(C) A light accumulation of timber debris, consisting of logs and branches up to 12 inches in diameter, was observed extending from the west shore out 20 feet to the upstream nose of Pier 1, and along the east face of the pier, extending off the face up to 10 feet. The debris extended from the channel bottom to the waterline.

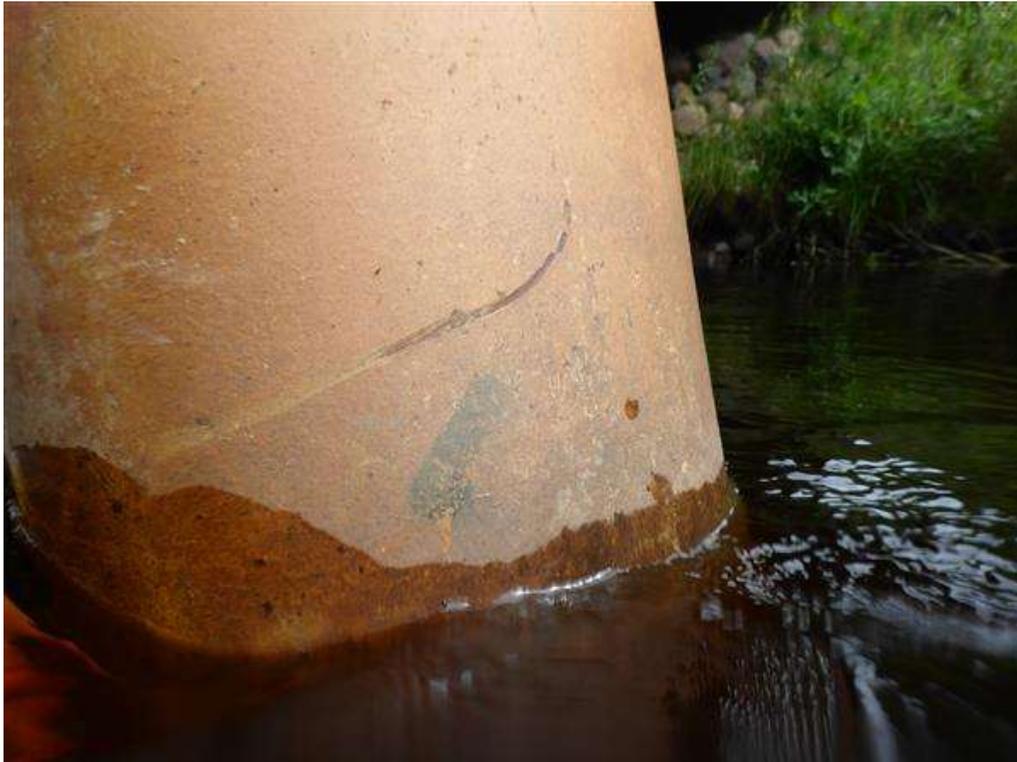
Photo 4 - Typical Steel Condition at the Waterline, Looking East

(B) All steel pipe piles typically exhibited surface corrosion from 1 foot below the waterline to the channel bottom, with no measurable section loss.

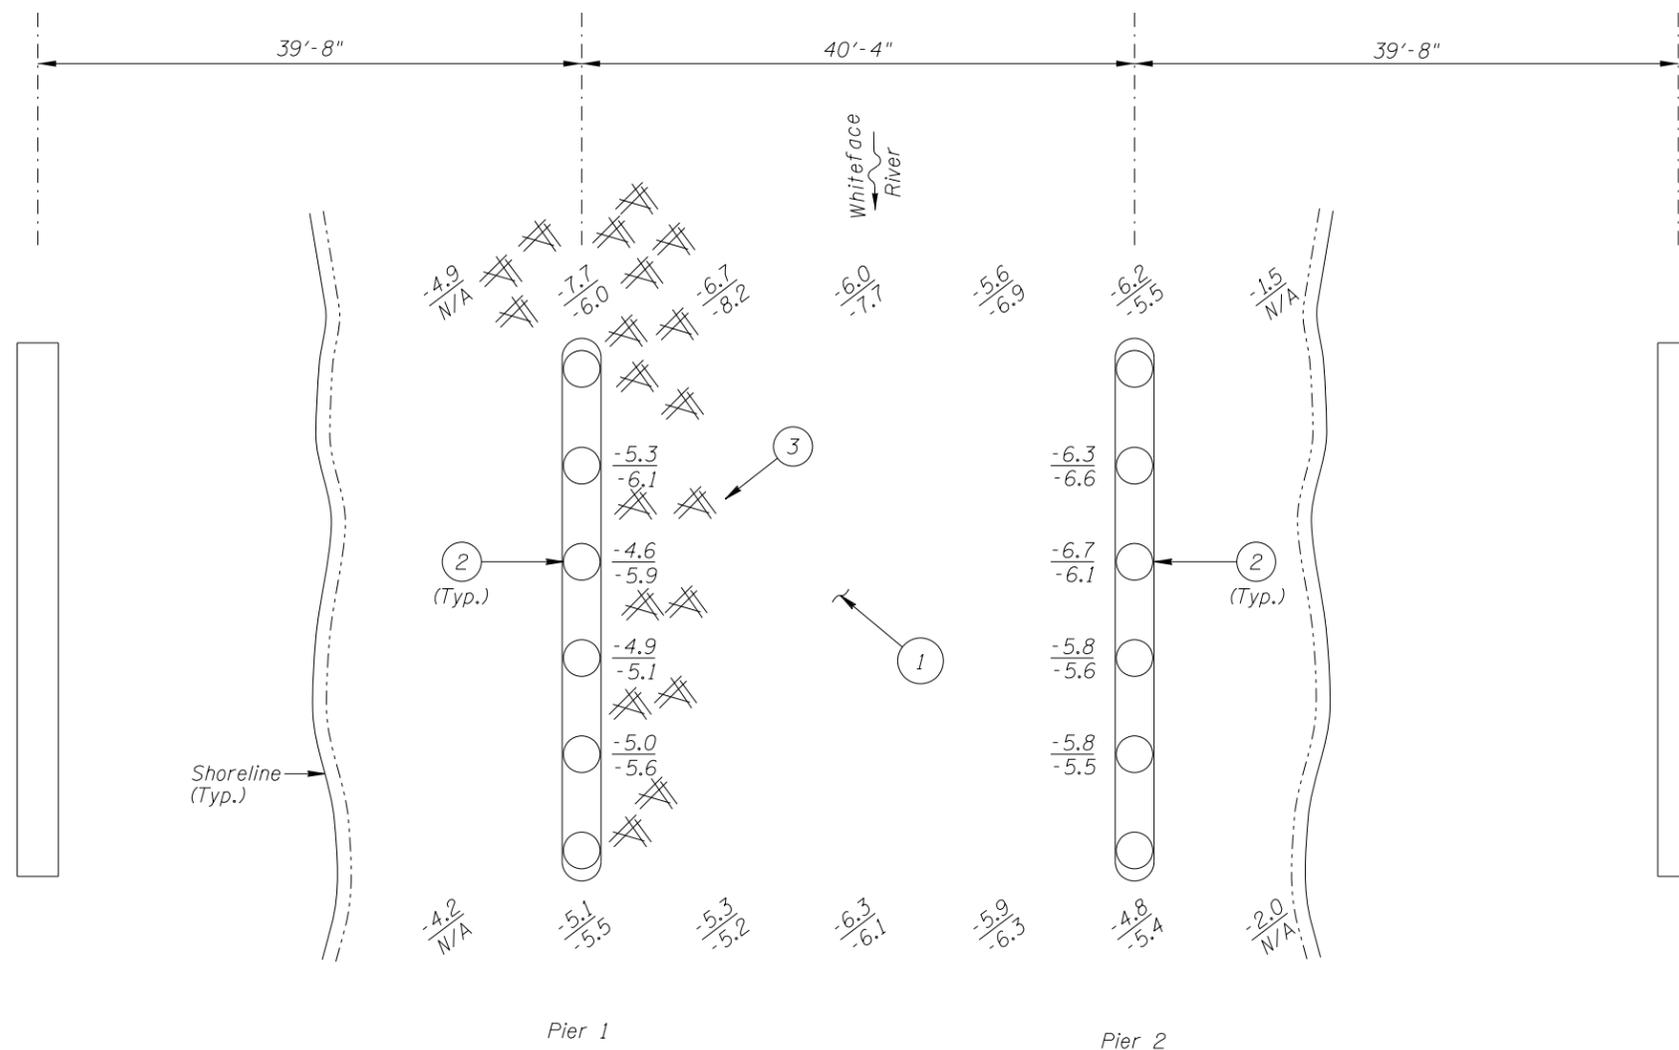
SOUNDING PLAN

- 1 The channel bottom material consisted of sand allowing up to 4 inches of probe rod penetration.
- 2 All steel pipe piles typically exhibited surface corrosion from 1 foot below the waterline to the channel bottom, with no measurable section loss.
- 3 A light accumulation of timber debris, consisting of logs and branches 12 inch diameter and smaller, was observed extending from the west shore out 20 feet to the upstream nose of Pier 1, and along the east face of the pier, extending off the face up to 10 feet. The debris extended from the channel bottom to the waterline.
