2017 UNDERWATER BRIDGE INSPECTION REPORT

BRIDGE # 69602 CR 694 over CLOQUET RIVER

Date of Inspection: 09/16/2016

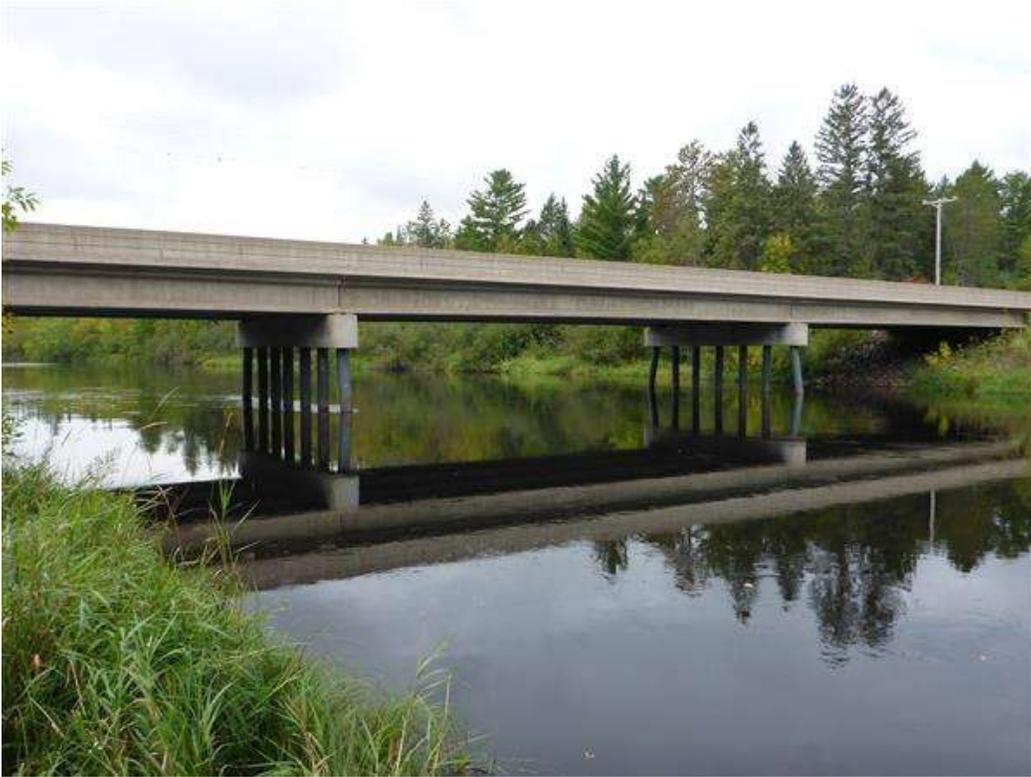
Photo 1 - Upstream Fascia, Looking Northwest

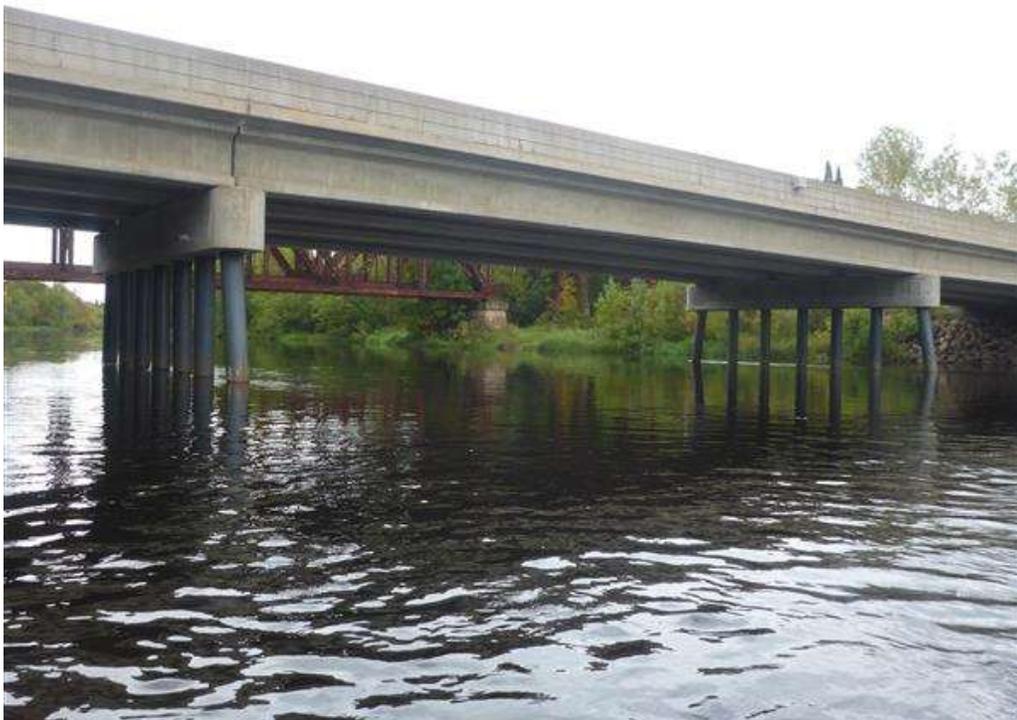
Photo 2 - Downstream Fascia, Looking Southeast

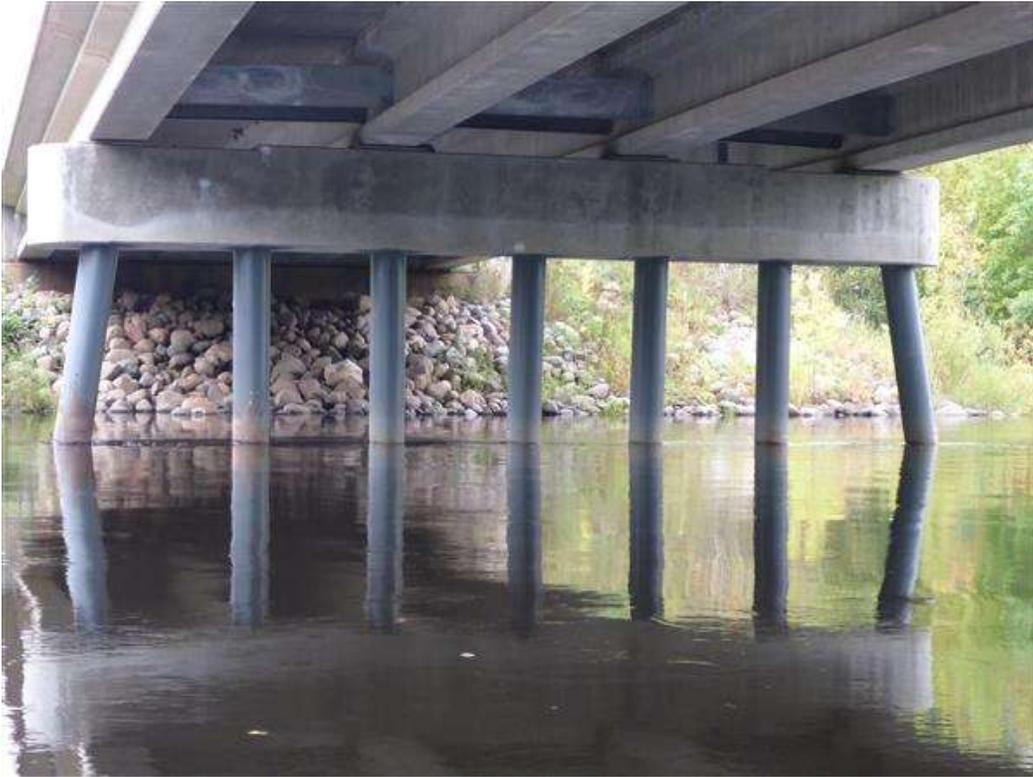
Photo 3 - Bent 1, Looking Southwest

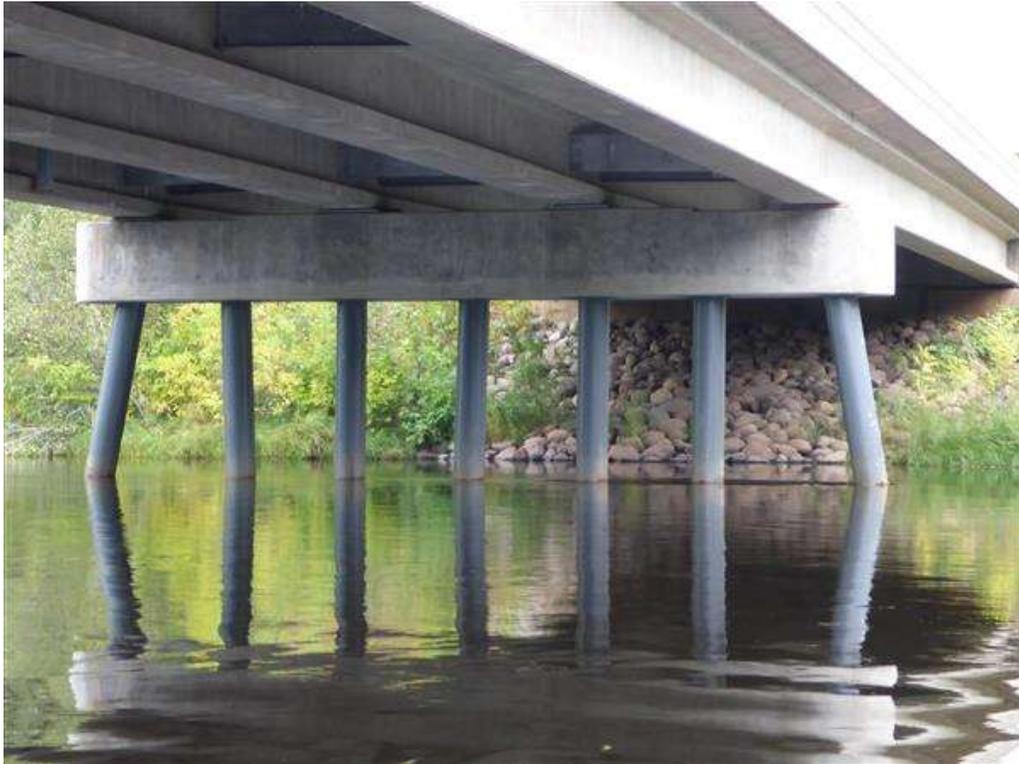
Photo 4 - Bent 2, Looking Northwest

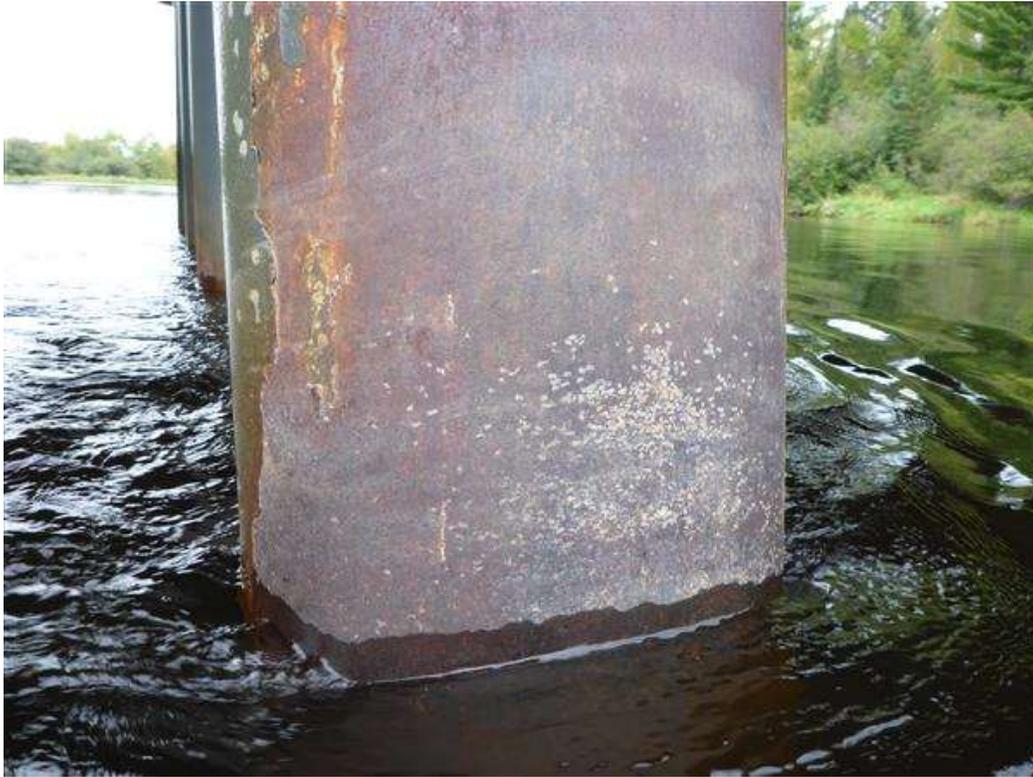
(B) The piles of Bents 1 and 2 exhibited coating loss on approximately 90 percent of the surface area extending from the channel bottom to the waterline with light corrosion extending from the waterline to 1 foot below the waterline.

Photo 5 - Typical Steel Condition at the Waterline (Bent 1 Shown), Looking West

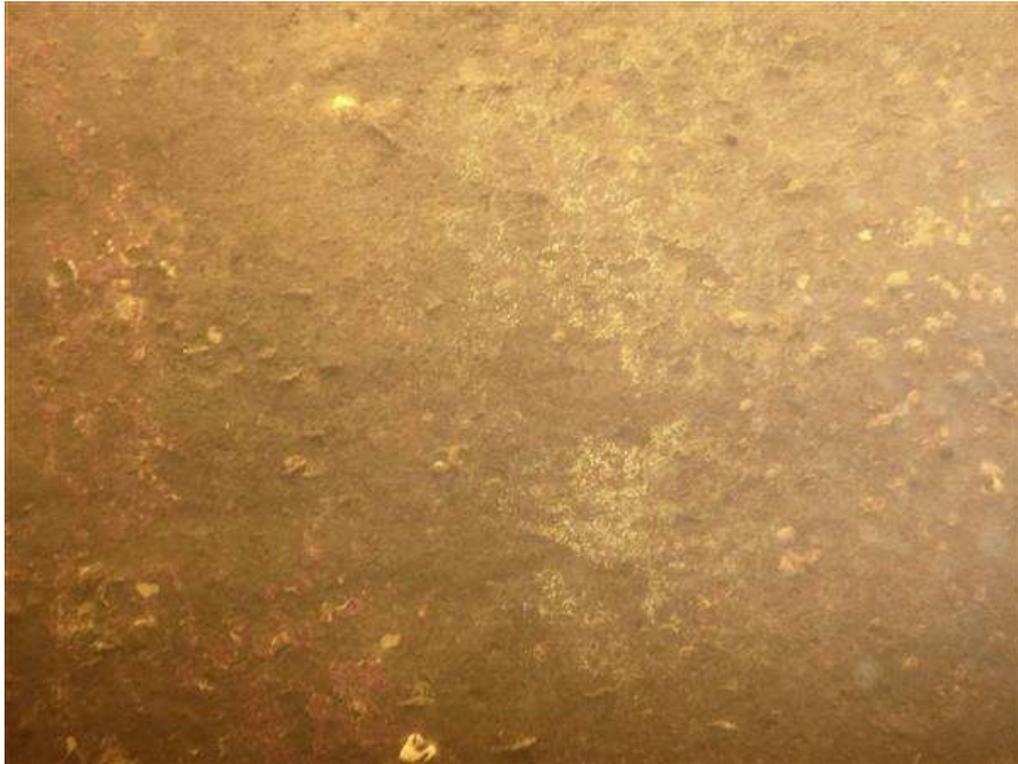
(C) The piles of Bent 1 exhibited rust nodules, up to 1/4 inch in diameter, covering approximately 20 percent of the pile surface area extending from the channel bottom to 1 foot below the waterline. The nodules typically had negligible pitting of the steel associated with them.

Photo 6 - Typical Steel Condition Below Water (Bent 1 Shown), Looking West
