2016 UNDERWATER BRIDGE INSPECTION REPORT

BRIDGE # 69623 CSAH 27 over ST LOUIS RIVER

Date of Inspection: 09/13/2016

Contractor: Collins Engineers, Inc.

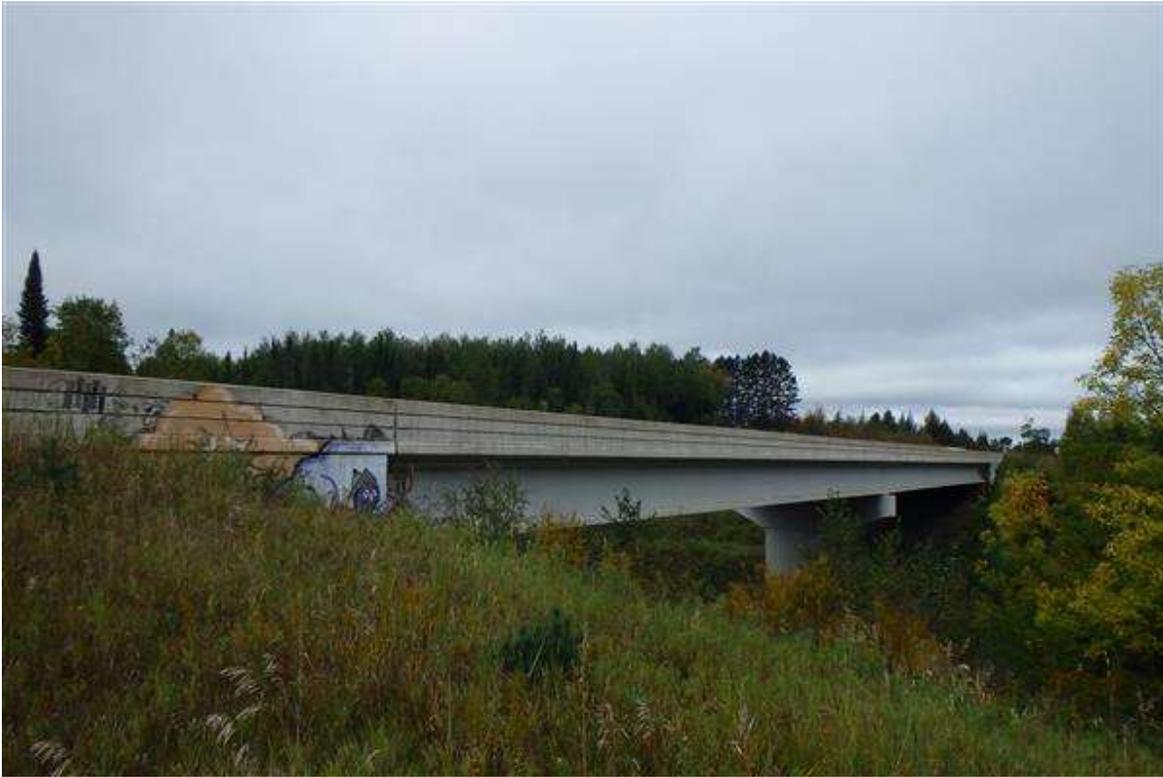
Photo 1 - Upstream Fascia, Looking Southwest

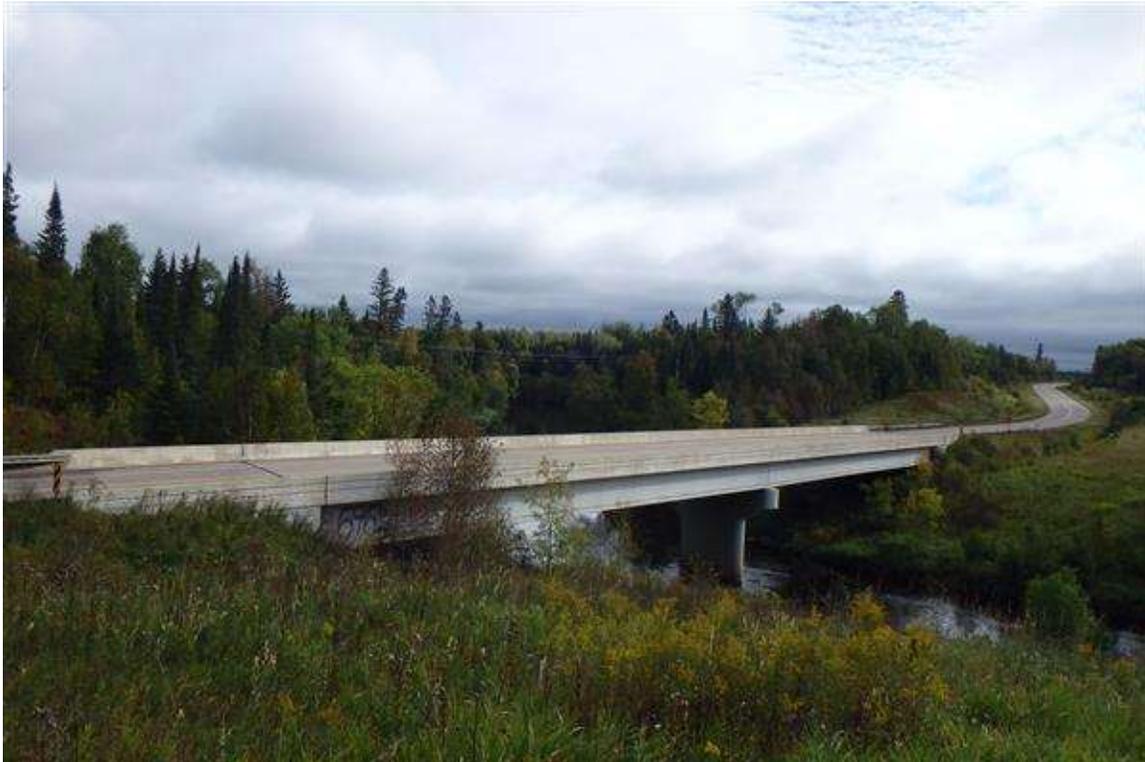
Photo 2 - Downstream Fascia, Looking Northeast

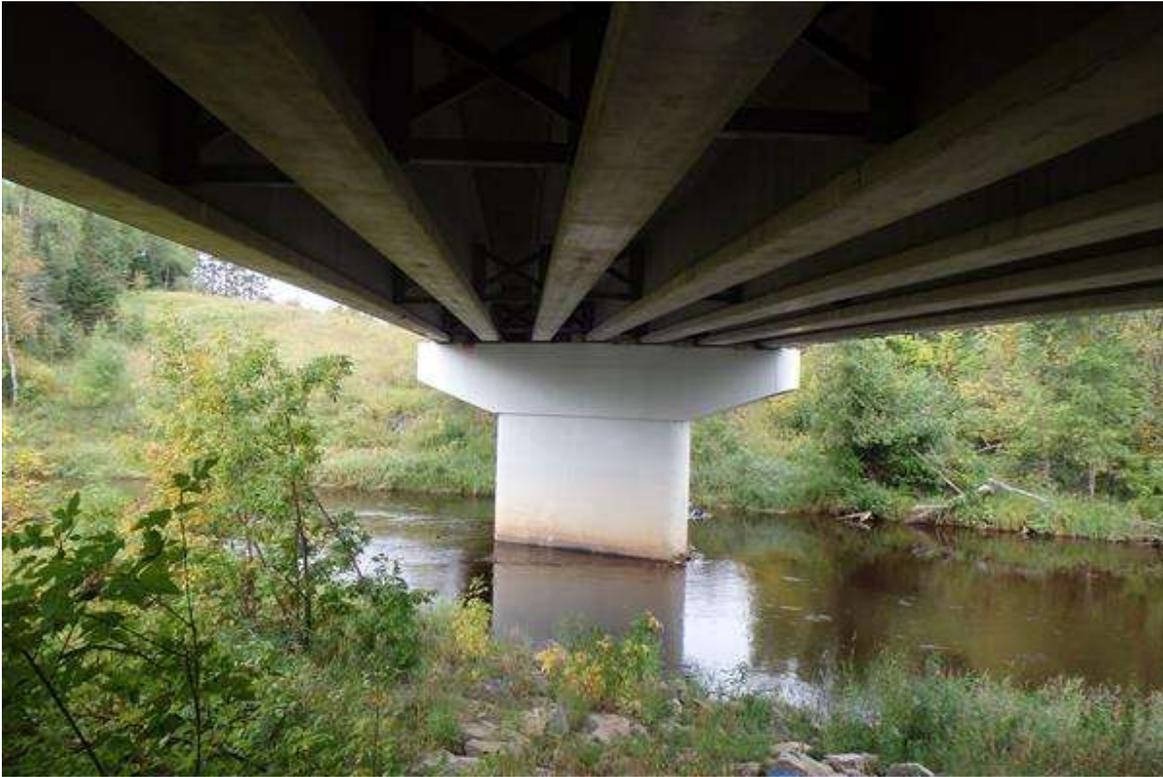
(B) The concrete of Pier 1 was typically smooth and sound.

(C) A moderate accumulation of timber debris consisting of logs and branches up to 12 inches in diameter was observed at the upstream and downstream noses of Pier 1 extending from the channel bottom to the waterline. The accumulation extended approximately 10 feet off the pier nose and faces.

(D) A band of light scaling was observed around the entire pier from the waterline to 4 feet below the waterline with 1/8 inch maximum penetration.

Photo 3 - Pier 1, Looking West

(A) Monitor the moderate accumulation of timber debris at the upstream and downstream noses of Pier 1 for signs of scour influence or a reduction in hydraulic capacity.

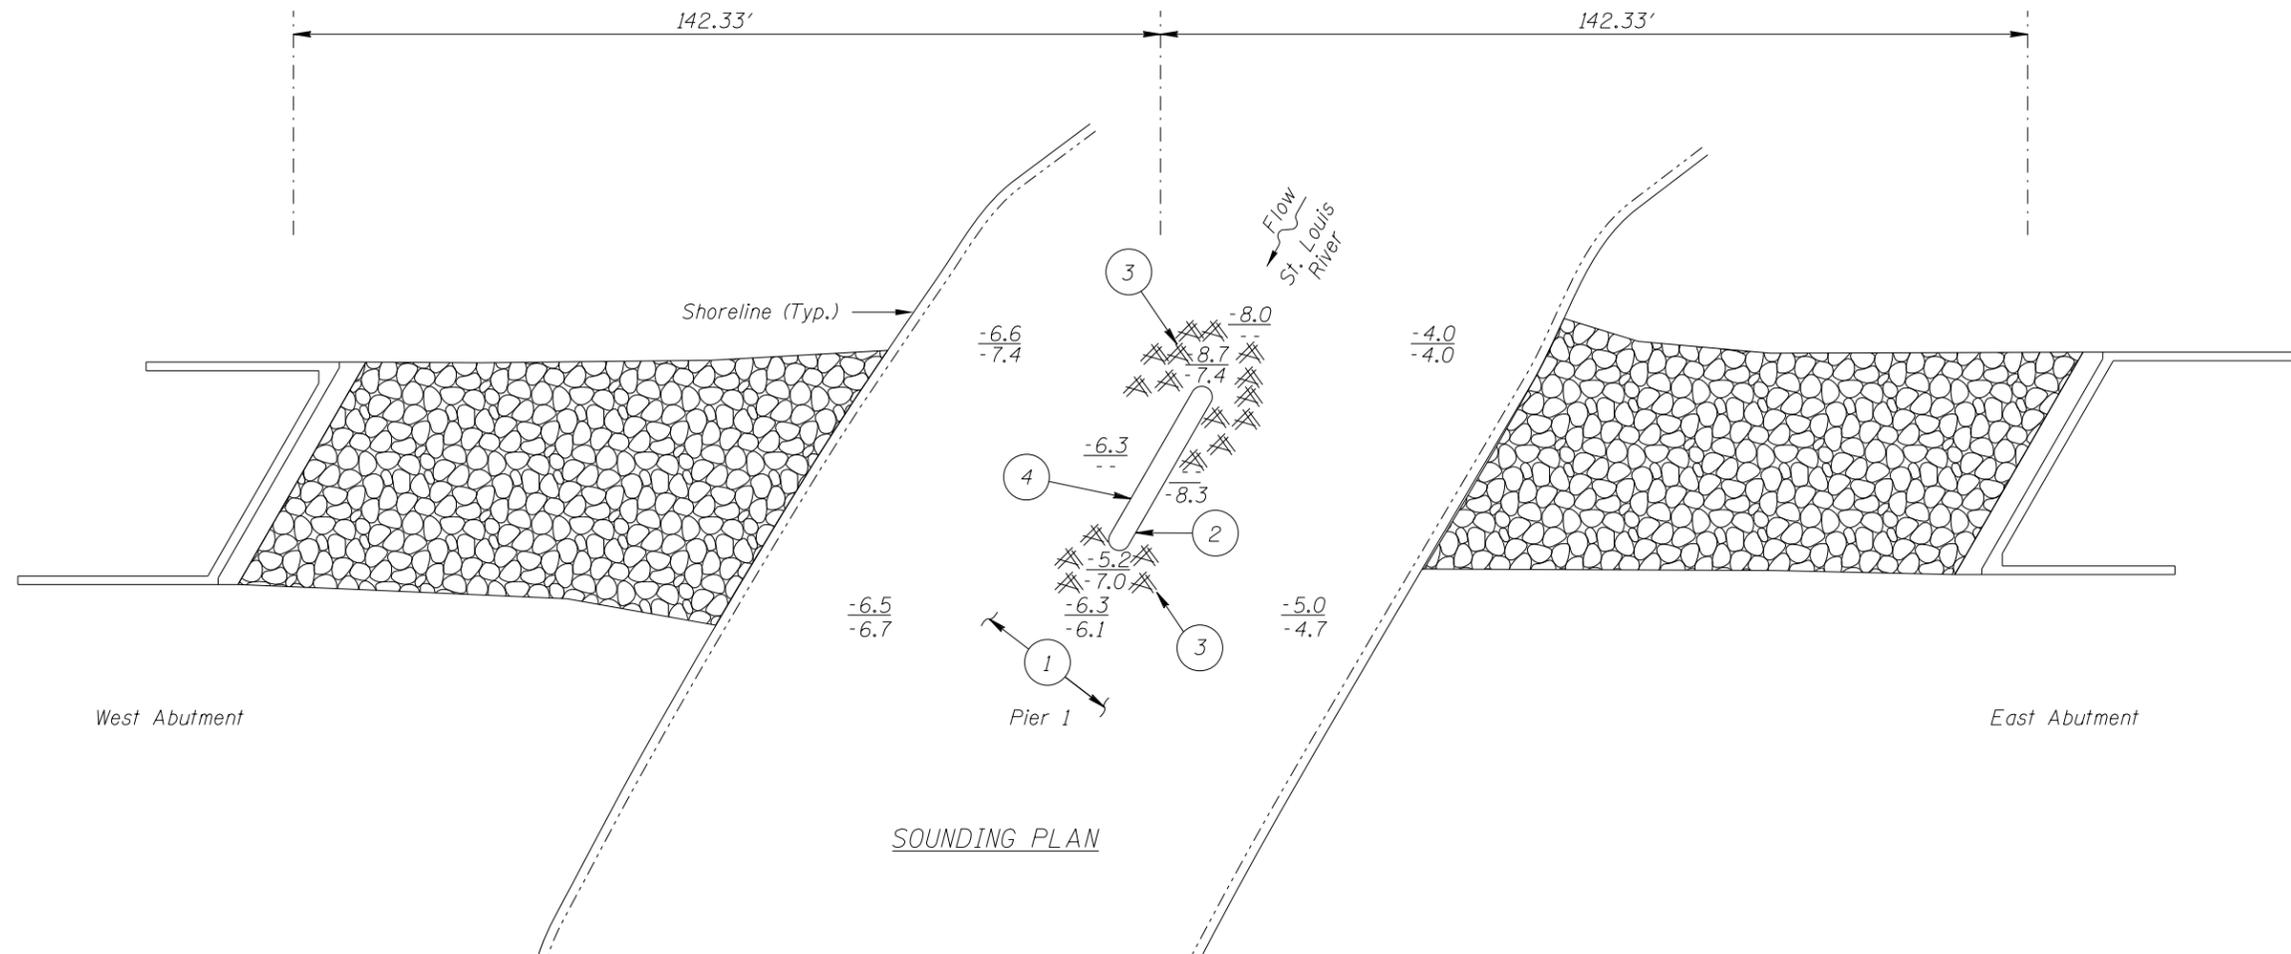
SOUNDING PLAN

- 1 The channel bottom consisted of soft silt with 1.5 to 2 feet of probe rod penetration and scattered rocks up to 2 feet in diameter.
- 2 The concrete of Pier 1 was typically smooth and sound.
- 3 A moderate accumulation of timber debris consisting of logs and branches up to 12 inch in diameter was observed at the upstream at downstream noses of Pier 1 extending from the channel bottom to the waterline. The accumulation extended approximately 10 feet off the pier nose and faces.
- 4 A band of light scaling was observed around the entire pier from the waterline to 4 feet below the waterline with 1/8 inch maximum penetration.
