2016 UNDERWATER BRIDGE INSPECTION REPORT

BRIDGE # 7065 CSAH 18 over GARDEN LAKE

Date of Inspection: 06/21/2016

Contractor: Collins Engineers, Inc.

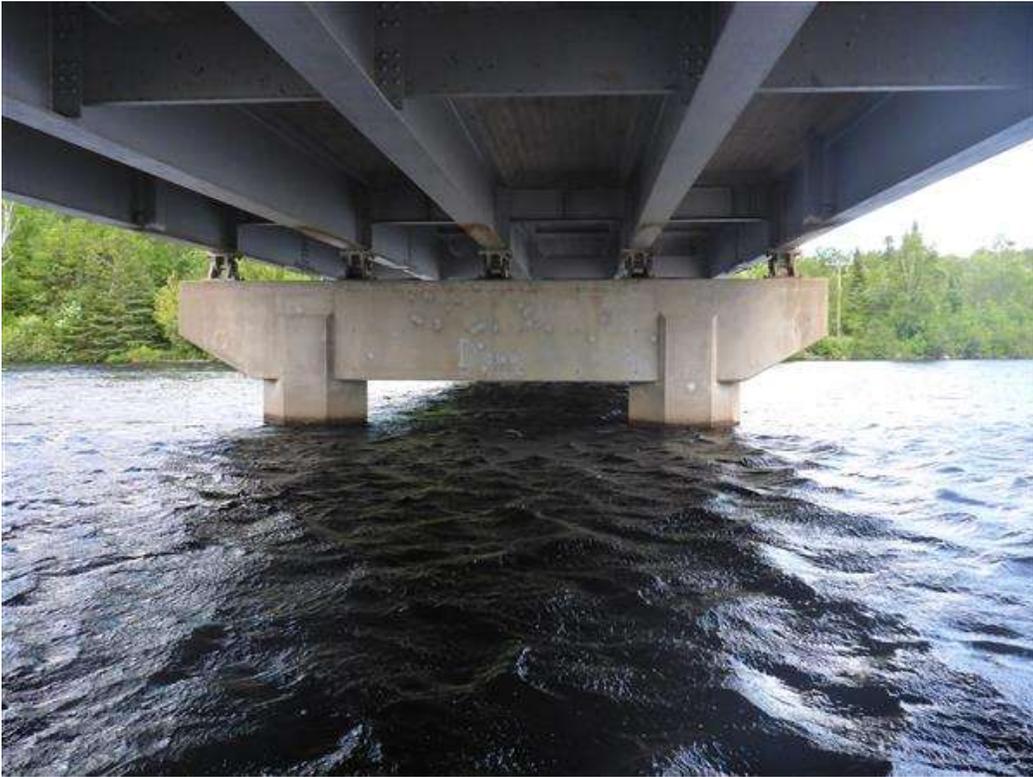
Photo 3 - Pier 1, Looking East

(B) An area of minor section loss, 12 inches high by 6 inches wide with 2 inches maximum penetration, was observed at the upstream nose of the downstream column of Pier 1 with no exposed reinforcing steel observed.

(C) The top of a horizontal strut was observed approximately 5.5 feet below the waterline. The channel bottom was generally flush with the bottom of the horizontal strut on both the east and west side of the pier.

(D) Several scattered 1 foot diameter logs were observed on the channel bottom around Pier 1, with one extending across the upstream column of the pier. Other 6 inch diameter and smaller drift was also scattered around the pier.

(F) At approximately 8 feet below the waterline at the center of the horizontal strut of Pier 1, a steel I-beam was observed extending out 5 feet on each side of the strut.

(G) A minor scour depression, 5 feet in radius by 1 foot deep, was observed at the upstream column of Pier 1.

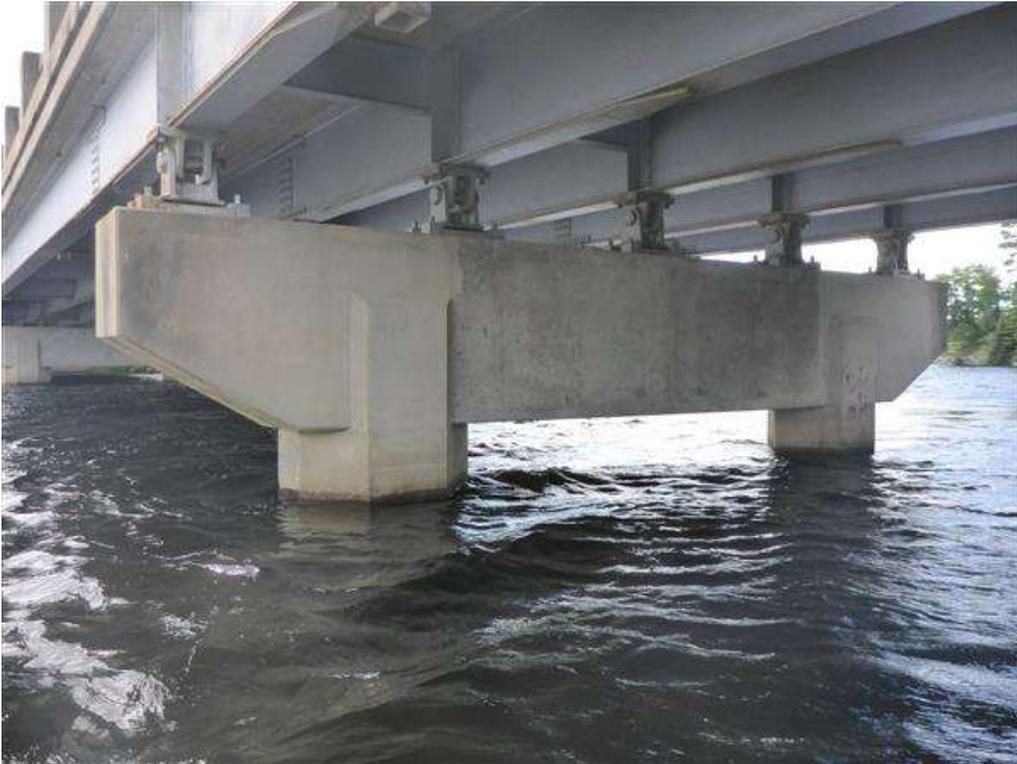
Photo 4 - Pier 2, Looking Northwest

(H) A heavy concentration of up to 4 foot diameter riprap was observed along the easterly side of the upstream column of Pier 2.

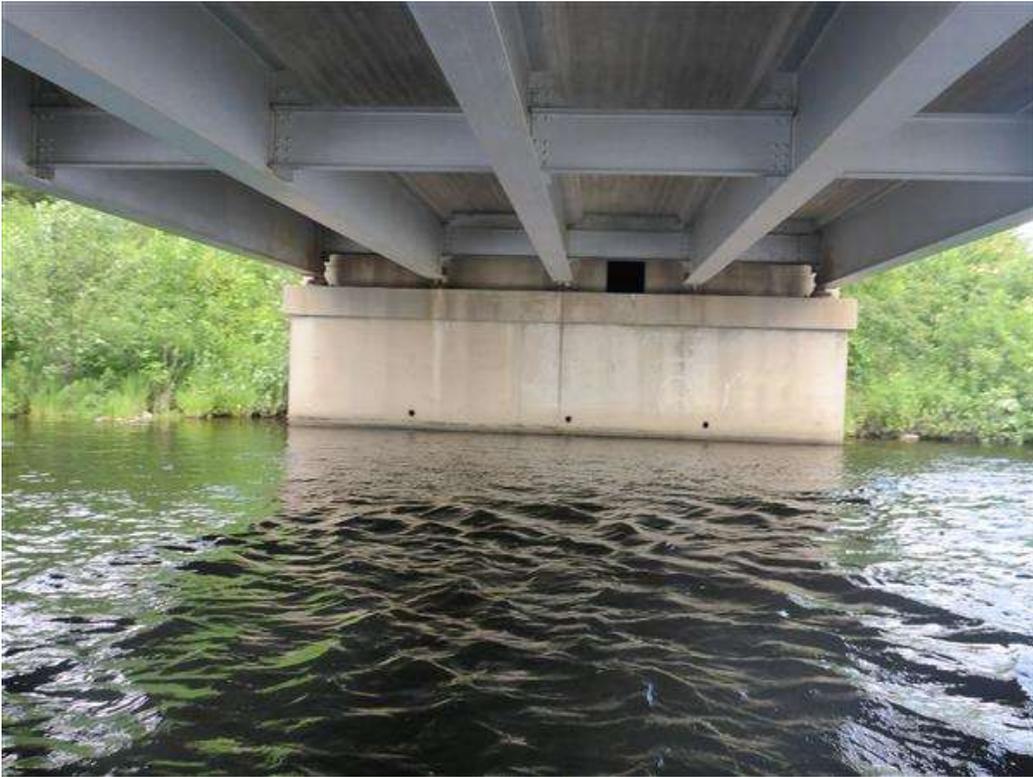
Photo 5 - East Abutment, Looking East

(I) 1/4 inch to 1/2 inch deep scaling was observed at the West and East abutments extending from the waterline to the channel bottom.

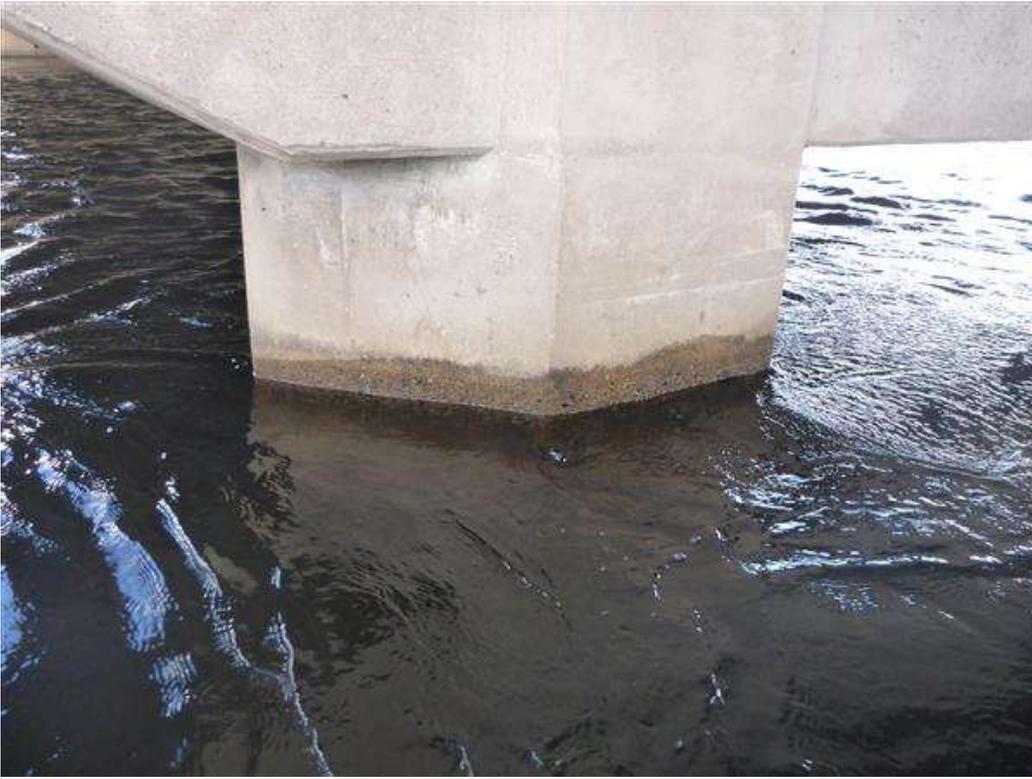
(E) The concrete surfaces on both piers from 6 inches above to 3 feet below the waterline exhibited up to 1/4 inch deep scaling with exposed aggregate.

Photo 7 - Typical Concrete Condition at Waterline (Pier 2 Downstream Column Shown), Looking West

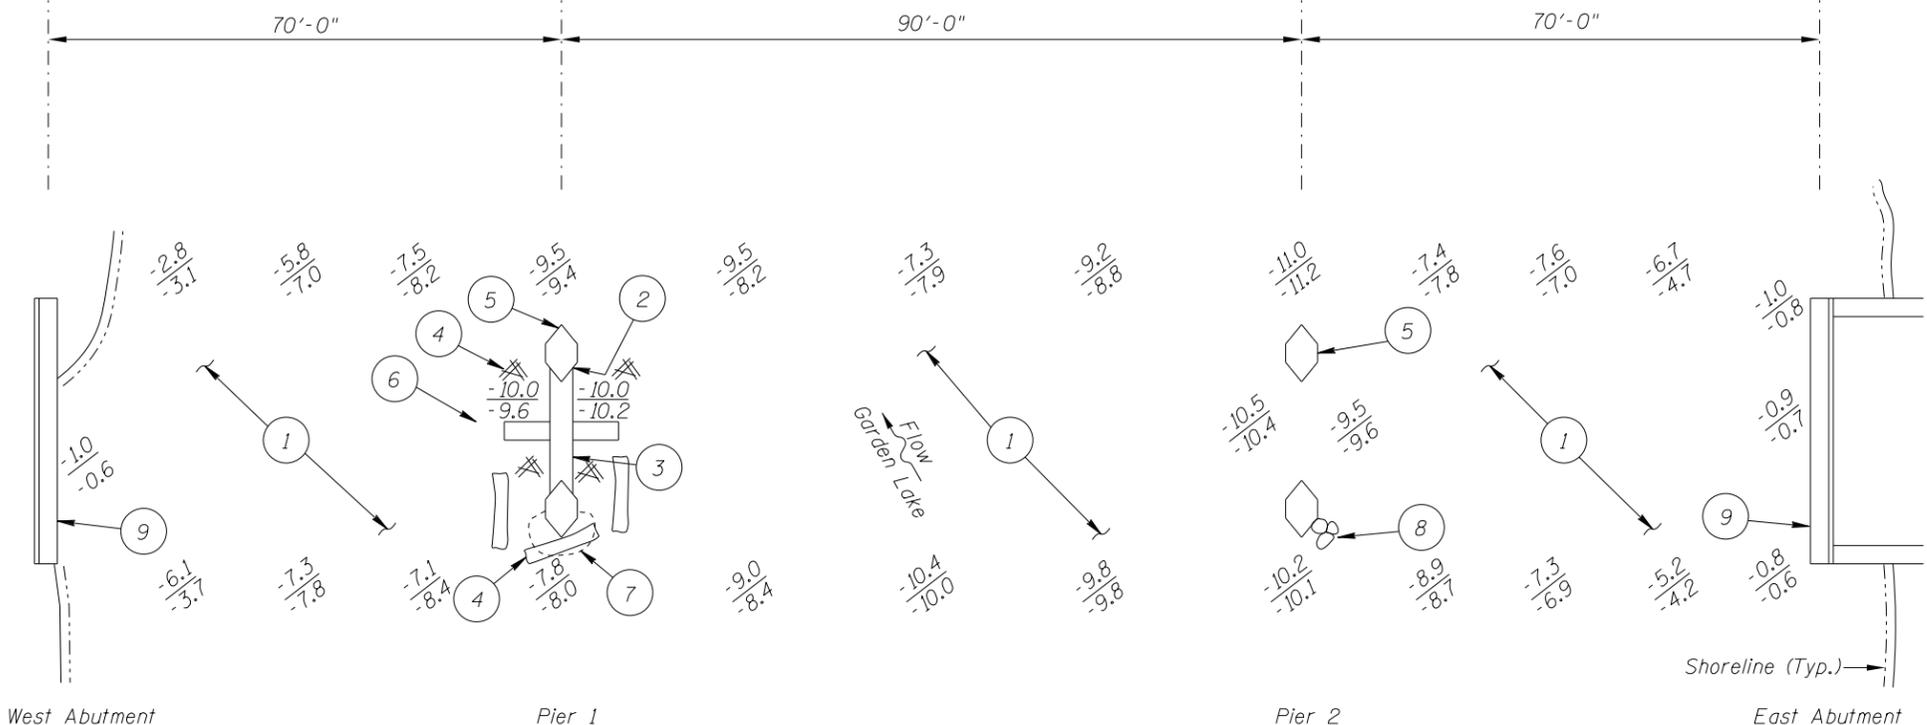
SOUNDING PLAN

1. The channel bottom material consisted of sandy gravel allowing 2 inches of probe rod penetration with scattered 1 to 3 foot diameter riprap and 6 inch diameter cobbles.

2. Section loss, approximately 12 inches high by 6 inches wide, with 2 inches maximum penetration was observed at the upstream nose of the downstream column of Pier 1. No exposed reinforcing steel was present.

3. The top of a horizontal strut was observed approximately 5.5 feet below the waterline. The channel bottom was generally flush with the bottom of the horizontal strut on both the east and west side of the pier.

4. Several scattered 1 foot diameter logs were observed on the channel bottom around Pier 1, with one extending across the upstream column of the pier. Other 6 inch diameter and smaller drift was also scattered around the pier.

5. The concrete surfaces on both piers from 6 inches above to 3 feet below the waterline exhibited up to a 1/4 inch deep scaling with exposed aggregate.

6. At approximately 8 feet below the waterline at the center of the horizontal strut of Pier 1, a steel I-beam was observed extending out 5 feet on each side of the strut.

7. A minor scour depression, 5 feet in radius by 1 foot deep, was observed at the upstream column of Pier 1.
8. Heavy concentration of up to 4 foot diameter riprap was observed along the easterly side of the upstream column of Pier 2.

9. 1/4 inch to 1/2 inch deep scaling was observed at the West and East abutments extending from the waterline to the channel bottom.
