2016 UNDERWATER BRIDGE INSPECTION REPORT

BRIDGE # 7759 CSAH 101 over EAST TWO RIVER

Date of Inspection: 09/12/2016

Contractor: Collins Engineers, Inc.

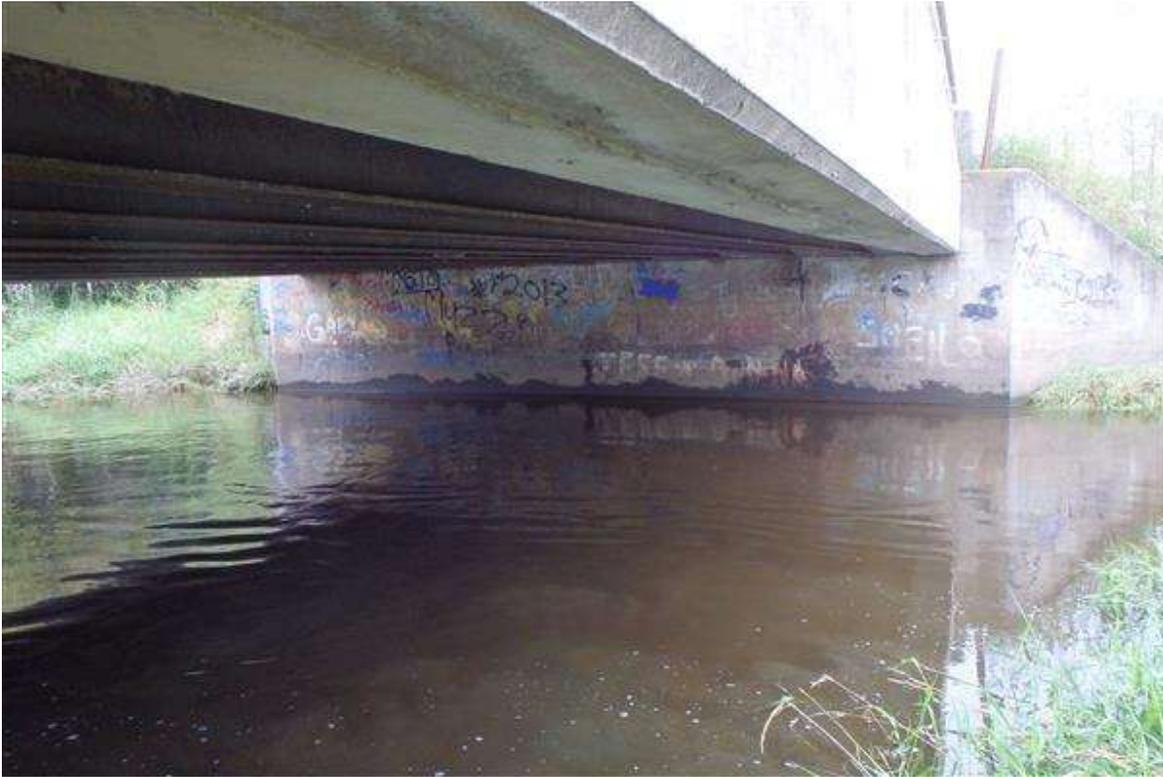
Photo 3 - West Abutment, Looking Southwest

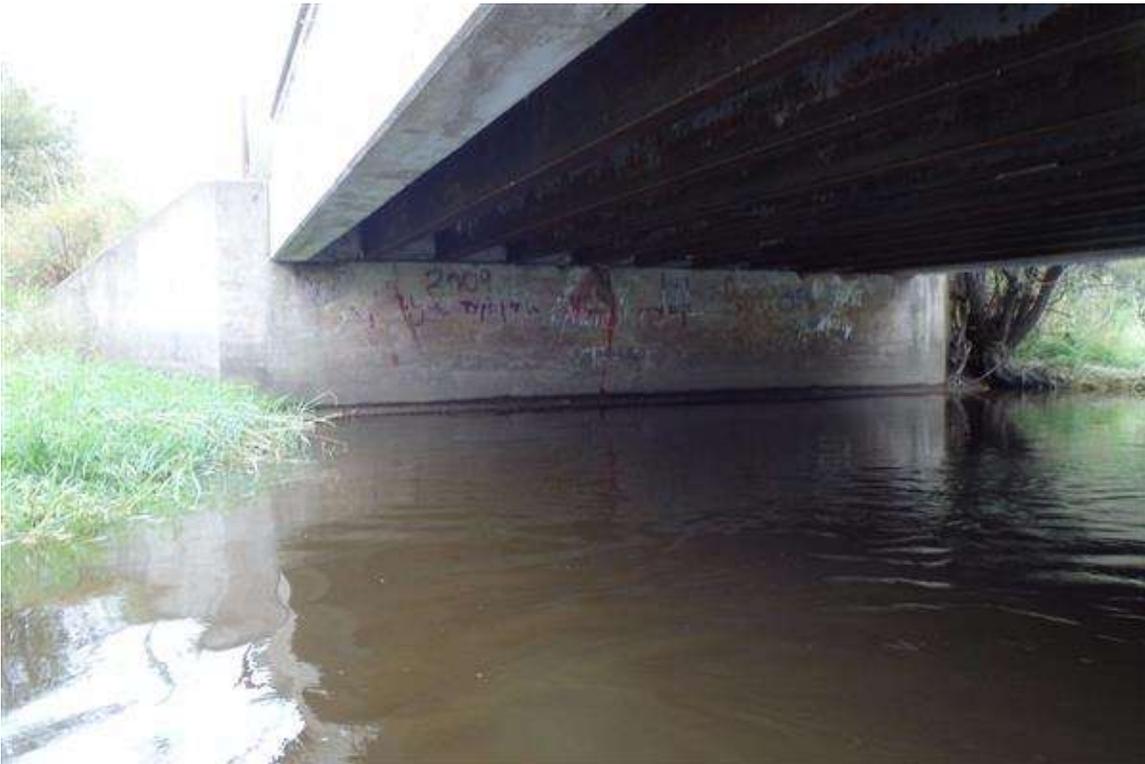
Photo 4 - East Abutment, Looking Southeast

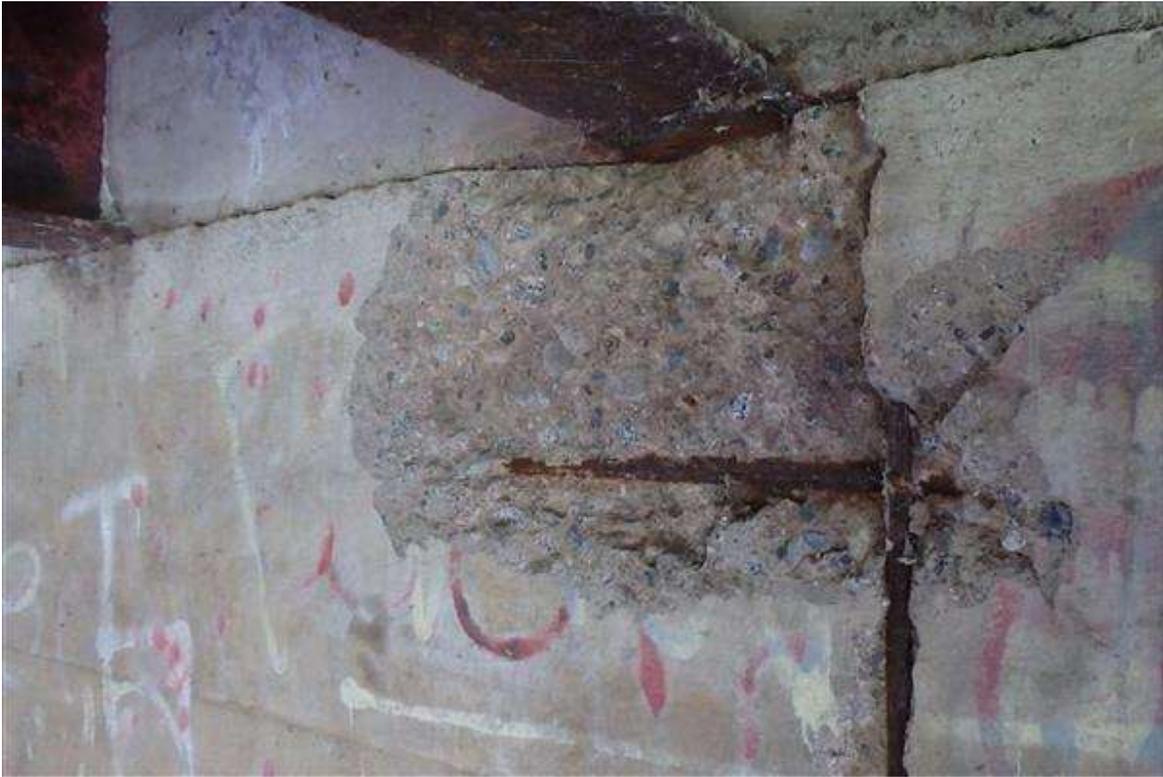
- (E) A spall 18 inches wide by 1 foot high with up to 3 inches of penetration and 2 exposed reinforcing bars with less than 5 percent section loss was present under Beam B of the West Abutment. The spall resulted in an approximately 20 percent loss of bearing area at Beam B.

Photo 5 - Spall Under Beam B at the West Abutment, Looking West

- 5 A spall 18 inches wide by 1 foot high with up to 3 inches of penetration and 2 exposed reinforcing bars with less than 5 percent section loss was present under Beam B of the West Abutment. The spall resulted in an approximately 20 percent loss of bearing area at Beam B.

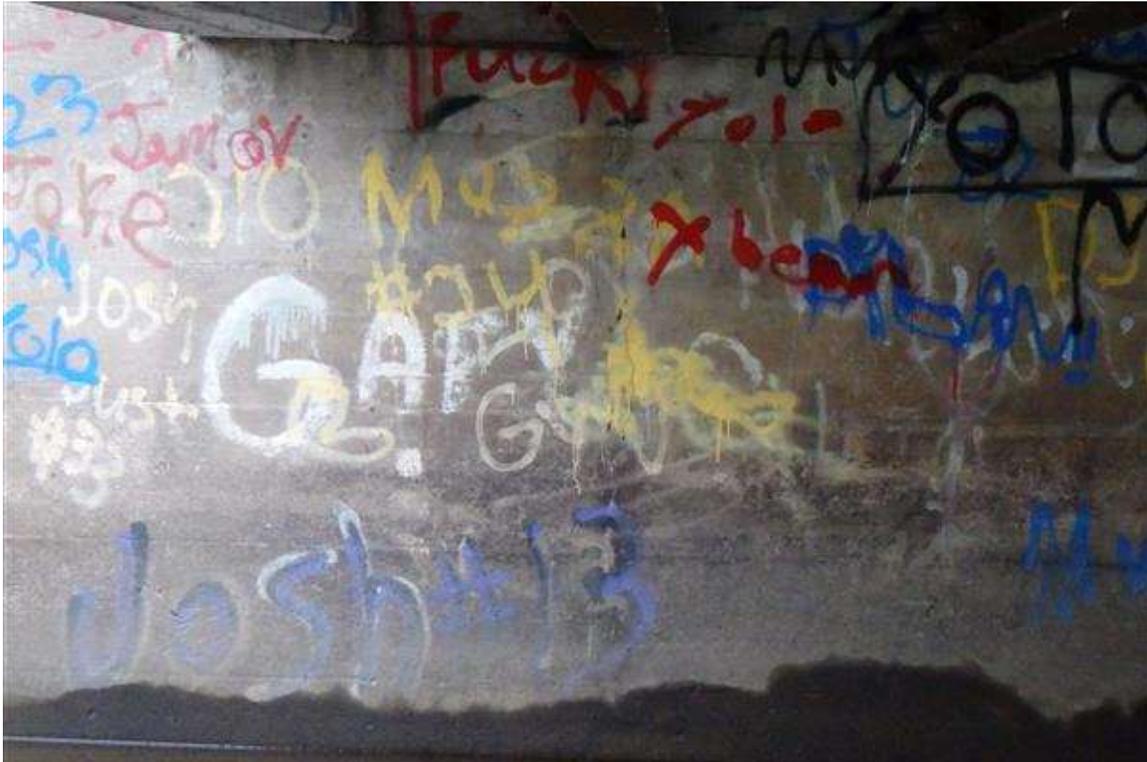
- (G) Vertical cracking up to 1/4 inch wide from the footing to the bridge seat was present at Beams B, D, and I of the West Abutment and between Beams A and B and D and E of the East Abutment. Associated spalling and impending spalling was observed along the length of the crack with up to 1 inch of penetration.

Photo 6 - Vertical Crack Under Beam I at the West Abutment, Looking West

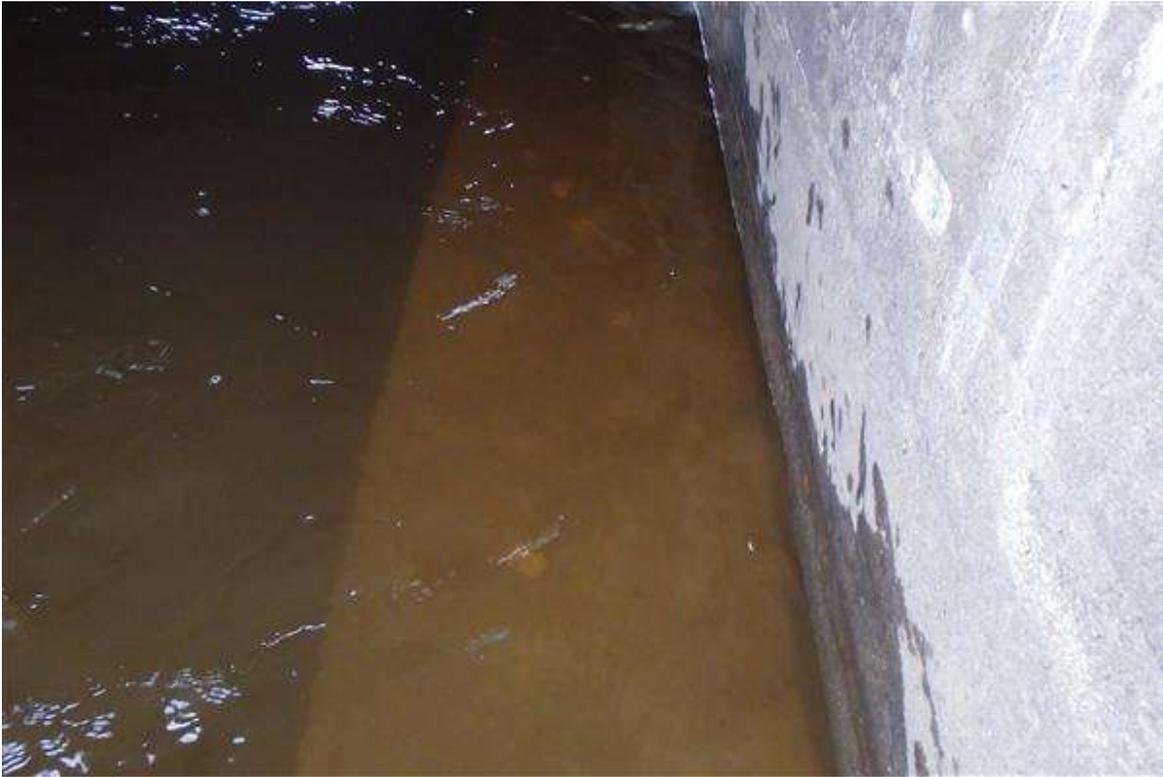
- (C) The West Abutment footing was exposed the full height (2.0 feet) and was undermined the entire length with an undermining void measuring up to 6 feet horizontally and 2.5 feet vertically. Within the undermine void the majority of the square concrete piles were exposed.

Photo 7 - West Abutment Footing, Looking South

- 3 The West Abutment footing was exposed the full height (2.0 feet) and was undermined the entire length with an undermining void measuring up to 6 feet horizontally and 2.5 feet vertically. Within the undermine void the square concrete piles were exposed as shown.

- (A) Riprap should be placed along both abutments to minimize any additional undermining and close attention should be given to both abutment foundations in future underwater inspections for signs of settlement or movement. If additional undermining, settlement, or movement occurs additional preventative actions may be necessary to ensure the structural integrity of the bridge.
- (B) Reinspect the submerged substructure units at the normal maximum recommended (NBIS) interval of sixty (60) months.

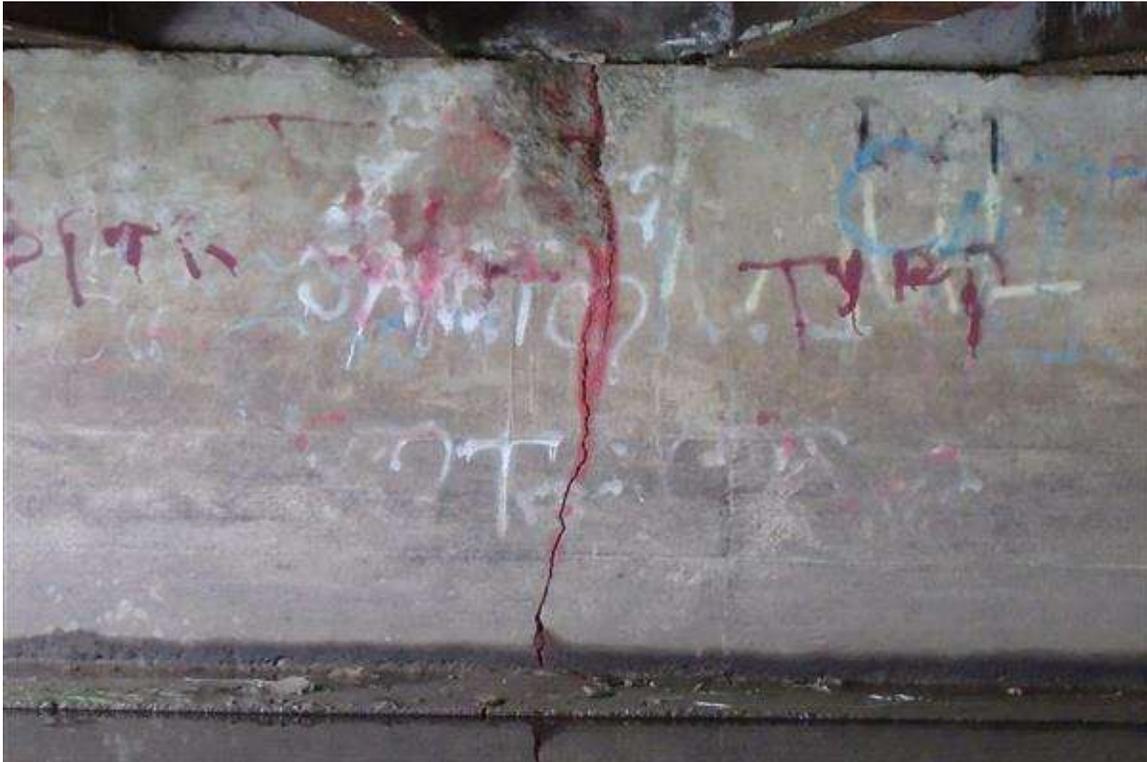
Photo 8 - Vertical Crack Between Beams D and E at the East Abutment, Looking East

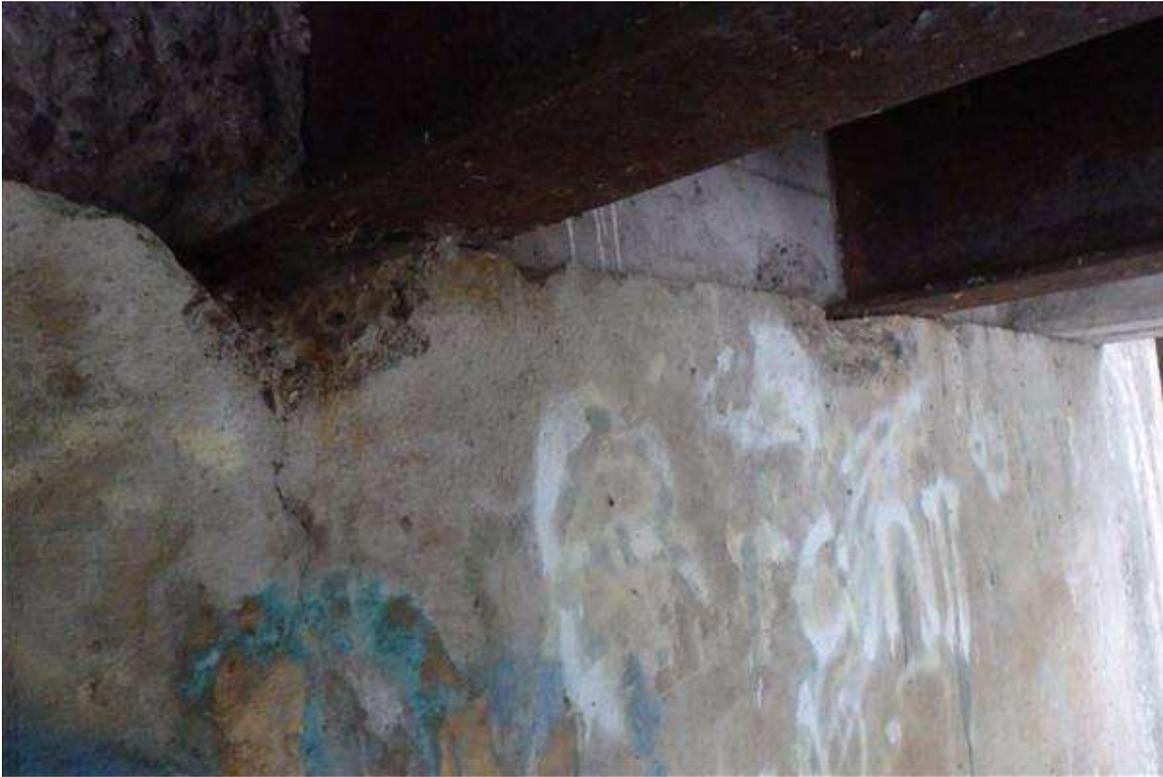
- (I) Two 6 inch diameter spalls with up to 3 inches of penetration was present under Beams H and I of the East Abutment. The spalls have resulted in an approximately 15 percent loss of bearing area at Beams H and I.

Photo 9 - Spalls Under Beams H and I at the East Abutment, Looking Southeast

- 9 Two 6 inch diameter spalls with up to 3 inches of penetration was present under Beams H and I of the East Abutment. The spalls have resulted in an approximately 15 percent loss of bearing area at Beams H and I.

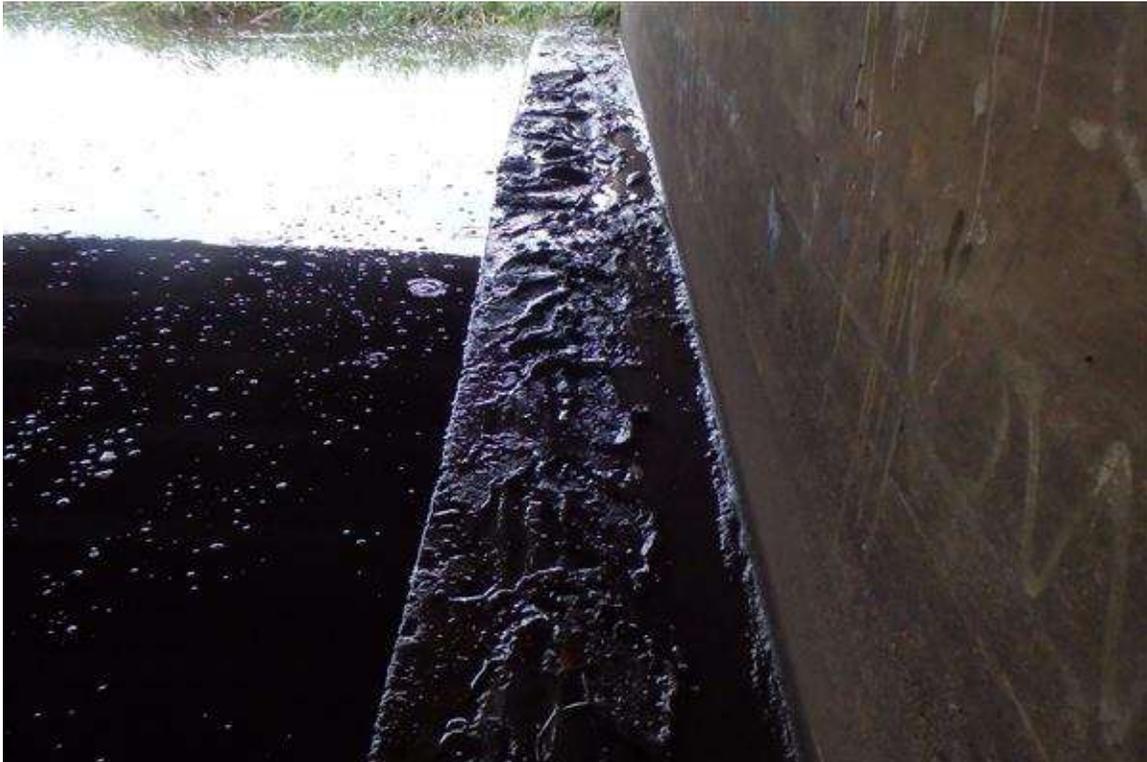
- (D) The East Abutment footing was exposed the full height (2.0 feet) and was undermined the entire length with an undermining void measuring up to 1 foot horizontally and 3 feet vertically. No piles were exposed.

Photo 10 - East Abutment Footing, Looking North

- 4 The East Abutment footing was exposed the full height (2.0 feet) and was undermined the entire length with an undermining void measuring up to 1 foot horizontally and 3 feet vertically. No piles were exposed.

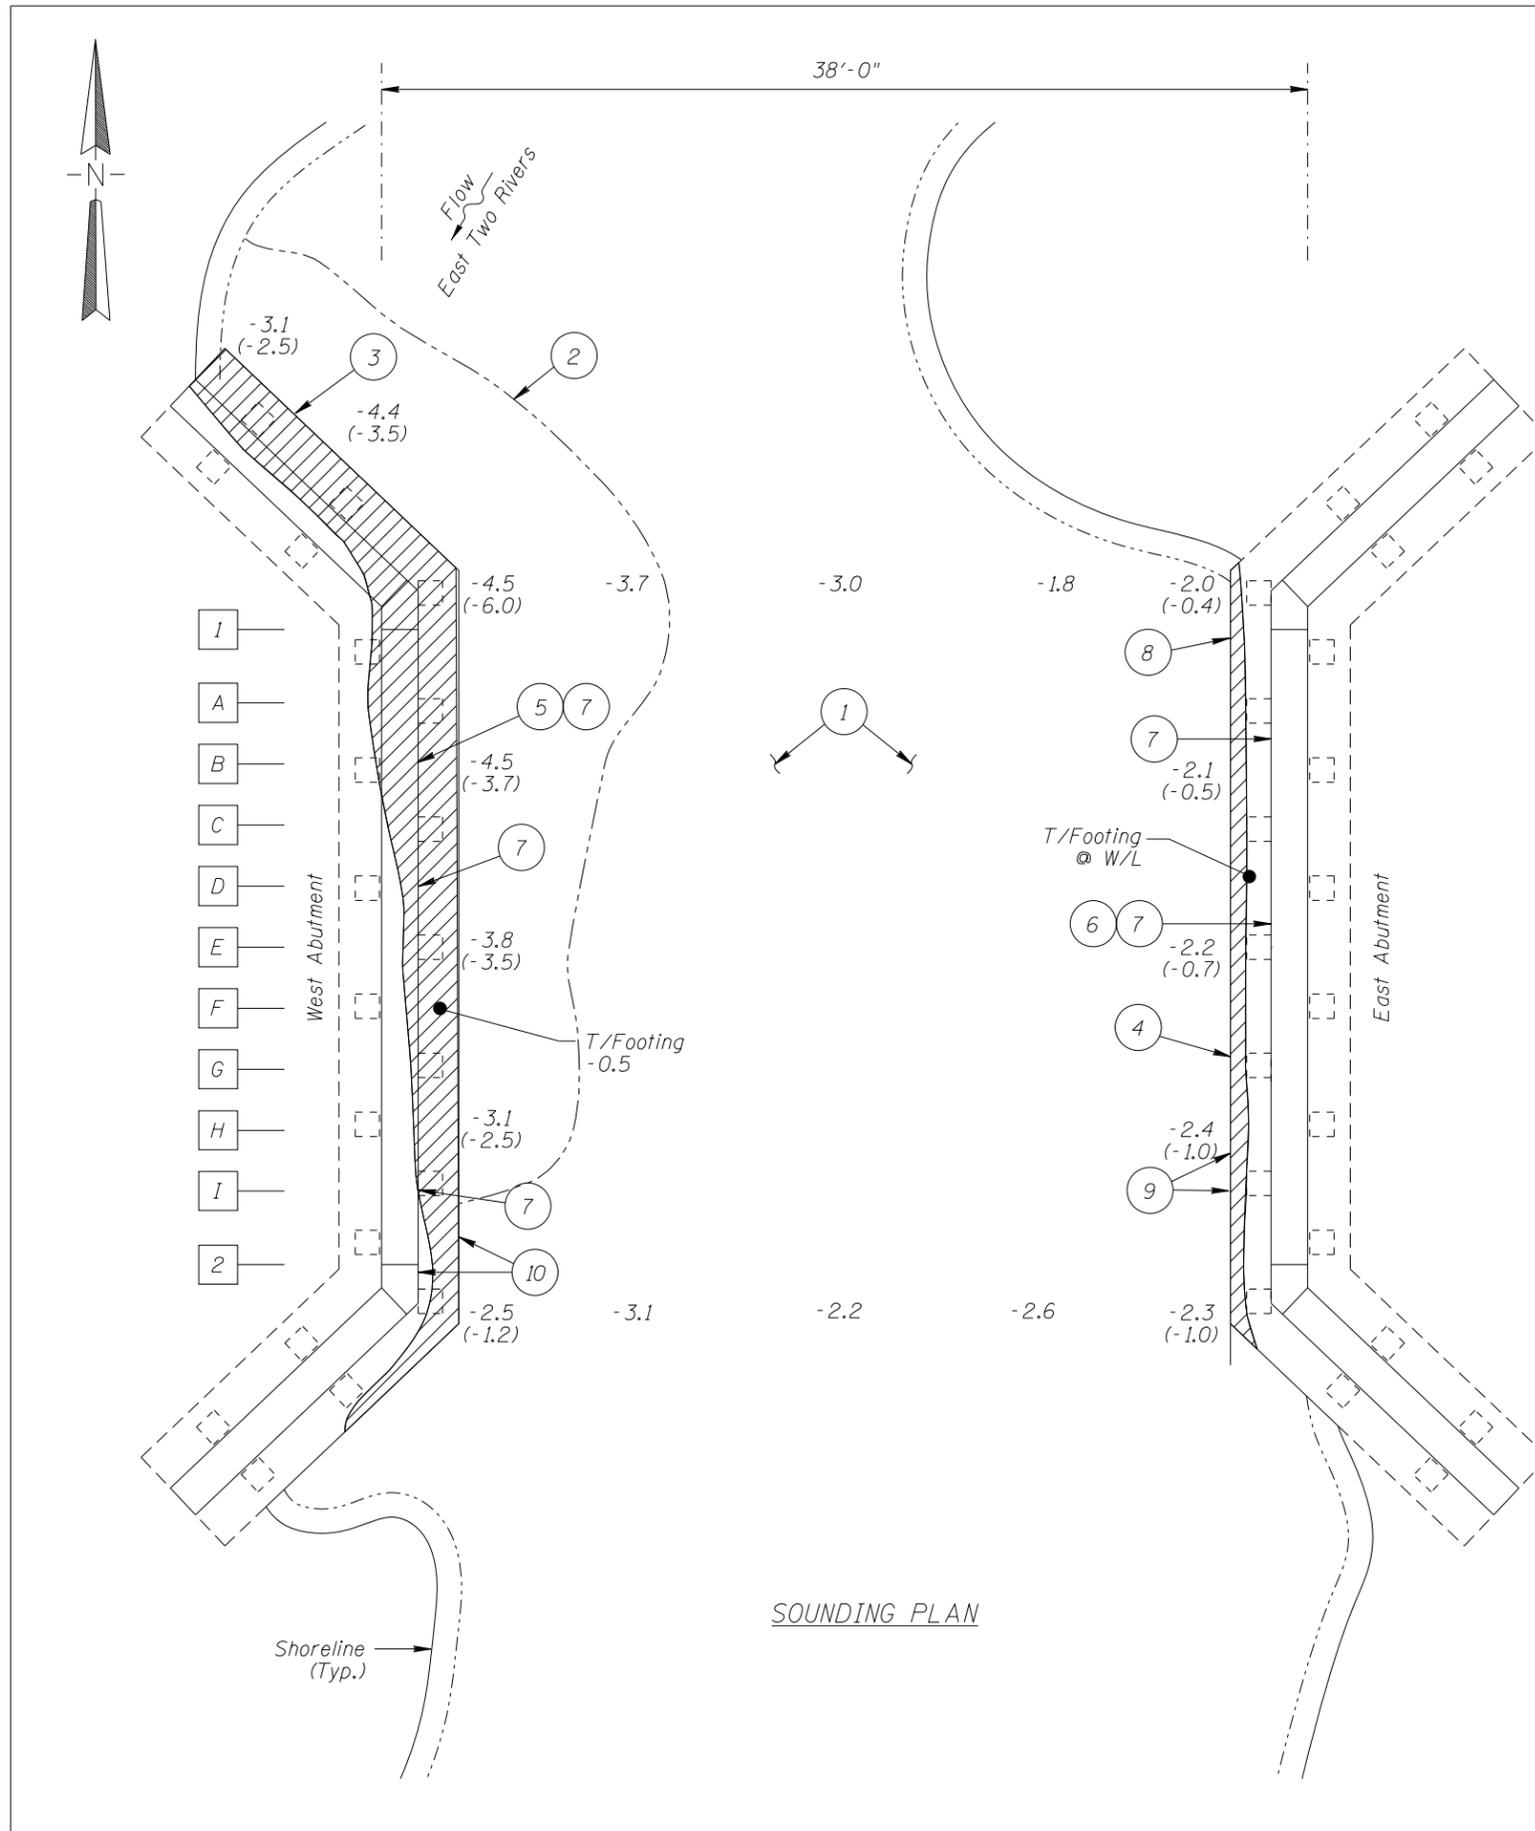
- 1 The channel bottom material typically consisted of soft silt allowing up to 1 foot of probe rod penetration.
- 2 A scour depression up to 1.5 feet deep was present at the West Abutment with the extents shown. The channel bottom material within the depression consisted of sandy gravel allowing up to 4 inches of probe rod penetration.

- 6 A spall was present between Beams D and E at the bridge seat measuring 2 feet high by 2 feet wide with 1 exposed reinforcing bar and up to 3 inches of penetration at the West Abutment.

- 7 Vertical cracking up to 1/4 inch wide from the footing to the bridge seat was present at Beams B, D, and I of the West Abutment and between Beams A and B and D and E of the East Abutment. Associated spalling and impending spalling was observed along the length of the crack with up to 1 inch of penetration.

- 8 A spall measuring 1 foot wide by 18 inches high with up to 3 inches of penetration and 2 exposed reinforcing bars with less than 5 percent section loss was present under the concrete fascia beam (Beam 1) at the East Abutment.
