2016 UNDERWATER BRIDGE INSPECTION REPORT

BRIDGE # 7819 CR 213 over STONE RIVER

Date of Inspection: 09/13/2016

UNDERWATER INSPECTION

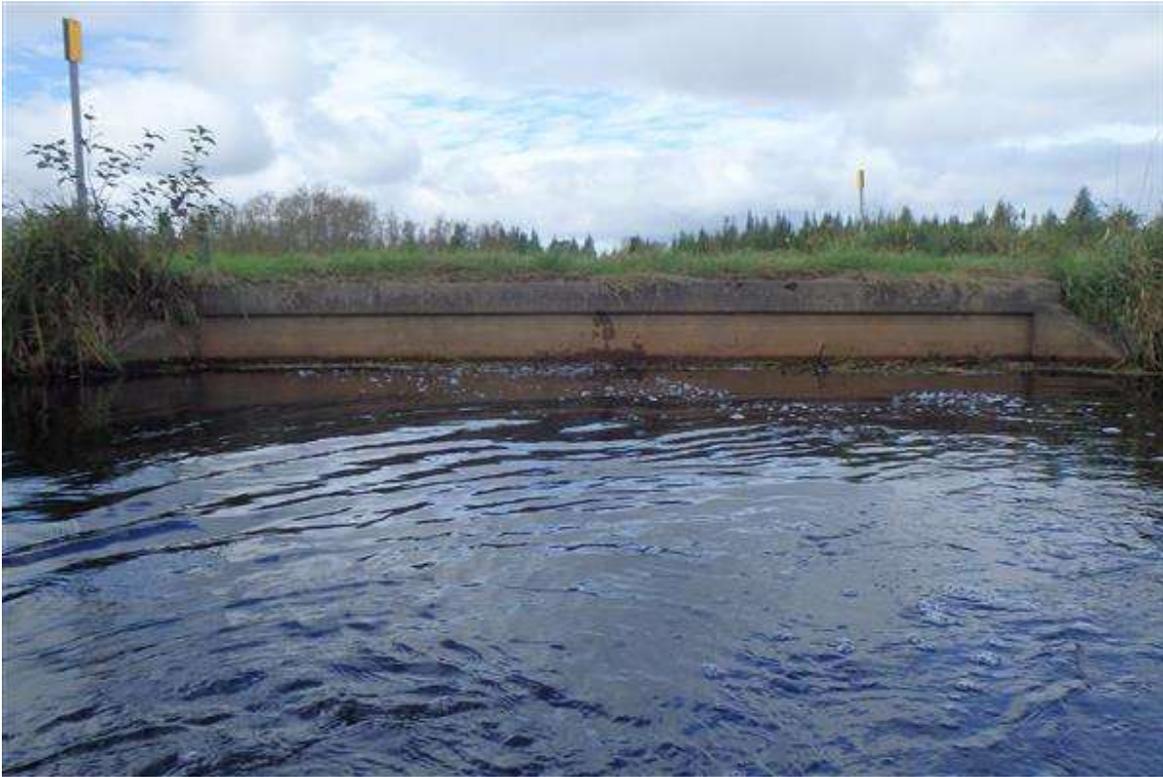
Photo 1 - Upstream Opening, Looking West

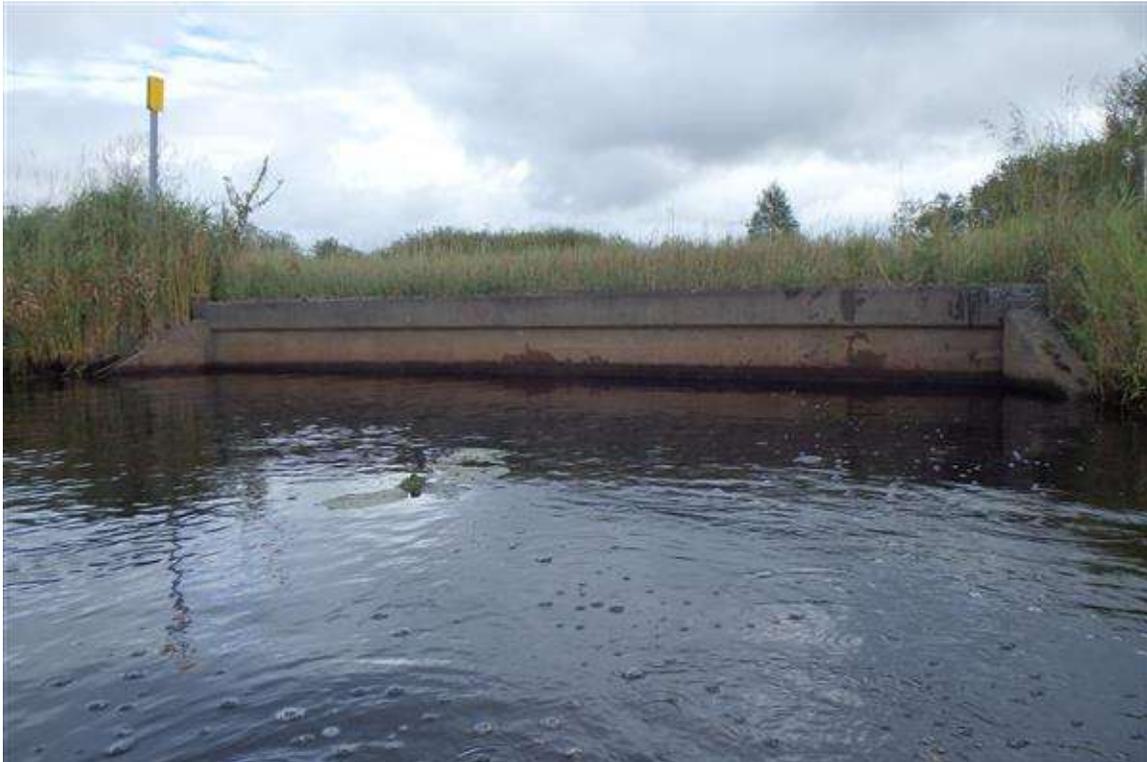
Photo 2 - Downstream Opening, Looking Northeast

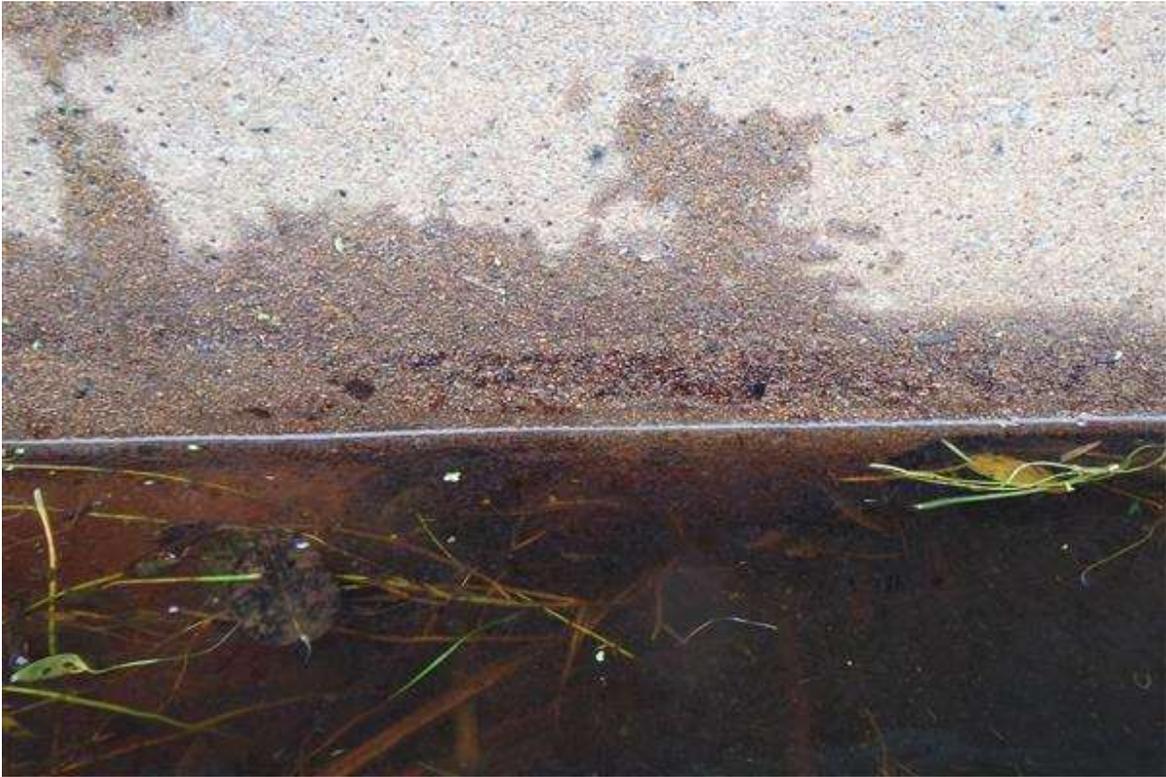
(B) Moderate scaling was observed on the walls and ceiling of both boxes with a typical penetration of 1/4 inch and a maximum penetration of 1/2 inch.

Photo 3 - Typical Concrete Condition at Waterline, Looking West

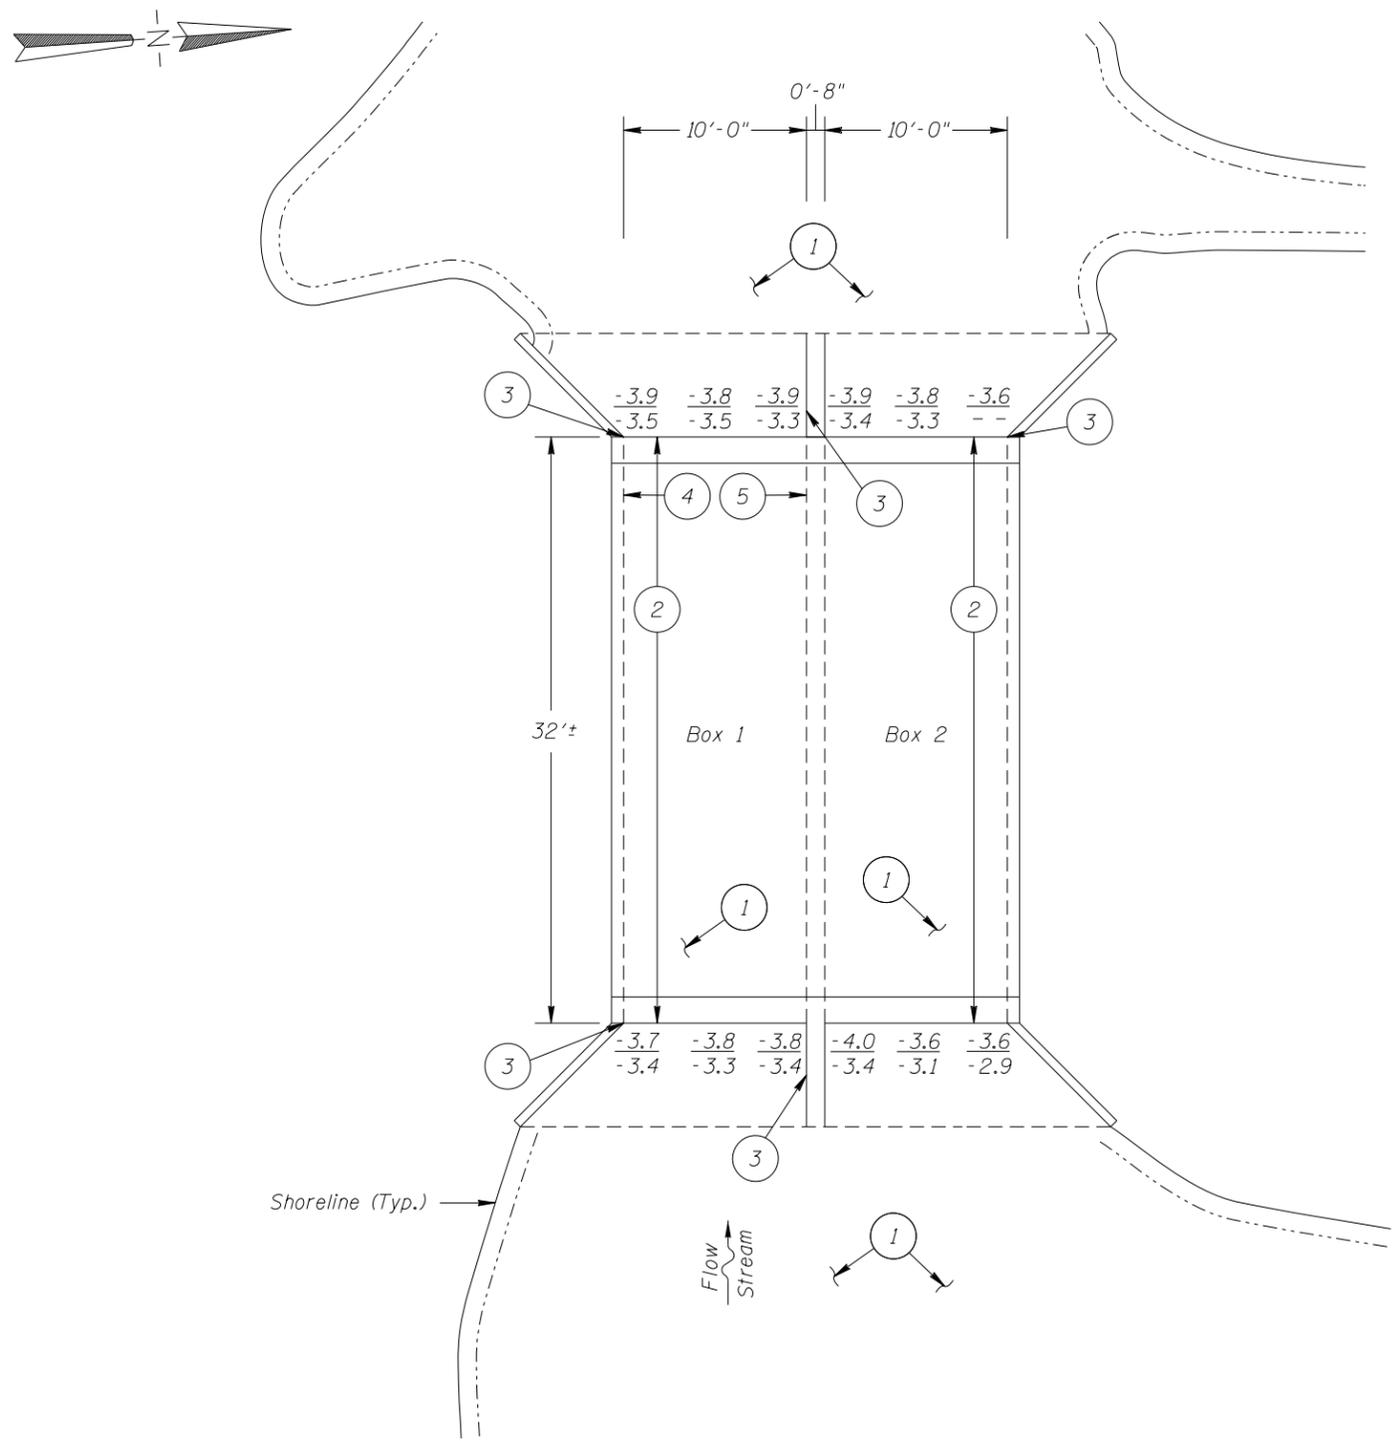
SOUNDING PLAN

- 1 The channel bottom material through the length of both boxes and upstream and downstream of the culvert consisted of silt and scattered stones allowing a maximum probe rod penetration of 2 feet.

- 2 Moderate scaling was observed on the walls and ceiling of both boxes with a typical penetration of 1/4 inch and a maximum penetration of 1/2 inch.
- 3 The center wall extensions at both the upstream and downstream ends of the culvert and the northwest, southwest and southeast wingwalls exhibited a diagonal crack extending from the channel bottom to the top of the wall. The cracks were typically 1/8 inch wide.

- 4 An area of heavy scaling was observed at the south upper wall haunch of Box 1 near the downstream opening. The area measured 3 feet long by 6 inches high with a maximum penetration of 2 inches. No reinforcing steel was exposed.

- 5 An area of heavy scaling was observed at the north wall of Box 1 near the downstream opening. The area measured 2 feet long by 8 inches high with a maximum penetration of 2 inches. No reinforcing steel was exposed.
