2016 UNDERWATER BRIDGE INSPECTION REPORT

BRIDGE # 7836 CR 737 over HELLEWEGS CREEK

UNDERWATER INSPECTION

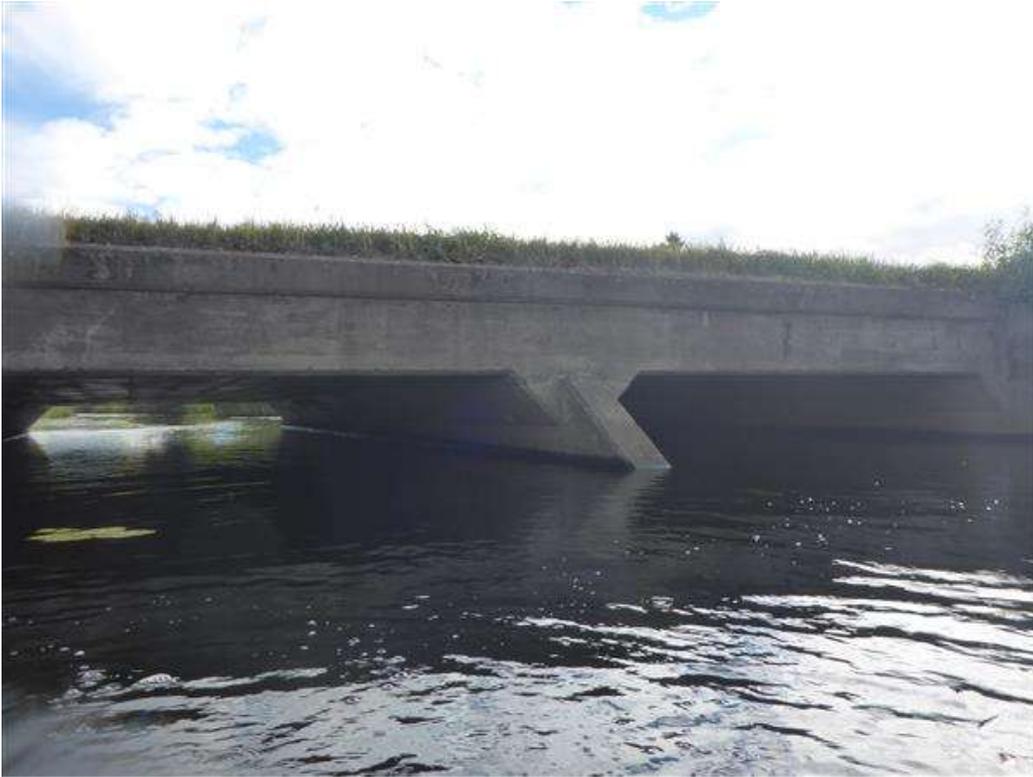
Photo 1 - Upstream Opening, Looking Southwest

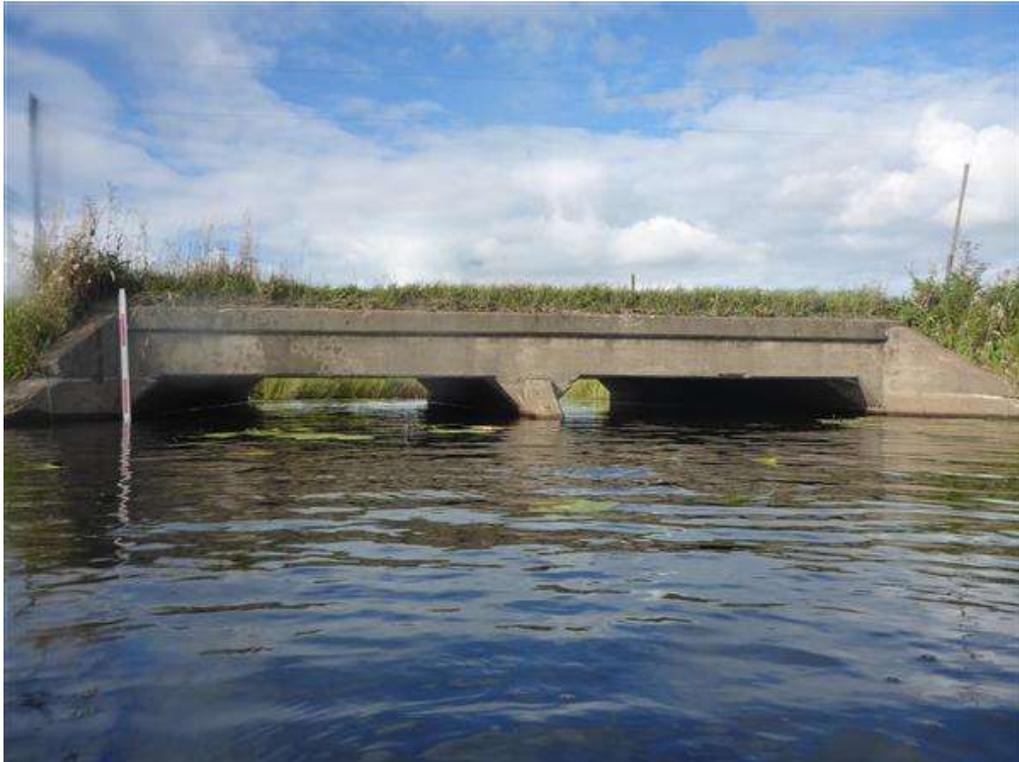
Photo 2 - Downstream Opening, Looking North

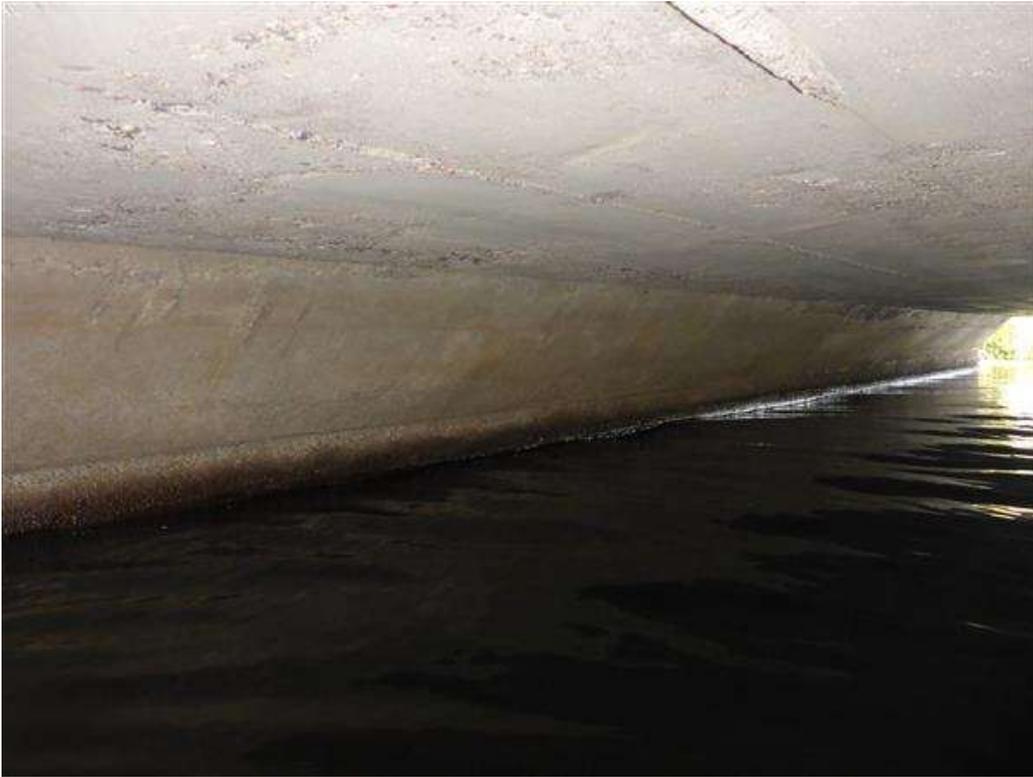
- (C) A band of heavy scaling, extending from the waterline to the culvert floor was observed on all exposed concrete walls. The scaling had a typical penetration of 1/2 inch with a maximum penetration of 1 inch on the east and west walls and 2 inches on the center wall.

Photo 3 - Typical Concrete Condition (Box 1 Shown), Looking Northwest

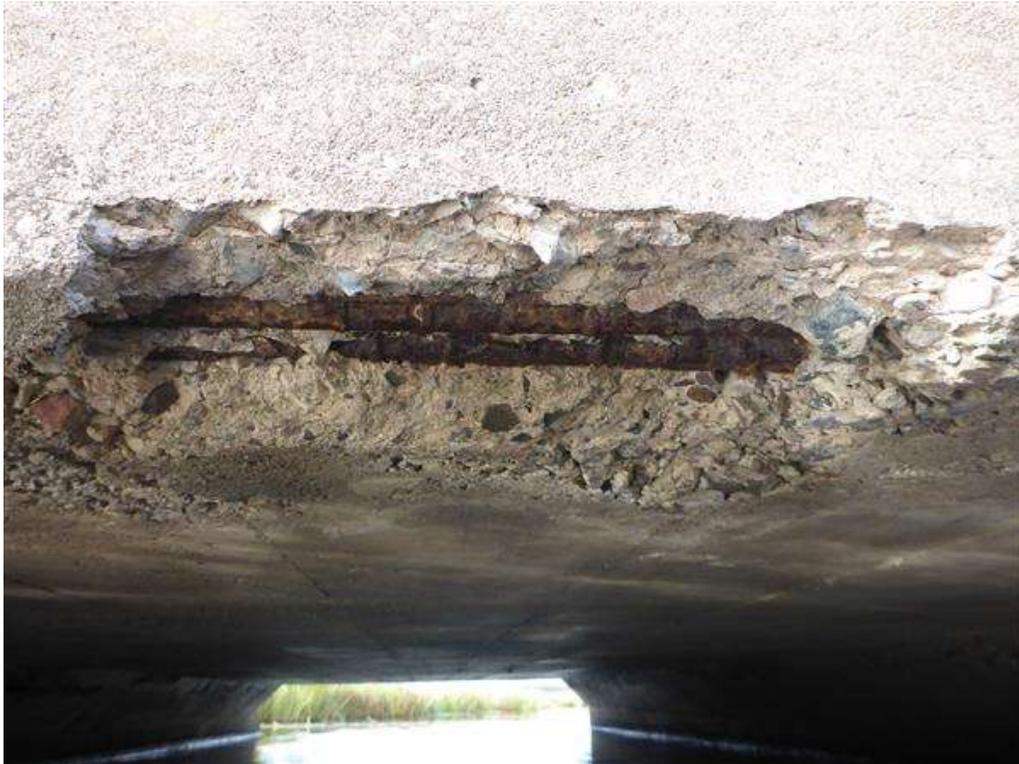
Photo 4 - Spall along Bottom of the Downstream Headwall of Box 2, Looking North

(A) The areas of concrete section loss and poor concrete consolidation with exposed reinforcing steel are not structural concerns at this time; however, they should be repaired to prevent further deterioration. The repairs should include removal of concrete to a minimum of 1 inch behind the reinforcing steel, cleaning and replacing reinforcing steel as required, and placing concrete designed to provide high durability with low permeability.

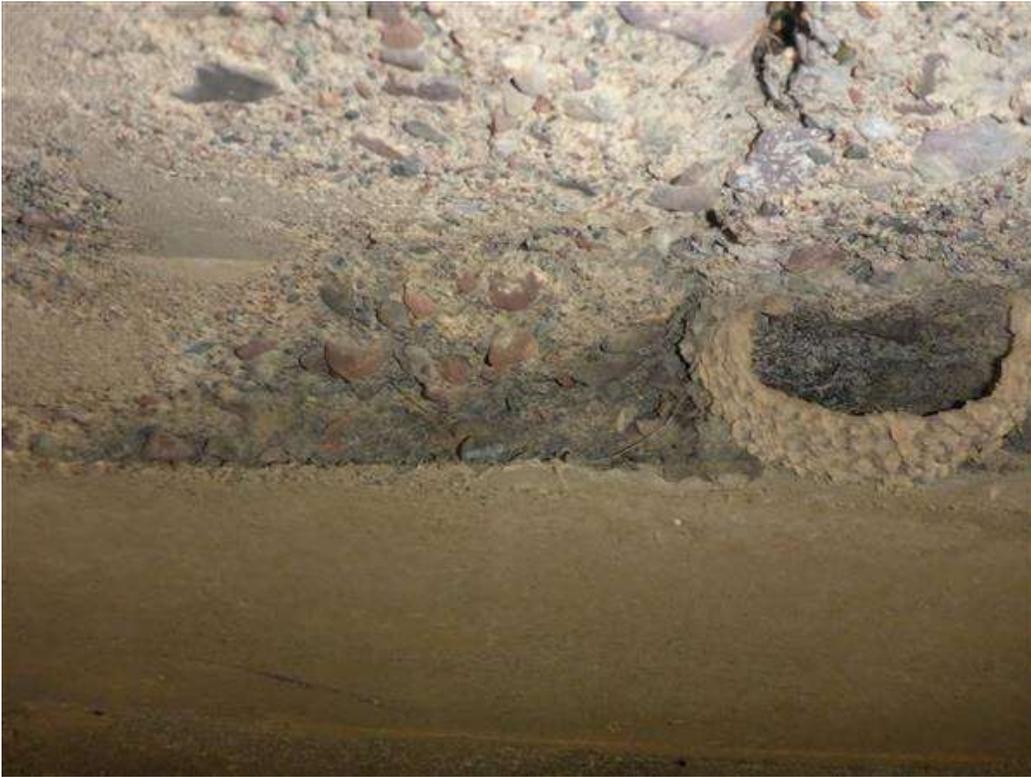
- (H) An area of poor concrete consolidation and concrete section loss was observed on the ceiling and east haunch of Box 1 at approximately 15 feet from the downstream opening. The area on the ceiling measured 4 feet long by 4 feet wide with a maximum penetration of 2 inches and the area on the haunch measured approximately 4 feet long by 3 inches high with a maximum penetration of 6 inches and one exposed reinforcing bar with no appreciable loss of section.

Photo 5 - Poor Concrete Consolidation Near Midpoint of Box 1, Looking East

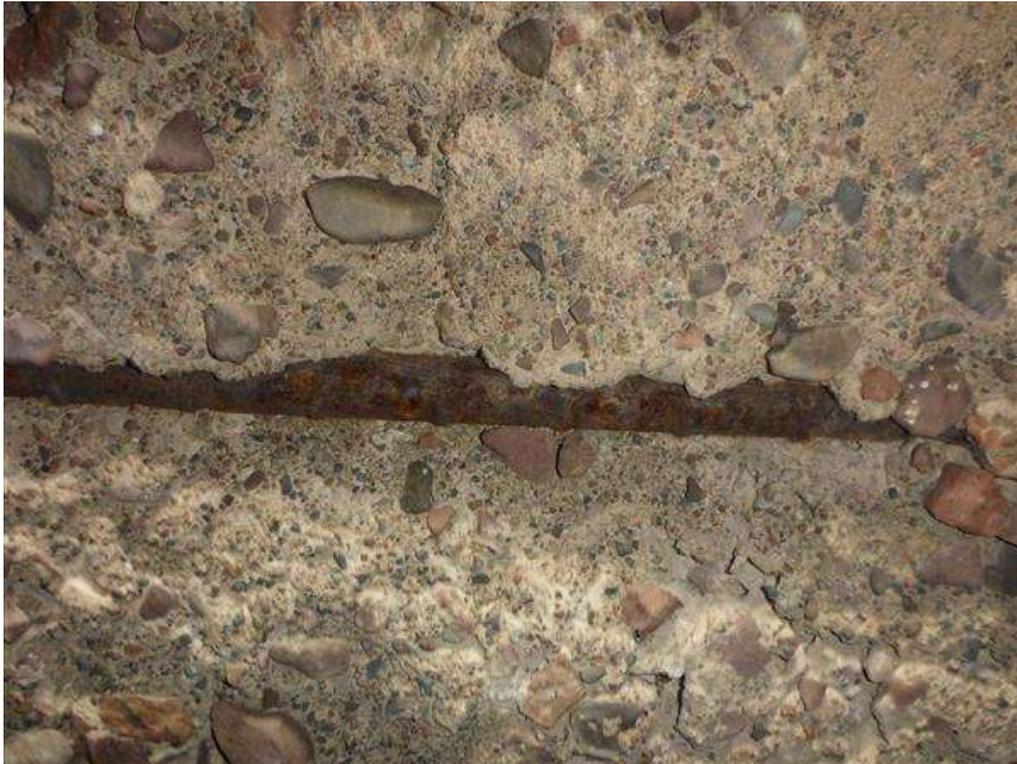
Photo 6 - Poor Concrete Consolidation along Box 1 with Exposed Reinforcing Steel, Looking Up

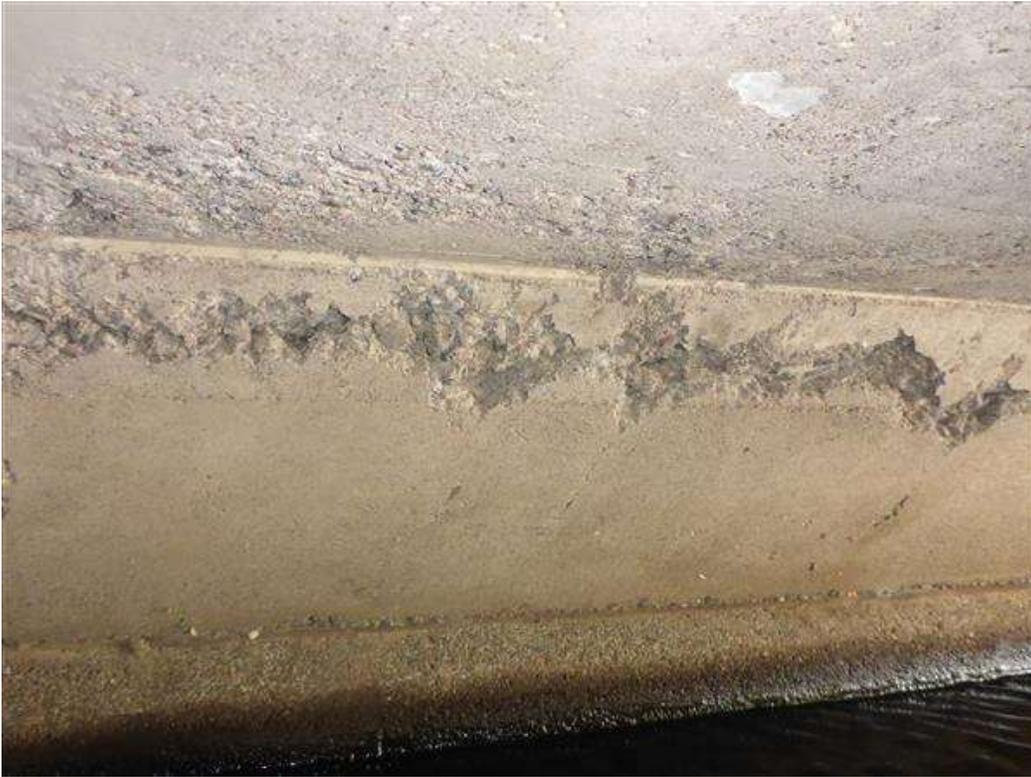
- (J) An area of poor concrete consolidation and concrete section loss was observed on the ceiling and east haunch of Box 2 at approximately 15 feet from the downstream opening. The area on the ceiling measured 4 feet long by 4 feet wide with a maximum penetration of 2 inches and the area on the haunch measured approximately 4 feet long by 3 inches high with a maximum penetration of 3 inches and several exposed reinforcing bars with no appreciable loss of section.

Photo 7 - Poor Consolidation along the East Wall of Box 2, Looking East

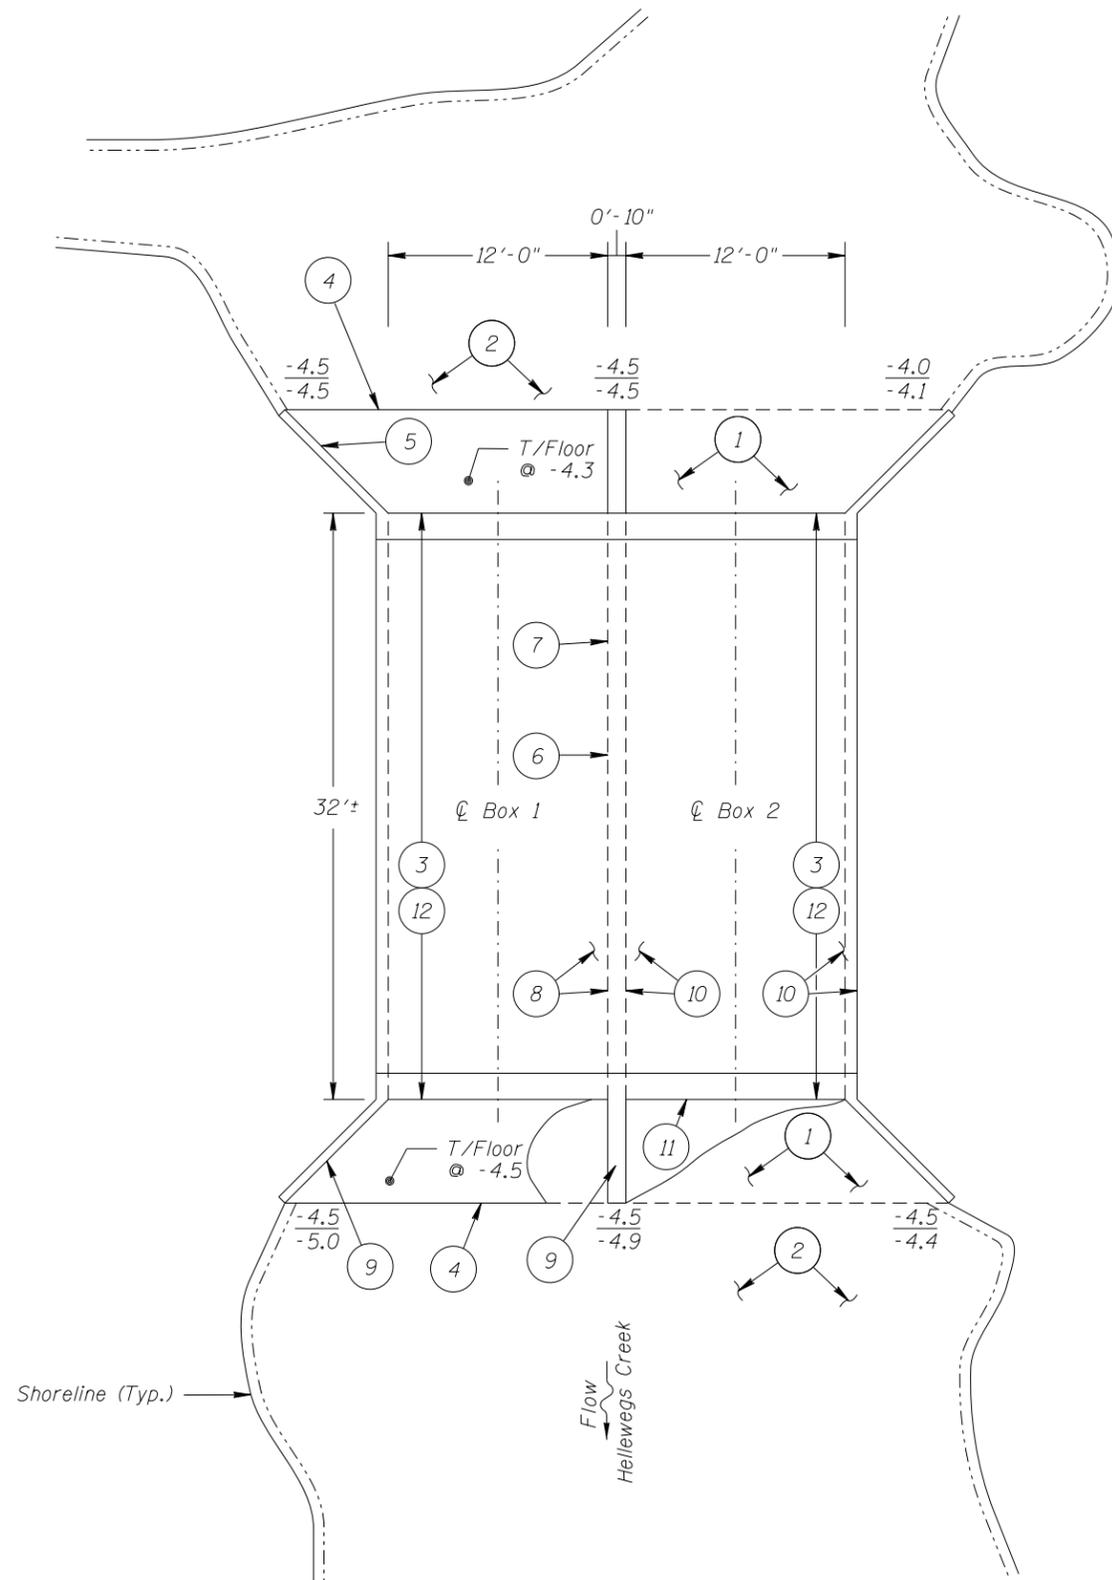
INSPECTION AND SOUNDING PLAN

- 1 The culvert floor was typically clear of any debris or silt build up. There was a layer of silty sand and gravel allowing up to 3 inches probe rod of penetration covering a portion of the concrete apron at the upstream and downstream openings of Box 2.

- 2 The channel bottom material upstream and downstream of the culvert apron consisted of soft silt allowing a maximum probe rod penetration of 1 foot.

- 3 A band of heavy scaling, extending from the waterline to the culvert floor was observed on all exposed concrete walls. The scaling had a typical penetration of 1/2 inch with a maximum penetration of 1 inch on the east and west walls and 2 inches on the center wall.

- 4 The apron floor was flush with the channel bottom at the upstream and downstream openings of Box 1 with no vertical face exposure.
- 5 A diagonal crack was observed on the northwest wingwall with a maximum width of 1/4 inch.

- 6 An area of concrete section loss measuring 2 feet long and 6 inches high with a maximum penetration of 6 inches was observed 1 foot above the waterline near the midpoint of the west face of the center wall.

- 7 An area of concrete section loss measuring 1 foot long and 3 inches high with a maximum penetration of 3 inches was observed 0.5 feet above the waterline and 6 feet from the upstream opening on the west face of the center wall. One horizontal reinforcing bar was exposed with minor loss of section.

- 8 An area of poor concrete consolidation and concrete section loss was observed along the ceiling and east haunch of Box 1 at approximately 15 feet from the downstream opening. The area on the ceiling measured 4 feet long by 4 feet wide with a maximum penetration of 2 inches and the area on the haunch measured approximately 4 feet long by 3 inches high with a maximum penetration of 6 inches and one exposed reinforcing bar with no appreciable loss of section.

- 9 Areas of concrete section loss with up to 2 inches of penetration were observed along the top of the southwest wingwall and the south center wall extension.

- 10 An area of poor concrete consolidation and concrete section loss was observed along the ceiling and east haunch of Box 2 at approximately 15 feet from the downstream opening. The area on the ceiling measured 4 feet long by 4 feet wide with a maximum penetration of 2 inches and the area on the haunch measured approximately 4 feet long by 3 inches high with a maximum penetration of 3 inches and several exposed reinforcing bars with no appreciable loss of section.

- 11 An area of poor concrete consolidation and concrete section loss was observed at the midpoint of the ceiling at the downstream opening of Box 2. The area measured 1.5 feet long by 6 inches wide with a maximum penetration of 2 inches and one exposed reinforcing bar with no appreciable loss of section.

- 12 The concrete of the walls from 0.5 feet above the waterline to the ceiling and the concrete of the ceiling was generally smooth and sound except where otherwise noted. The ceiling and haunches had numerous random areas of poor concrete consolidation and associated areas of concrete section loss with up to 1 inch of penetration.
