2017 UNDERWATER BRIDGE INSPECTION REPORT

BRIDGE # 88696 IRR 120 over SIMIAN CREEK

TABLE OF CONTENTS

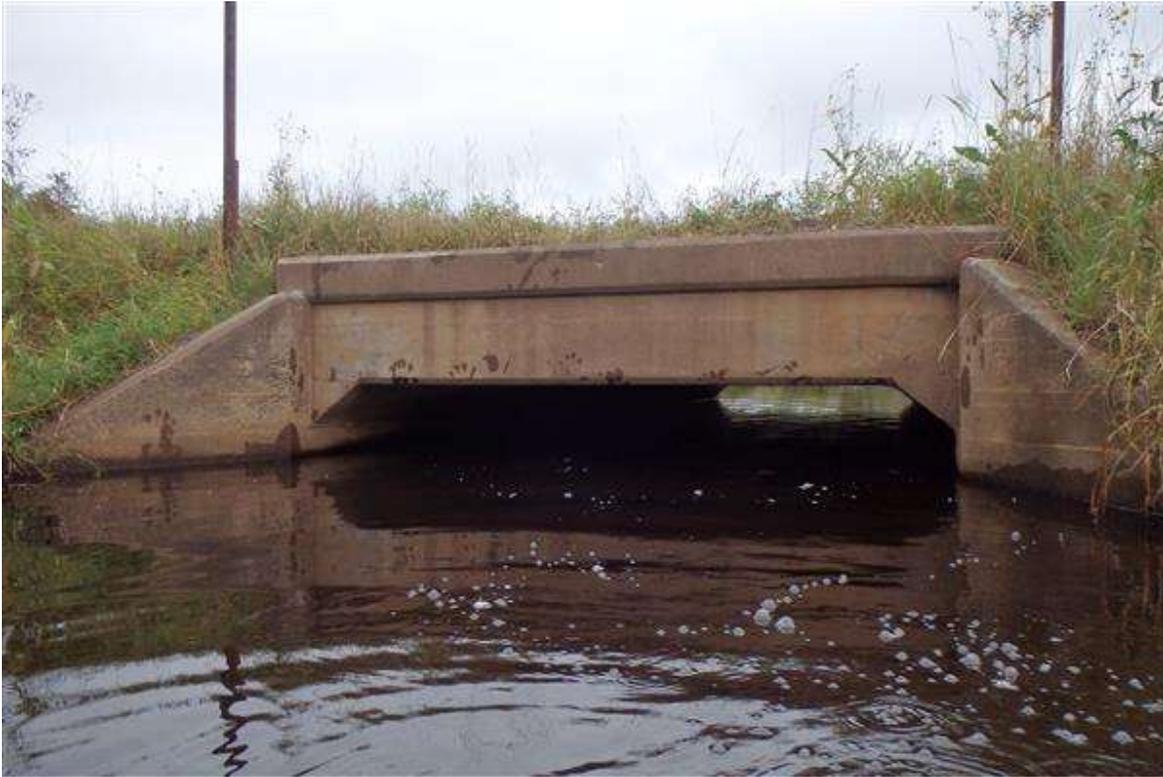
Photo 1 - Upstream Opening, Looking Northeast

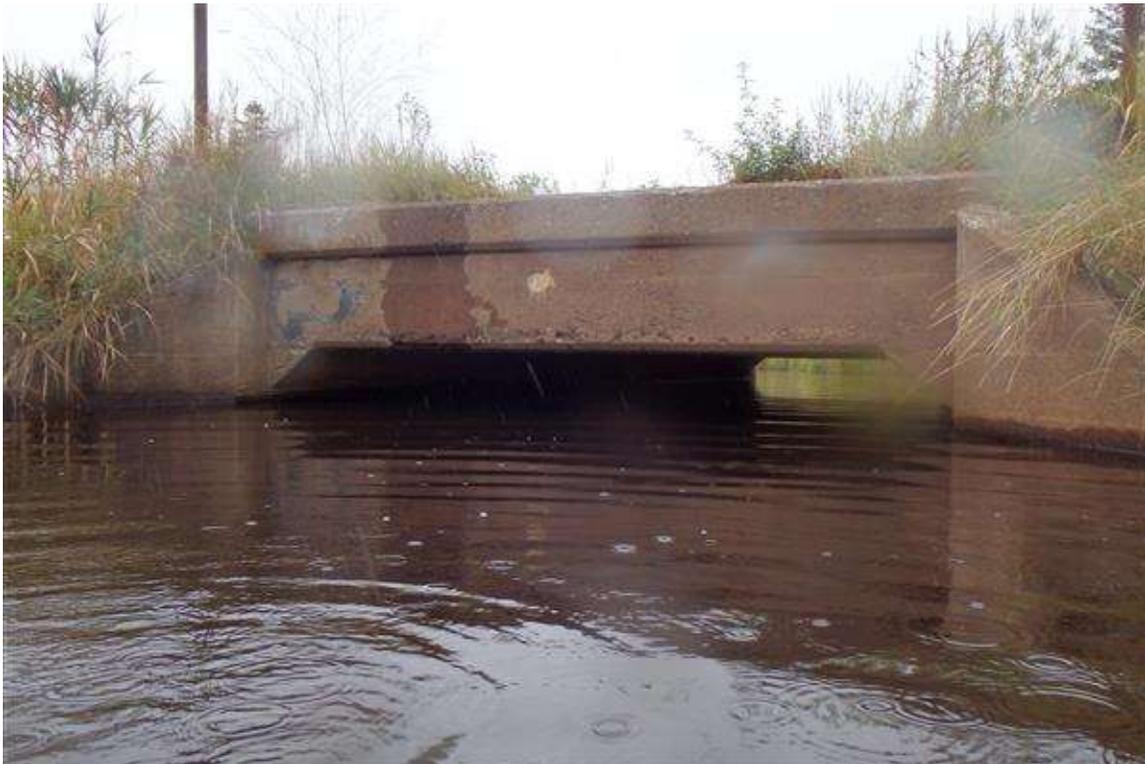
Photo 2 - Downstream Opening, Looking Southwest

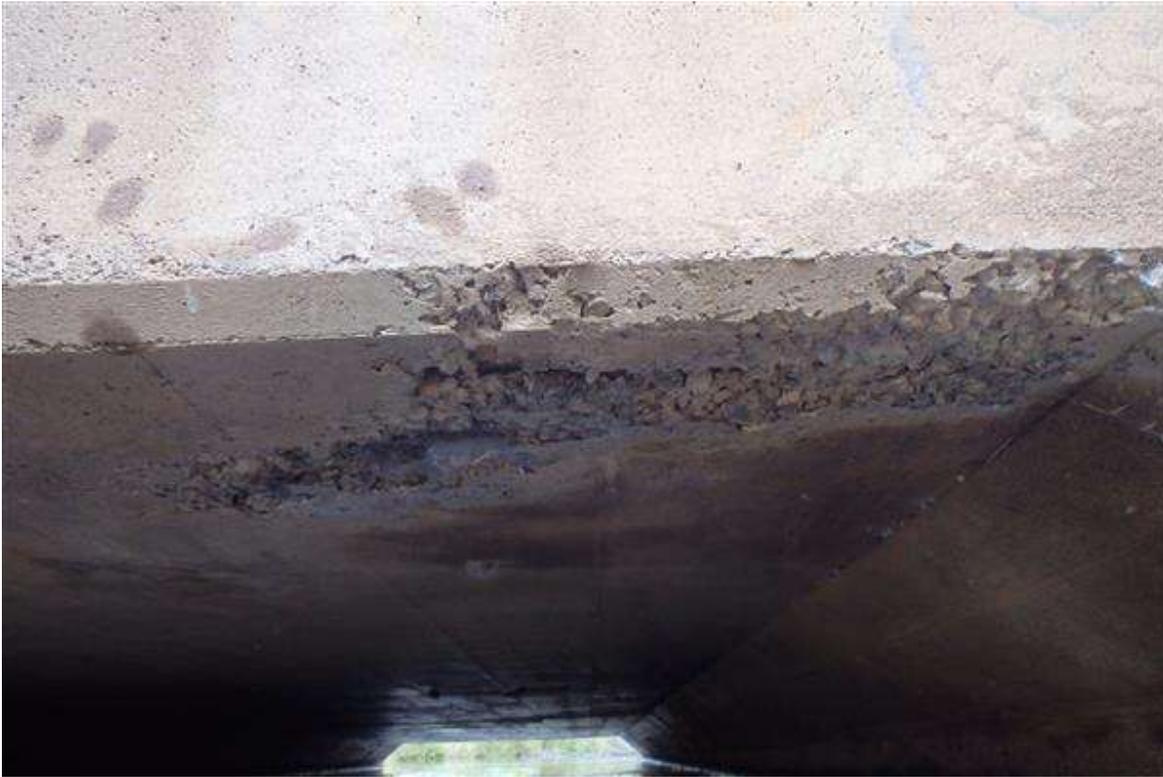
- (D) An area of poor consolidation, 2 feet by 3 feet and up to 1 inch of penetration with 3 exposed reinforcing bars that exhibited up to 25 percent section loss was present on the ceiling near the south wall approximately 1 foot from the upstream opening.

Photo 3 - Area of Poor Consolidation Near the Upstream Headwall, Looking East

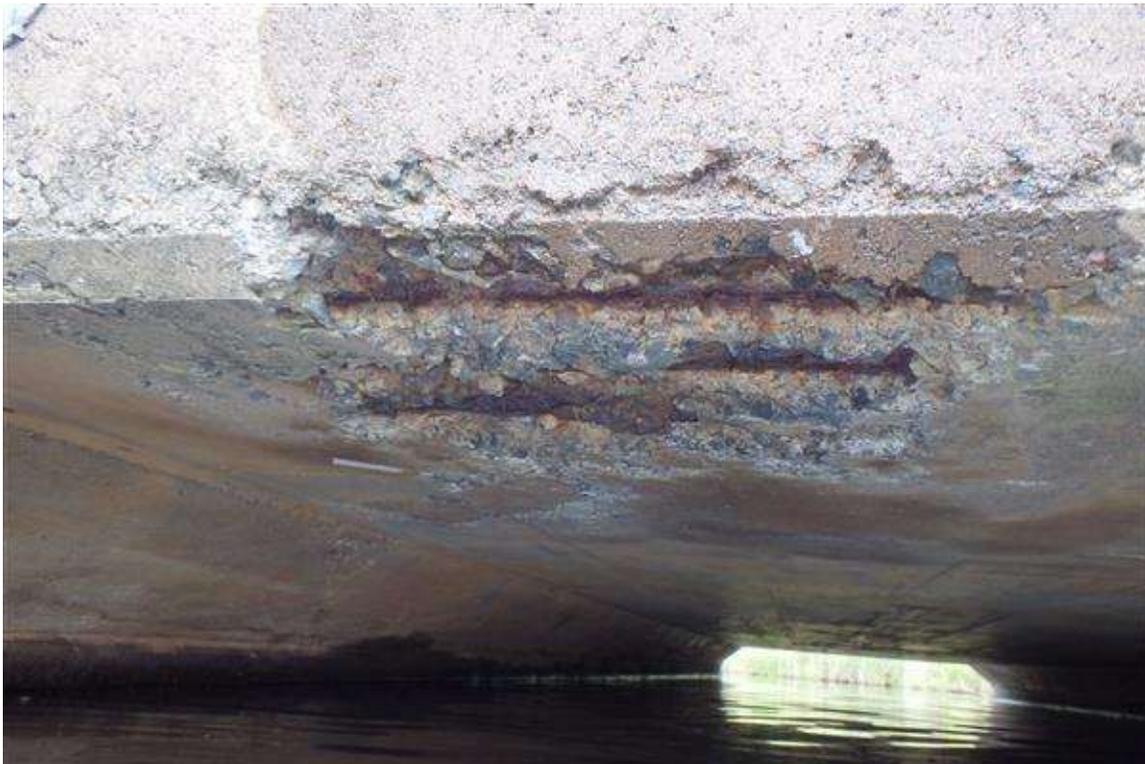
- (E) The top of the floor throughout the box was exposed and free of any channel bottom material aggradation.
- (F) A spall measuring 3 feet by 3 feet with 3 exposed reinforcing bars that exhibited 25 percent section loss and up to 1.5 inches of penetration was present on the ceiling at the downstream opening near the south wall.

Photo 4 - Spall at the Downstream Headwall, Looking Southwest

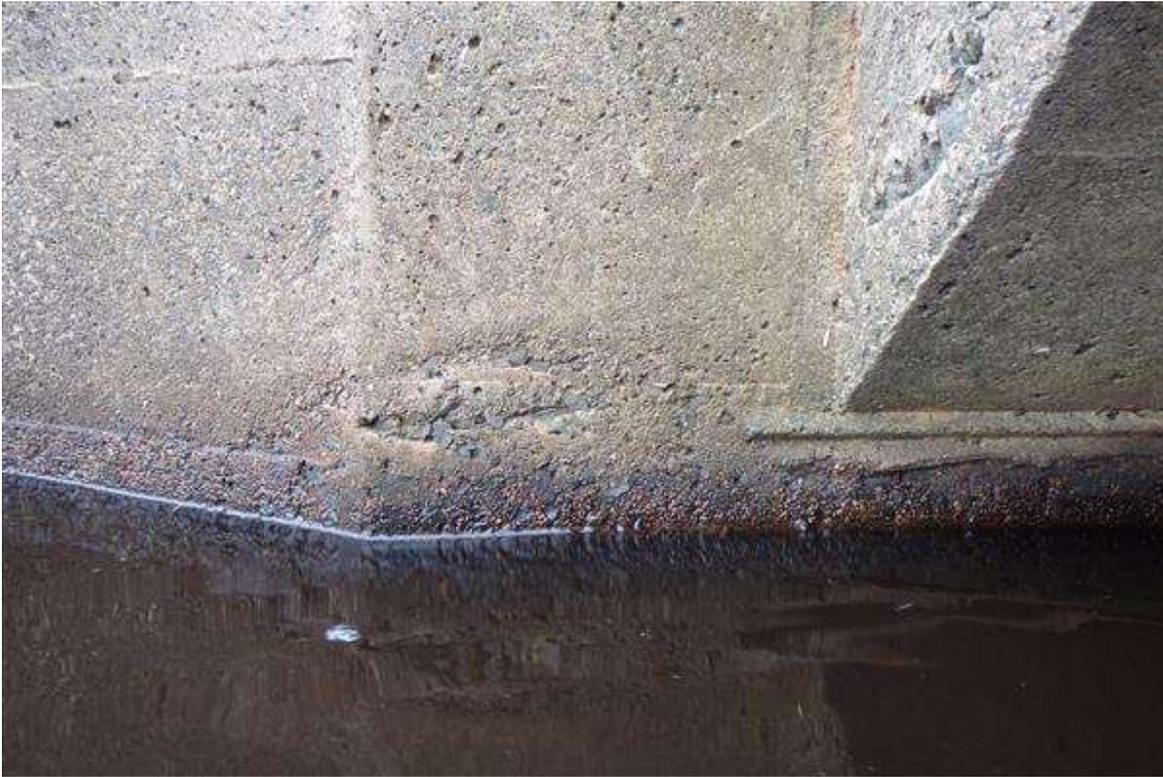
- (A) The channel bottom material consisted of silt with up to 1 foot of probe rod penetration and scattered rocks up to 1 foot in diameter.
- (B) The concrete typically exhibited light scaling with up to 1/8 inch of penetration.

Photo 5 - Typical Concrete Condition at the Waterline, Looking South

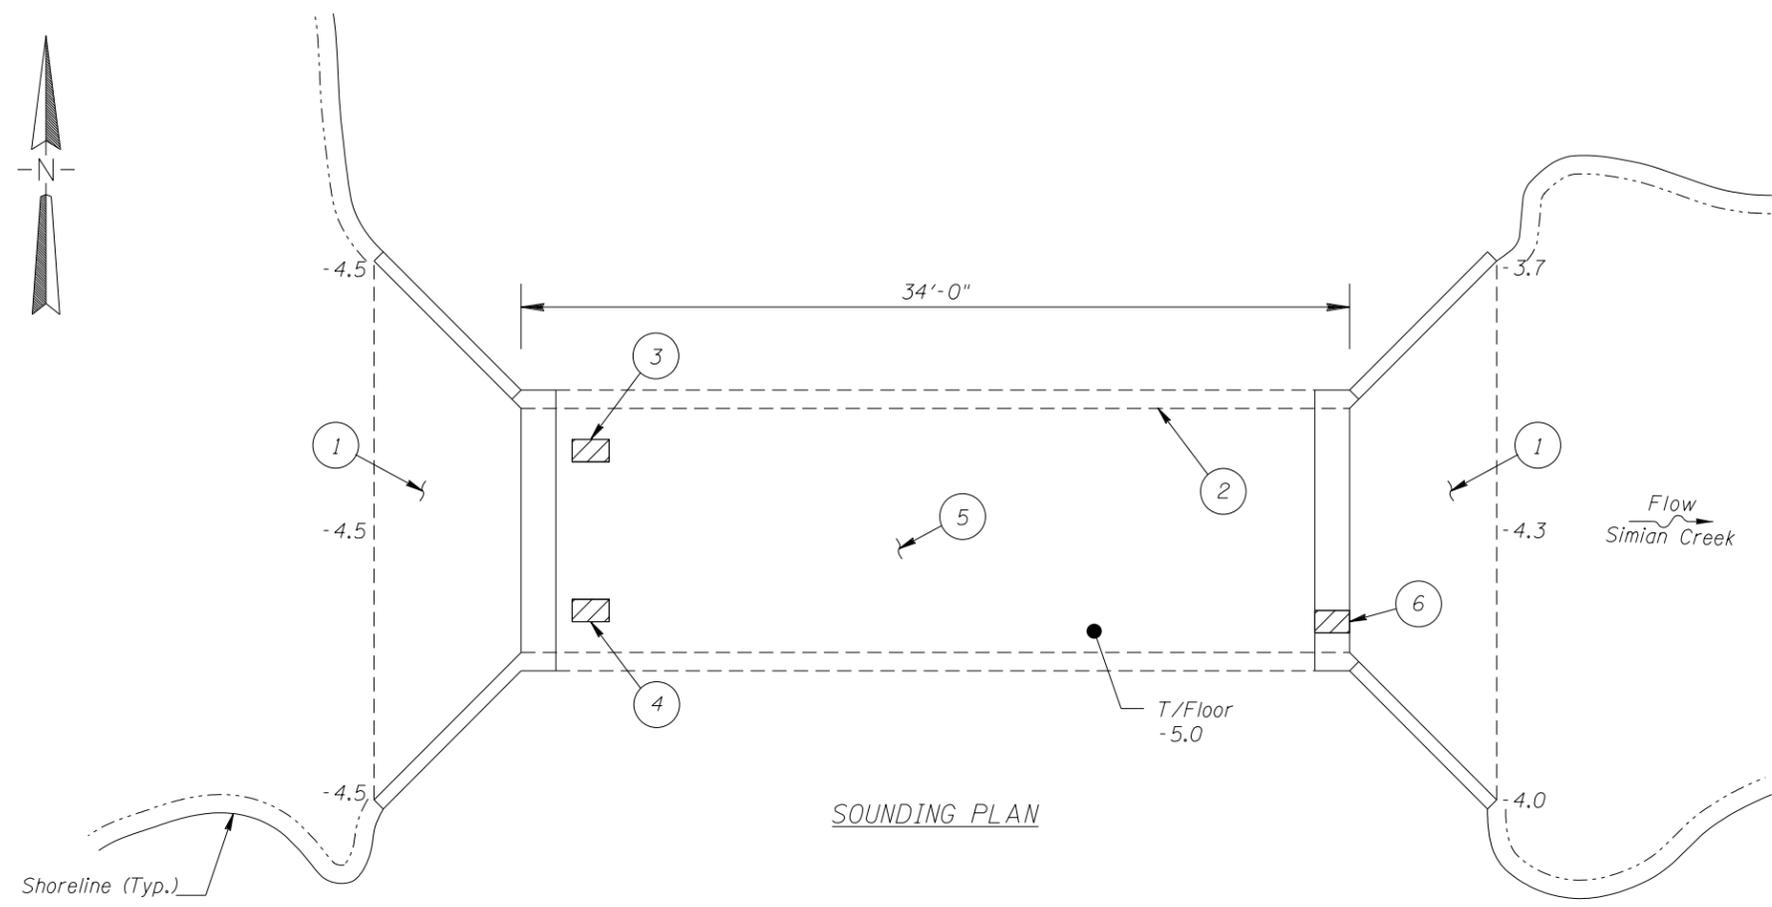
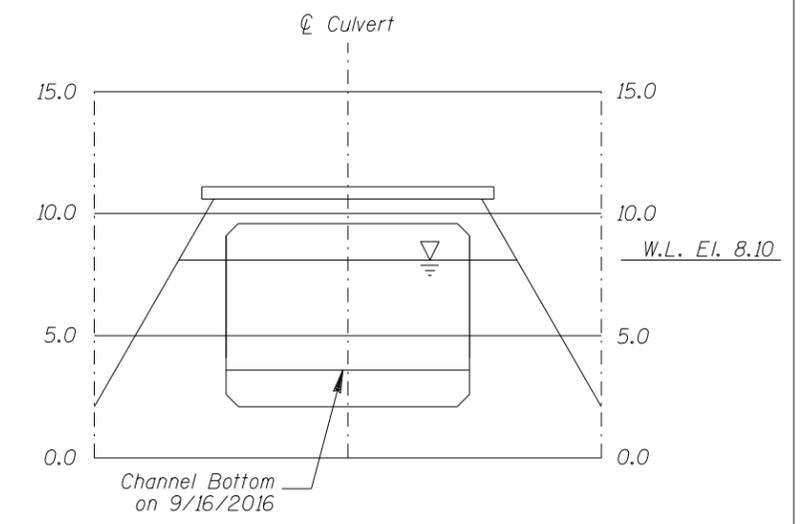
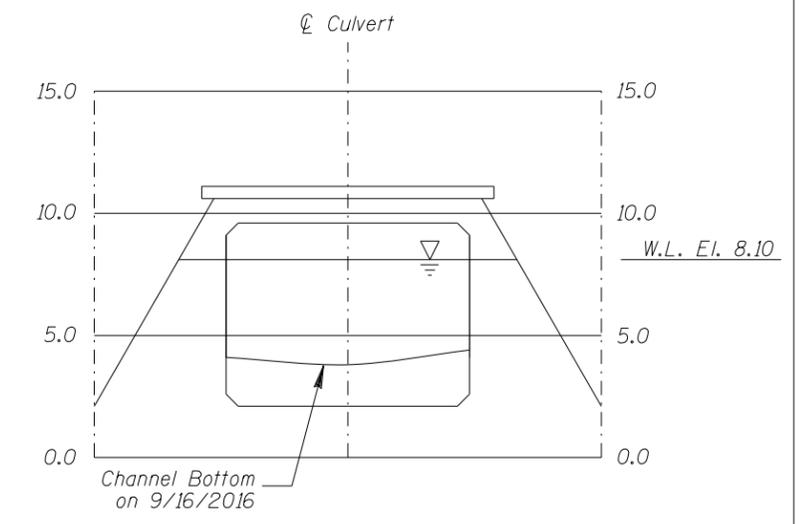
1. The channel bottom material consisted of silt with up to 1 foot of probe rod penetration and scattered rocks up to 1 foot in diameter.
2. The concrete typically exhibited light scaling with up to 1/8 inch of penetration.

3. A spall 1 foot long by 4 inches wide and up to 1 inch of penetration with 1 exposed reinforcing bar that exhibited up to 25% section loss was located on the ceiling near the north wall approximately 1 foot from the upstream opening.

4. An area of poor consolidation, 2 feet by 3 feet and up to 1 inch of penetration with 3 exposed reinforcing bars that exhibited up to 25% section loss was present on the ceiling near the south wall approximately 1 foot from the upstream opening.

5. The top of the floor throughout the box was exposed and free of any channel bottom material aggradation.
6. A spall measuring 3 feet by 3 feet and up to 1.5 inches of penetration with 3 exposed reinforcing bars that exhibited 25% section loss was present on the ceiling at the downstream opening near the south wall.
