2017 UNDERWATER BRIDGE INSPECTION REPORT

BRIDGE # 88699 CR 877 over LESTER RIVER

Date of Inspection: 09/15/2016

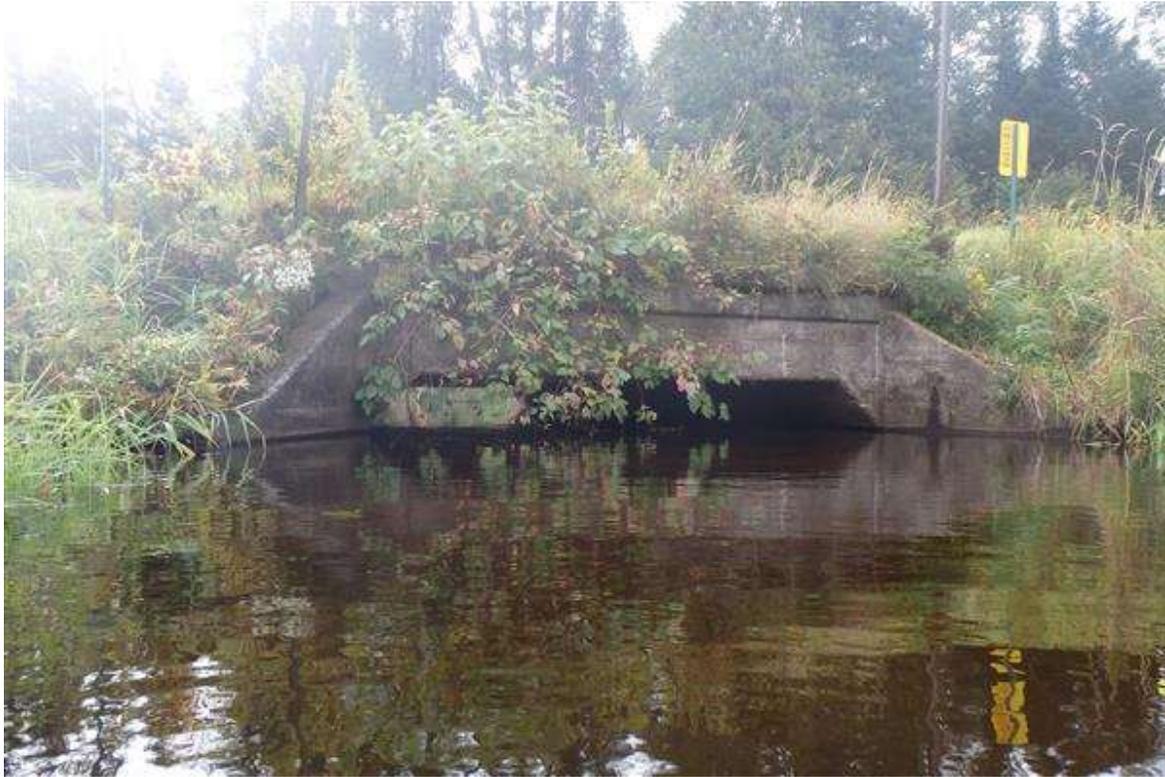
Photo 1 - Upstream Opening, Looking South

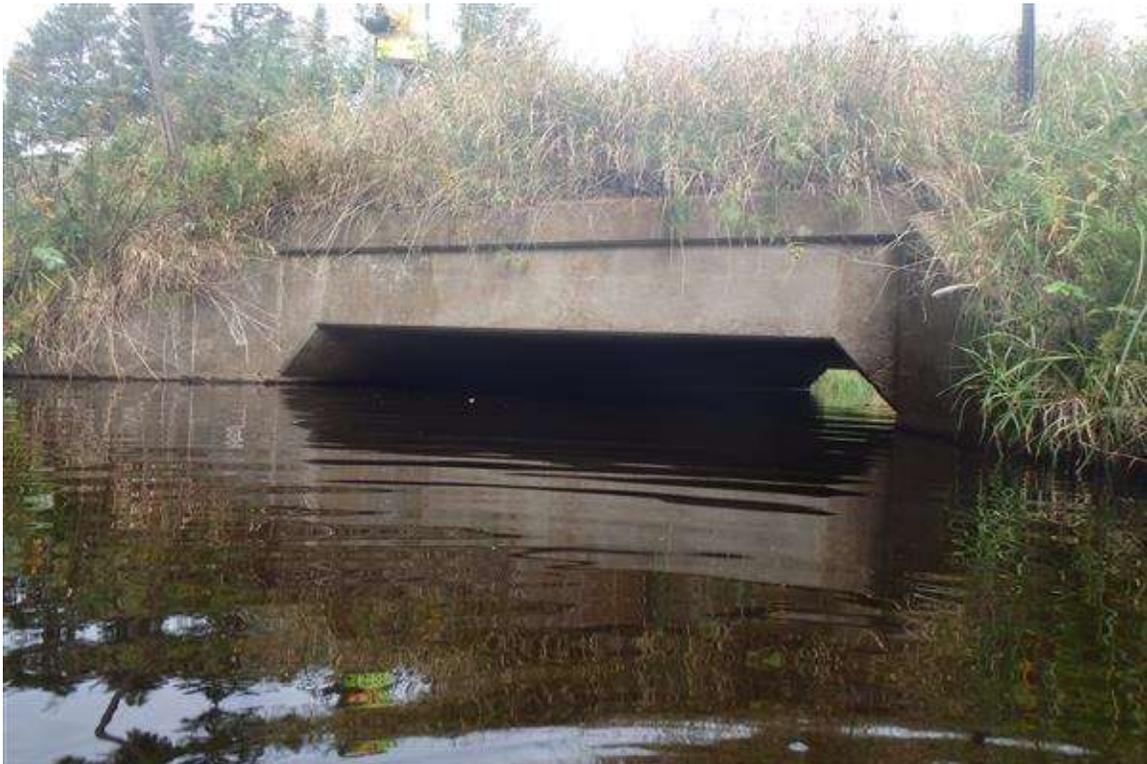
Photo 2 - Downstream Opening, Looking Northwest

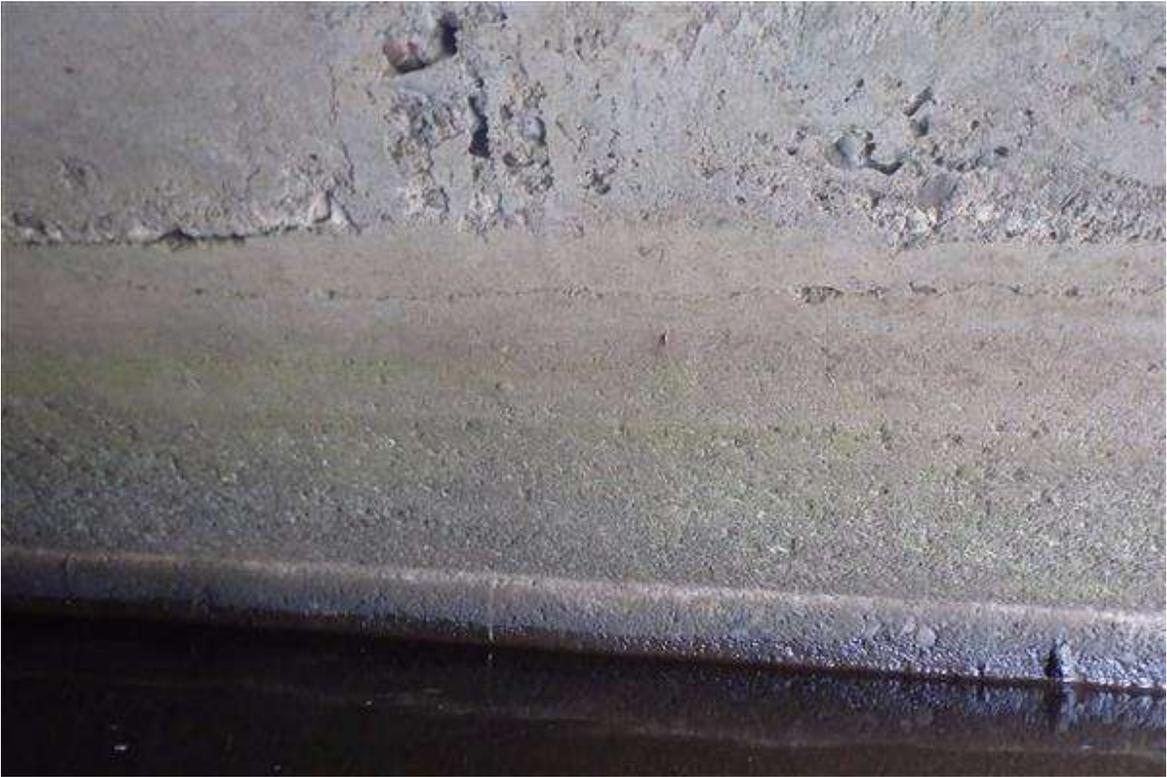
The substructure inspected at Structure No. 88699, a concrete box culvert, was found to be in good condition with no defects of structural significance below water. A band of light scaling was observed around the waterline along the length of the culvert. The apron was exposed at both the downstream and upstream openings with a maximum vertical toe exposure of 0.3 feet.

Photo 3 - Typical Concrete Condition at Waterline, Looking West

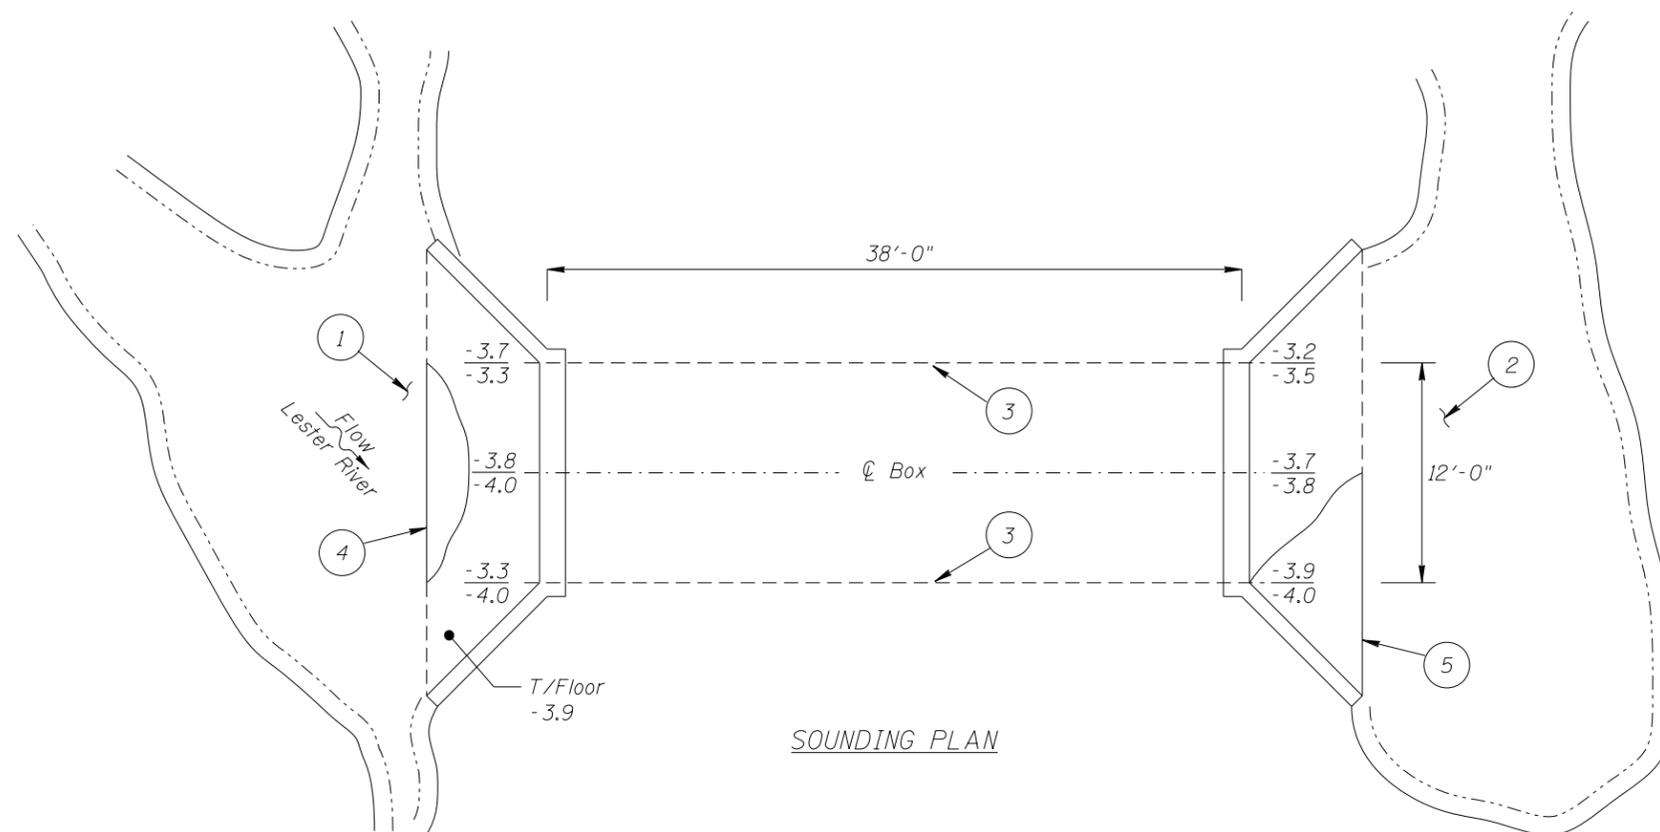
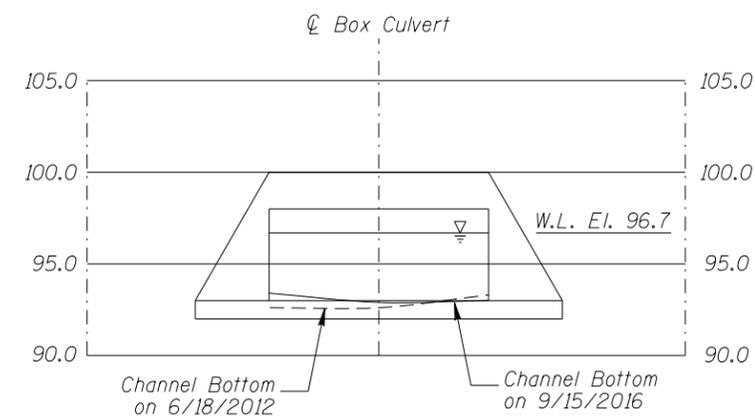
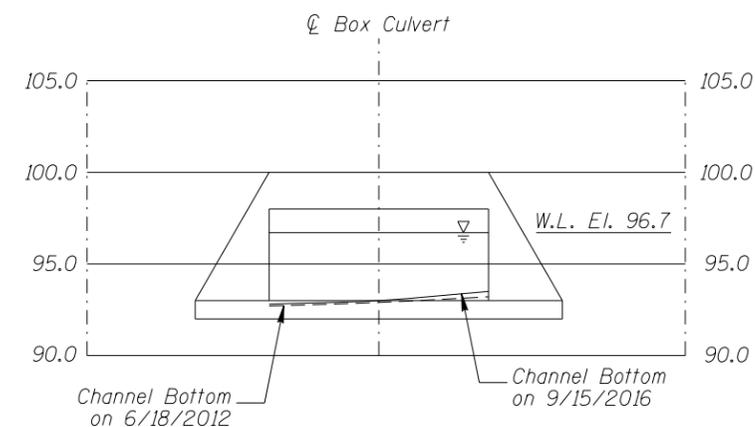
1. The upstream channel bottom material consisted of 6 inch diameter cobblestones and smaller gravel.
2. The downstream channel bottom material consisted of soft silt with up to 2 feet of probe rod penetration
3. A band of light scaling was observed around the waterline along the length of the culvert walls and floor with a typical penetration of 1/16 inch and a maximum penetration of 1/8 inch. Random areas of poor consolidation accounting for less than 5% of the surface area were present along the haunches and the ceiling.
4. The concrete apron at the upstream opening of the culvert was partially exposed for the culvert width with maximum vertical exposure of 0.3 feet.
5. The concrete apron at the downstream opening of the culvert was partially exposed for the west half of the barrel with maximum vertical exposure of 0.3 feet.

- (A) Reinspect the submerged substructure units at the normal maximum (NBIS) interval of sixty (60) months.
