# 2016 UNDERWATER BRIDGE INSPECTION REPORT

## BRIDGE # 88754 UT 8146 over ASH RIVER

Date of Inspection: 06/19/2016

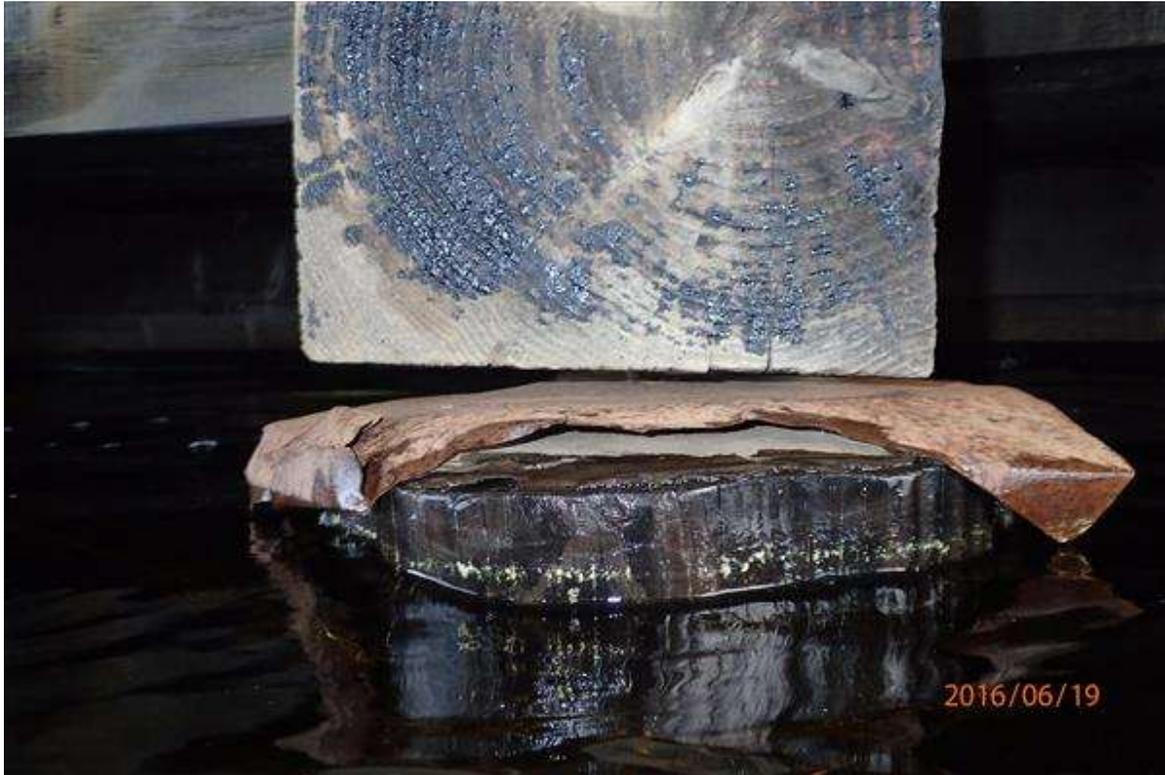
Photo 3 - Pile C of North Abutment, Looking North

- (C) A 1 inch and 2 inch gap was observed between the pile and the pile cap resulting in no bearing at the southern Pile C of the North Abutment and the northern Pile A of the South Abutment respectively.

- (D) The southern Pile C of the South Abutment and the northern Pile C of the North Abutment exhibited splits resulting in 25 percent of the pile no longer being attached to other 75 percent of the pile. Both sections were load bearing separately. The split ranged from 3 inches wide at the pile cap to 1 inch wide at the channel bottom.

- (A) The southern Pile C at the South and North Abutment, the northern Pile C at the North Abutment, and the northern Pile A of the South Abutment should be repaired to regain full structural integrity and proper load bearing of the timber piles. The repair should include jacketing or replacing the pile.
- (B) Fill the cavities behind the North Abutment and the South Abutment wingwalls with a suitable material (for instance, pumped lean concrete) and repair the gaps between the backwall and wingwall boards. Monitor the roadway and roadway slopes for any signs of further loss of backfill and settlement.
- (C) Consider removal of the timber debris from the channel.
- (D) Reinspect the submerged substructure at the normal maximum recommended (NBIS) interval of sixty (60) months.

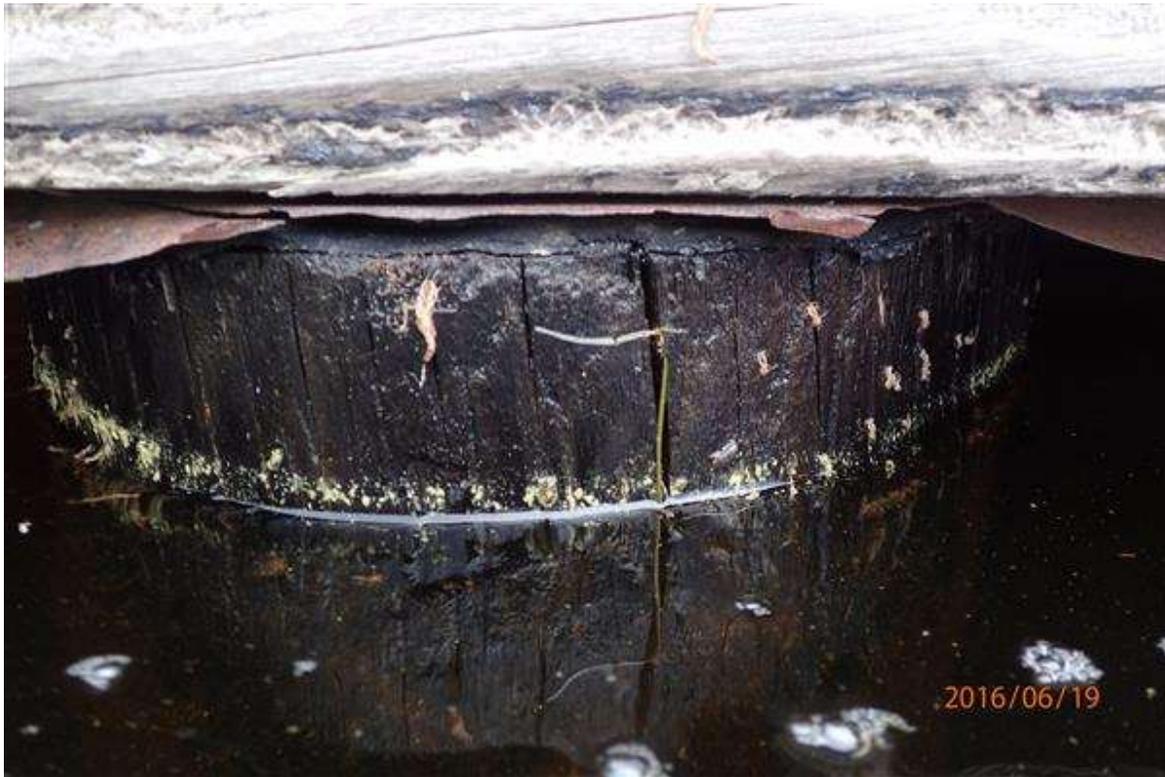
- (A) The channel bottom material typically consisted of sandy gravel with a maximum probe rod penetration of 6 inches.
- (B) The timber piles and bent caps were typically sound with random checks up to 1/4 inch wide and 1/4 inch deep.

Photo 5 - Typical Pile Condition Near the Waterline, Looking North

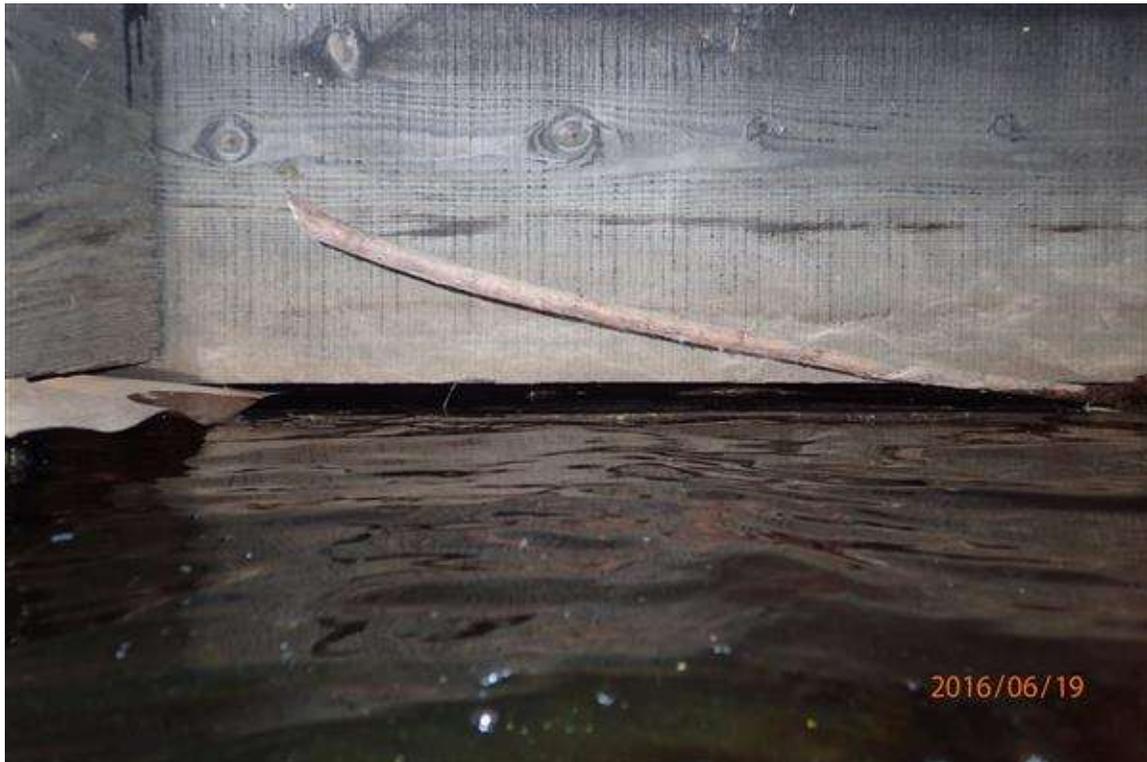
- (E) A gap, up to 8 inches wide, was observed between the timber backwall boards and both the wingwalls at the South Abutment. A loss of backfill material was observed with a maximum penetration of 3 feet and a typical penetration of 1 foot.

Photo 6 - Gap in South Abutment Backwall Boards, Looking South

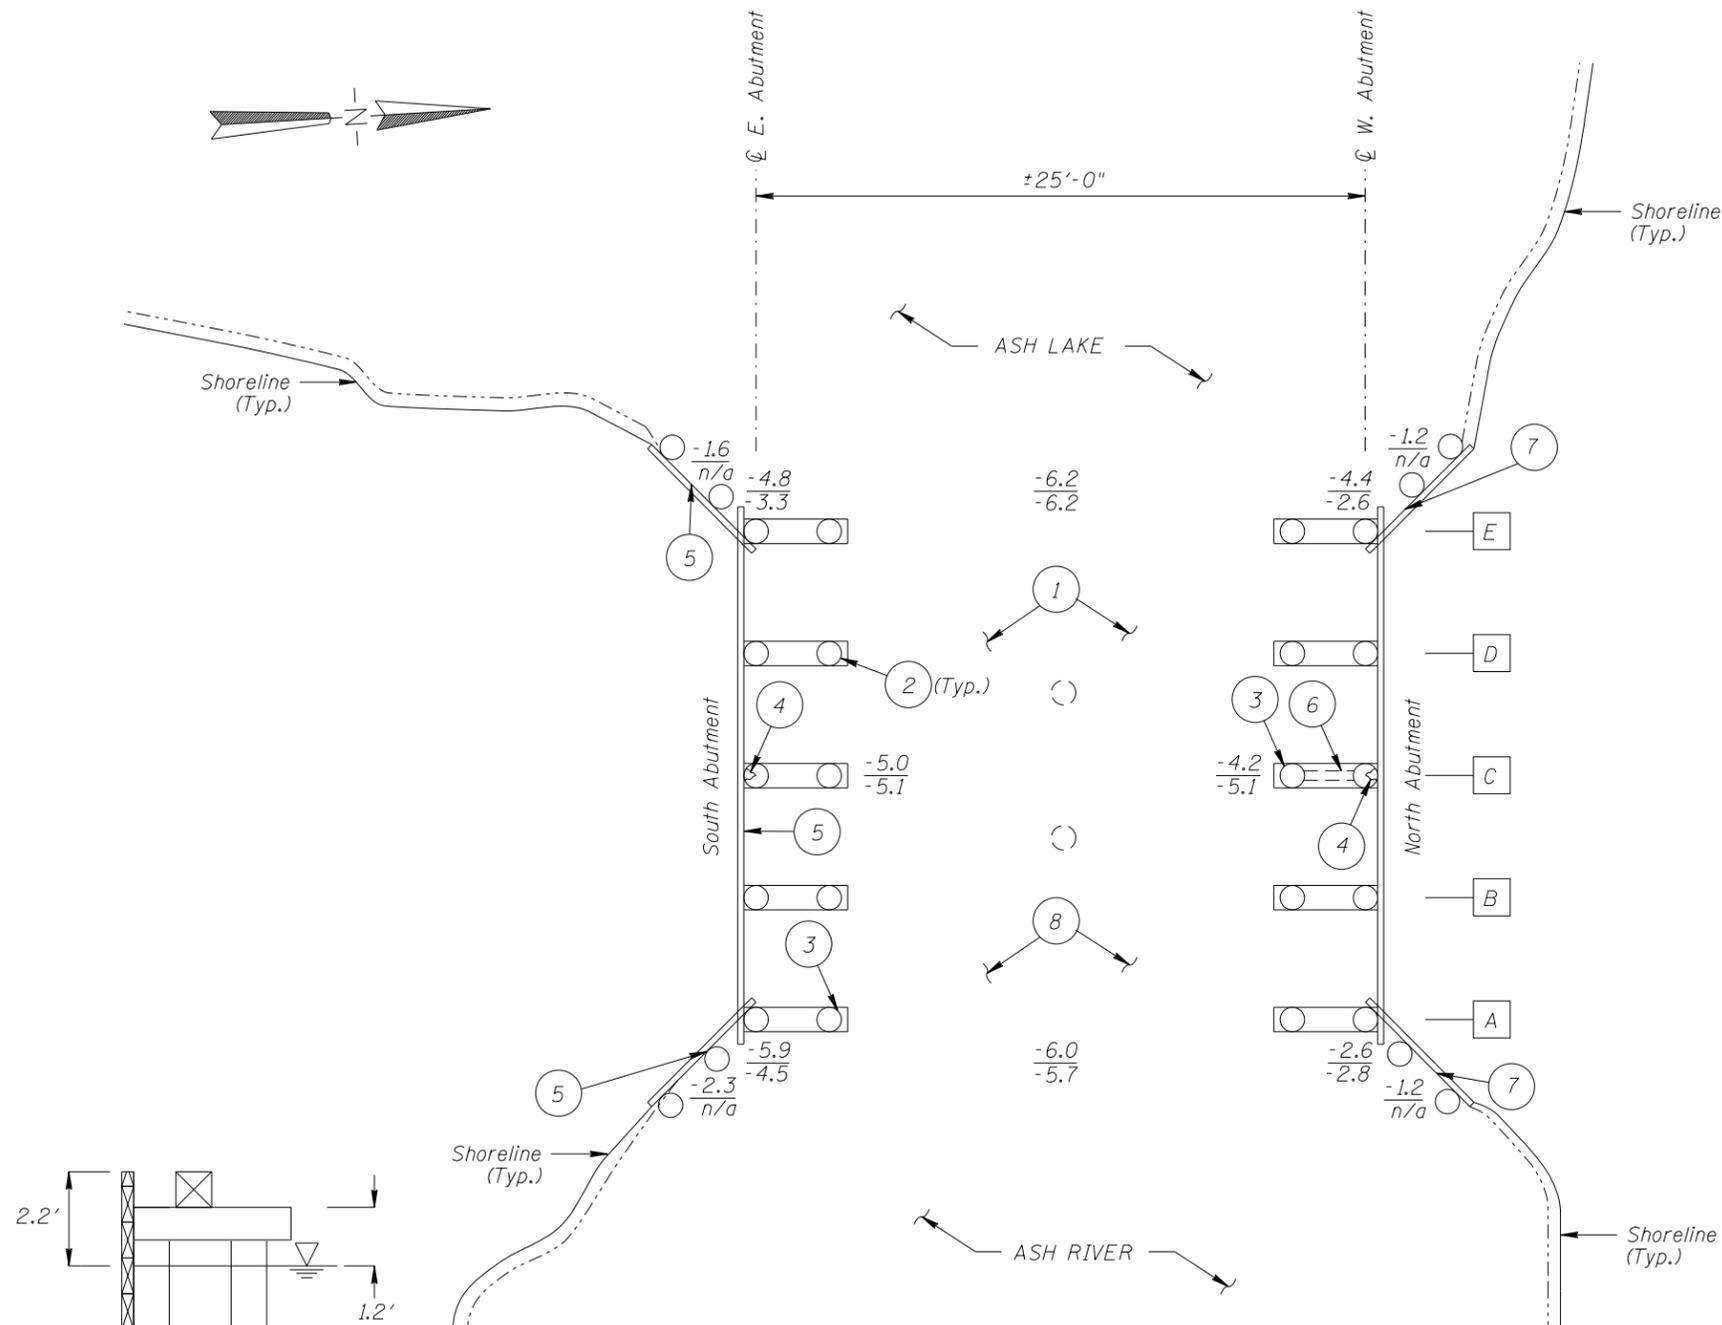
**INSPECTION AND SOUNDING PLAN**

- 1 The channel bottom material typically consisted of sandy gravel with a maximum probe rod penetration of 6 inches.
- 2 The timber piles and bent caps were typically sound with random checks up to 1/4 inch wide and 1/4 inch deep.

- 3 A 1 inch and 2 inch gap was observed between the pile and the pile cap resulting in no bearing at the southern Pile C of the North Abutment and the northern Pile A of the South Abutment respectively.

- 4 The southern Pile C of the South Abutment and the northern Pile C of the North Abutment exhibited splits resulting in approximately a quarter of the pile cross section being detached from the pile. Both sections were load bearing separately. The split ranged from 3 inches wide near the top of the pile to 1 inch wide near the channel bottom.

- 5 A gap, up to 8 inches wide, was observed between the timber backwall boards and both the wingwalls at the South Abutment. A loss of backfill material was observed with a cavity behind the wall having a maximum penetration of 3 feet and a typical penetration of 1 ft.

- 6 A 4 inch by 4 inch timber strut was observed bracing the south and north Pile C at the North Abutment.
- 7 A gap, up to 6 inches high, was observed between the channel bottom and the bottom wingwall boards at both wingwalls of the North Abutment. A loss of backfill was observed behind the boards with up to 6 inches of penetration.

- 8 A moderate timber debris accumulation, consisting of 1 foot diameter and smaller logs, was scattered throughout the channel and extended from the channel bottom to the waterline.
