2016 UNDERWATER BRIDGE INSPECTION REPORT

BRIDGE # 91725 CR 52 over CALDWELL BROOK

DISTRICT: District 1 COUNTY: Koochiching CITY/TOWNSHIP: T - 151 R - 27
STATE: Minnesota

Date of Inspection: 06/04/2016

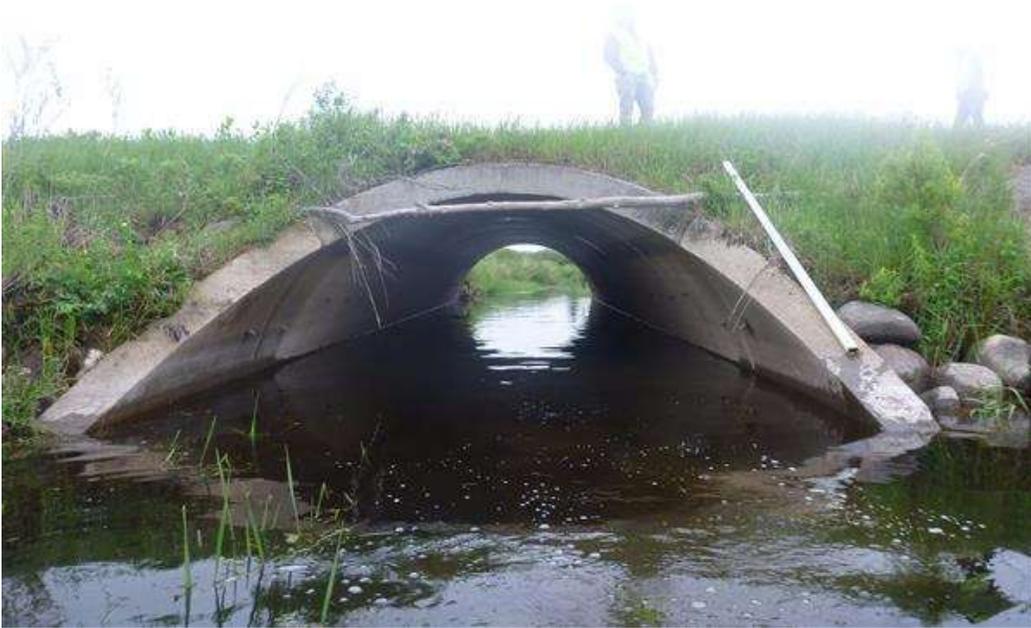
(A) The channel bottom of Culvert 1 consisted of 6 inches of silt and scattered rocks which extended 15 feet in from the east end: the rest of the culvert was clean with bare concrete floor exposed.

Photo 3 - Culvert 1, Looking East

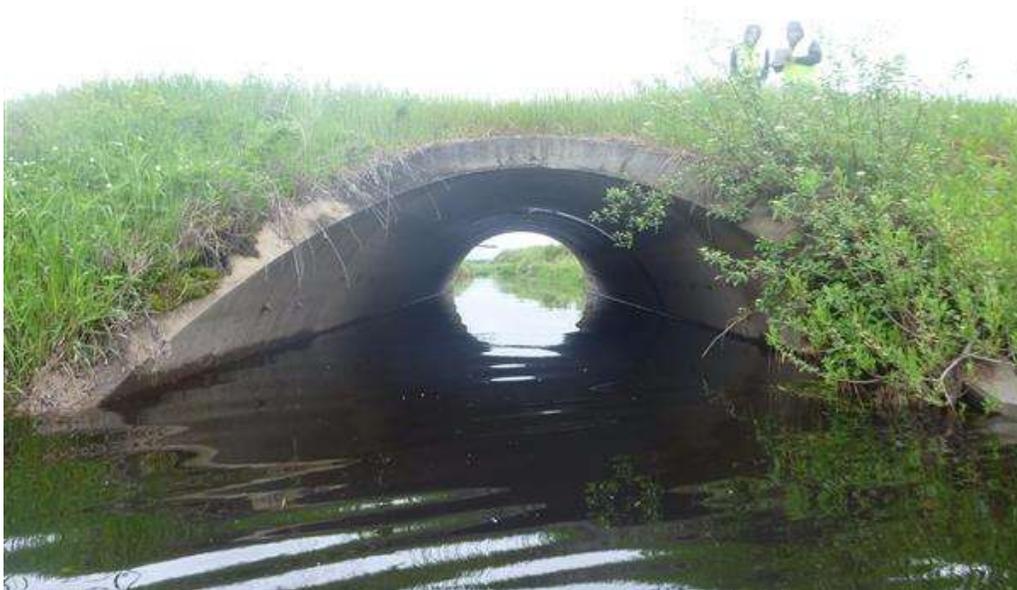
(C) The concrete floor of Culvert 2 was exposed 15 feet in from the east end and extended to the west end of the culvert. The remaining channel bottom throughout Culvert 2 consisted of 3 to 6 inches of silt.

Photo 4 - Culvert 2, Looking West

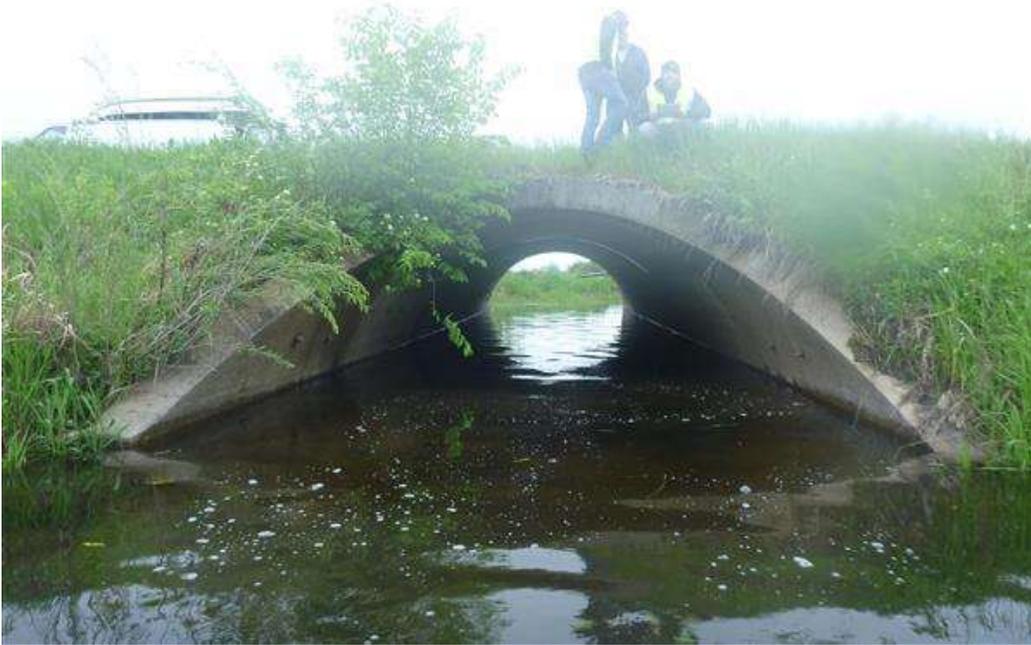
(D) The channel bottom was level with the floor in Culvert 3 at the west end and 6 inches of silty sand and scattered rocks was present from the eastern opening to approximately 15 feet into the culvert.

Photo 5 - Culvert 3, Looking East

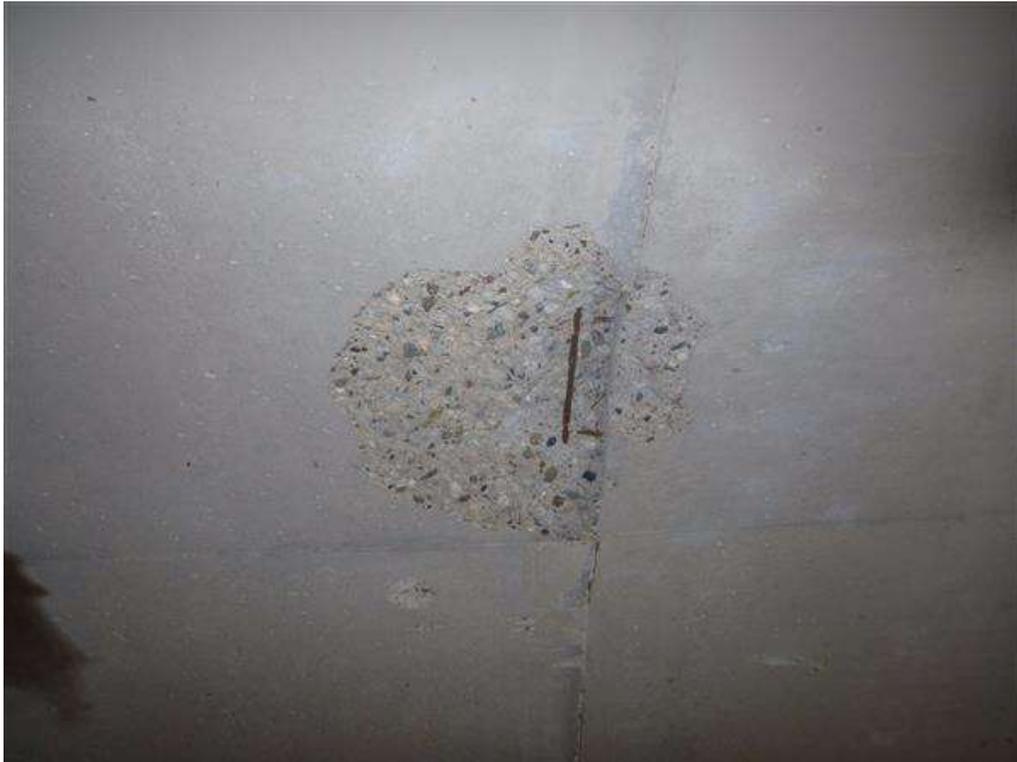
(B) An area of section loss 18 inches in diameter with an exposed corroded reinforcing bar and up to 1.5 inches of penetration was present at the joint approximately 7 feet from the west end of Culvert 2.

Photo 6 - Culvert 2 Joint Spall, Looking South

- ② An area of section loss 18 inches in diameter with an exposed corroded reinforcing bar and up to 1.5 inches of penetration was present at the joint approximately 7 feet from the west end of Culvert 2.

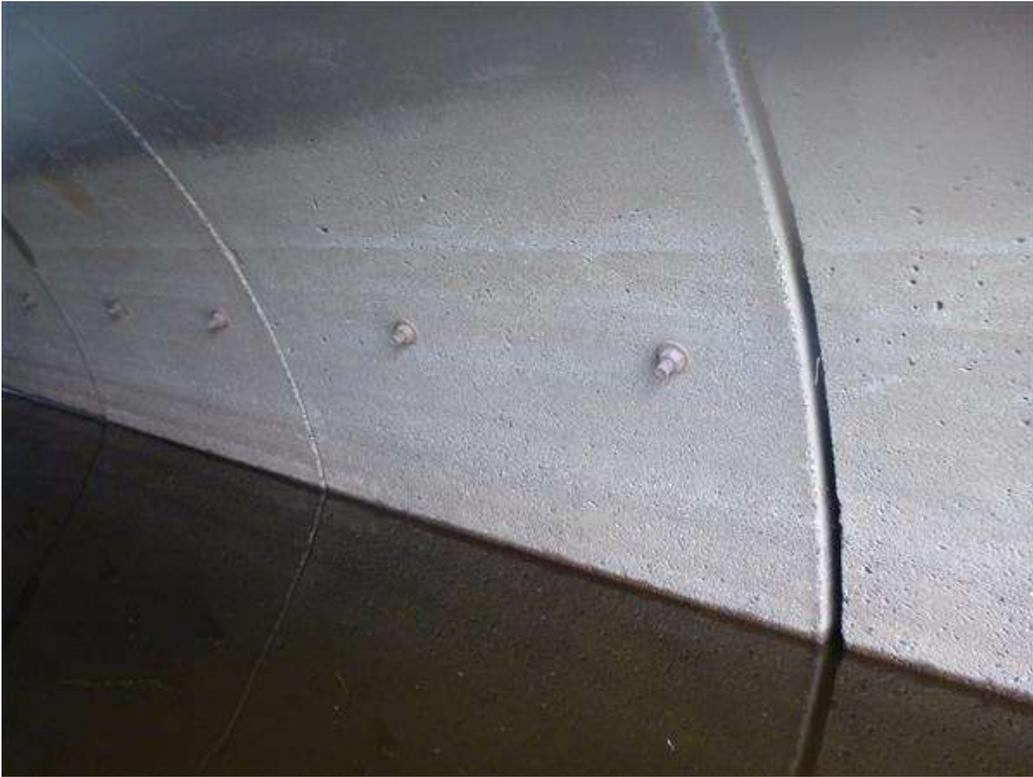
Photo 7 - Culvert 1 Typical Joints and Concrete Condition (South Wall Shown), Looking Southeast

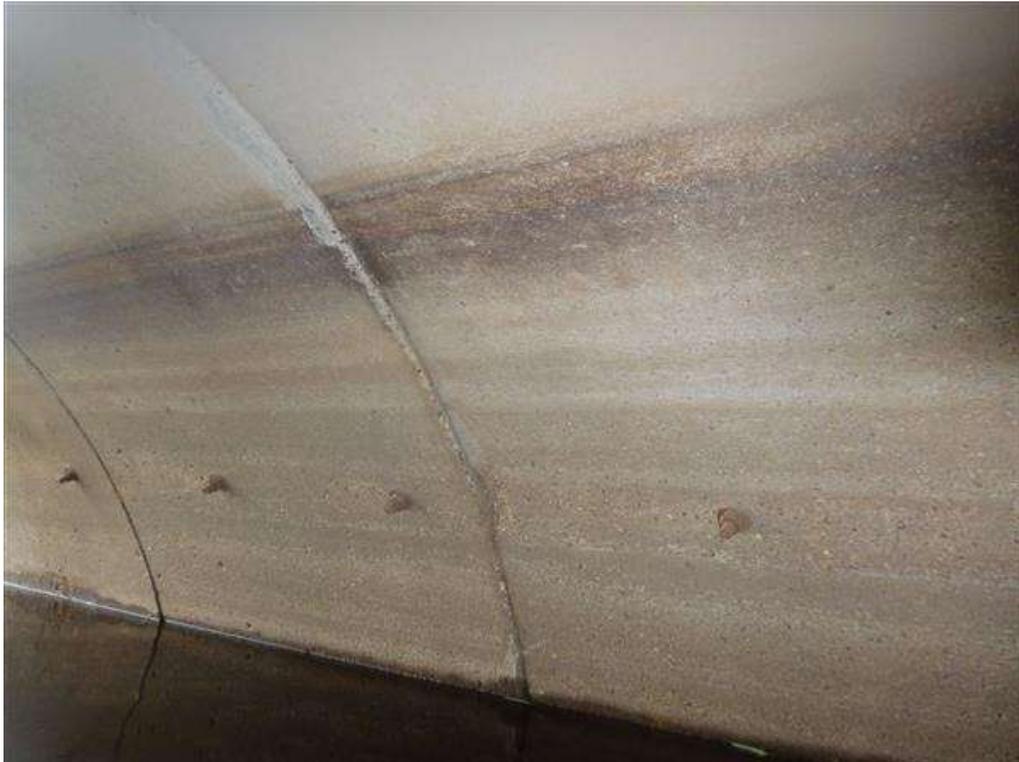
Photo 8 - Culvert 2 Typical Joint and Concrete Condition (South Wall Shown), Looking Southeast

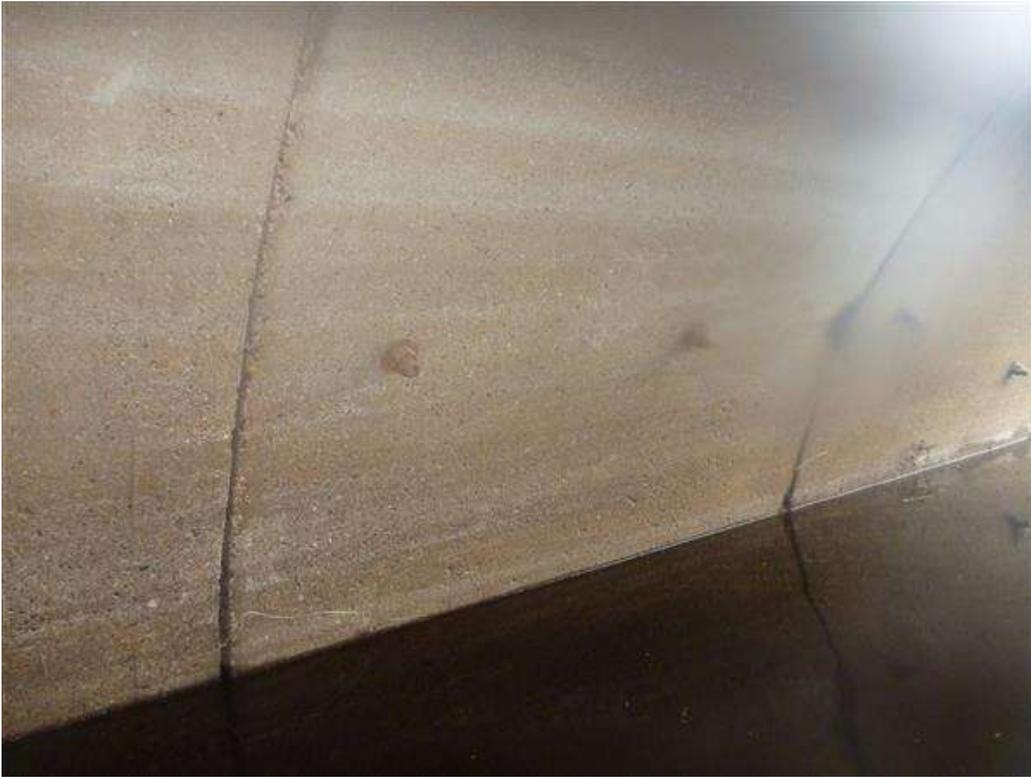
Photo 9 - Culvert 3 Typical Joint and Concrete Condition (North Wall Shown), Looking Southeast

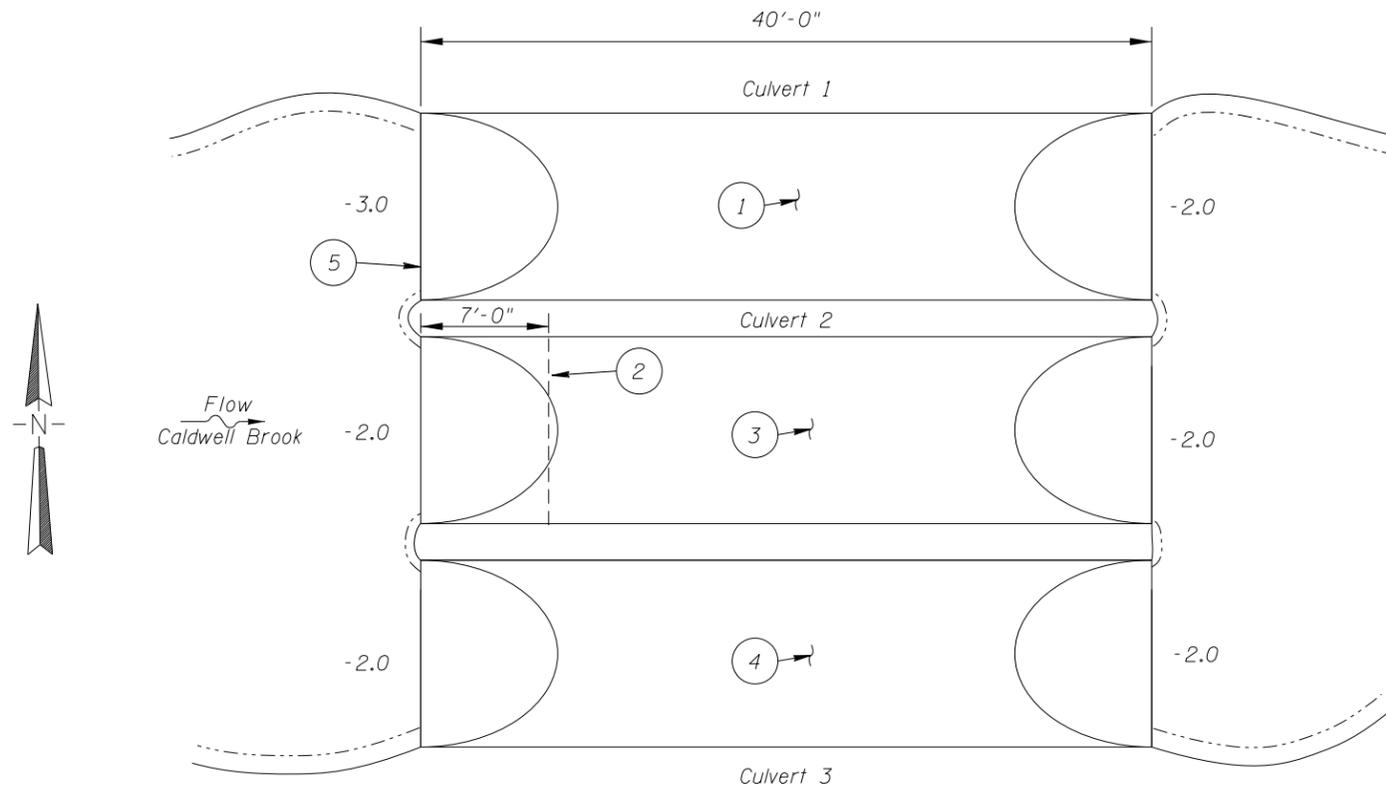
STRUCTURE NO. 91725
OVER CALDWELL BROOK
DISTRICT I, KOOCHICHING COUNTY
INSPECTION AND SOUNDING PLAN

- ① The channel bottom of Culvert 1 consisted of 6 inches of silt and scattered rocks which extended 15 feet in from the east end; the rest of the culvert was clean with the bare concrete floor exposed.

- ③ The concrete floor of Culvert 2 was exposed 15 feet in from the east end and extended to the west end of the culvert. The remaining channel bottom throughout Culvert 2 consisted of 3 to 6 inches of sit.

- ④ The channel bottom was level with the floor in Culvert 3 at the west end and 6 inches of silty sand and scattered rocks was present from the eastern opening to approximately 15 feet into the culvert.

- ⑤ At the west opening of Culvert 1 the south half of the culvert floor slab toe exhibited a maximum vertical exposure of 1 foot while the northern half of the culvert exhibited no vertical exposure.
