2016 UNDERWATER BRIDGE INSPECTION REPORT

BRIDGE # 92628 UT 9230 over COOLIDGE CREEK

Date of Inspection: 06/23/2016

Contractor: Collins Engineers, Inc.

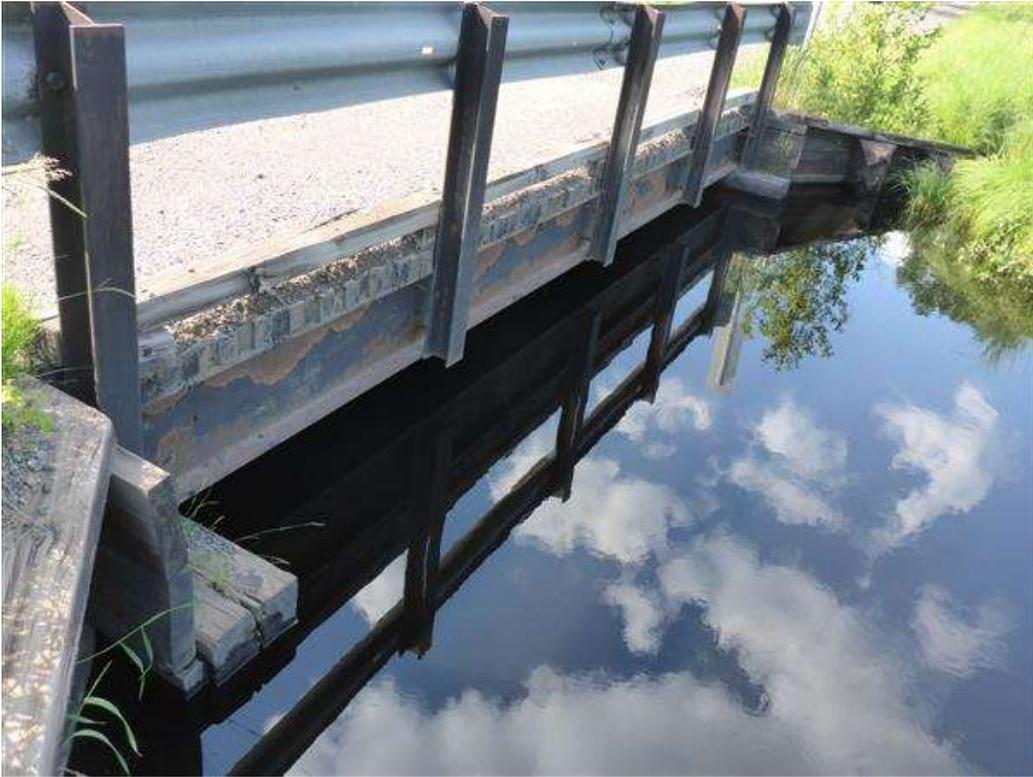
Photo 1 - Upstream Fascia, Looking Northwest

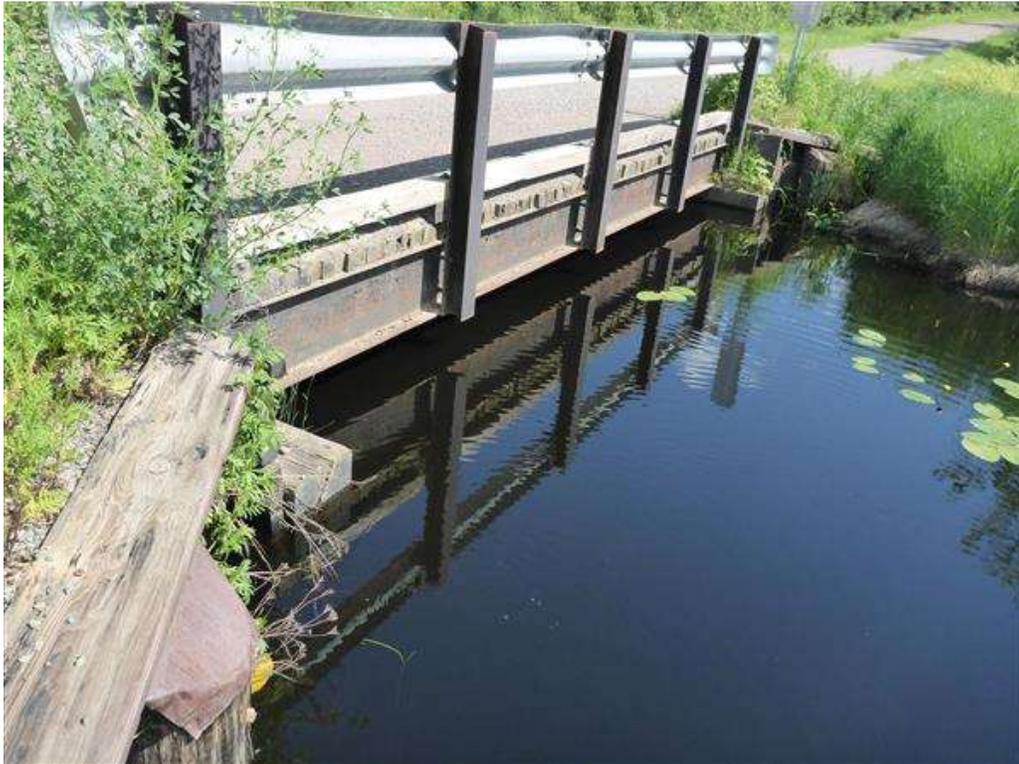
Photo 2 - Downstream Fascia, Looking Southeast

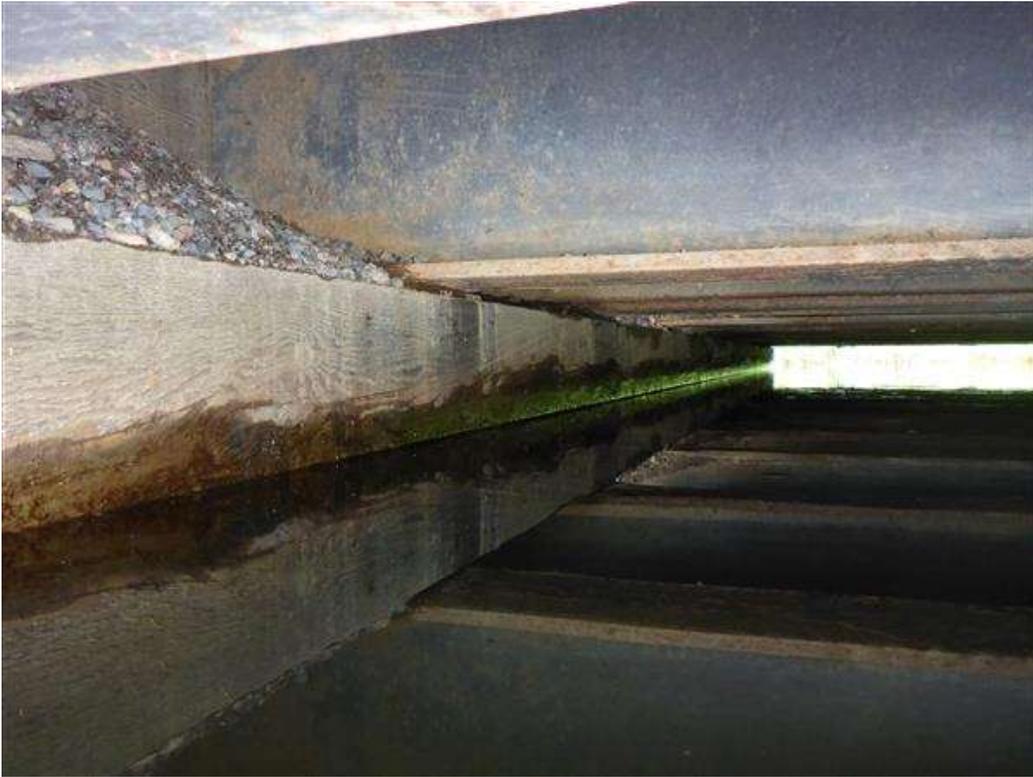
60. Substructure NBI: [2016-2015] Splits on ends of north cap and on east end of south cap. Pile 2 has .5" gap between cap and pile. 3 piles total need shims on north abutment. Pile 5 on north has outer shell separating from pile.
 [2014] Water within 6" of bottom of beams.
 [2013] Bottom of North abutment is pushing in causing piling to lose bearing. North cap has through spit on the east end. 4 piling have moderate splits and checks with minor decay.

Photo 3 - North Abutment, Looking Northeast

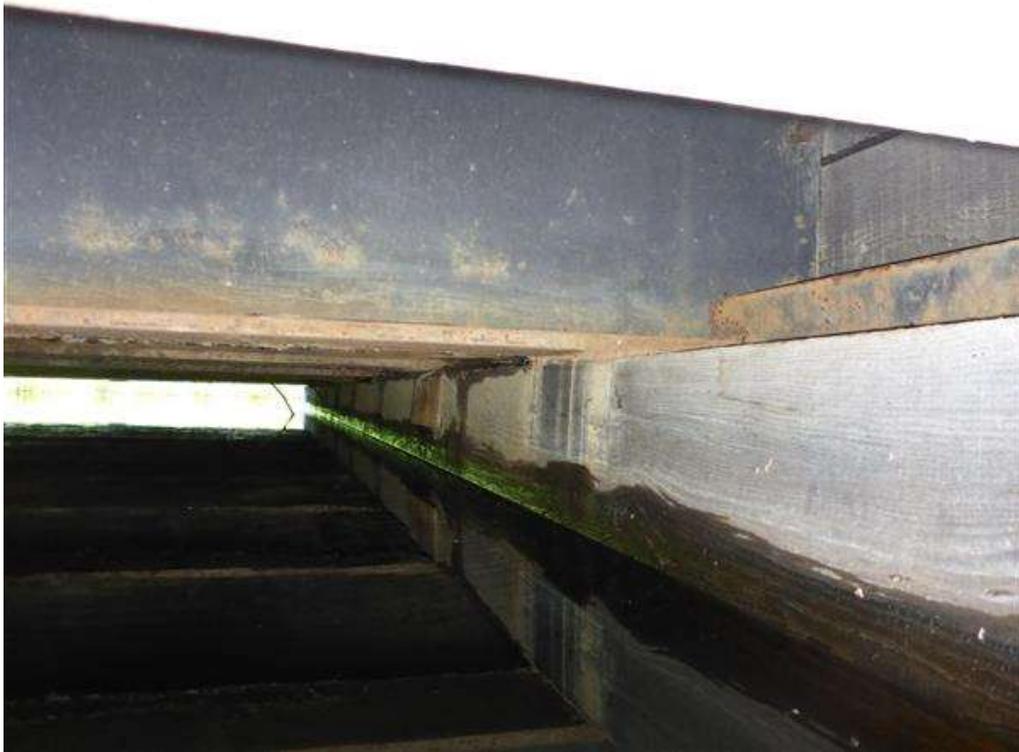
Photo 4 - South Abutment, Looking Southeast

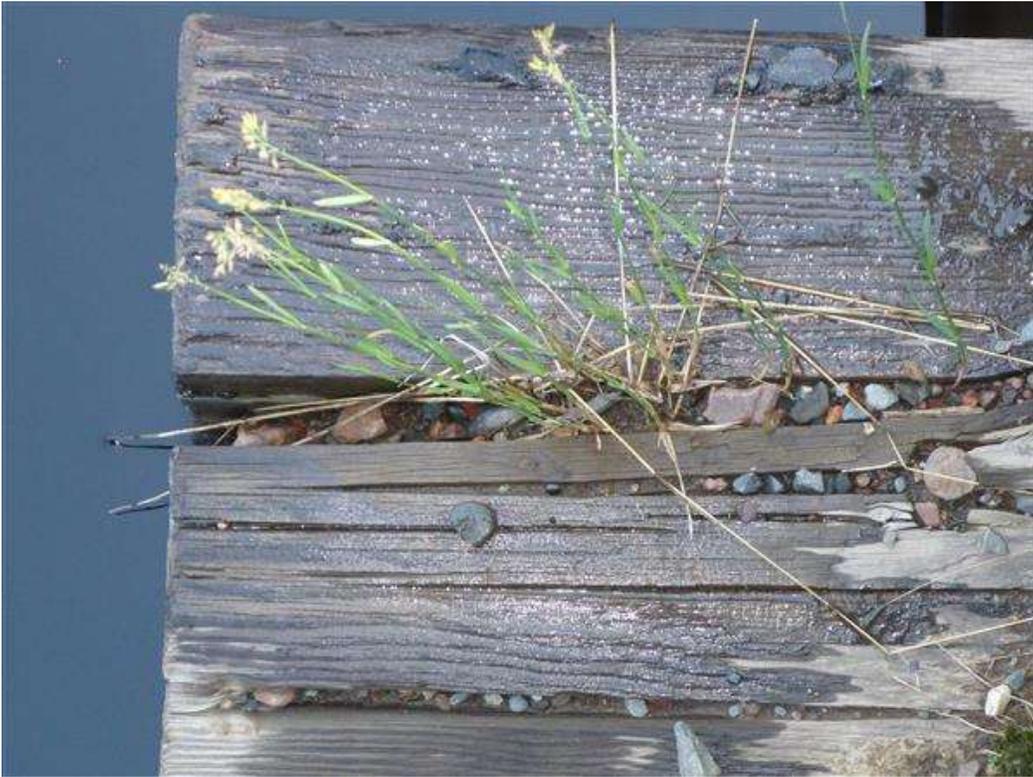
The substructure units inspected at Bridge No. 92628, the North and South Abutments, were found to be in fair to poor condition, with only minor defects of structural significance observed. The timber piles were typically sound apart from some random splits. A split through the full section of the pile cap at the North and South Abutments was observed running the full length of the cap. A minor rotation of the pile cap has resulted from the split.

Photo 5 - Split Through North Abutment Pile Cap Upstream End, Looking Down

- (A) Consider repairing the split pile caps at the North and South Abutments.
- (B) Reinspect the submerged substructure at the normal maximum recommended (NBIS) interval of sixty (60) months.

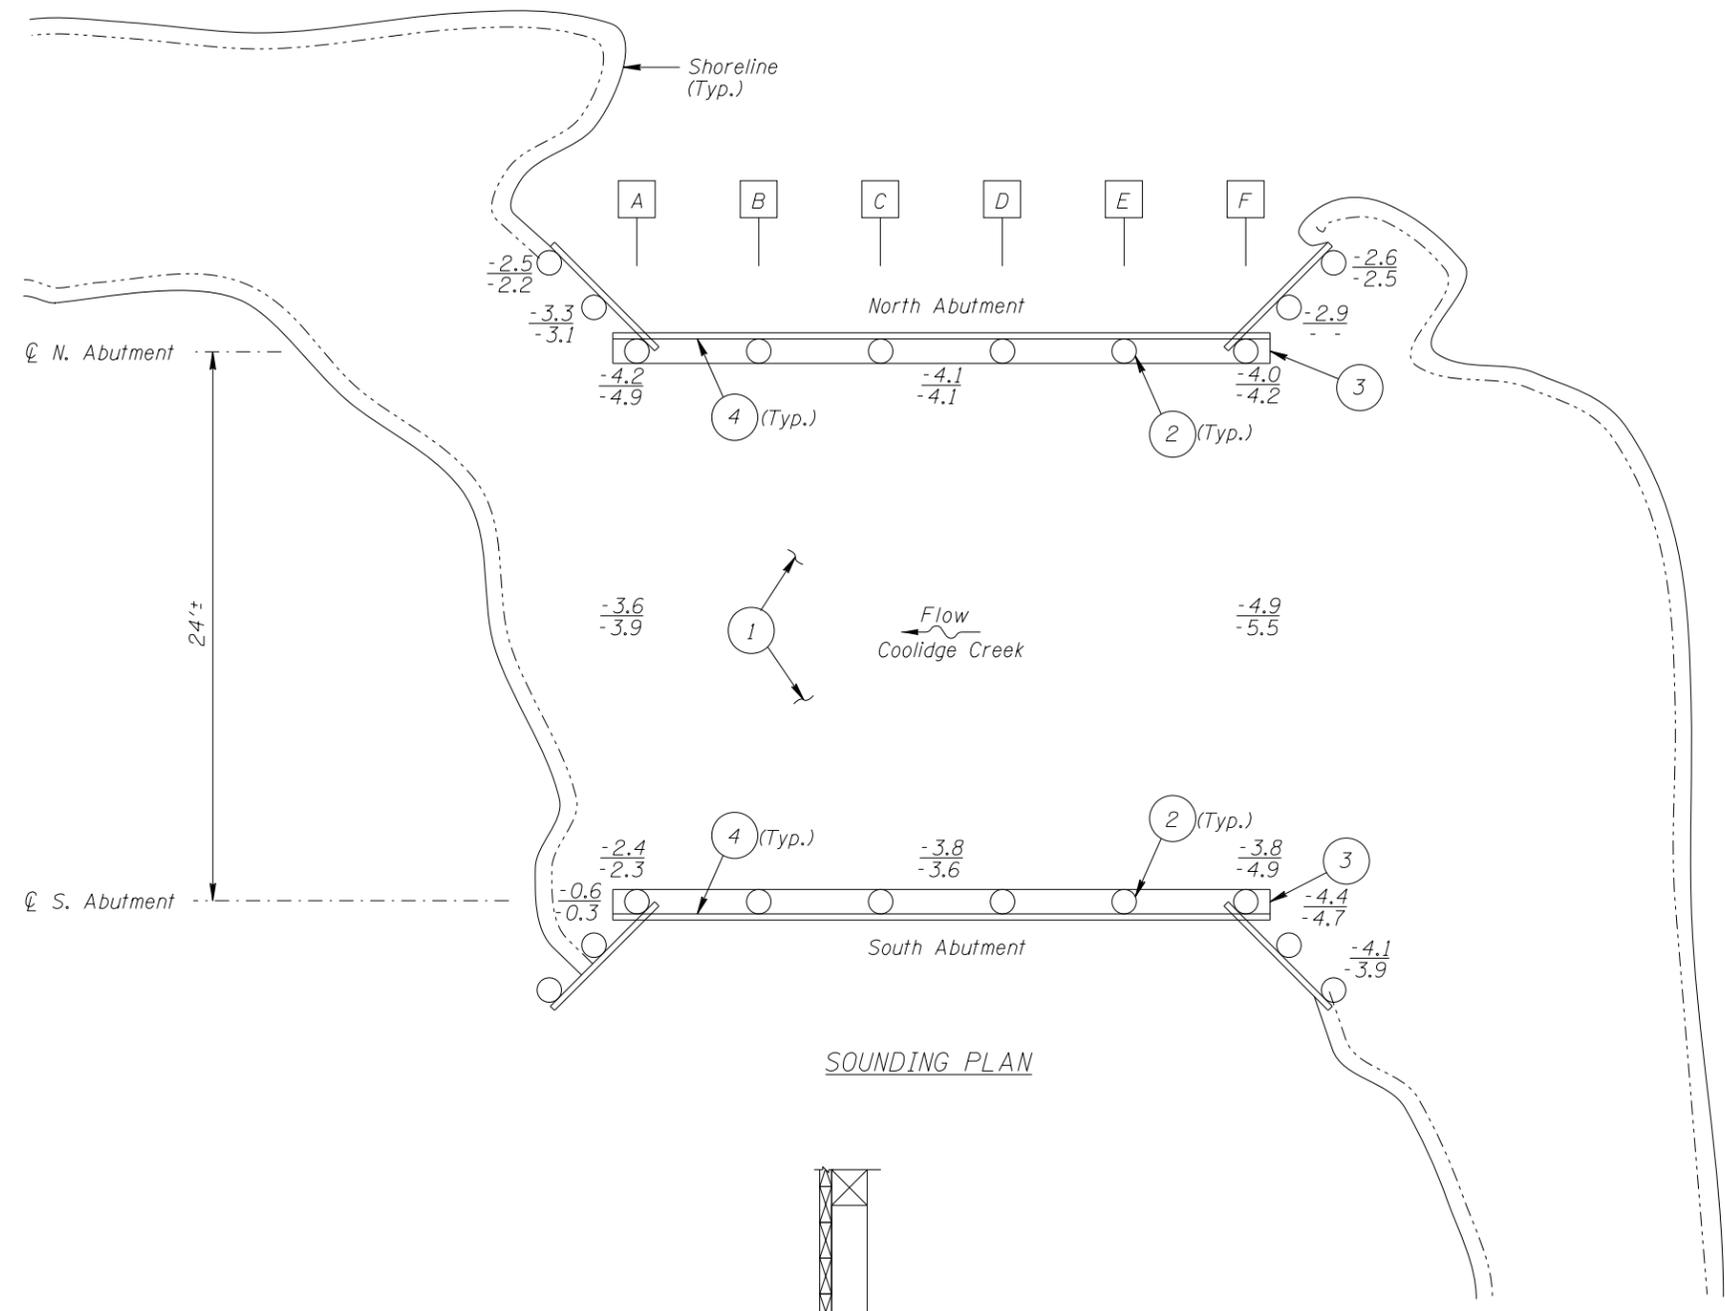
SOUNDING PLAN

- 1 The channel bottom material typically consisted rocks, gravel, and silt allowing up to 6 inches of probe rod penetration.
- 2 The timber piles were typically sound allowing typical awl penetration of 1/16 inch and exhibiting random splits or checks up to 1/16 inch wide and 1 inch deep.
- 3 A split through the full height of the North and South Abutment pile cap was observed running the entire length of the cap. The split was typically 1/8 inch wide and up to 1 inch wide at the last 5 feet of the upstream and downstream ends. Both pile caps exhibited a minor rotation (less than 3°) as a result of the split.
- 4 The timber backwall was typically sound and tight with no noticeable loss of backfill or defects of structural significance.
