2016 UNDERWATER BRIDGE INSPECTION REPORT

BRIDGE # 93280 CR 119 over E BR RAT ROOT RIVER

DISTRICT: District 1 COUNTY: Koochiching CITY/TOWNSHIP: T - 69 R - 23
STATE: Minnesota

Date of Inspection: 06/03/2016

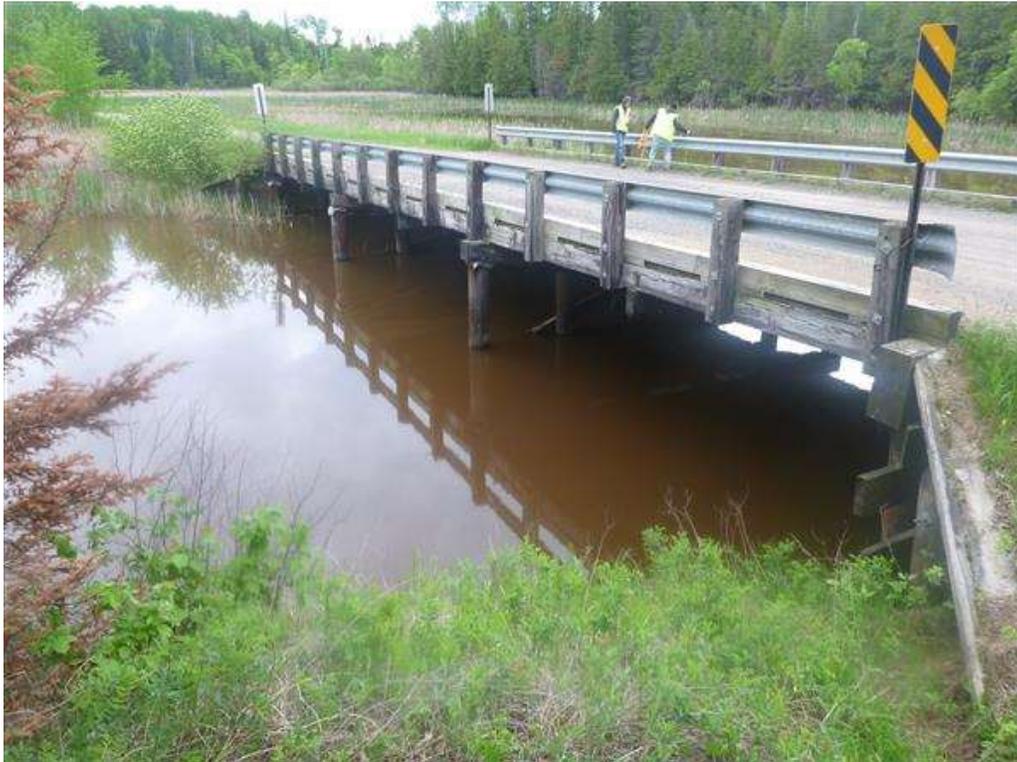
Photo 3 - West Abutment, Looking Southwest

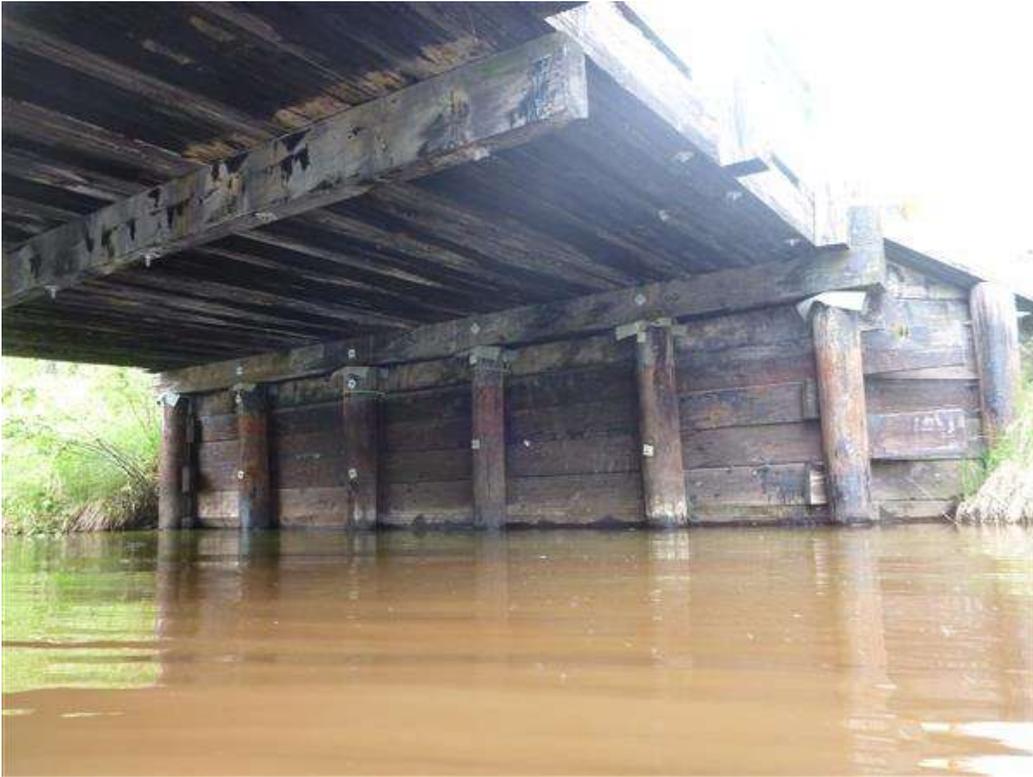
Photo 4 - Pier 1, Looking Northwest

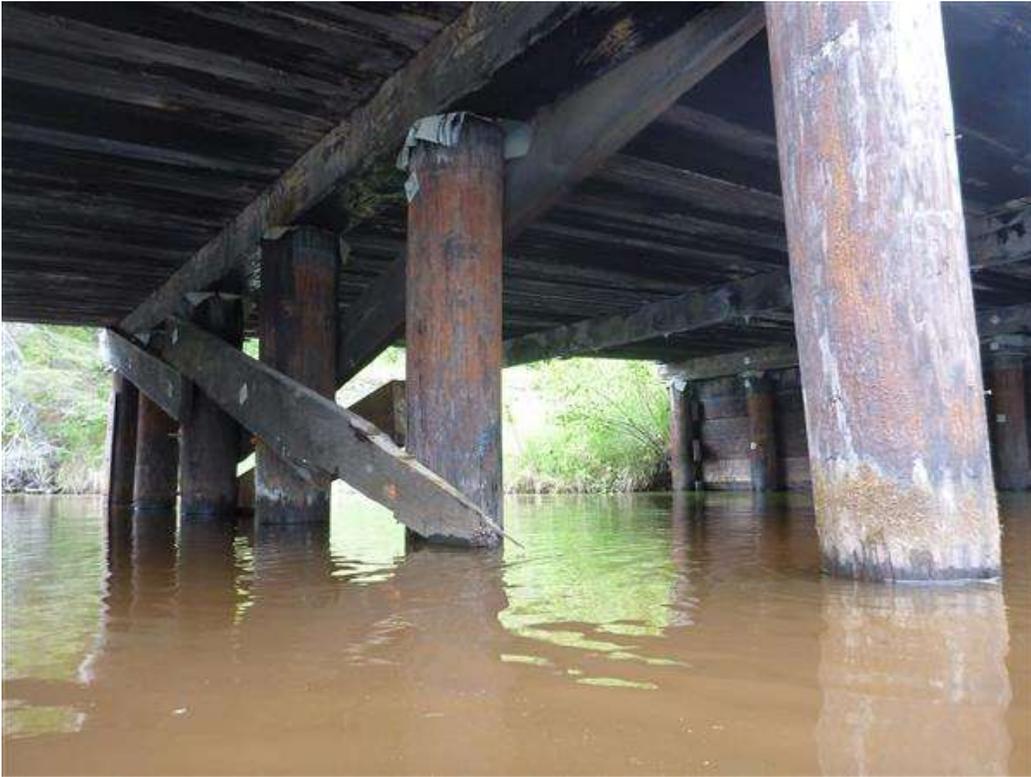
Photo 5 - Broken Cross Brace between Piles 1 & 2 of Pier 1, Looking Southwest

- 2 The channel bottom material around Piers 1 and 2 and the East Abutment consisted of 6 inch to 12 inch diameter riprap with silty sand infill.
 - 3 The east diagonal brace at Pier 1 was broken between Piles 1 & 2 and between Piles 2 & 3 the diagonal brace was cracked with up to 50% section loss.

(A) The diagonal timber cross braces that are split and/or deteriorated through the fasteners at Piers 1 and 2 should be replaced during routine maintenance. (B) Reinspect the submerged substructure units at the normal maximum recommended (NBIS) interval of sixty (60) months.

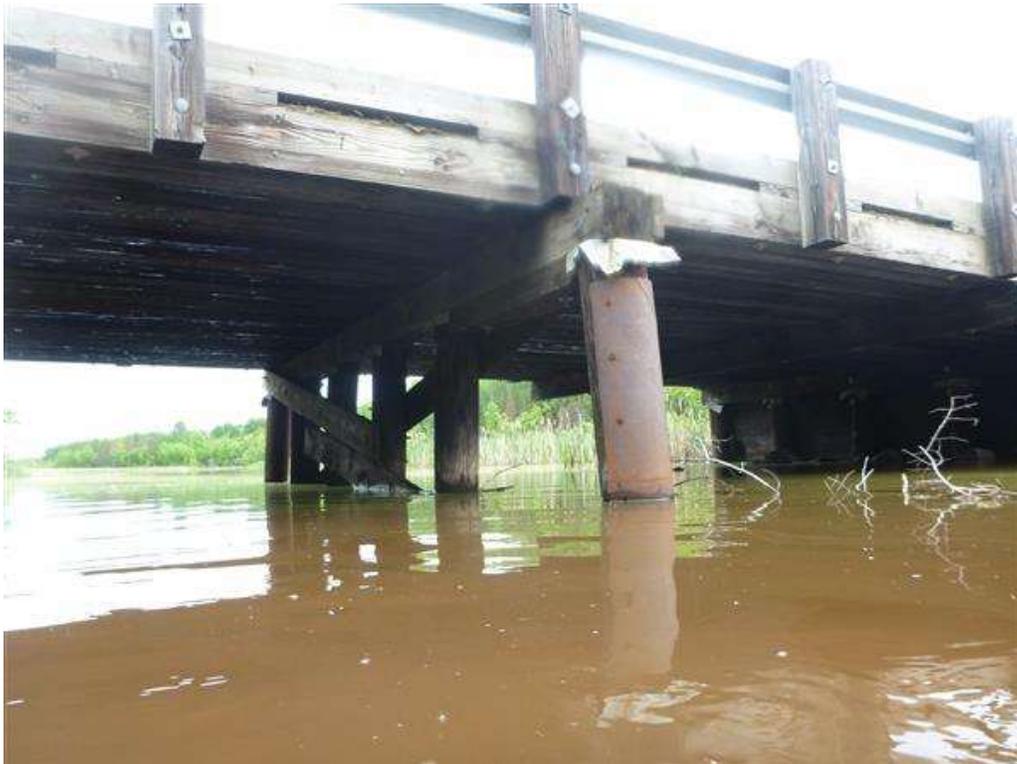
Photo 6 - Pier 2, Looking Northeast

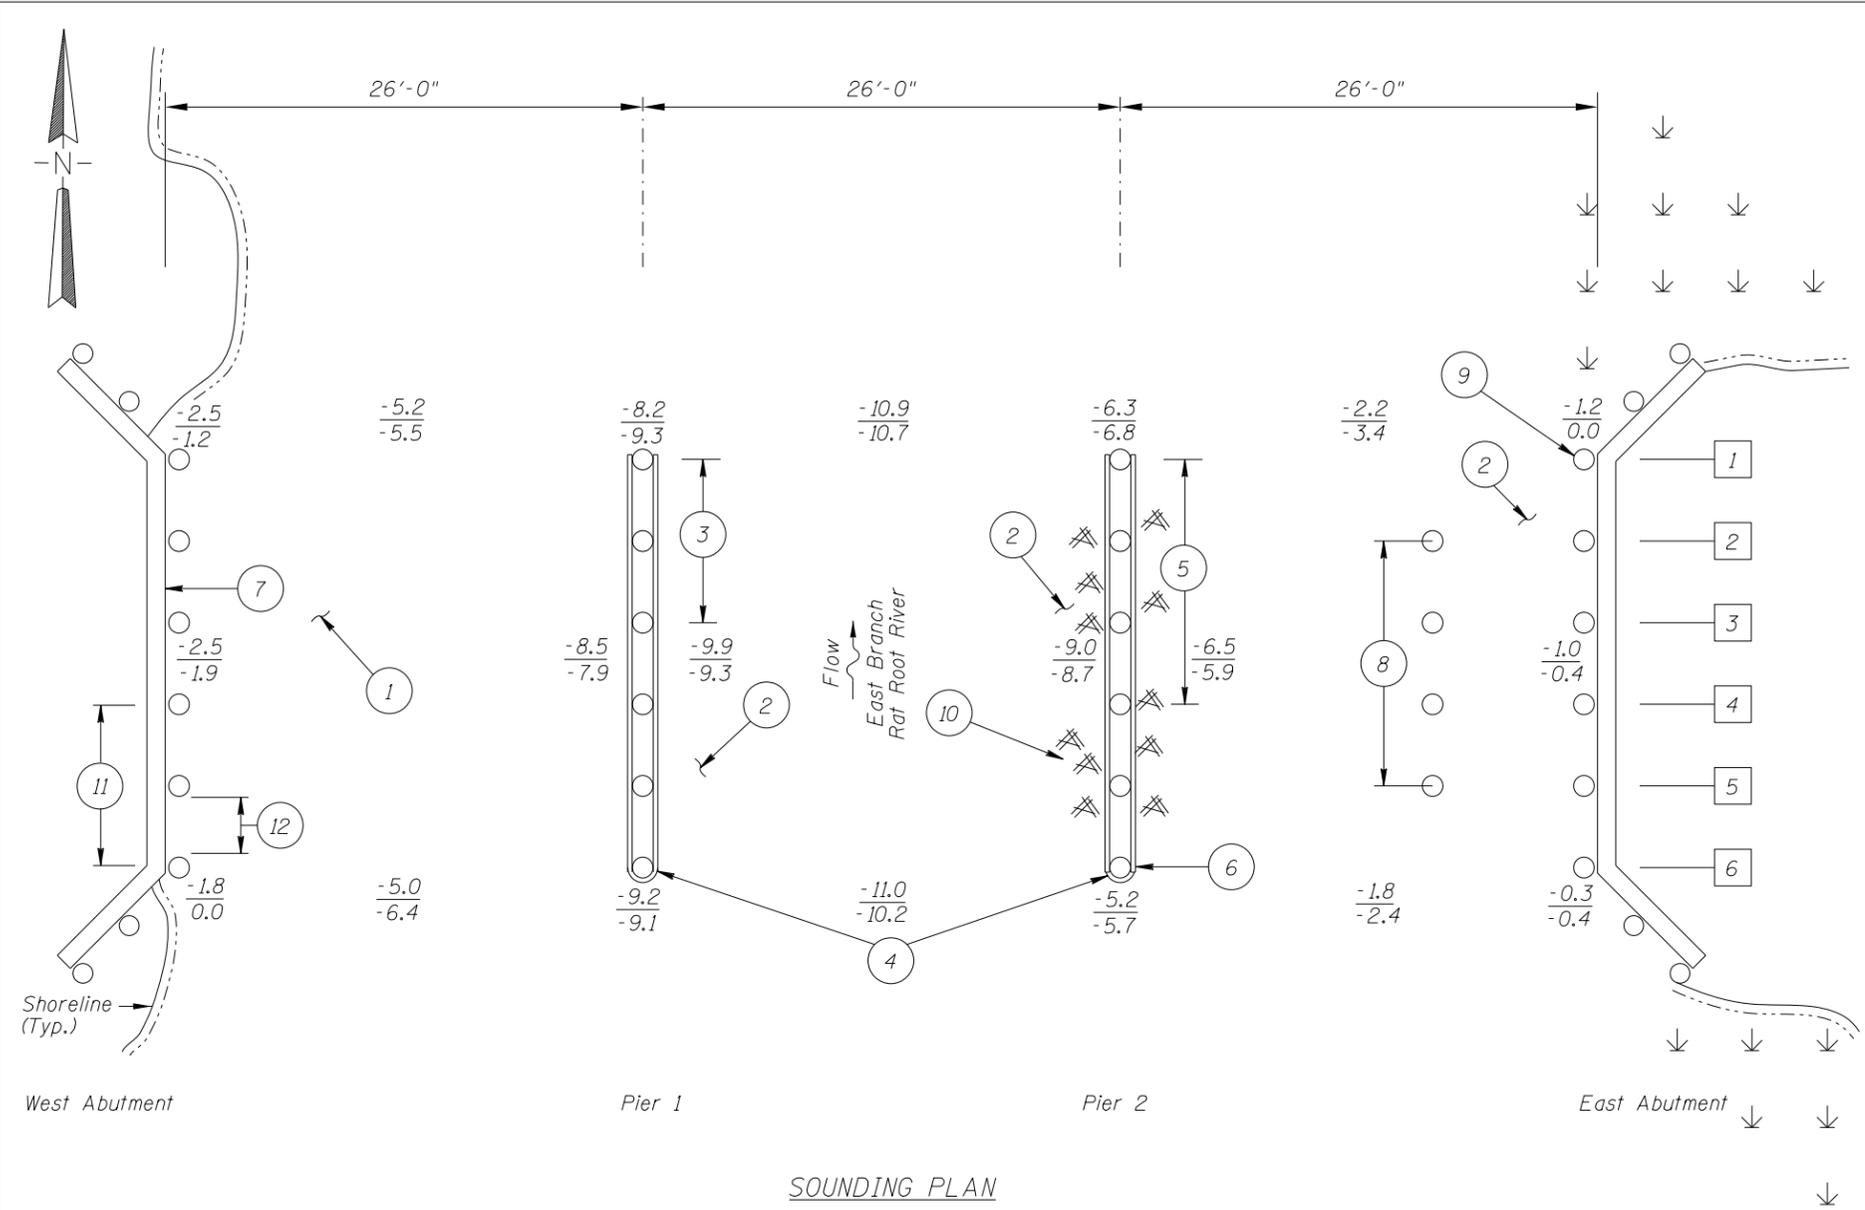
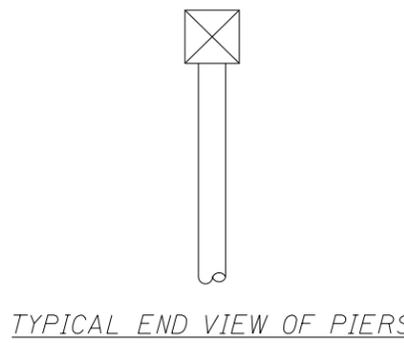
SOUNDING PLAN

- INSPECTION NOTES:**
- 1 The channel bottom material at the West Abutment consisted of soft, silty, sandy clay allowing 6 inches to 1 foot of probe rod penetration.

- 4 Curved steel ice-breaker plates from just below the pile caps down to approximately 1 foot below the waterline were attached to the south face of Pile 6 at Piers 1 and 2.

- 5 The east diagonal brace at Pier 2 exhibited a full depth split up to 2 inches wide from Pile 1 to Pile 3, located 2 inches to 6 inches from the top face and goes through the connection at Pile 1 rendering it ineffective.

- 6 The west diagonal brace of Pier 2 contained a split at Pile 6 that is 1.5 feet long, 1 inch wide and runs through the connection rendering it ineffective.

- 7 The pile cap of the West Abutment was slightly rotated back with 75 percent typical bearing on the piles.
 - 8 A row of abandoned cut off piles 2 feet above the channel bottom was present between Pier 2 and the East Abutment.

- 9 A large vertical split approximately 2 feet high by 1/4 inch wide, allowing 3 inches of penetration was located at the top of Pile 1 of the East Abutment.

- 10 Light accumulation of timber debris at Piles 2 through 6 of Pier 2, with up to 6 inch diameter pieces, typically extending from the channel bottom to the waterline.

- 11 Escaping fill was observed at 1 inch gap in horizontal planking of the West Abutment, 4 feet above waterline, with 3 inches maximum penetration.
 - 12 Escaping fill was observed at 1 inch gap in horizontal planking of the West Abutment, 3 feet above waterline, with 3 inches maximum penetration.

5. Piles exhibited random checking from the top of the pile to the channel bottom with up to 1/4 inch maximum checking and at times piles sounded slightly hollow with some softening of the exterior surface and minor delaminating and splintering between 1 foot above and below the waterline.
