2016 UNDERWATER BRIDGE INSPECTION REPORT

BRIDGE # 96224 CR 720 over BEAVER CREEK

Date of Inspection: 06/20/2016

Contractor: Collins Engineers, Inc.

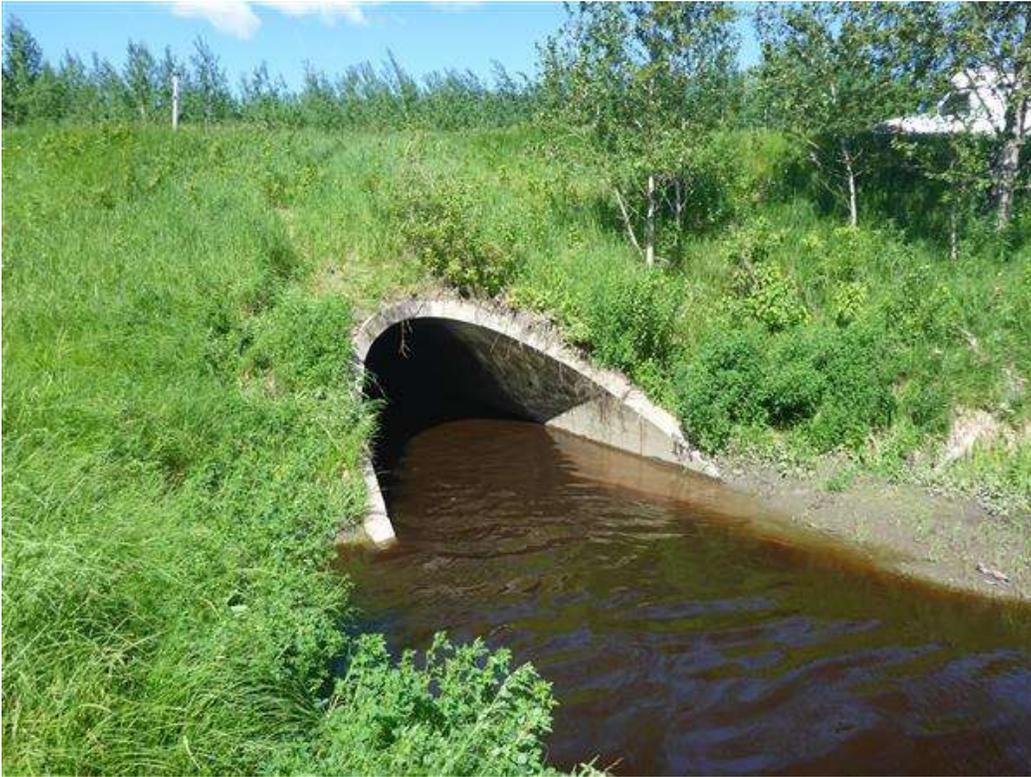
Photo 1 - Upstream Opening, Looking Northwest

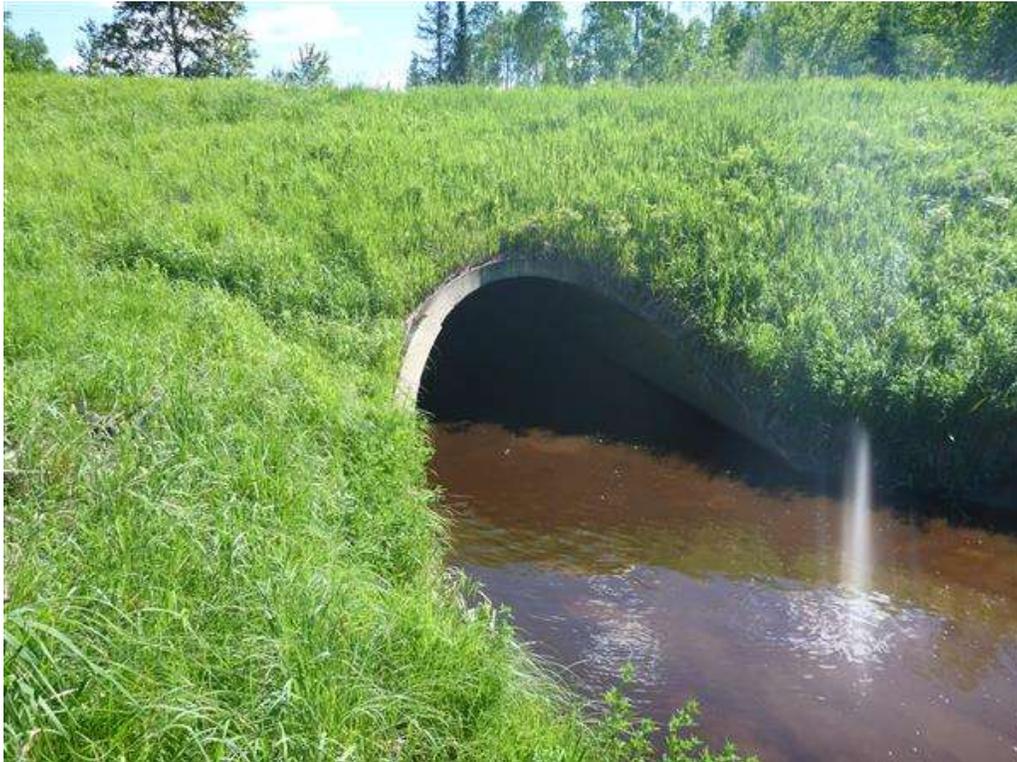
Photo 2 - Downstream Opening, Looking Southeast

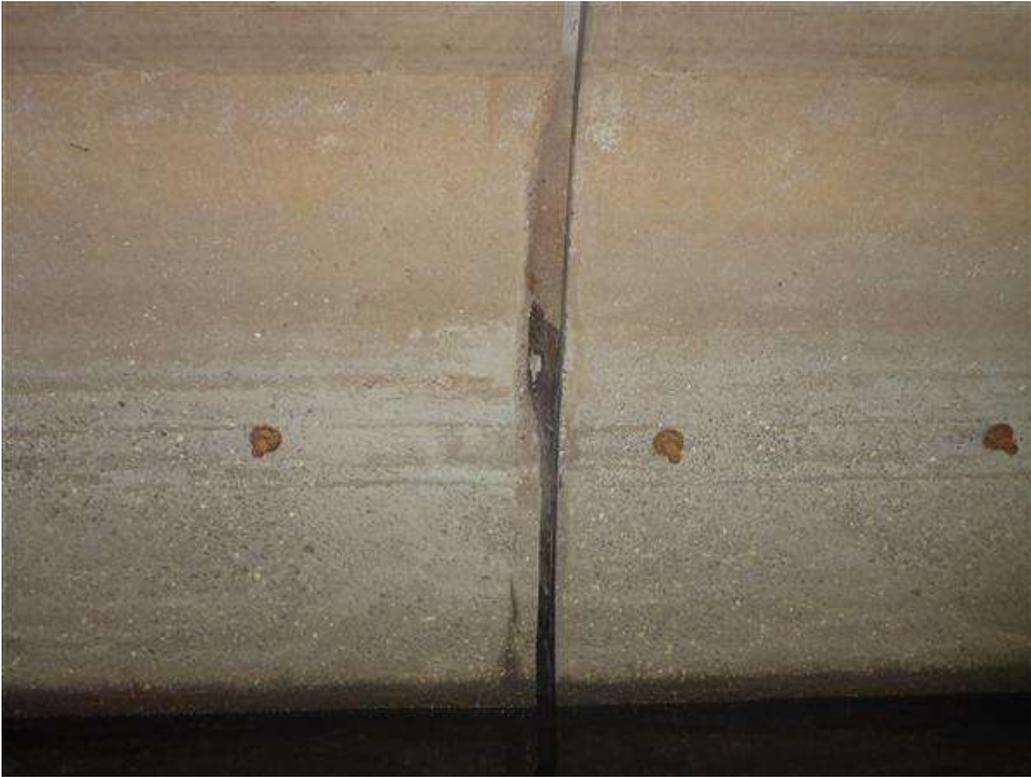
Photo 3 - Grout Deterioration along Seam, Looking South

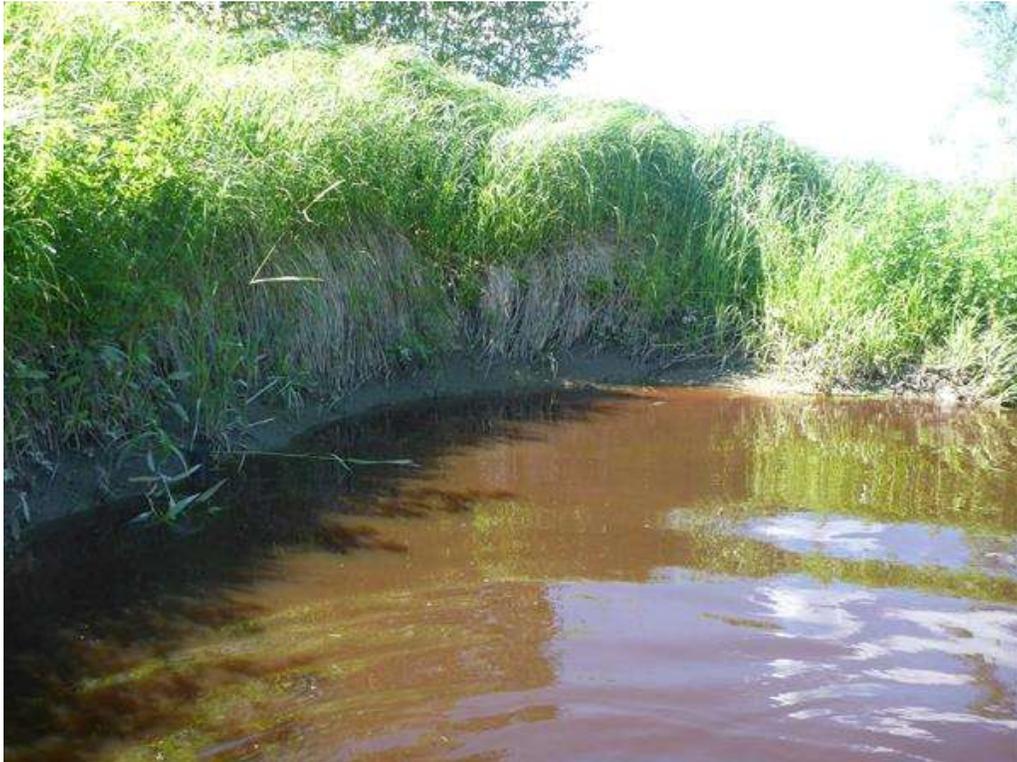
- (A) The channel bottom material consisted of soft silt allowing 18 inches of probe rod penetration.
- (B) The concrete floor was typically covered by 6 inches to 1.5 foot thick layer of silt infill.
- (C) The concrete was typically sound along the entire interior of the culvert. Light scaling with 1/16 inch of penetration extended from the channel bottom to 2.5 feet above the waterline.
- (D) Minor deterioration of concrete grout was observed along the seams of the individual culvert segments.
- (E) Minor erosion was present along the southwest bank with up to a 5 foot vertically cut bank.

Photo 4 - Southeast Bank Erosion, Looking Southwest

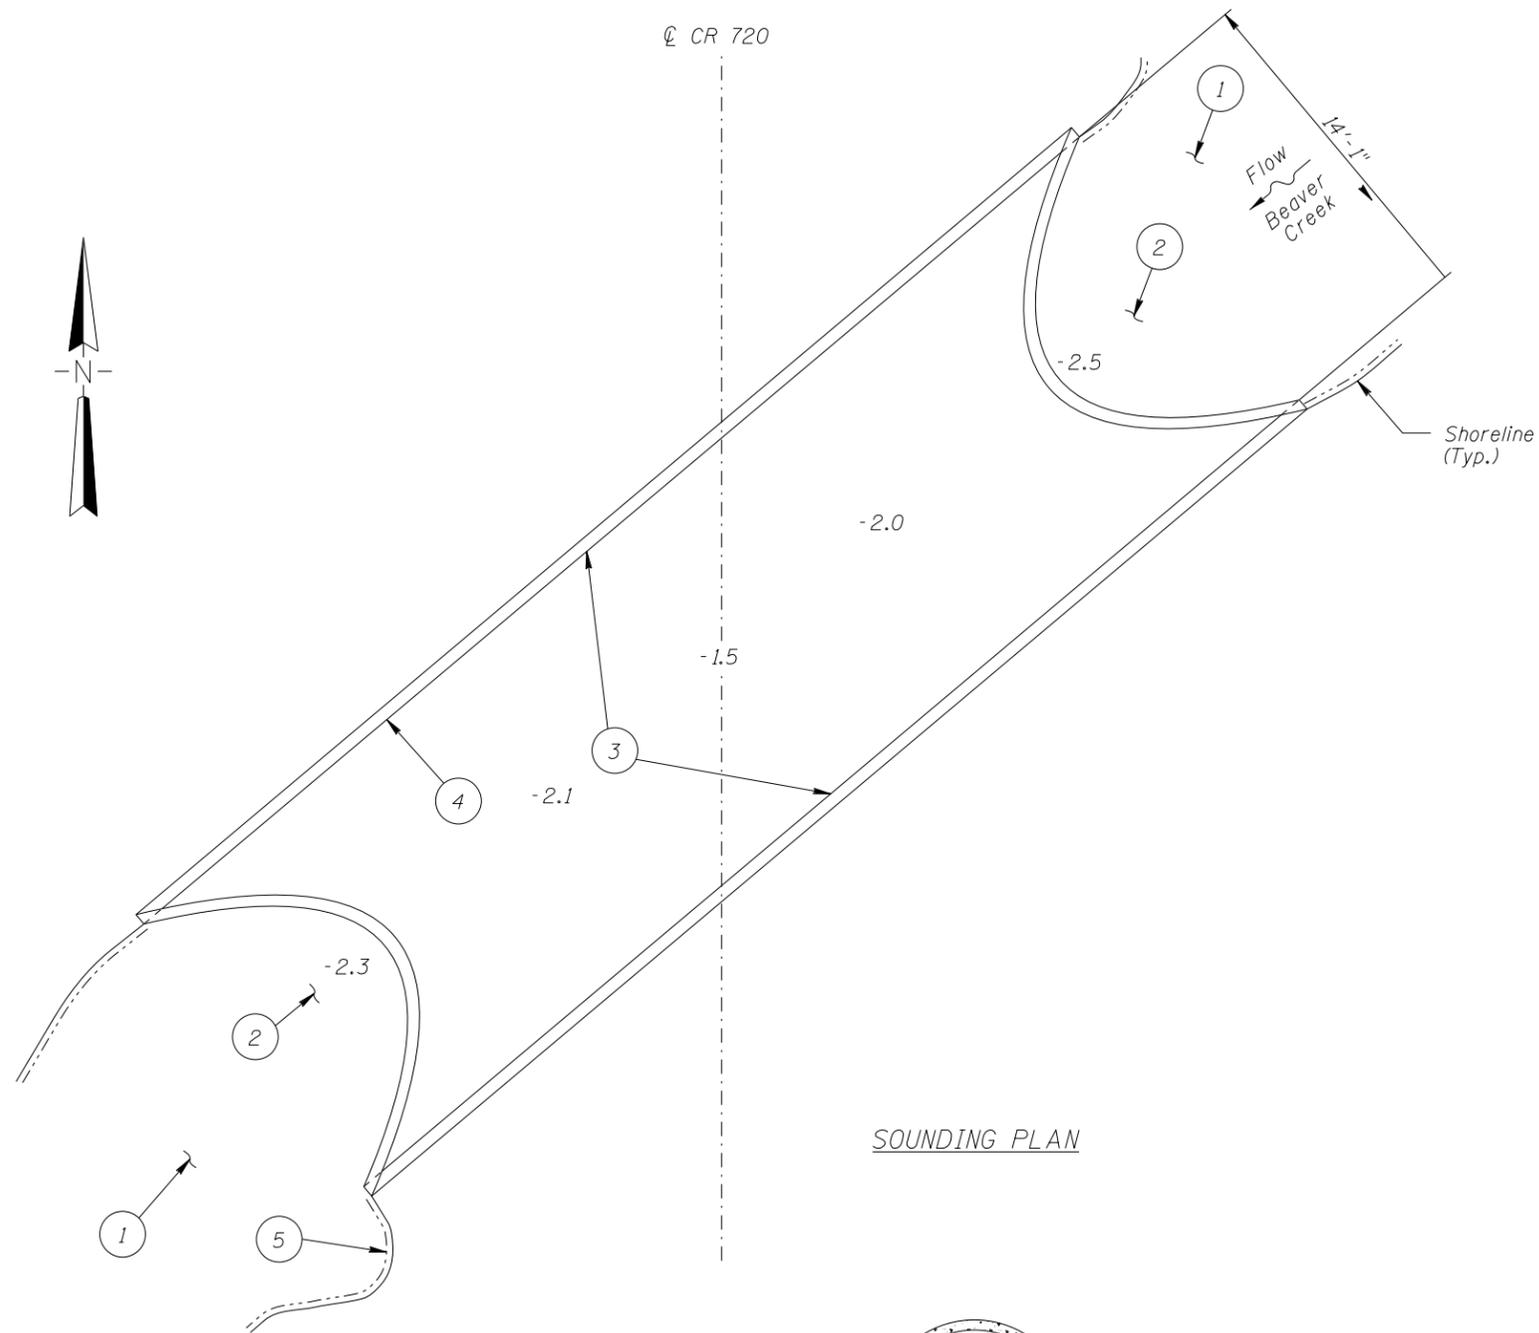
SOUNDING PLAN

- ① Channel bottom material consisted of soft silt allowing 18 inches of probe rod penetration.
- ② Concrete floor was typically covered by 6 inches to 1.5 foot thick layer of silt infill.
- ③ Concrete was typically sound along the entire interior of the culvert. Light scaling with 1/16 inch of penetration extended from the channel bottom to 2.5 feet above the waterline.
- ④ Minor deterioration of concrete grout was observed along the seams of the individual culvert segments.
- ⑤ Minor erosion was present along the southwest bank with up to a 5 foot vertically cut bank.
