# 2016 UNDERWATER BRIDGE INSPECTION REPORT

## BRIDGE # 96750 TH 38 over BURR CREEK

Date of Inspection: 06/04/2016

Contractor: Collins Engineers, Inc.

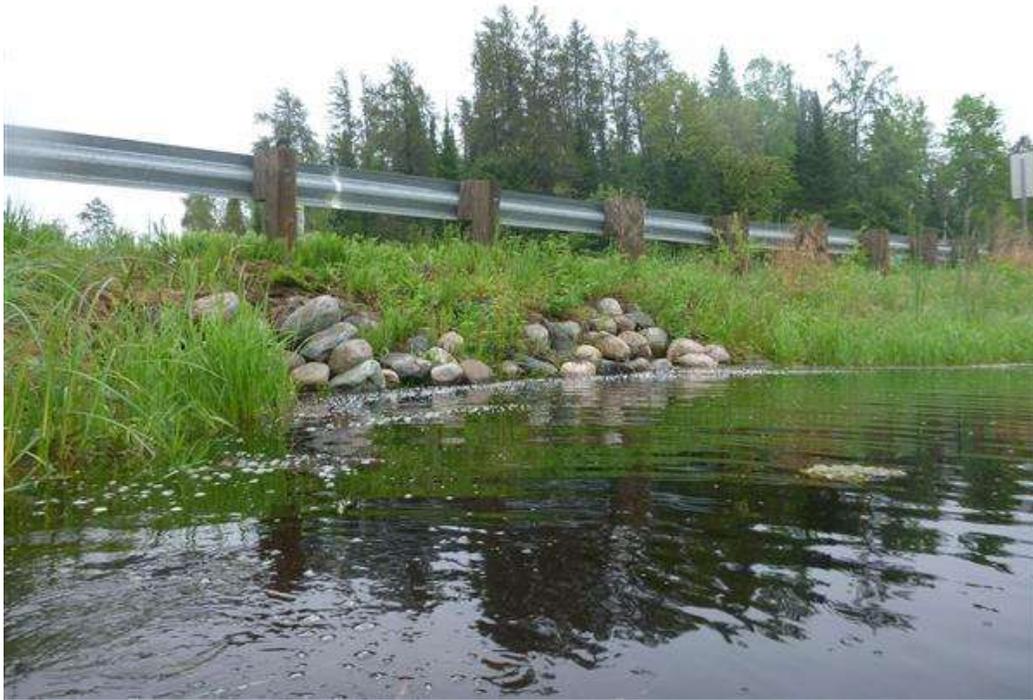
Photo 1 - Upstream Fascia, Looking Southeast

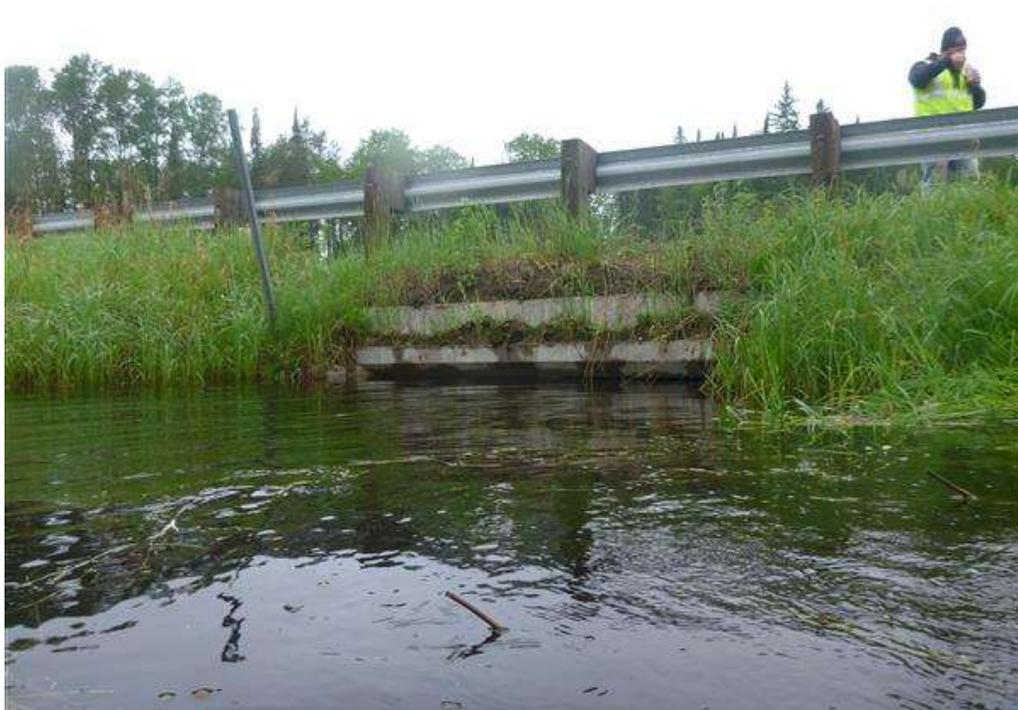
Photo 2 - Downstream Fascia, Looking Southwest

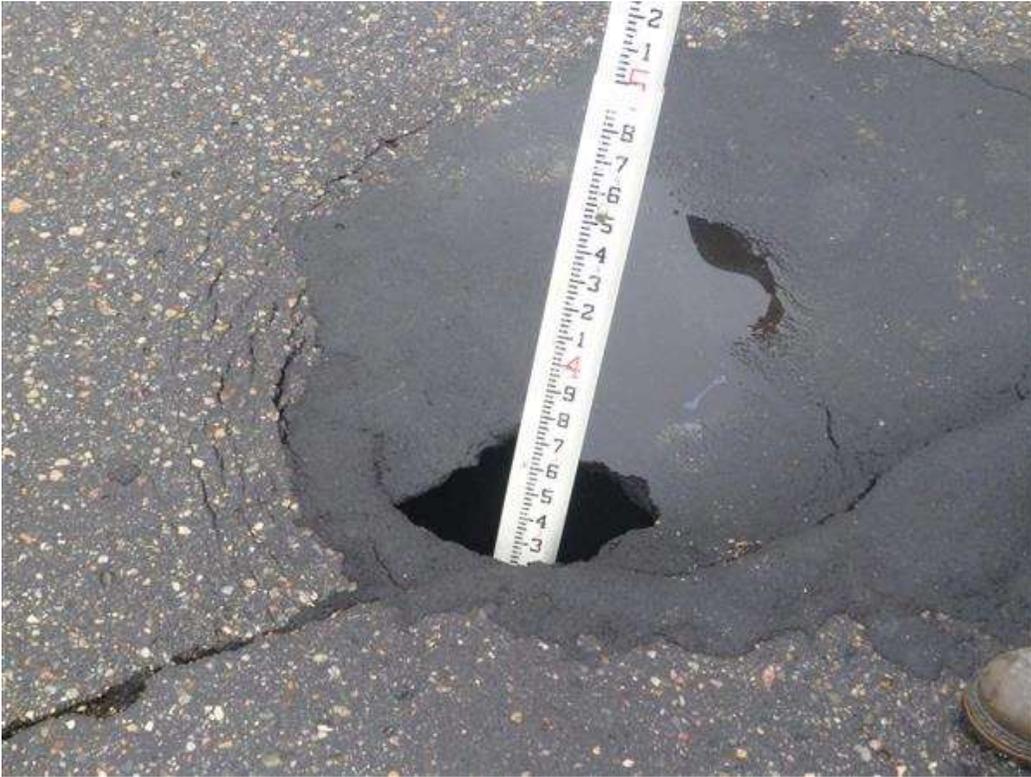
Photo 3 - Hole in Asphalt Patch above Open Culvert Joint, Looking Northeast

- ② The south side of the barrel contained a 2 foot high mound of fill material that was predominately by the open joint in the culvert.
- ③ The culvert joint located approximately 20 feet from the upstream end of the culvert was open along the roof for 8 to 10 inches wide with a steel plate over the gap. Along the walls, a gap up to 6 inches wide (width decreases moving downward) with exposed escaping fill was present on the south side of the culvert. The escaping fill on the south side has created a cavity (up to 3 feet high) in the roadbed under the asphalt pavement. At the north wall, there was a larger rock behind the gap and less evidence of fill loss.

(A) Corrective measures should be implemented immediately to repair the open culvert joint and eliminate the cavity beneath the roadway. (B) Assuming repairs are implemented, reinspect the submerged substructure units at the normal maximum recommended (NBIS) interval of sixty (60) months.

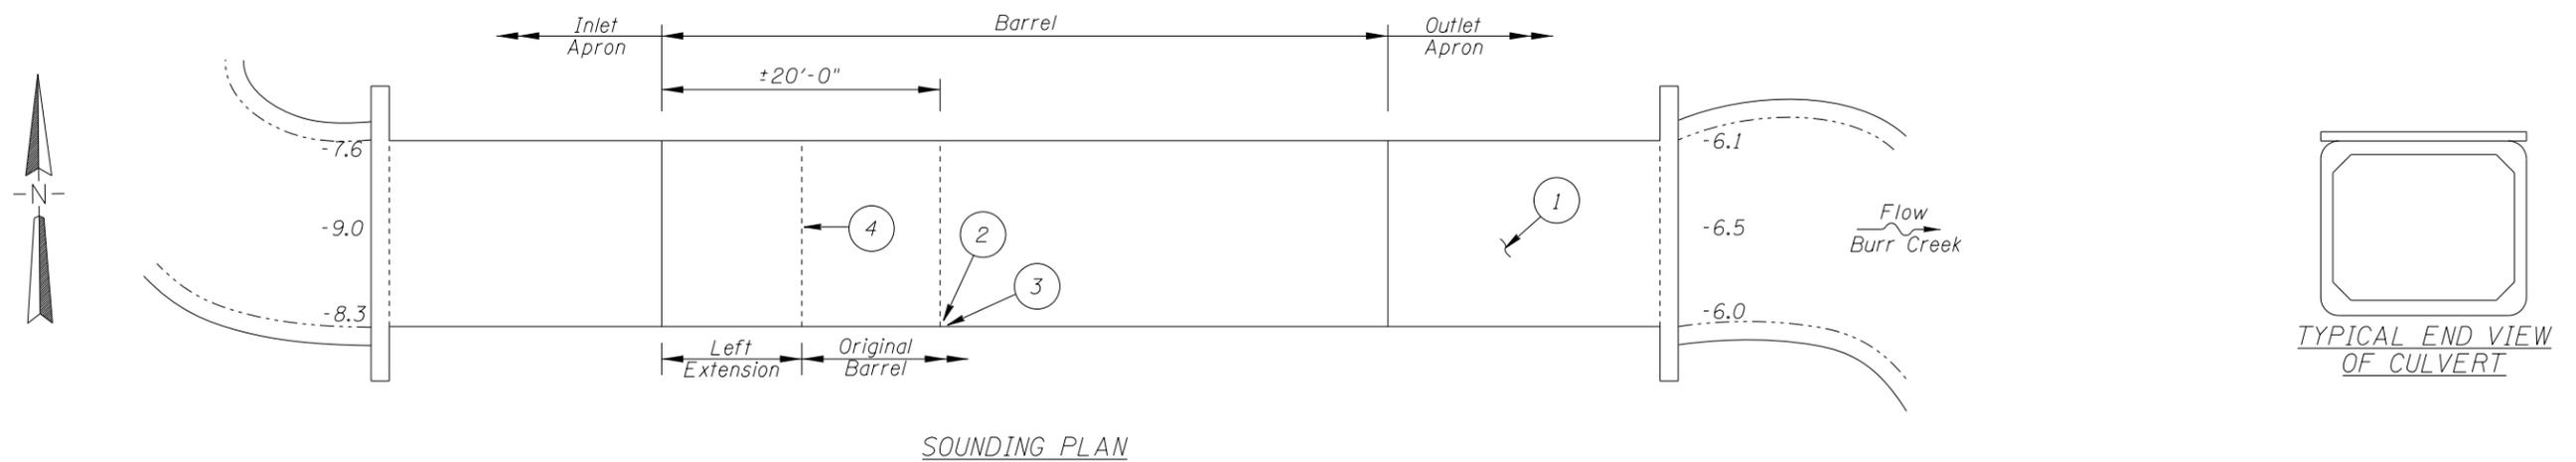
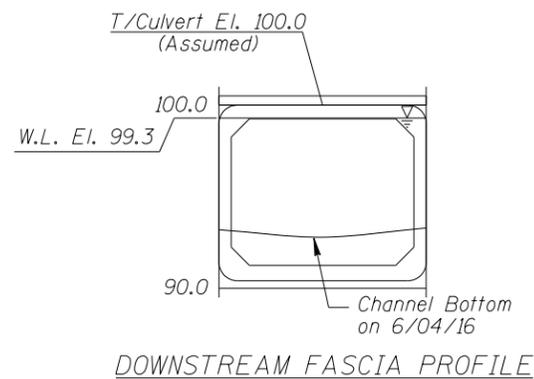
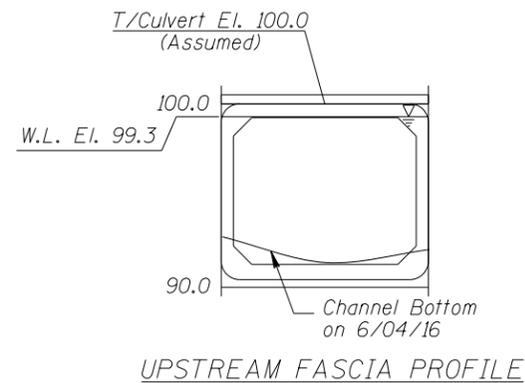
3. The concrete was typically in good condition with no notable deterioration and only minor scaling was present on the roof and wall surfaces. The scaling typically had up to 1/8 inch of penetration on the culvert surfaces.

- ① There was typically 2 to 3 feet of sediment on the floor of the culvert barrel and outlet apron. There was generally less sediment on the inlet apron floor.

- ④ The joint between the original barrel and left extension was up to 3 inches wide, but there was no exposed or escaping fill.
